NC DEPARTMENT OF TRANSPORTATION  
 DIVISION OF HIGHWAYS  
 STRUCTURE MANAGEMENT UNIT

ATTENTION: **PAR ISSUED, UPDATED SUPERSTRUCTURE SKETCH, UPDATED SOUTH BOUND LANE UNDERCLEARANCE SKETCH, UPDATED NORTH BOUND LANE UNDERCLEARANCE SKETCH.**

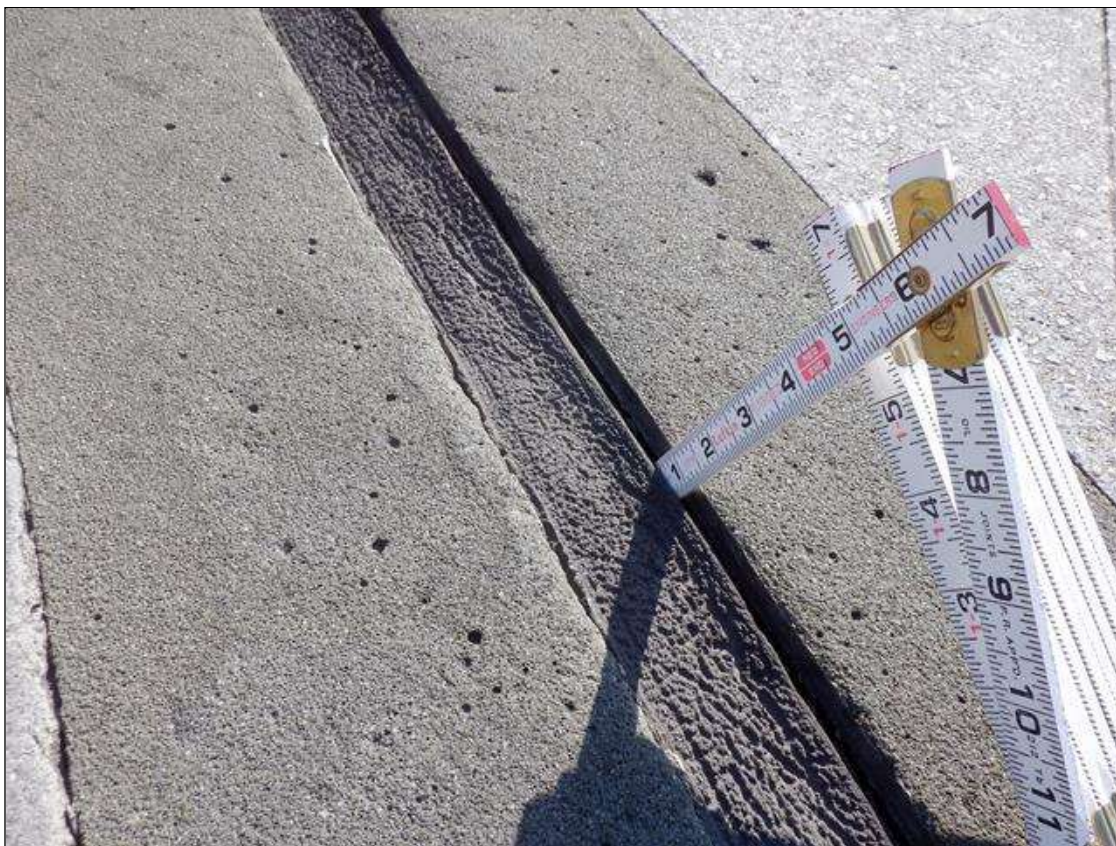
Expansion Joint : ADHESION FAILURE AT RANDOM LOCATIONS THROUGHOUT

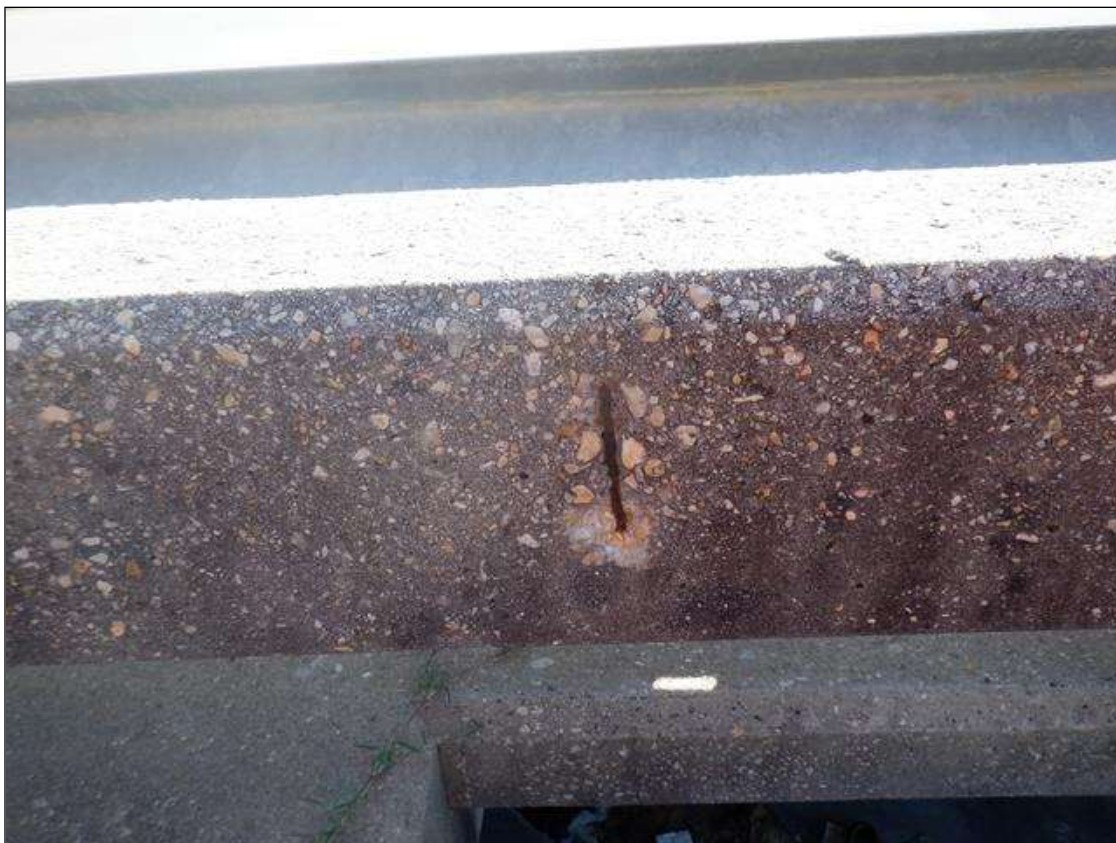
Span 4 Left Bridge Rail: 1 - SPALL WITH EXPOSED REBAR UP TO 6" DIAMETER X 1/2" DEEP IN RAIL

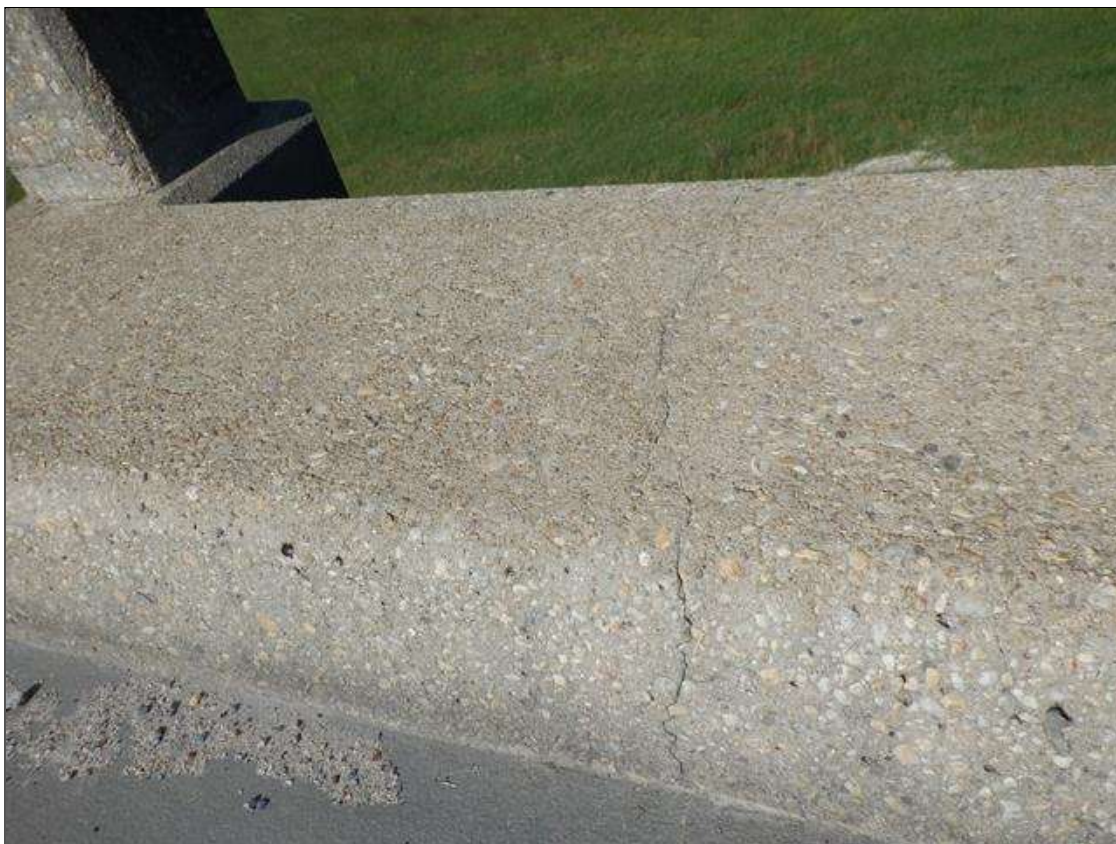
Span 4 Left Bridge Rail: 8 - 18" TRANSVERSE CRACKS UP TO 1/16" WIDE IN CURB

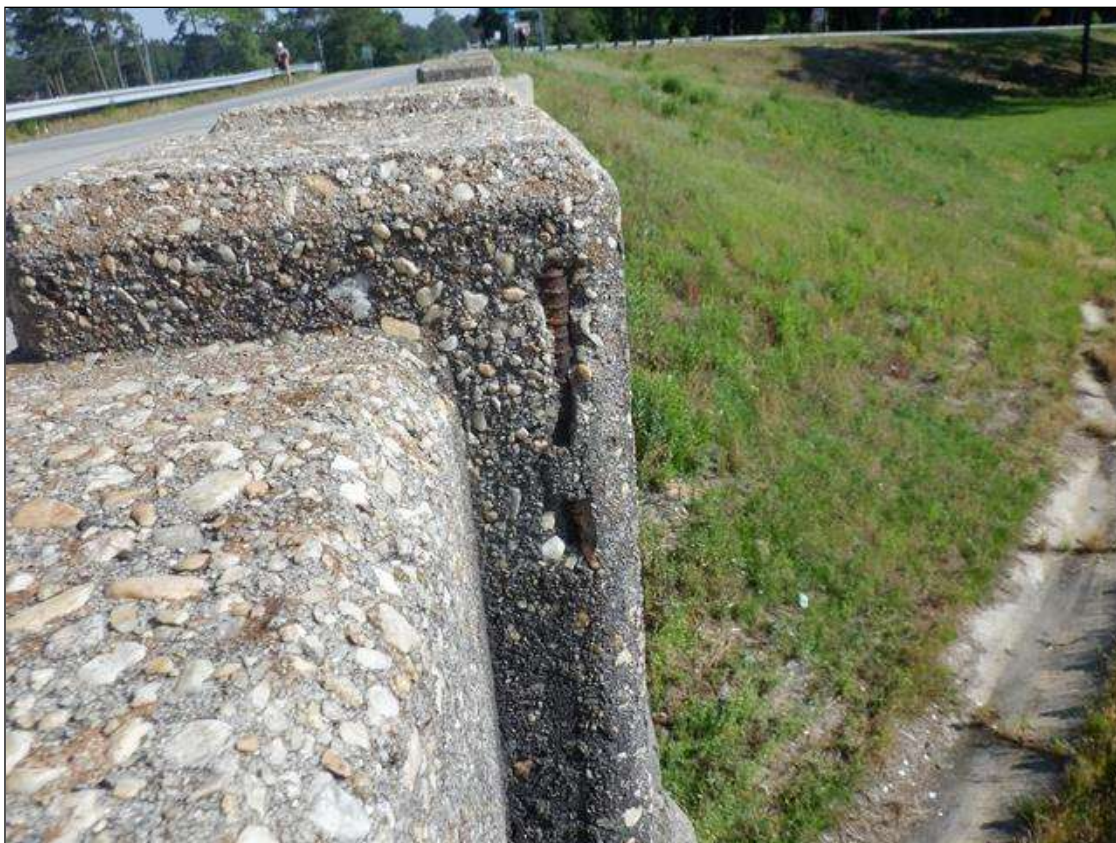
Span 3 Right Bridge Rail: 5 - SPALLS WITH EXPOSED REBAR UP TO 6" DIAMETER X 1/2" DEEP IN RAIL

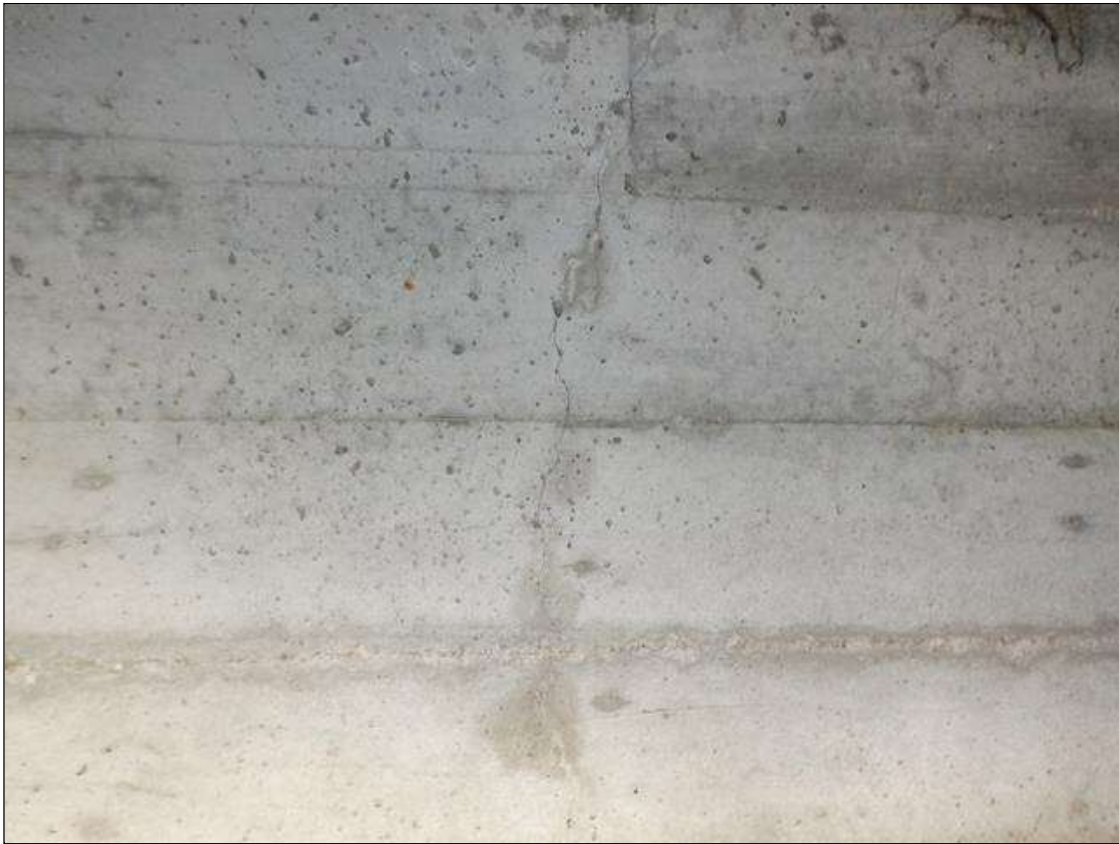
End Bent 1 Abutment/Backwall : 3 - 24" VERTICAL HAIRLINE CRACKS IN BAY 1

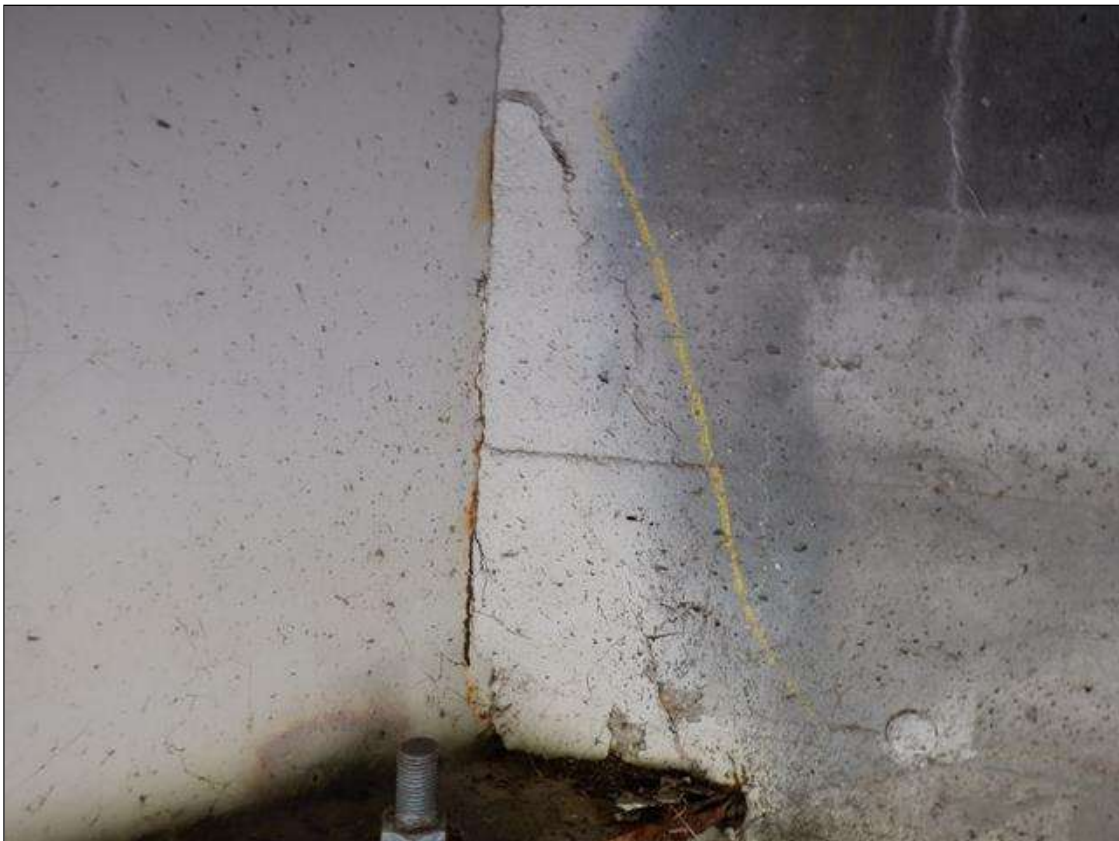
End Bent 1 Abutment/Backwall : 12" X 6" DELAMINATION IN BAY 1

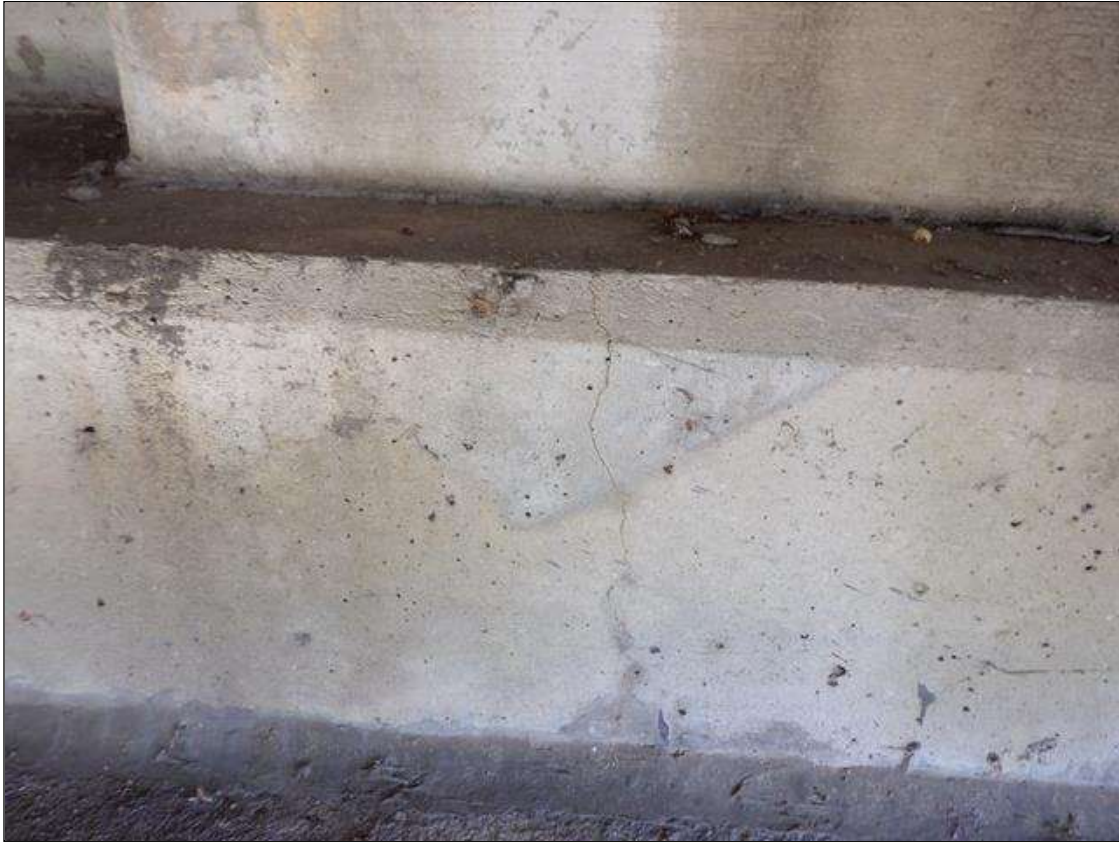
End Bent 1 Cap 1: 3 - 12" VERTICAL CRACKS UP TO 1/16" WIDE UNDER BAY 1

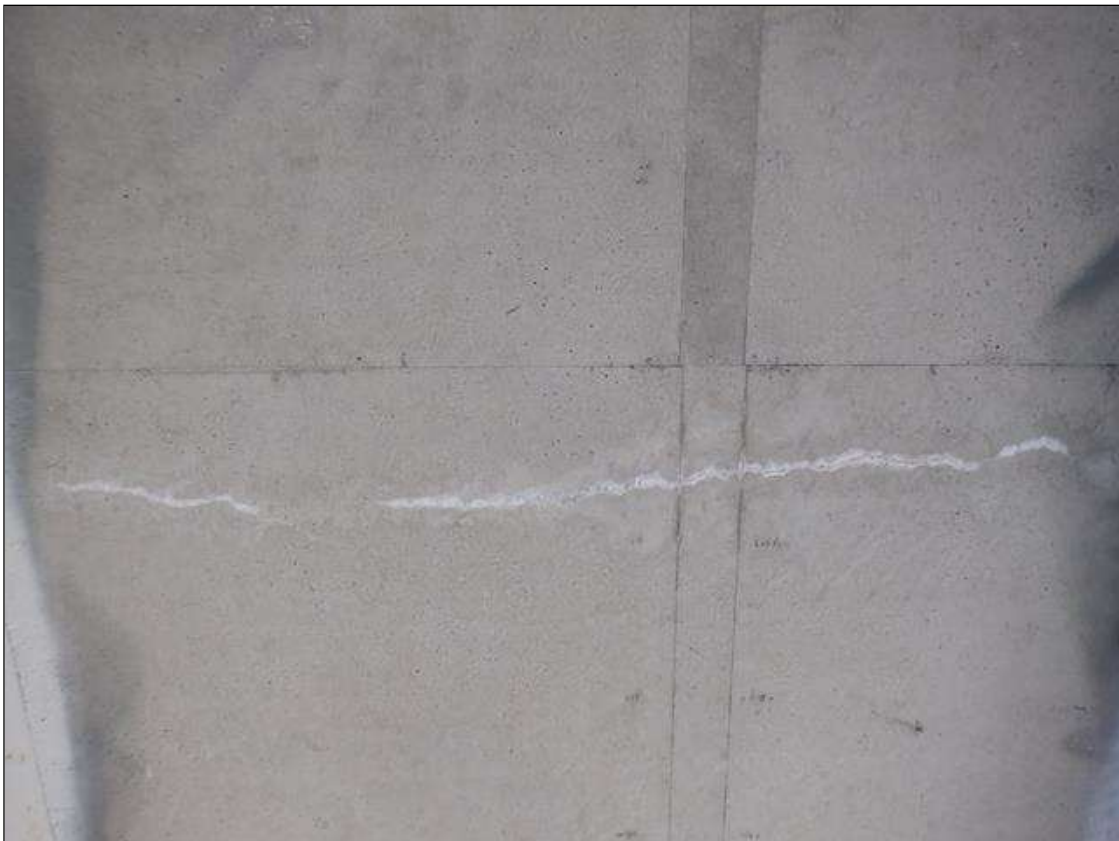
Span 1 Deck: 300 SF. OF TRANSVERSE HAIRLINE CRACKS IN BOTTOM OF DECK

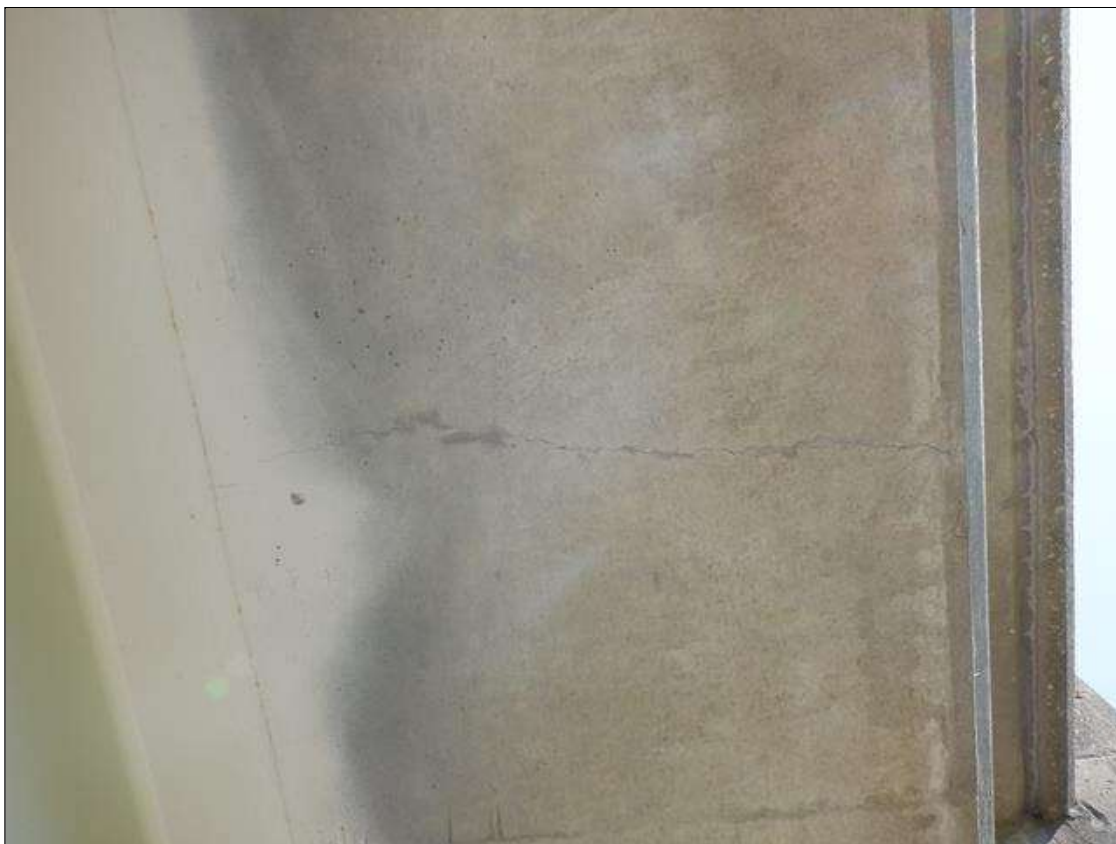
Span 1 Deck: 14 - 24" TRANSVERSE HAIRLINE CRACKS IN BOTTOM OF DECK EAST OVERHANG

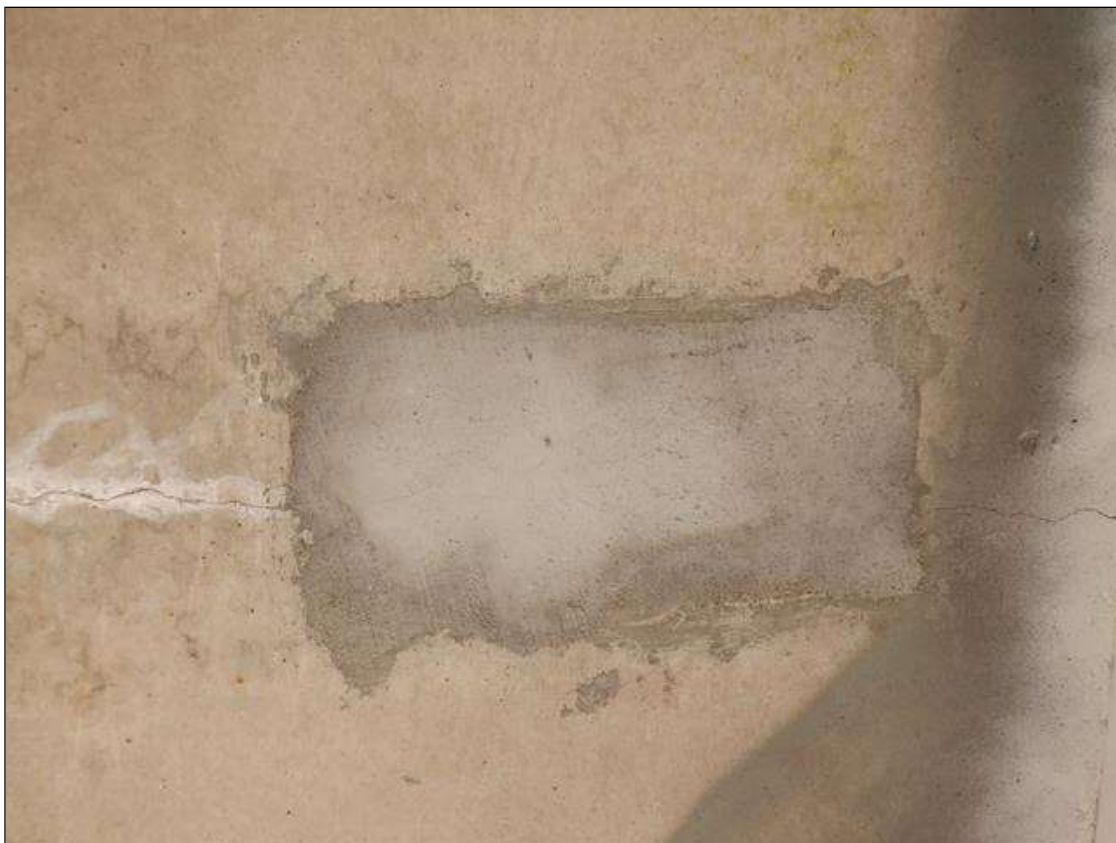
Span 1 Deck: 25 SF. OF PATCHED AREAS IN BOTTOM OF DECK

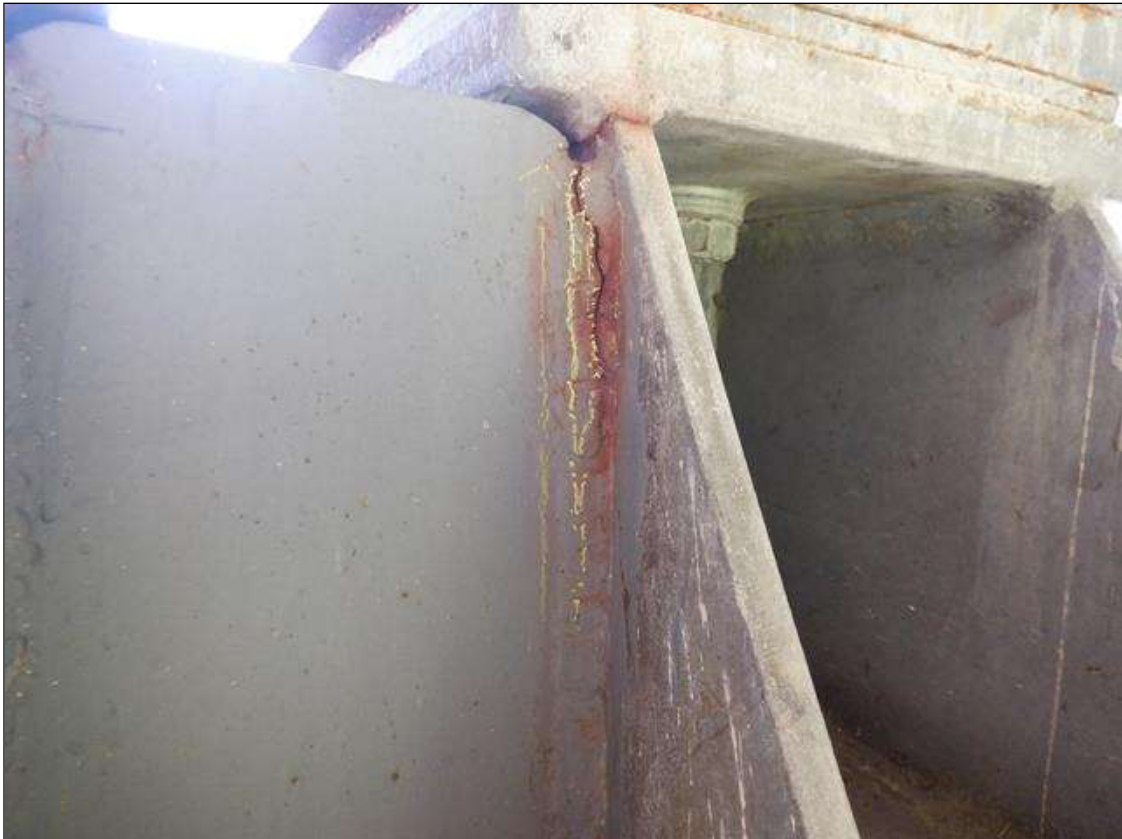
Span 1 Beam 1 Far Bearing: 2" LONG CRACK IN WELD OF EAST STIFFENER TO VERTICAL PLATE PAR

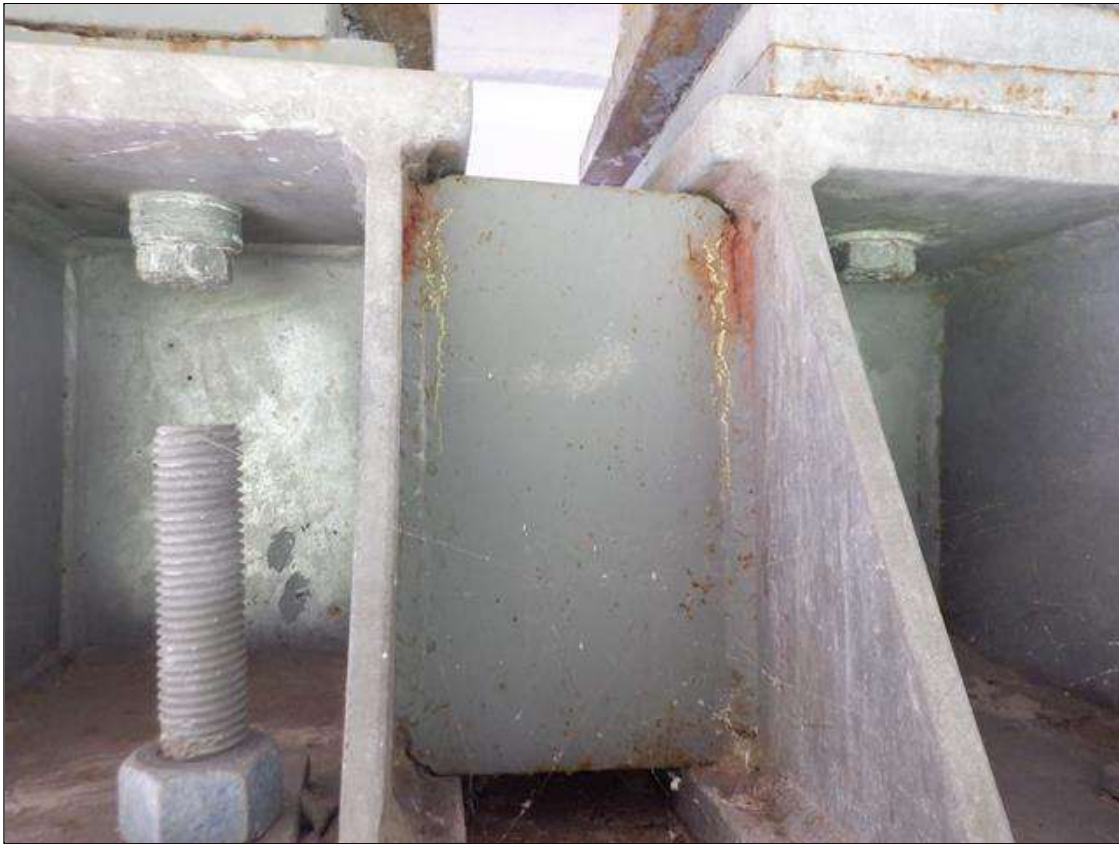
Span 1 Beam 2 Far Bearing: 2" LONG CRACK IN WELD OF EAST STIFFENER TO VERTICAL PLATE (BOTH PLATES) PAR

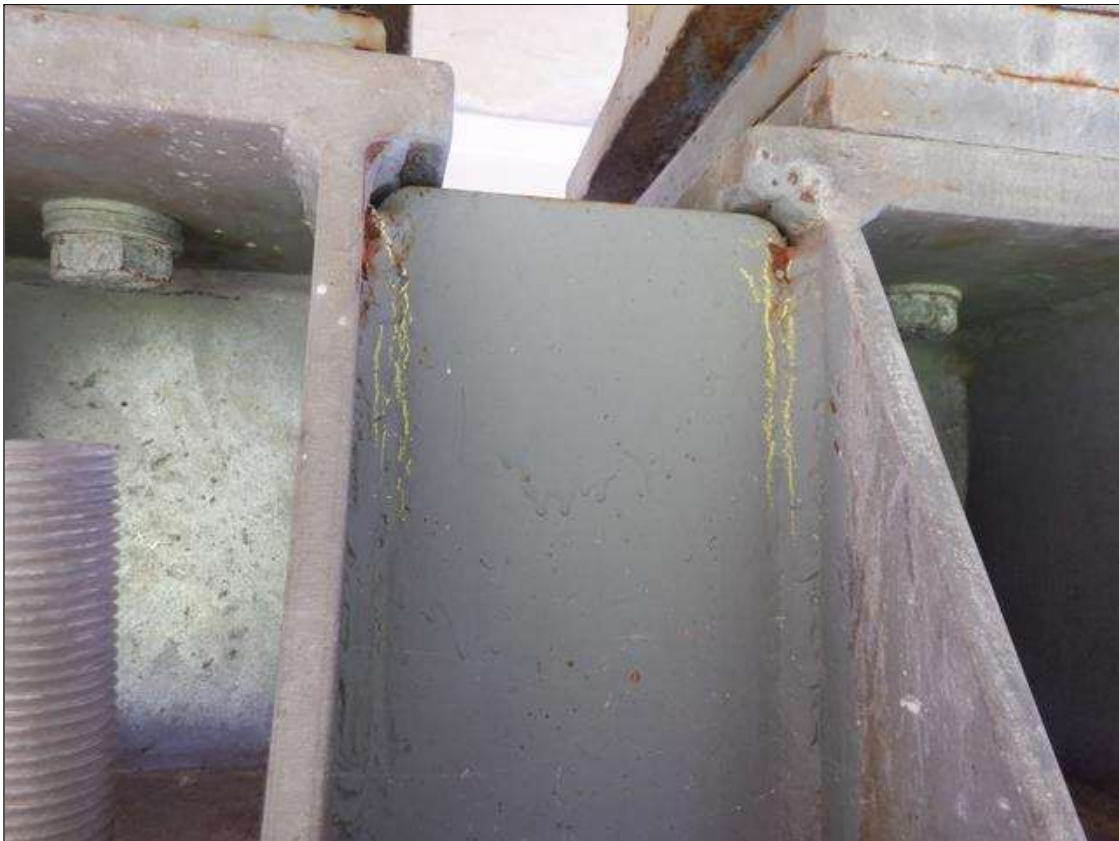
Span 1 Beam 3 Far Bearing: 1" LONG CRACK IN WELD OF WEST STIFFENER TO VERTICAL PLATE (BOTH PLATES) PAR

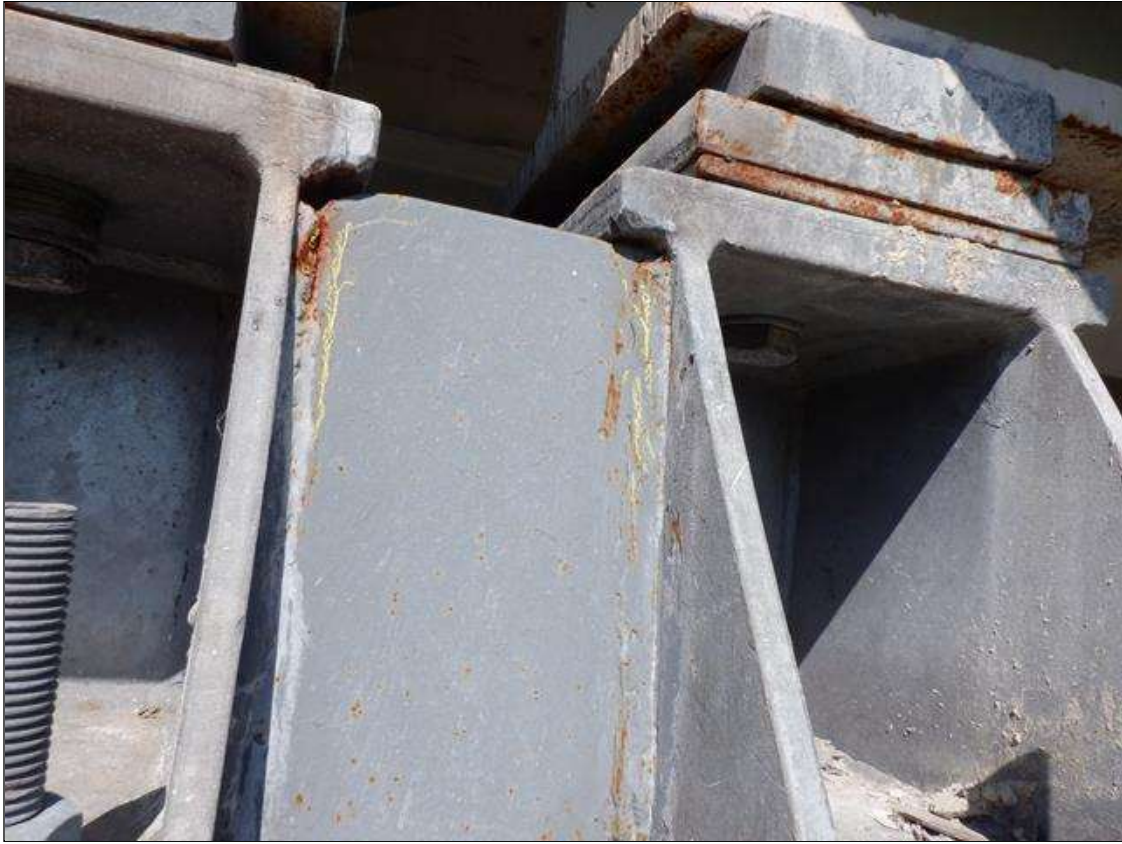
Span 1 Beam 4 Far Bearing: 1" LONG CRACK IN WELD OF EAST STIFFENER TO VERTICAL PLATE (BOTH PLATES) PAR

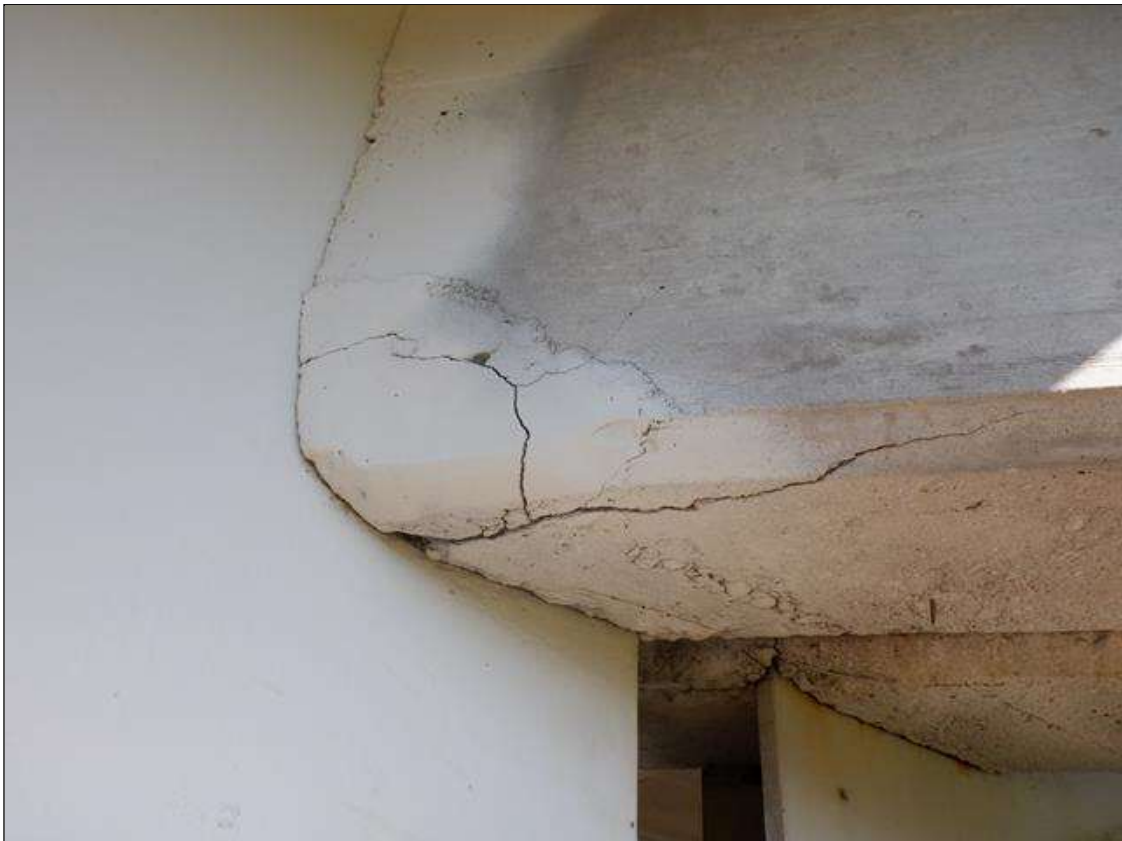
END DIAPHRAGM EAST OVERHANG AT BENT 1: 12" X 4" DELAMINATION

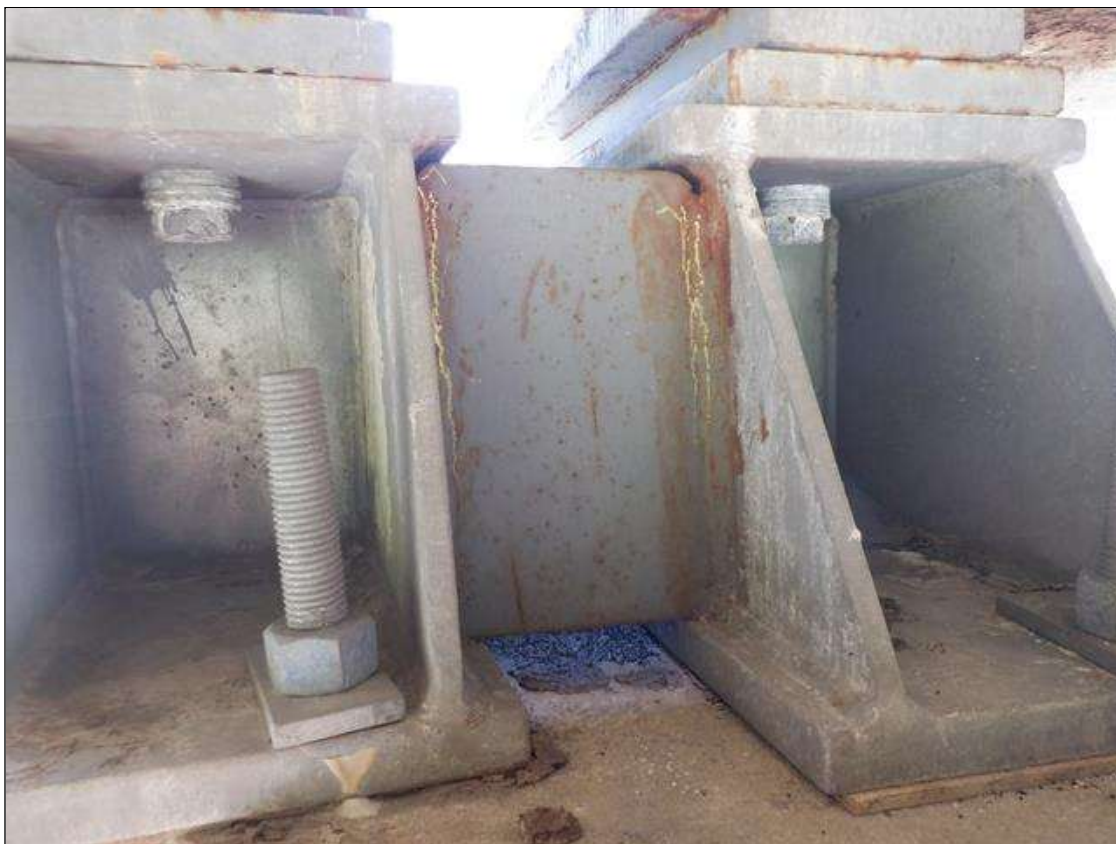
Span 2 Beam 1 Far Bearing: 1" LONG CRACK IN WELD OF EAST STIFFENER TO VERTICAL PLATE (BOTH PLATES) PAR

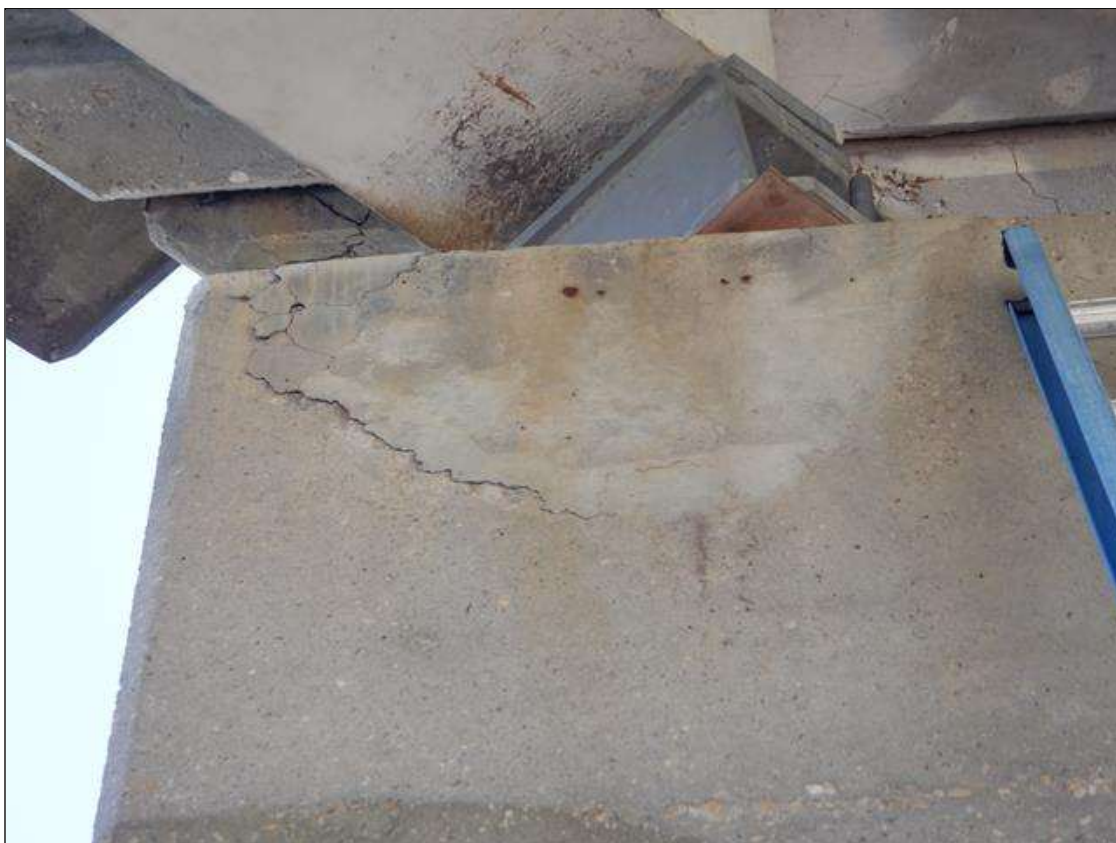
Bent 2 Cap 1: 18" X 6" DELAMINATION IN TOP OF CAP UNDER BEAM 1 SPAN 2 SIDE

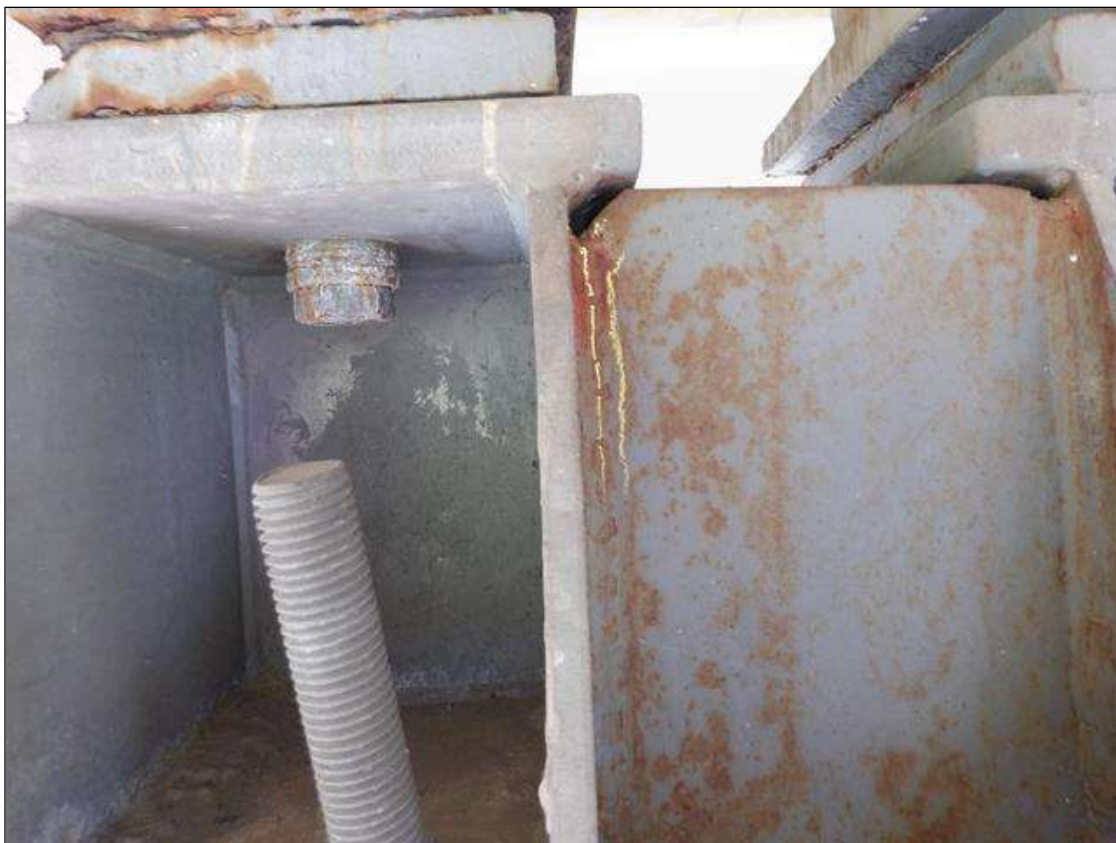
Span 2 Beam 3 Far Bearing: 1" LONG CRACK IN WELD OF WEST STIFFENER TO VERTICAL PLATE (BOTH SIDES) PAR

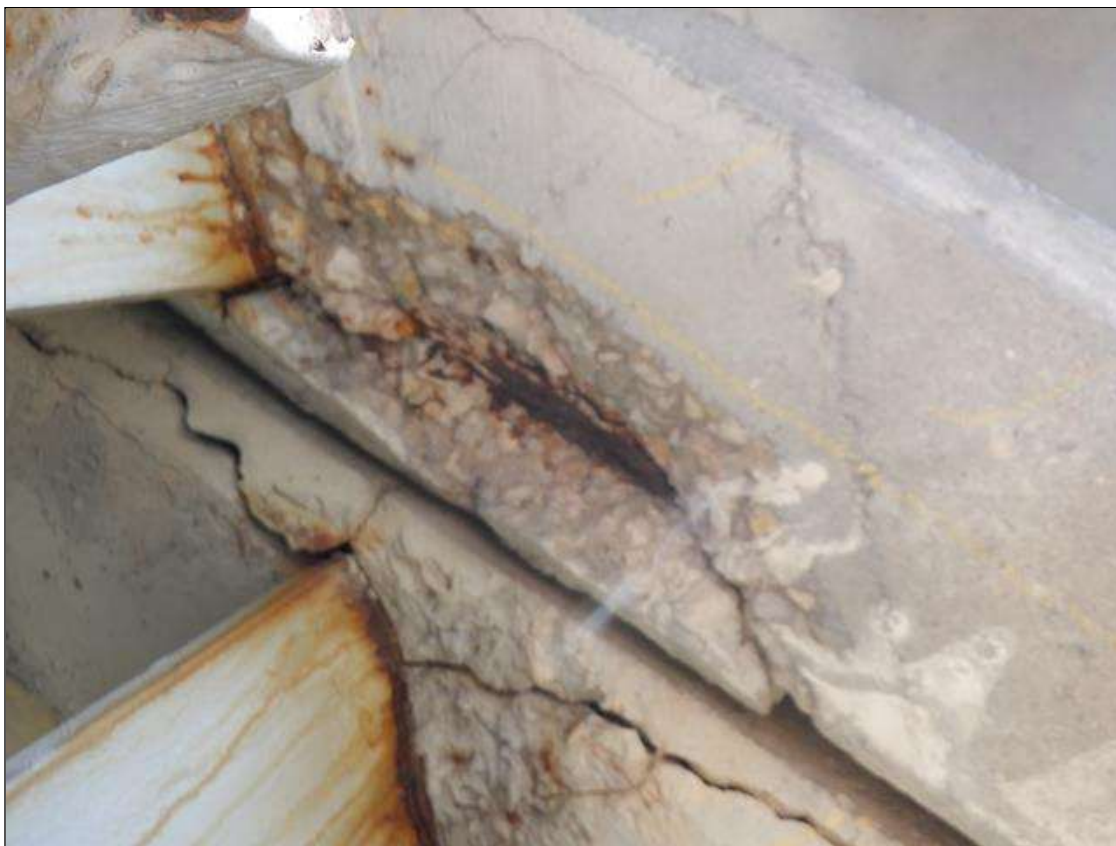
END DIAPHRAGM EAST OVERHANG AT BENT 2: 14" X 3" X 2" DEEP SPALL WITH EXPOSED REBAR

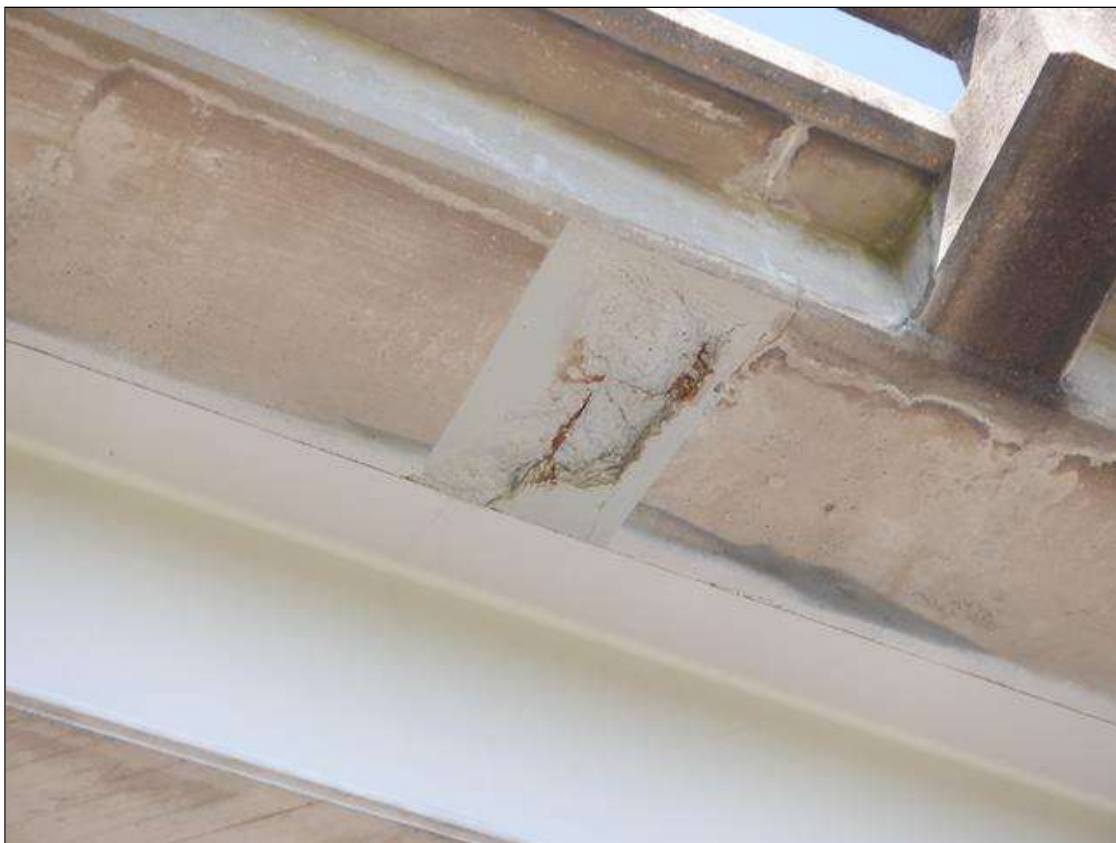
Span 2 Deck: 12" X 6" SPALL IN BOTTOM OF DECK EAST OVERHANG NEAR MIDSPAN OVER TRAFFIC PAR

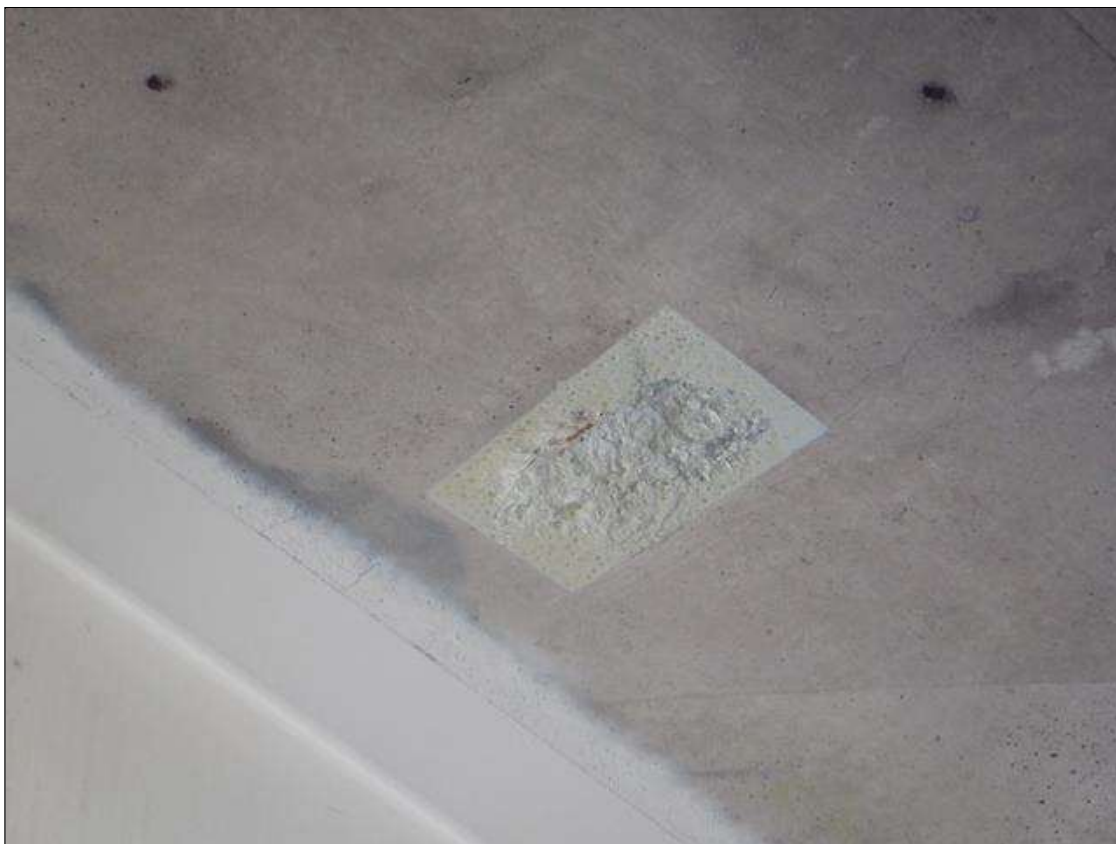
Span 2 Deck: 12" DIAMETER SPALL IN BOTTOM OF DECK BAY 1 OVER TRAFFIC PAR

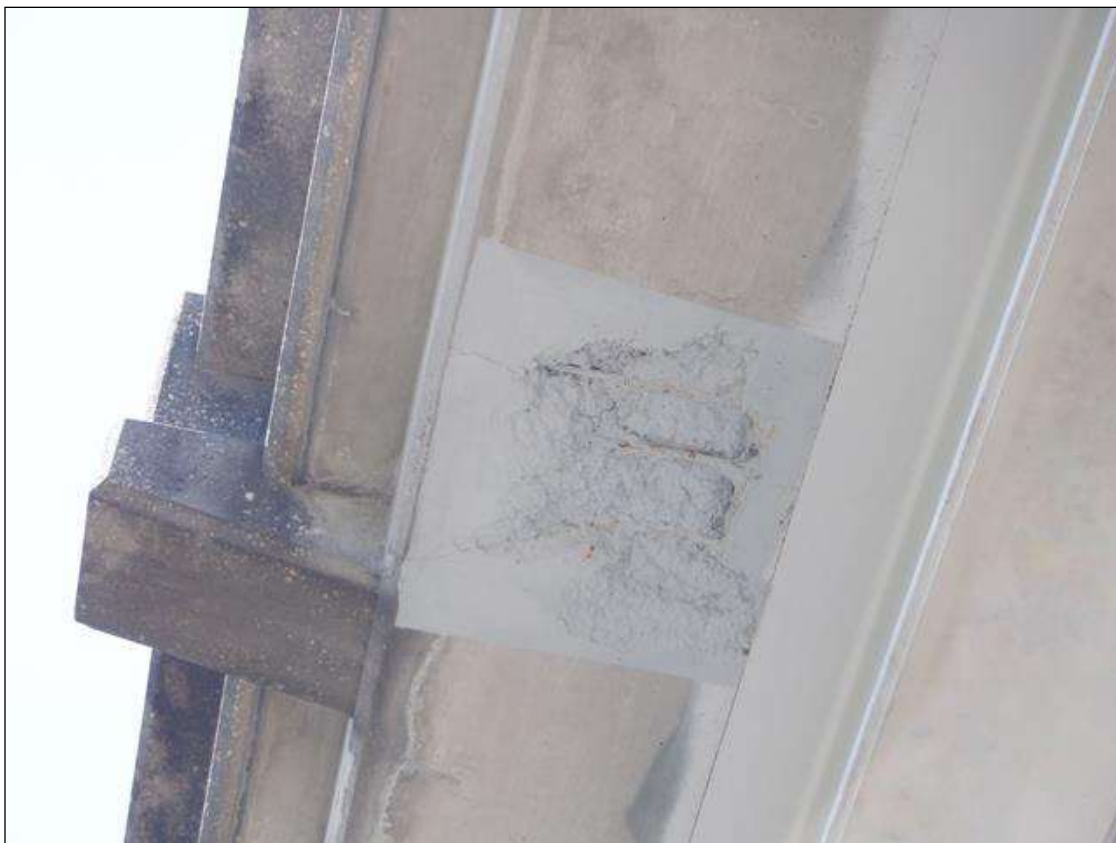
Span 2 Deck: 12" DIAMETER SPALL IN BOTTOM OF DECK EAST OVERHANG OVER TRAFFIC PAR

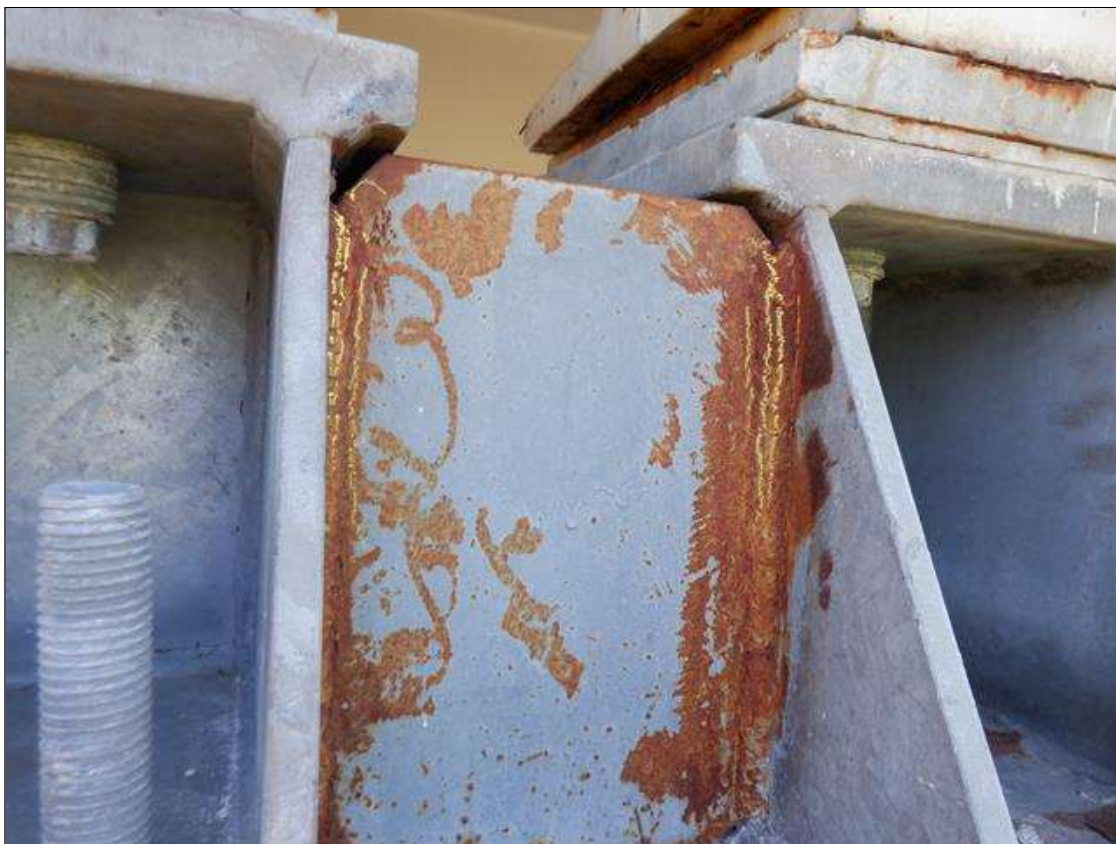
Span 3 Beam 1 Far Bearing: 1" LONG CRACK IN WELD OF EAST STIFFENER TO VERTICAL PLATE (BOTH SIDES)  
PAR

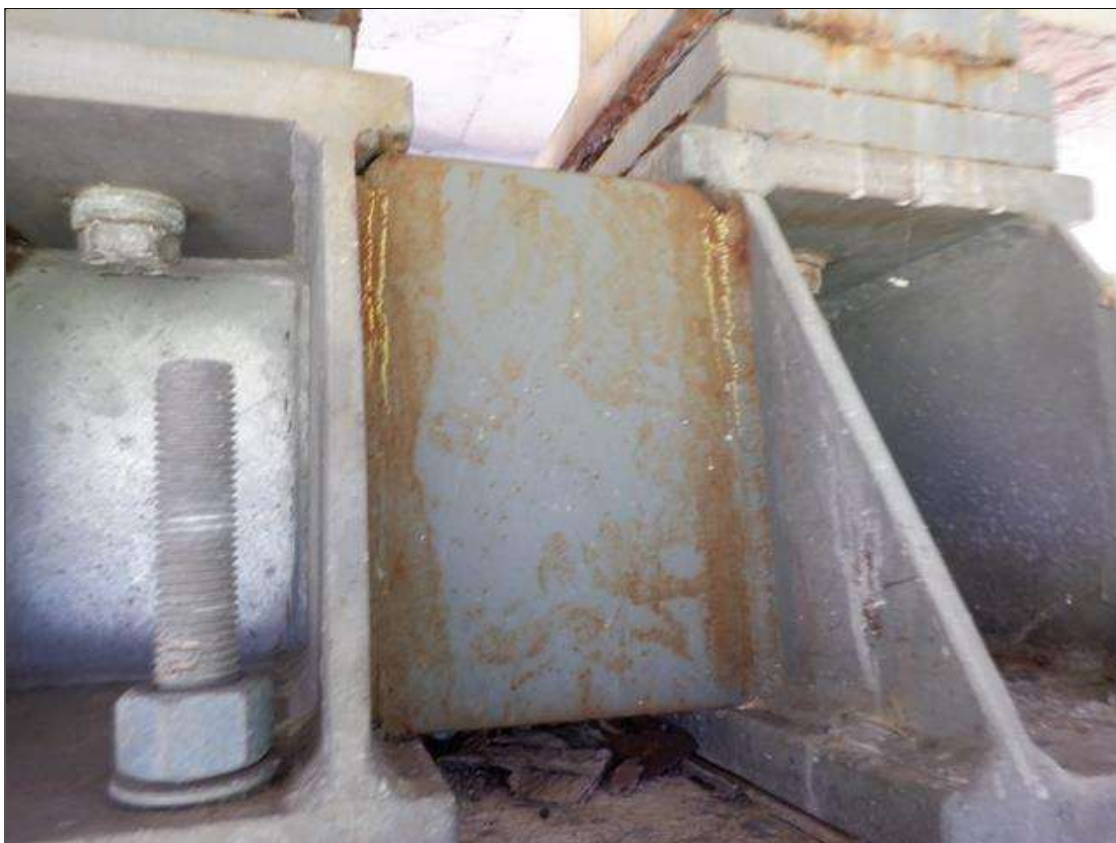
Span 4 Beam 2 Near Bearing: 2" LONG CRACK IN WELD OF EAST STIFFENER TO VERTICAL PLATE PAR
