NC DEPARTMENT OF TRANSPORTATION  
 DIVISION OF HIGHWAYS  
 STRUCTURE MANAGEMENT UNIT

ATTENTION: **PAR ISSUED, UPDATED SUPERSTRUCTURE SKETCH, UPDATED SOUTH BOUND LANE UNDERCLEARANCE SKETCH, UPDATED NORTH BOUND LANE UNDERCLEARANCE SKETCH.**

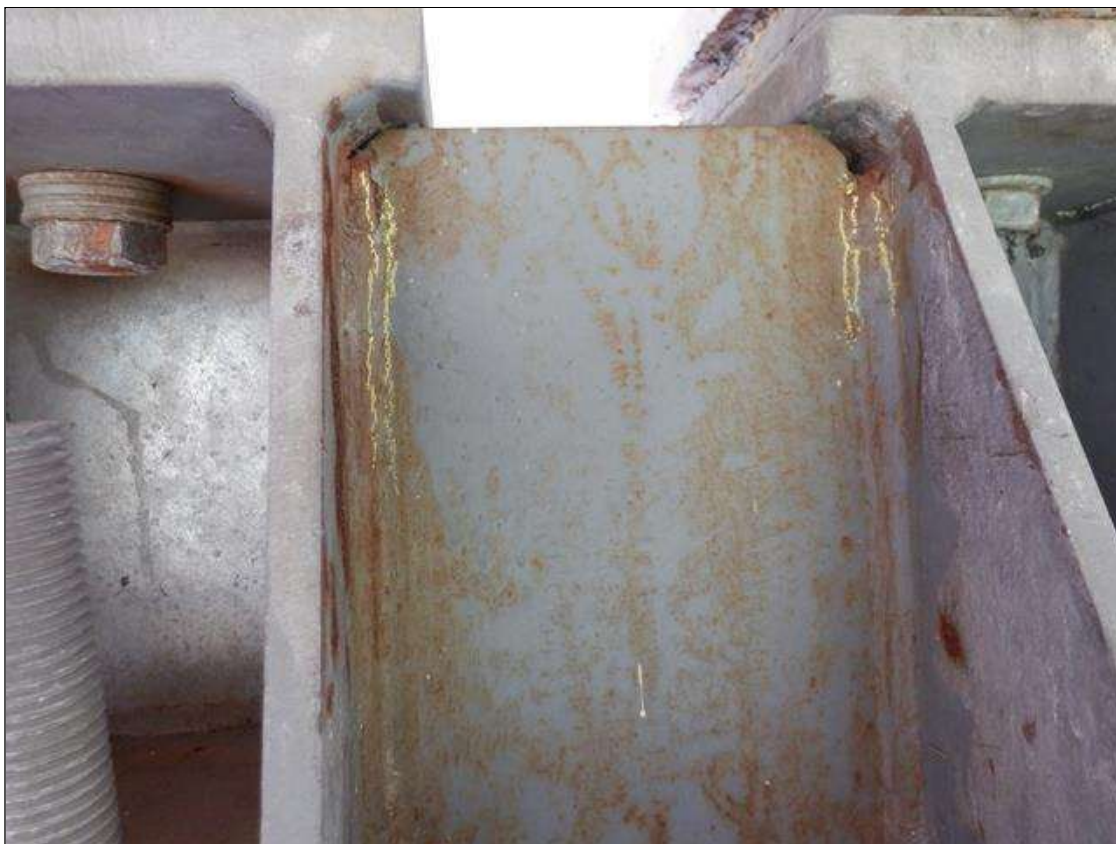
Span 4 Beam 3 Near Bearing: 1" LONG CRACK IN WELD OF WEST STIFFENER TO VERTICAL PLATE PAR

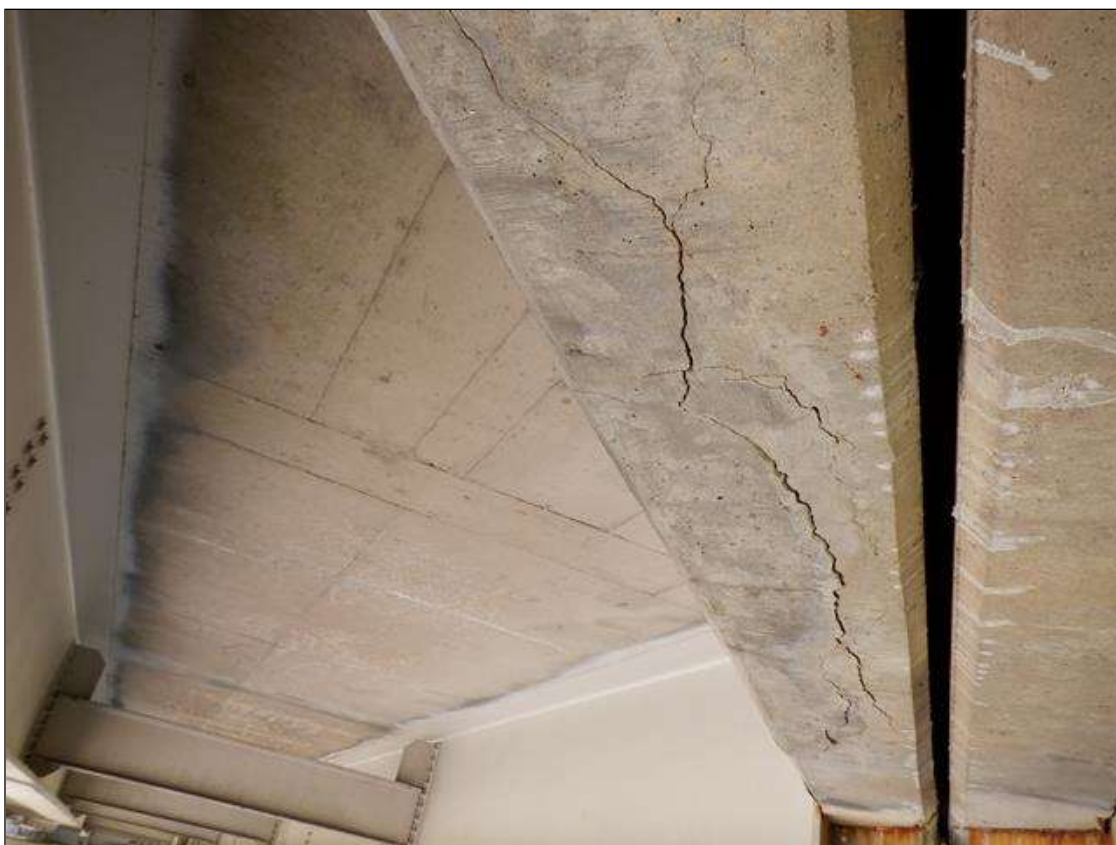
END DIAPHRAGM BAY 2 AT BENT 3: 84" X 10" DELAMINATION

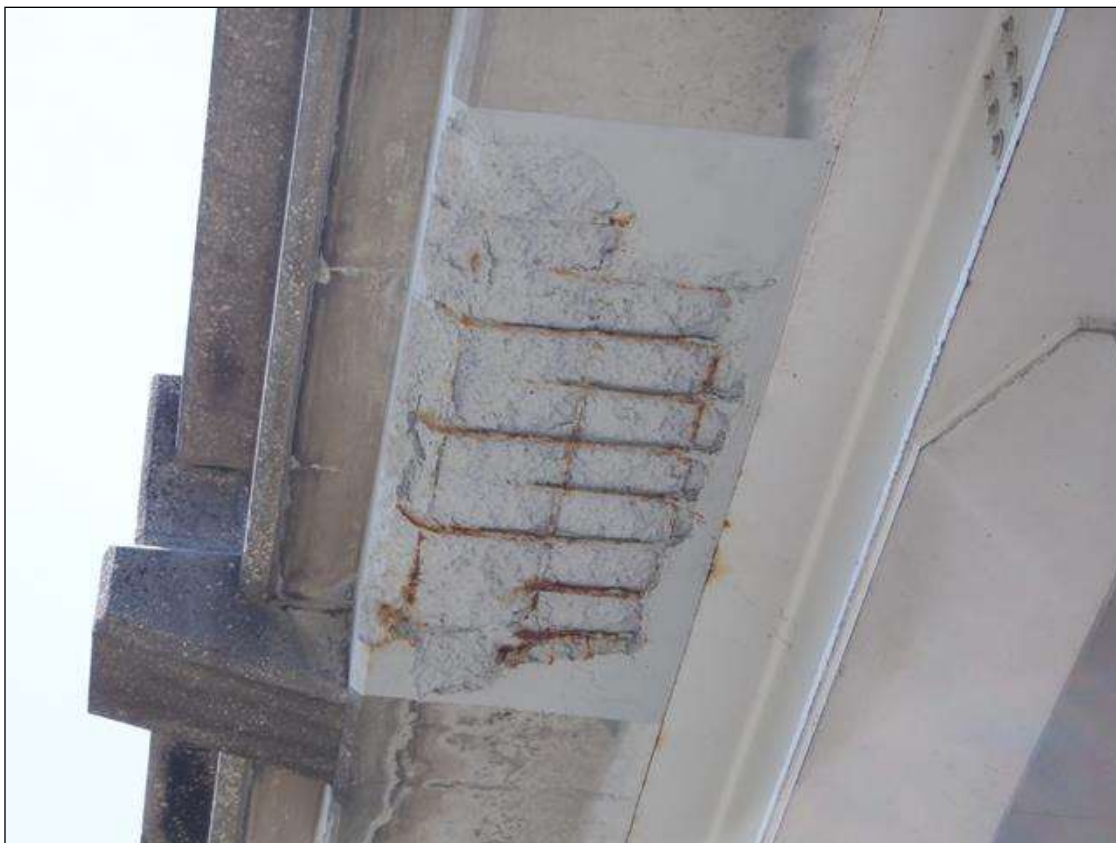
Span 3 Deck: 48" X 24" X 2" SPALL WITH EXPOSED REBAR IN BOTTOM OF DECK EAST OVERHANG OVER TRAFFIC PAR

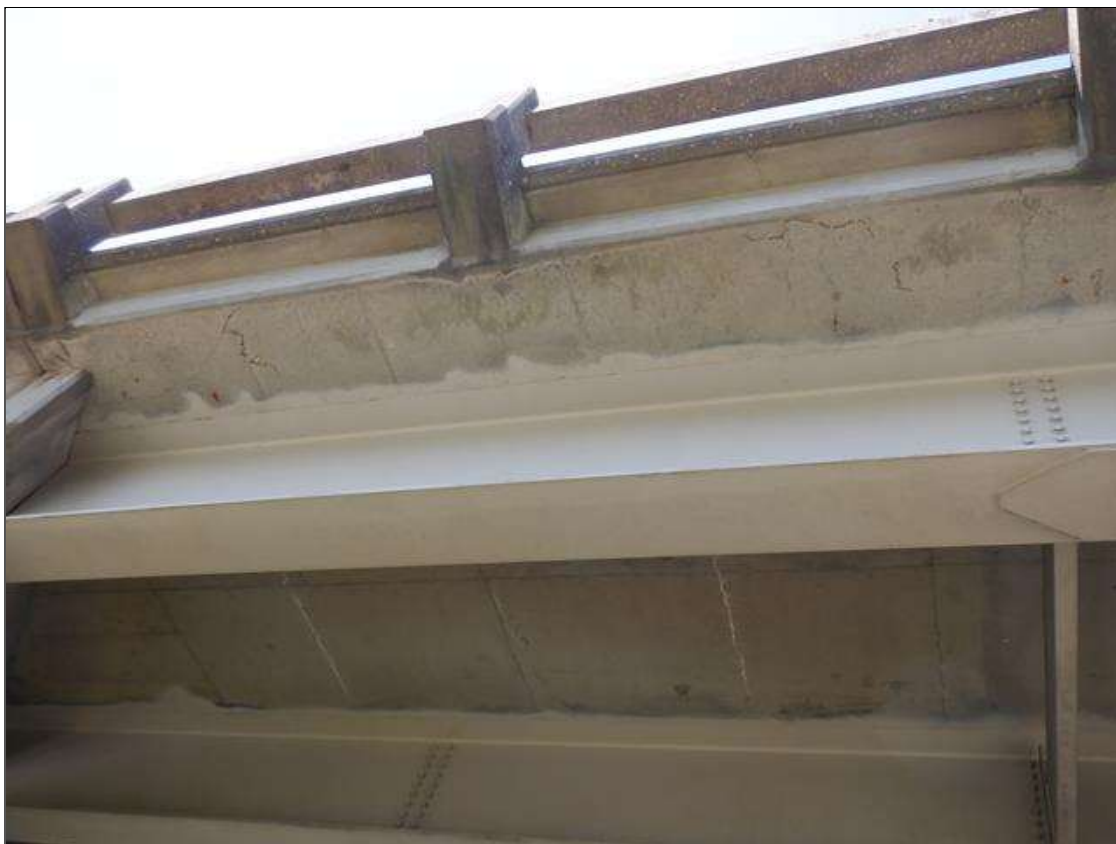
Span 3 Deck: 2-2FTX2FT DELAMINATION IN BOTTOM OF DECK AT EAST OVERHANG NEAR BENT 2 OVER SHOULDER

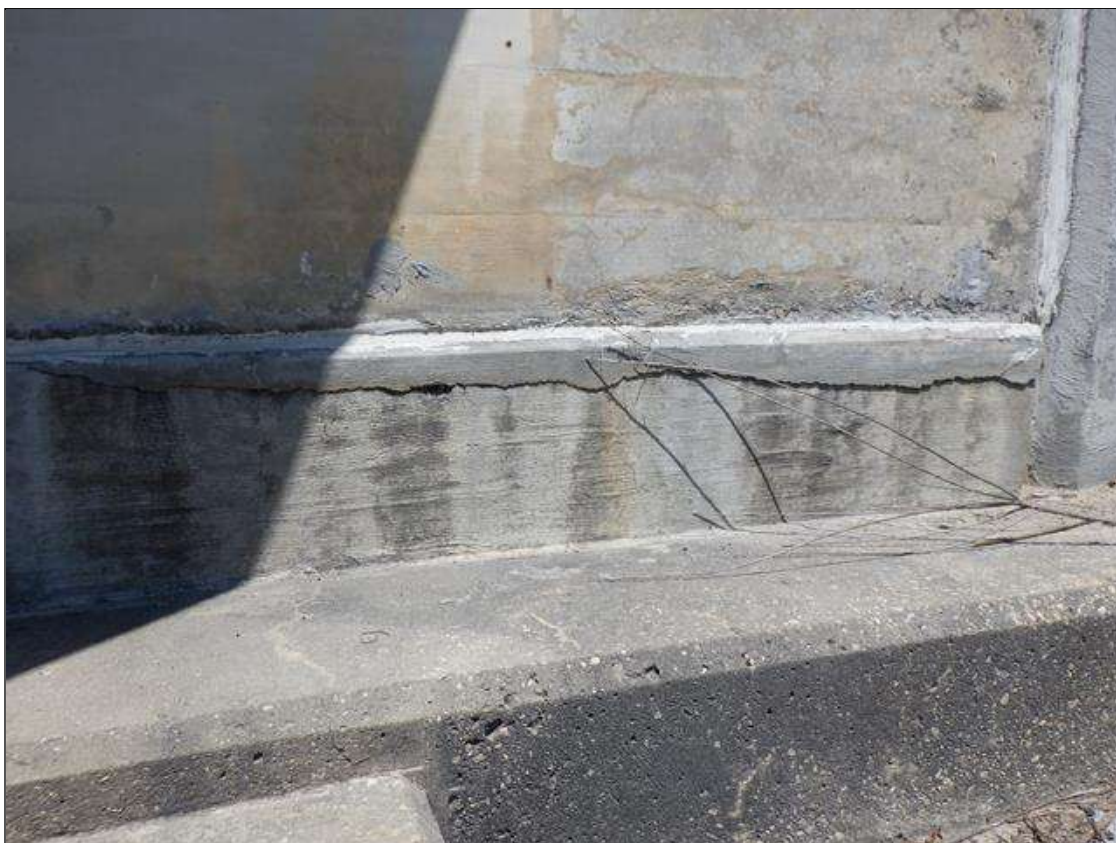
End Bent 2 Abutment/Backwall : 3 SF. OF HAIRLINE MAP CRACKING UNDER EAST OVERHANG WITH 4FT X 1/16" HORIZONTAL CRACK

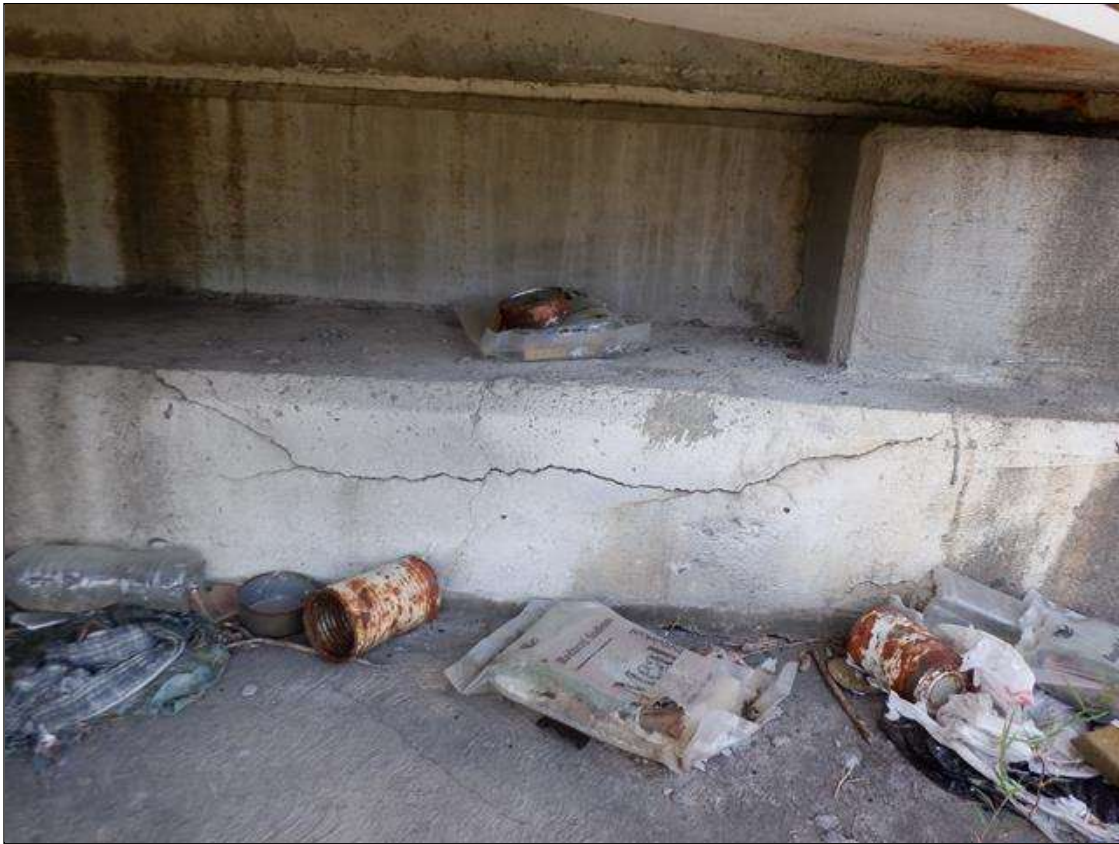
End Bent 2 Cap 1: 36" HORIZONTAL CRACK UP TO 1/8" WIDE UNDER BEAM 4

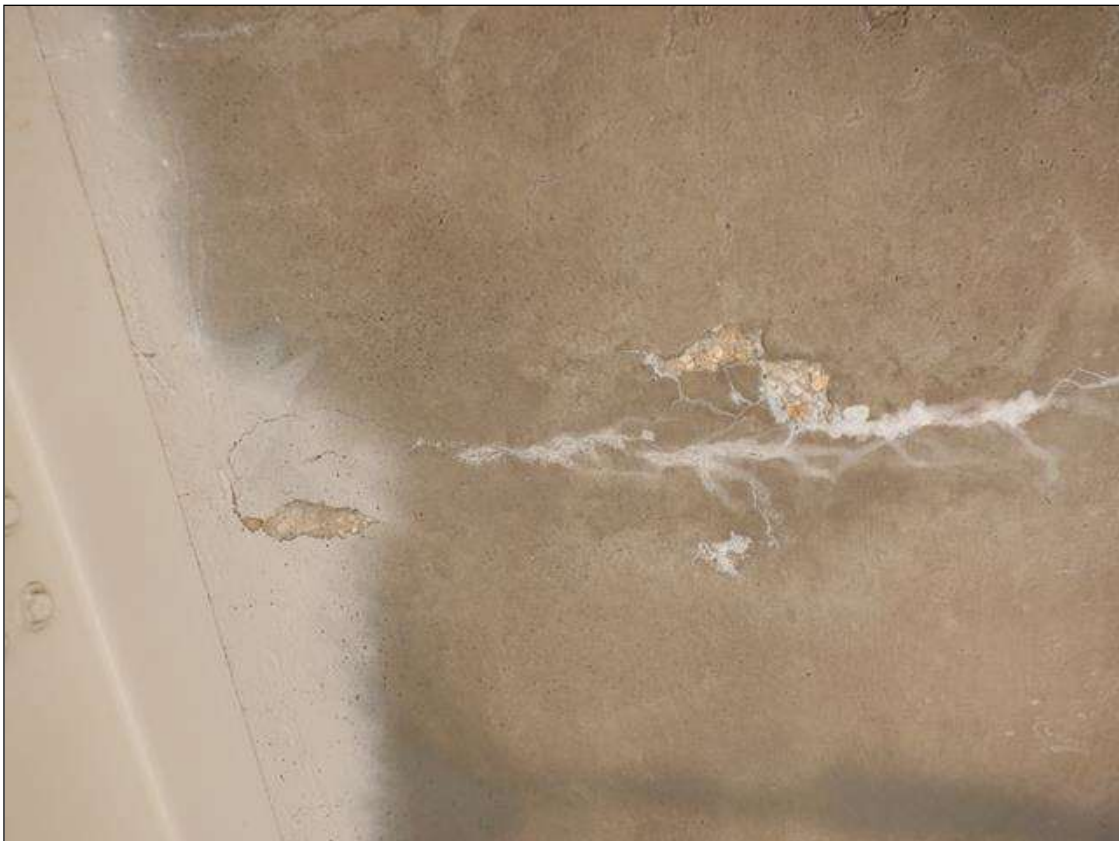
Span 4 Deck: 2FT LONG X 8' WIDE X 1/2" DEEP SPALL LOCATED IN BAY 3 BOTTOM OF DECK

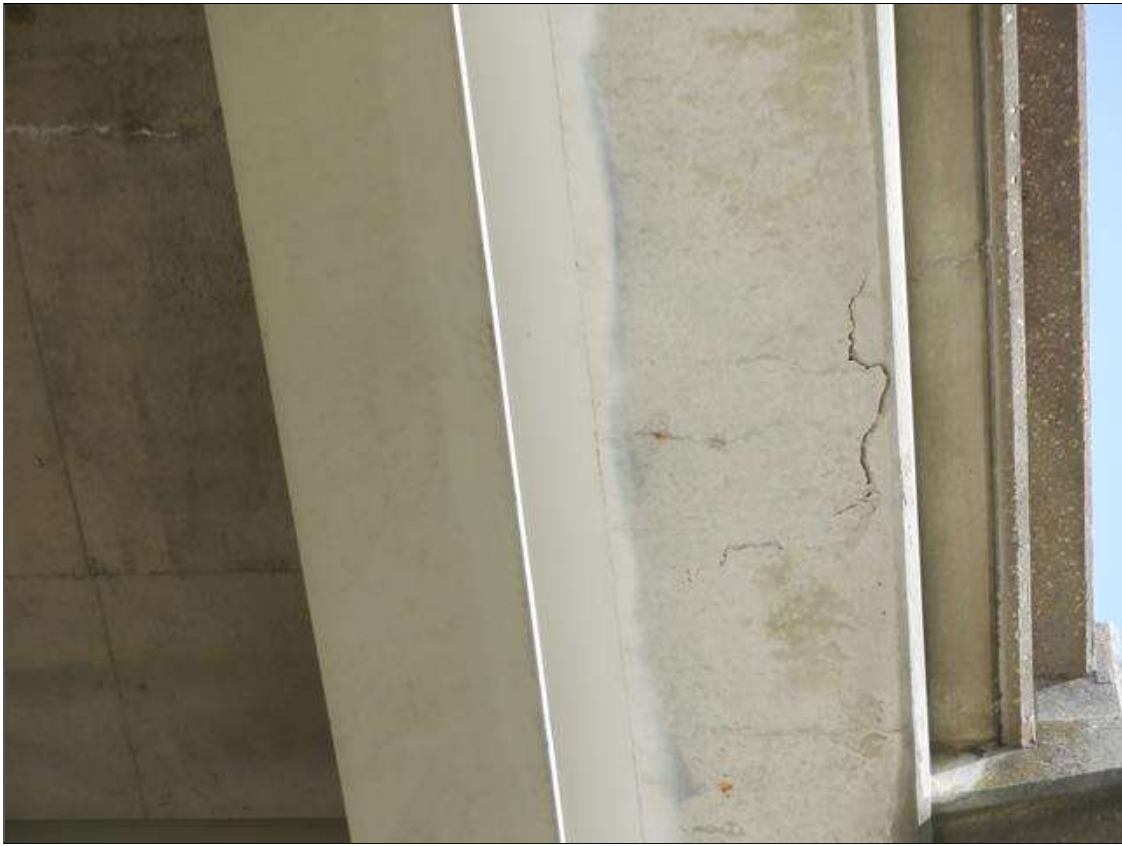
Span 3 Deck: 2 SF DELAMINATION LOCATED 12 FT FROM BENT 2 UNDER EAST OVERHANG OVER LEFT SHOULDER OF SB TRAVEL LANE

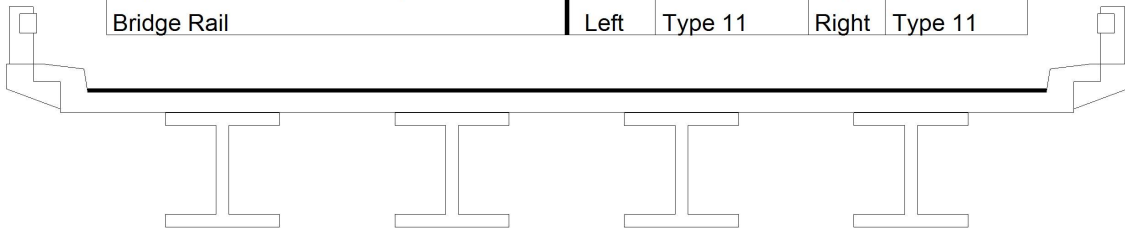
Measurements for Span #	1	SPANS 2-4 SIMILAR	
Deck Thickness	0.583	Left Overhang	4.708
Top of Rail to Bottom of Beam	6.188	Right Overhang	4.708

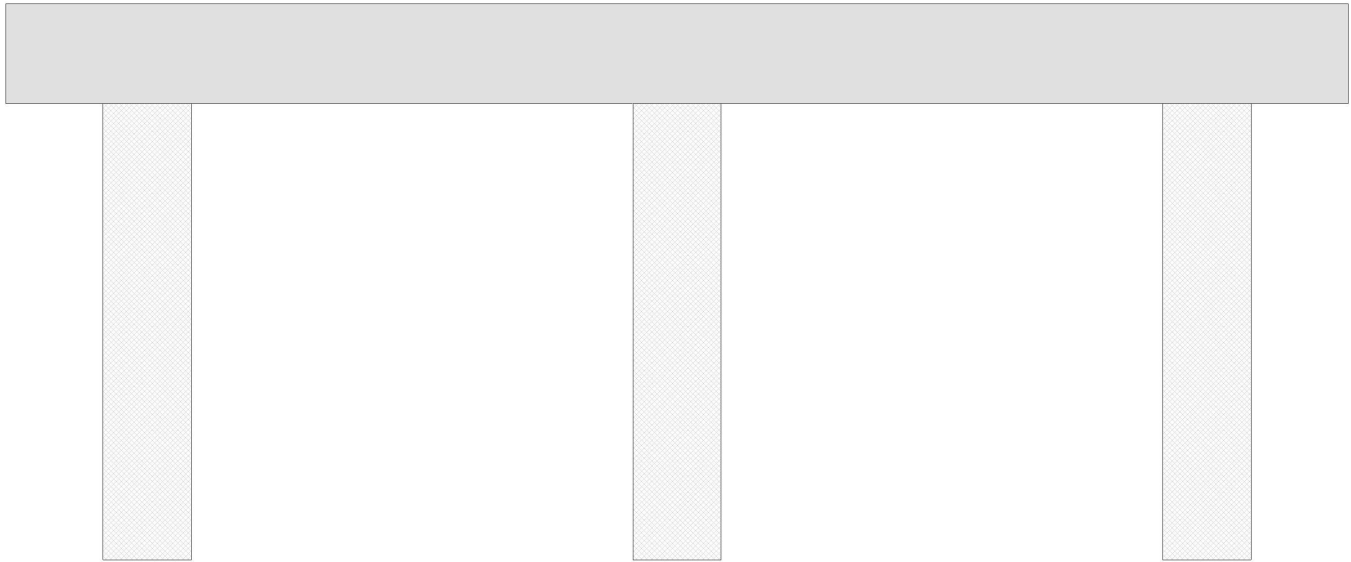
<b>Cap Information</b>			Material Cast-in-Place Concrete							
Length	Width	Height	Left Overhang	Right Overhang	Left Beam to End of Cap.	Right Beam to End of Cap.				
38.000 ft.	2.500 ft.	2.667 ft.	4.000 ft.	4.000 ft.	1.667 ft.	1.667 ft.				
<b>Subcap Information</b>			Material							
Length	Width	Height	Left Overhang	Right Overhang	Left Pile to Splice.					
<b>Sill Information</b>			Material							
Length	Width	Height								
Pile #	Material	Spacing	Width/Dia.	Height	Length	Orientation	Driven?	Replacement?	Removed?	Collar?
1	Concrete	15 ft.	2.5 ft.	2.5 ft.		Vertical	No	No	No	No
2	Concrete	15 ft.	2.5 ft.	2.5 ft.		Vertical	No	No	No	No
3	Concrete		2.5 ft.	2.5 ft.		Vertical	No	No	No	No
MEASUREMENTS VERIFIED 5/17/2019 BY JTE										
<b>Bent/Abutment #:</b> 1			<b>Similar Bents:</b> 2&3
