NC DEPARTMENT OF TRANSPORTATION
 DIVISION OF HIGHWAYS
 STRUCTURE MANAGEMENT UNIT

ATTENTION: PAR ISSUED, UPDATED STRUCTURE DATA WORKSHEET, UPDATED SUPERSTRUCTURE SKETCH, UPDATED SPAN 2 EAST BOUND LANE CLEARANCE SKETCH, UPDATED SPAN 2 WEST BOUND LANE CLEARANCE SKETCH.

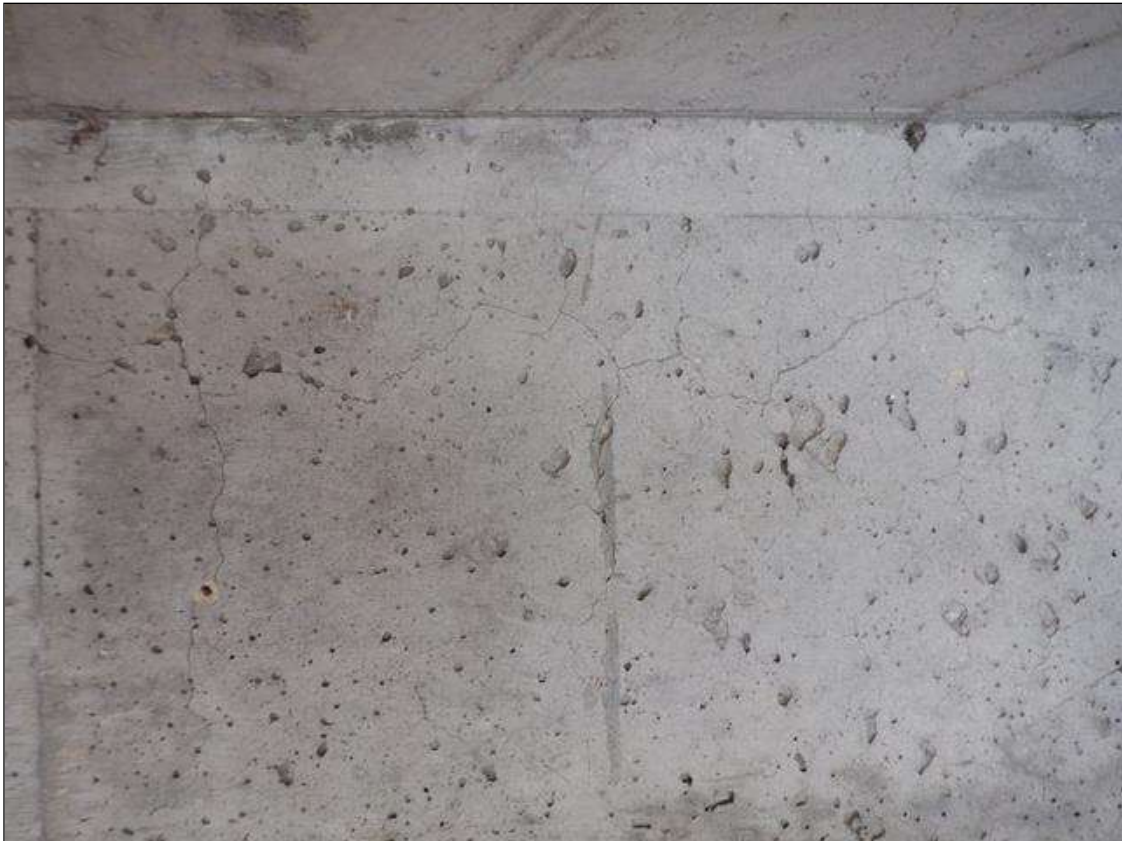
End Bent 1 Abutment/Backwall : 8 SF. OF HAIRLINE MAP CRACKING IN BAY 3

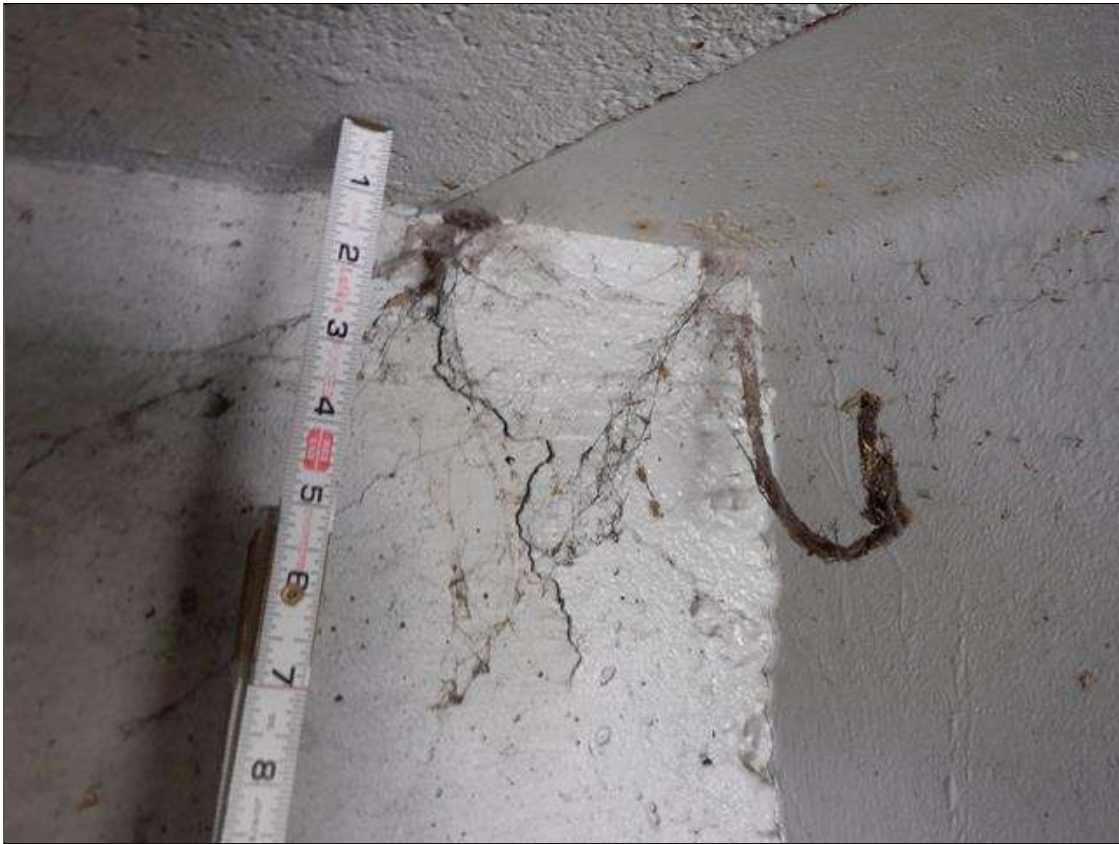
End Bent 1 Abutment/Backwall : 6" X 4" DELAMINATION IN BAY 2

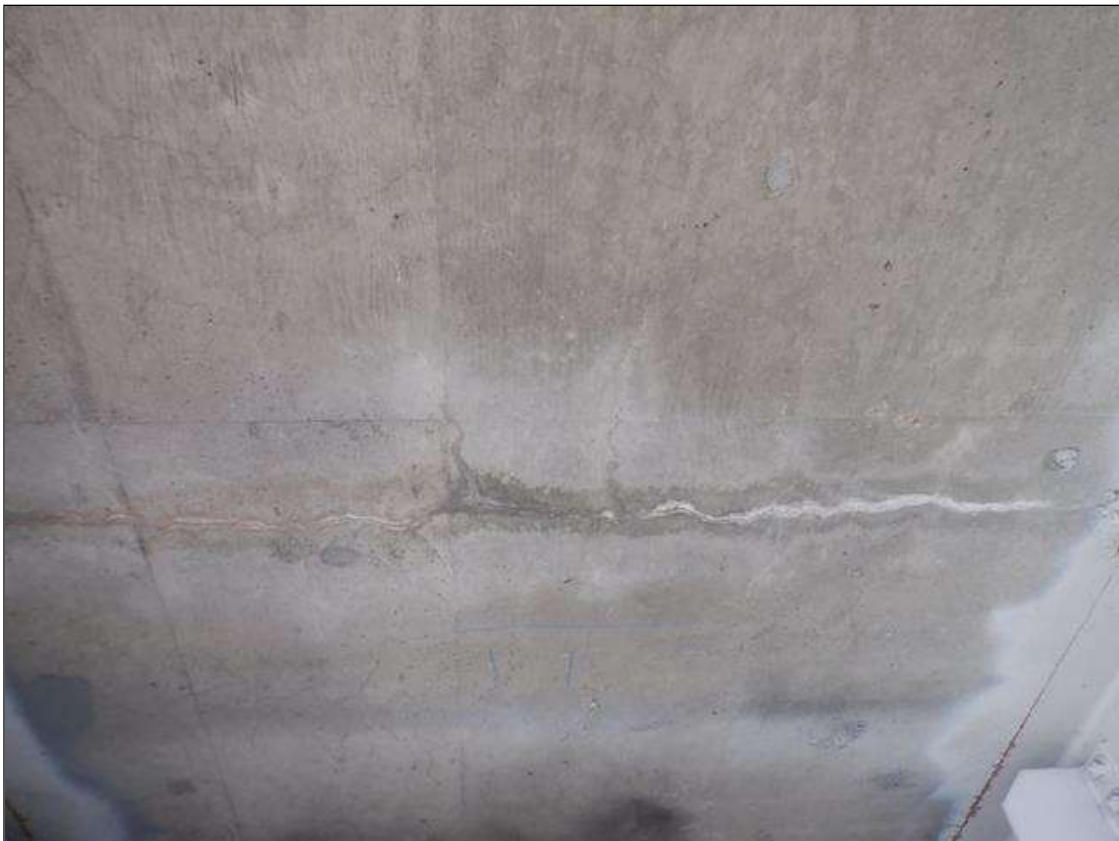
Span 1 Deck: 500 SF. OF HAIRLINE MAP AND TRANSVERSE CRACKING WITH EFFLORESCENCE IN BOTTOM OF DECK

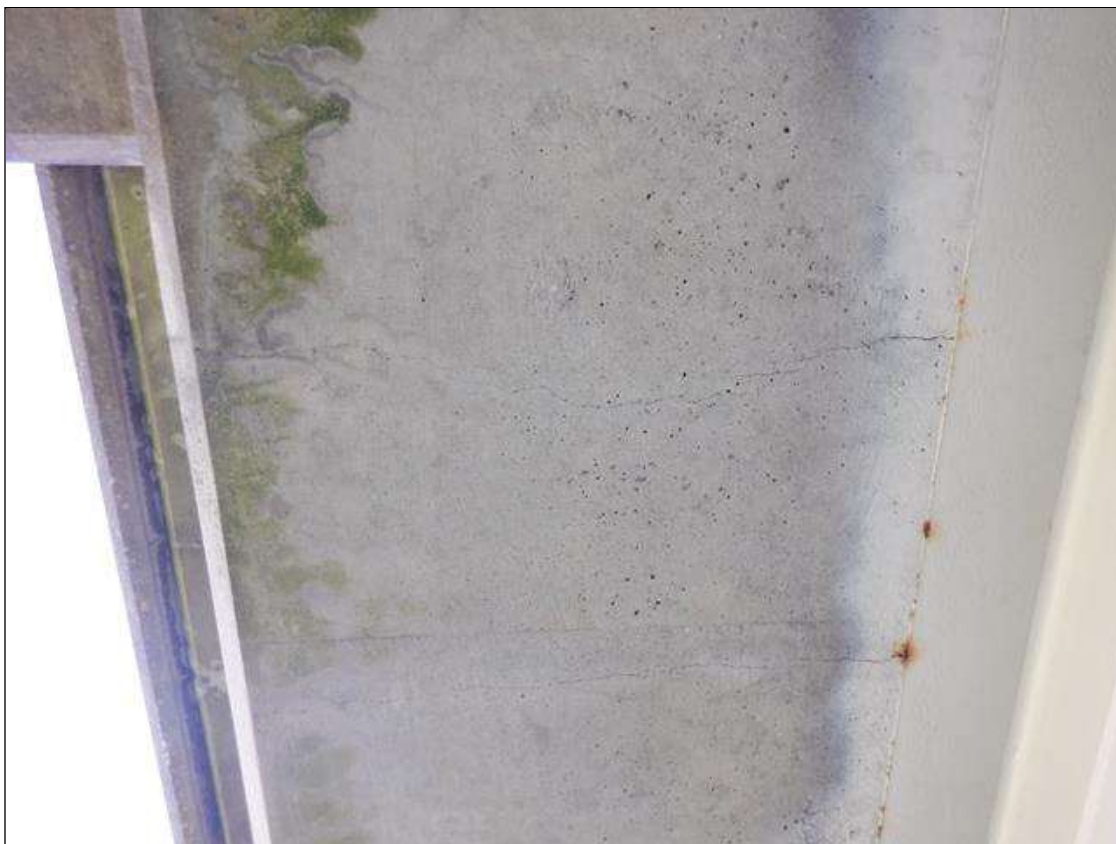
Span 1 Deck: 11 - 2 FT. TRANSVERSE HAIRLINE CRACKS WITH EFFLORESCENCE IN BOTTOM OF DECK WEST OVERHANG

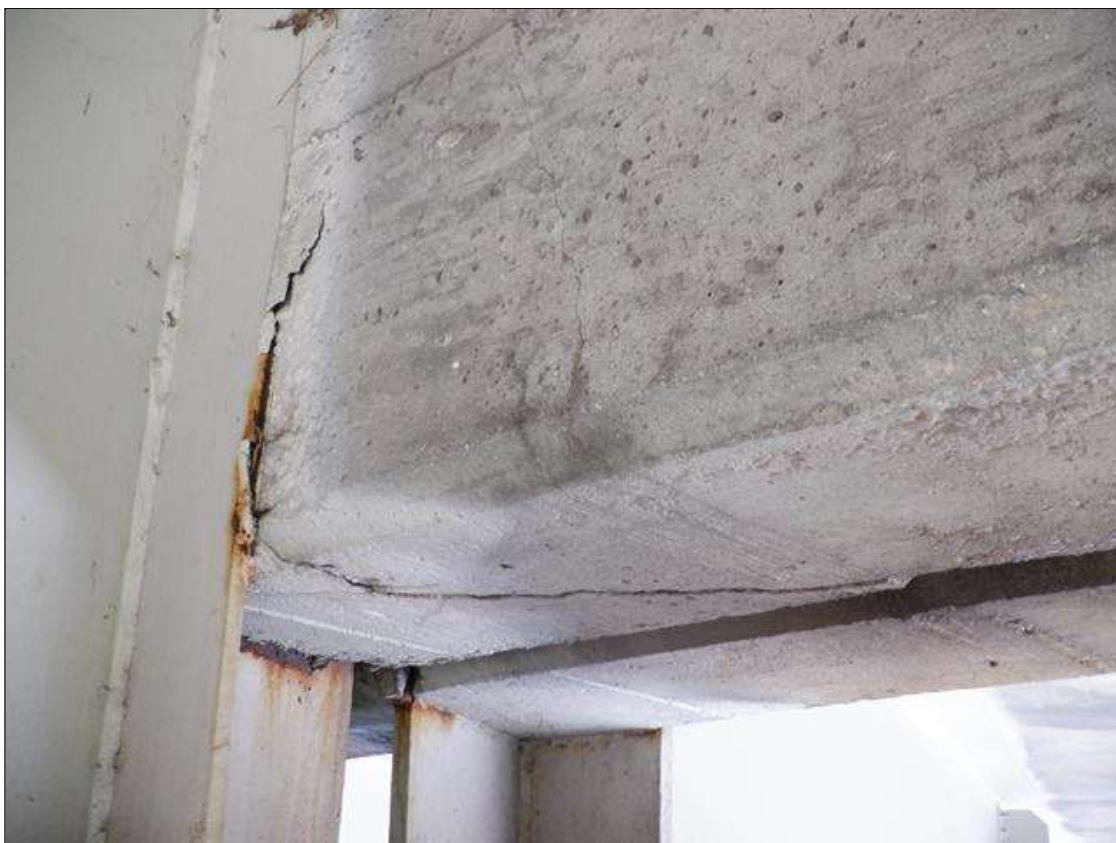
END DIAPHRAGM BAY 3 AT BENT 1: 18" X 6" DELAMINATION IN SOUTH FACE

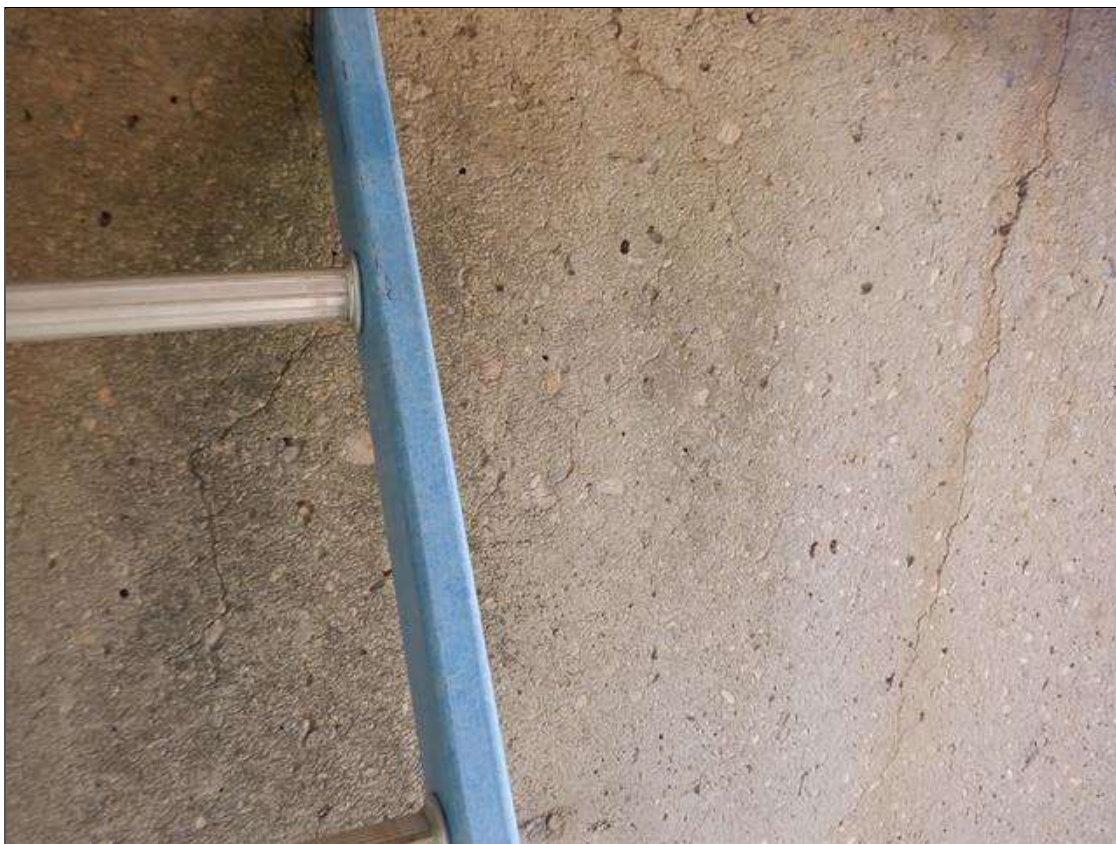
Bent 1 Cap 1: 2 - 36" VERTICAL HAIRLINE CRACKS IN SOUTH FACE UNDER BAY 3

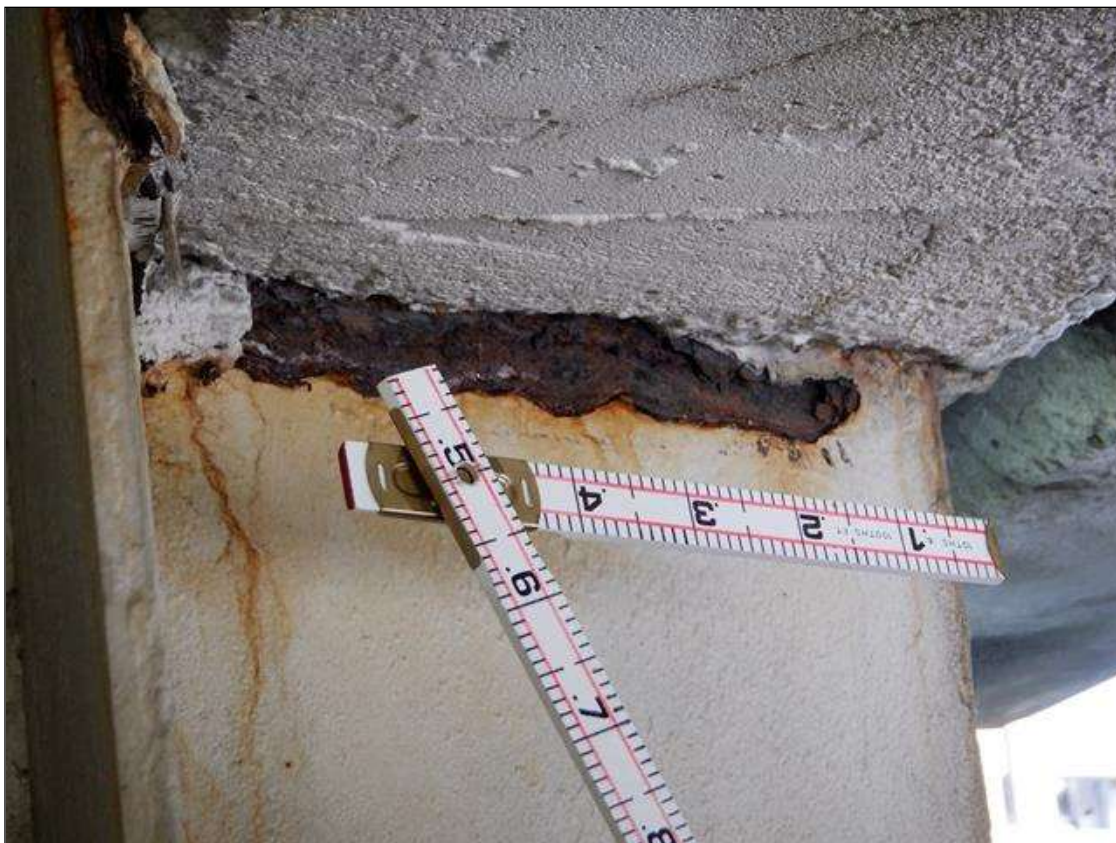
Span 1 Beam 1: 1 FT. OF CORROSION WITH 11/16" REMAINING SECTION IN WEB AROUND END DIAPHRAGM AT BENT 1 PAR

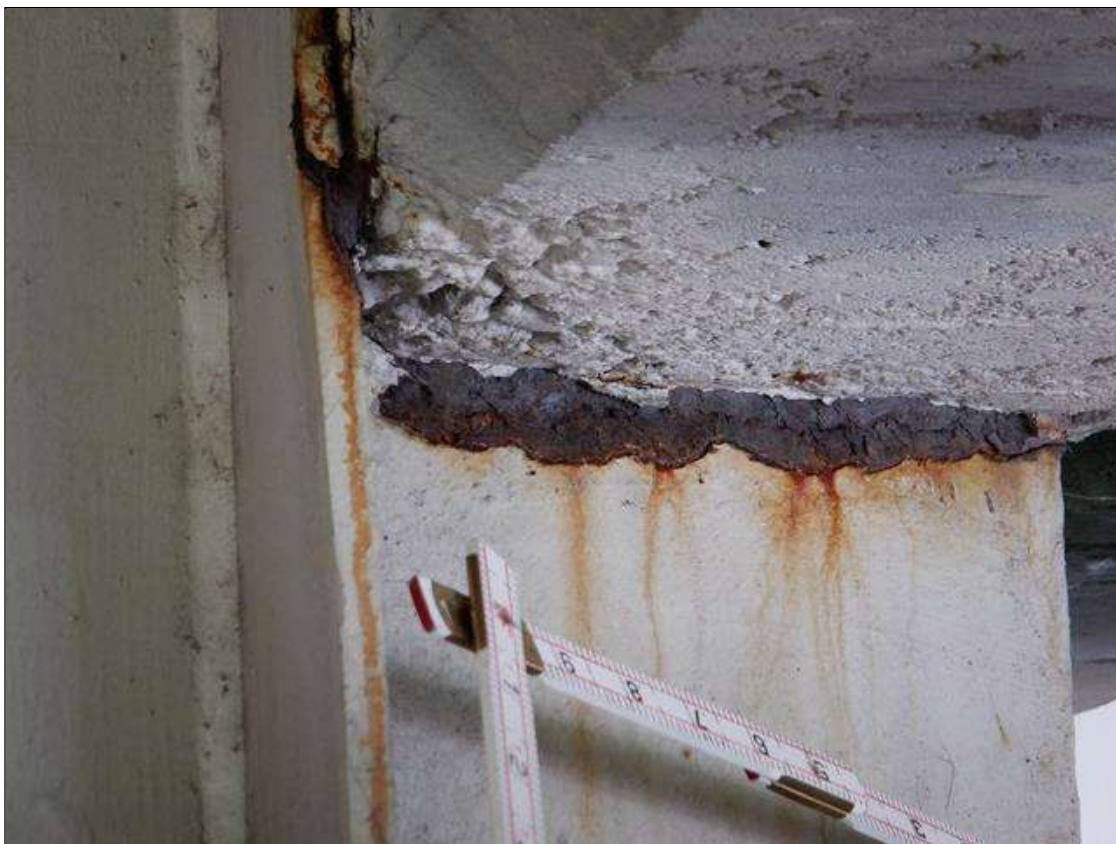
Span 1 Beam 2: 1 FT. OF CORROSION WITH 11/16" REMAINING SECTION IN WEB AROUND END DIAPHRAGM AT BENT 1 PAR

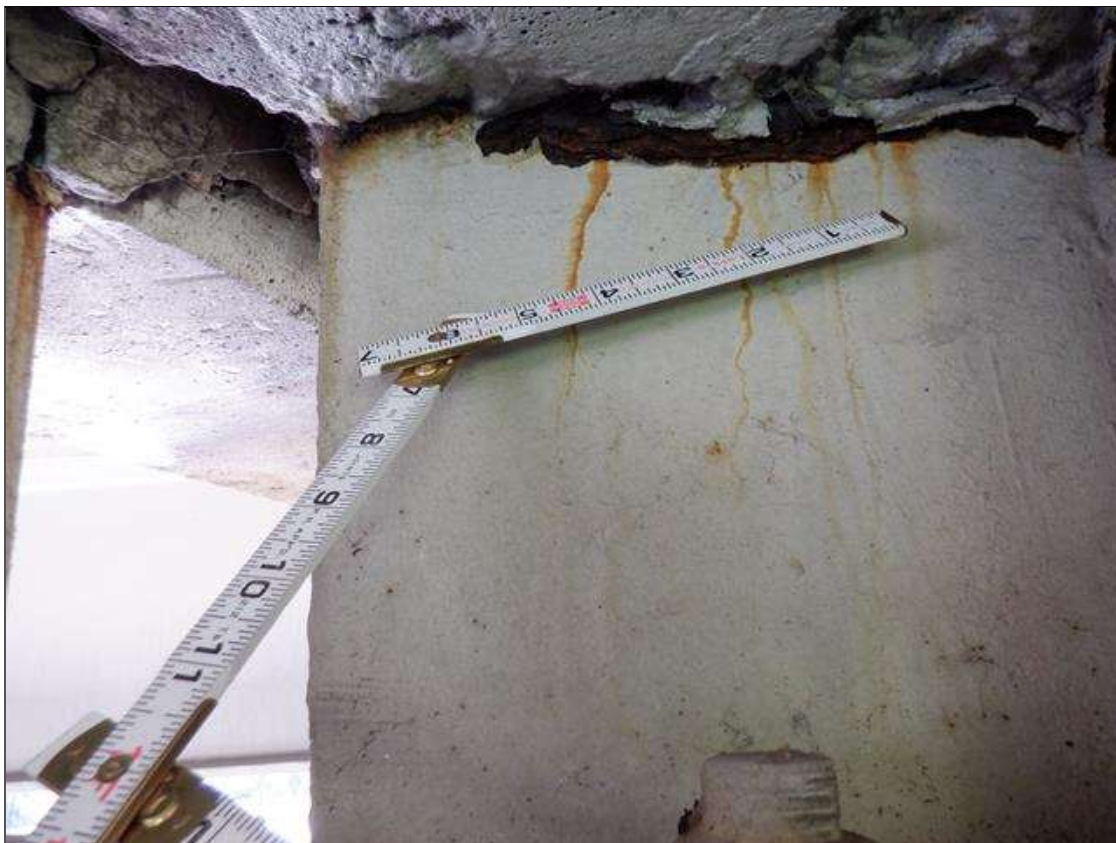
Span 1 Beam 3: 1 FT. OF CORROSION WITH 11/16" REMAINING SECTION IN WEB AROUND END DIAPHRAGM AT BENT 1 PAR

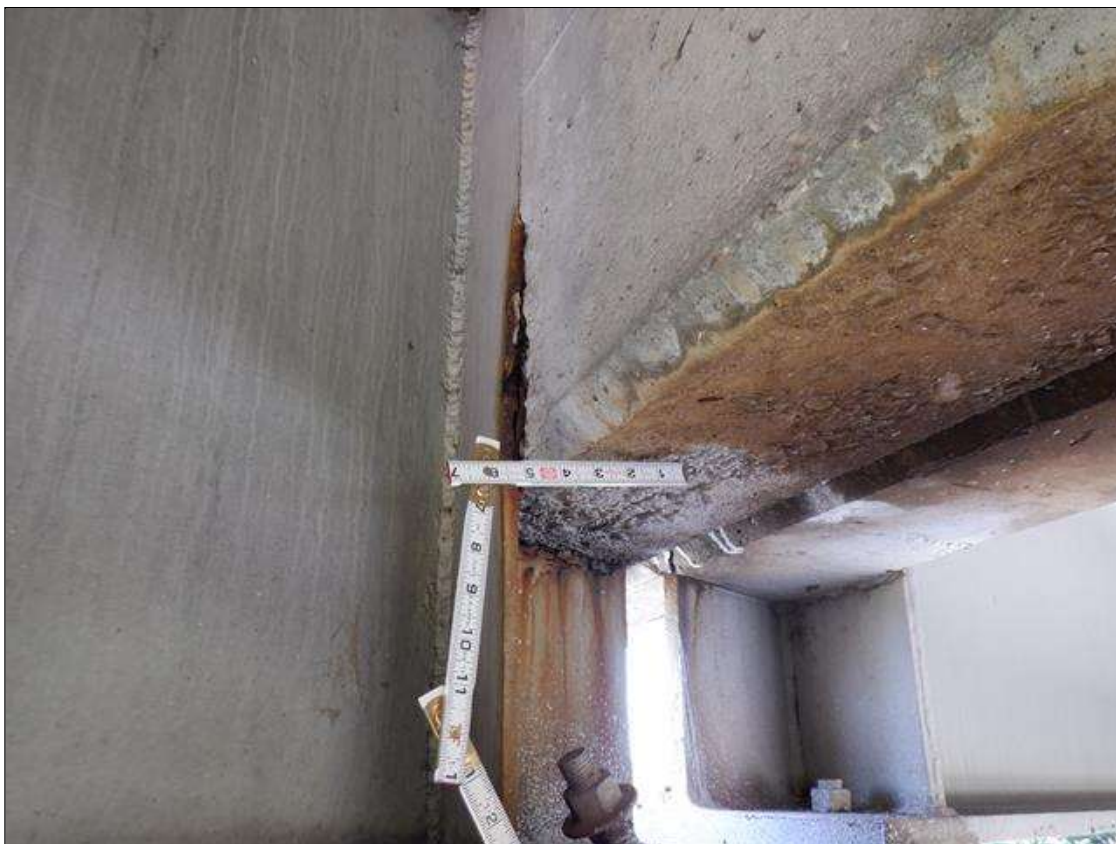
Span 3 Beam 4: 1 FT. OF PAINTED OVER PITTING UP TO 1/16" DEEP WITH RUST BLEEDING IN WEB AROUND END DIAPHRAGM AT BENT 2

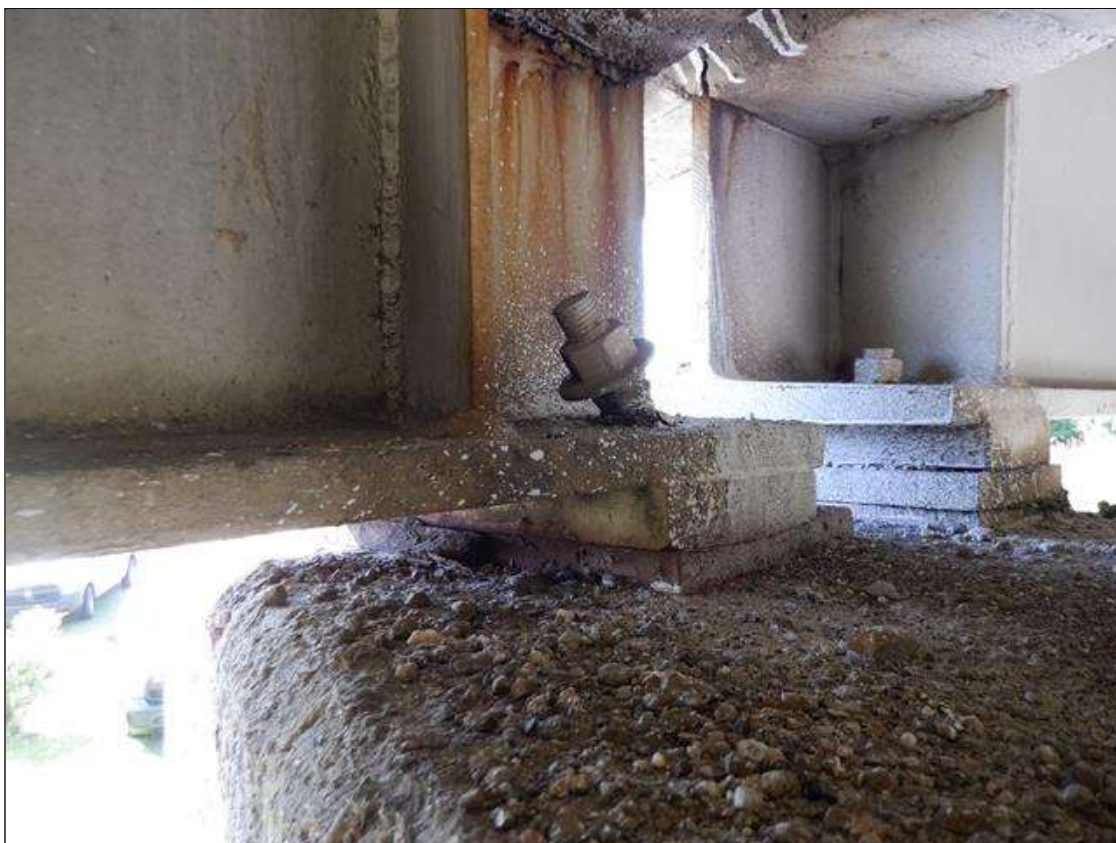
Span 3 Beam 4 Near Bearing: EAST AND WEST ANCHOR BOLT LEANING TOWARDS NORTH PAR

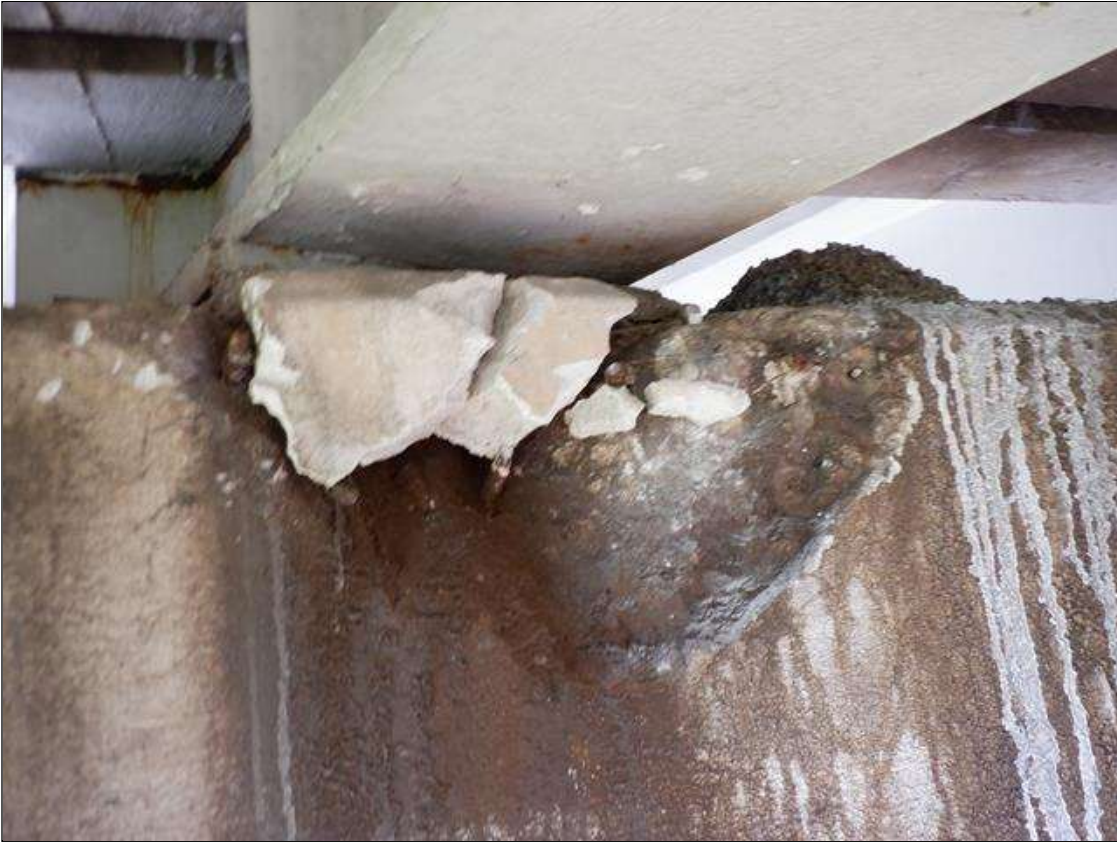
Bent 2 Cap 1: 18" X 6" X 4" FAILED PATCH WITH 4" X 1 1/2" LOSS OF BEARING AREA IN NORTH FACE UNDER BEAM 3 PAR

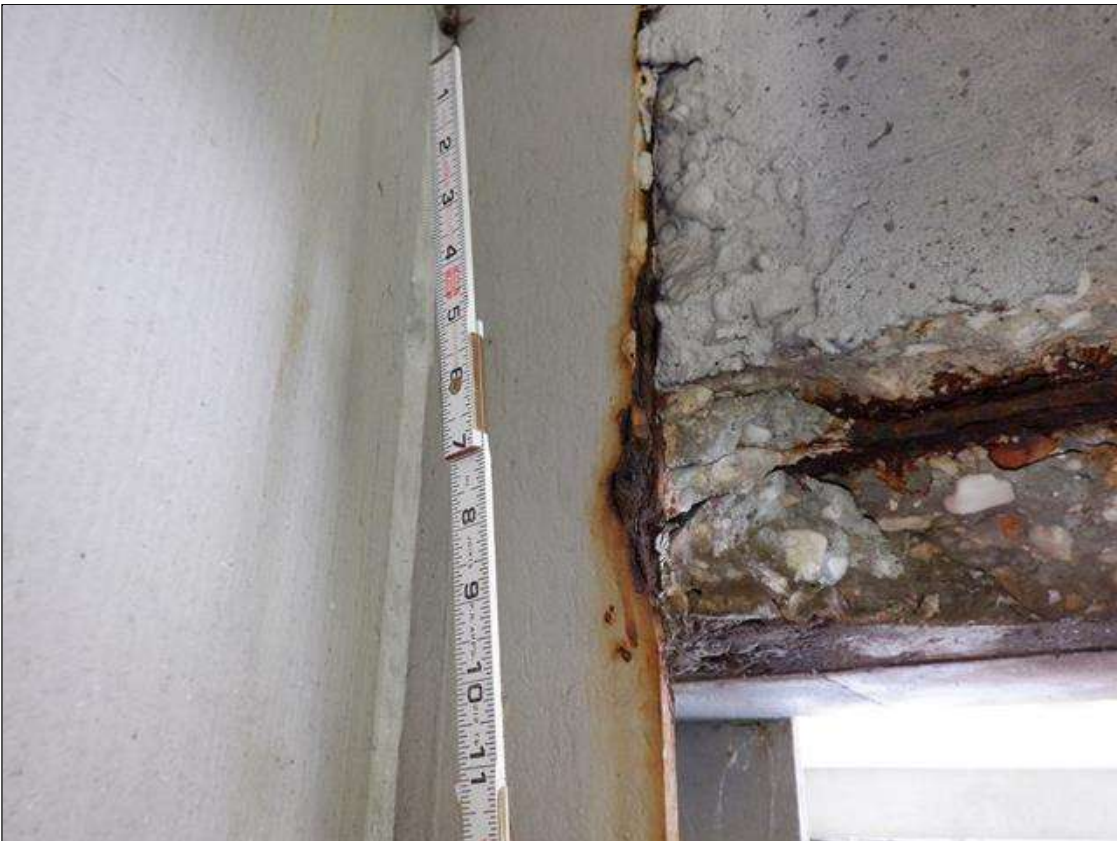
Span 3 Beam 3: 1 FT. OF CORROSION WITH 11/16" REMAINING SECTION IN WEB AROUND END DIAPHRAGM AND 1/4" REMAINING SECTION IN BEARING STIFFENER AT BENT 2 PAR

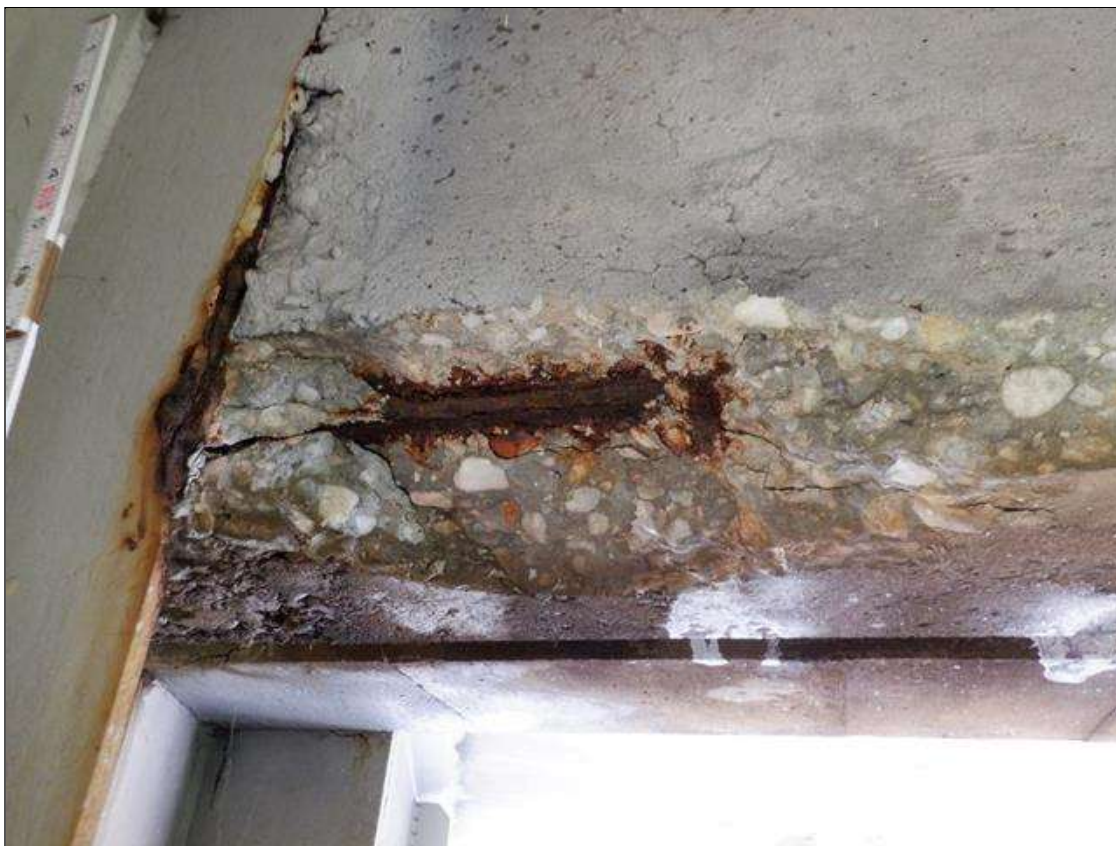
END DIAPHRAGM BAY 2 AT BENT 2: 12" X 3" X 2" DEEP SPALL WITH EXPOSED REBAR IN NORTH FACE PAR

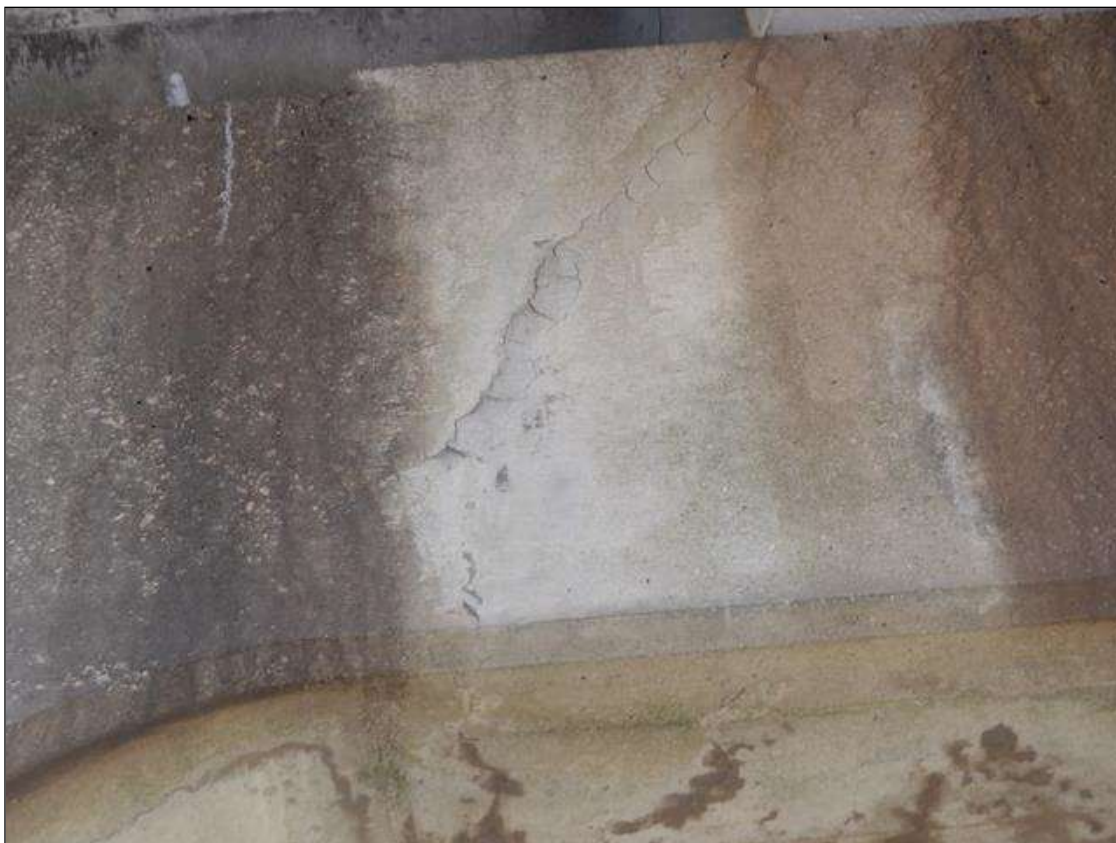
Bent 2 Cap 1: 3 FT. DIAGONAL HAIRLINE CRACK IN SOUTH FACE UNDER BAY 1

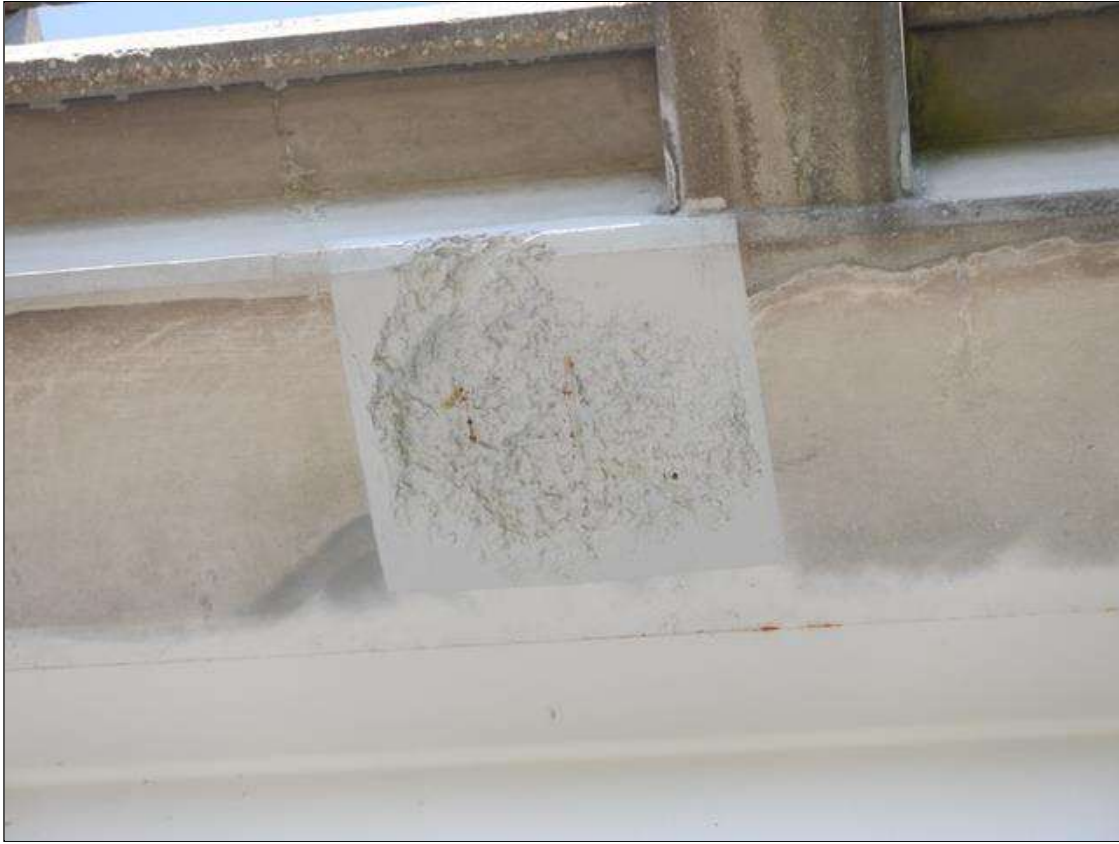
Span 2 Deck: 20" DIAMETER DELAMINATION IN BOTTOM OF DECK EAST OVERHANG 10 FT. FROM BENT 2.
PAINTED OVER SPALL

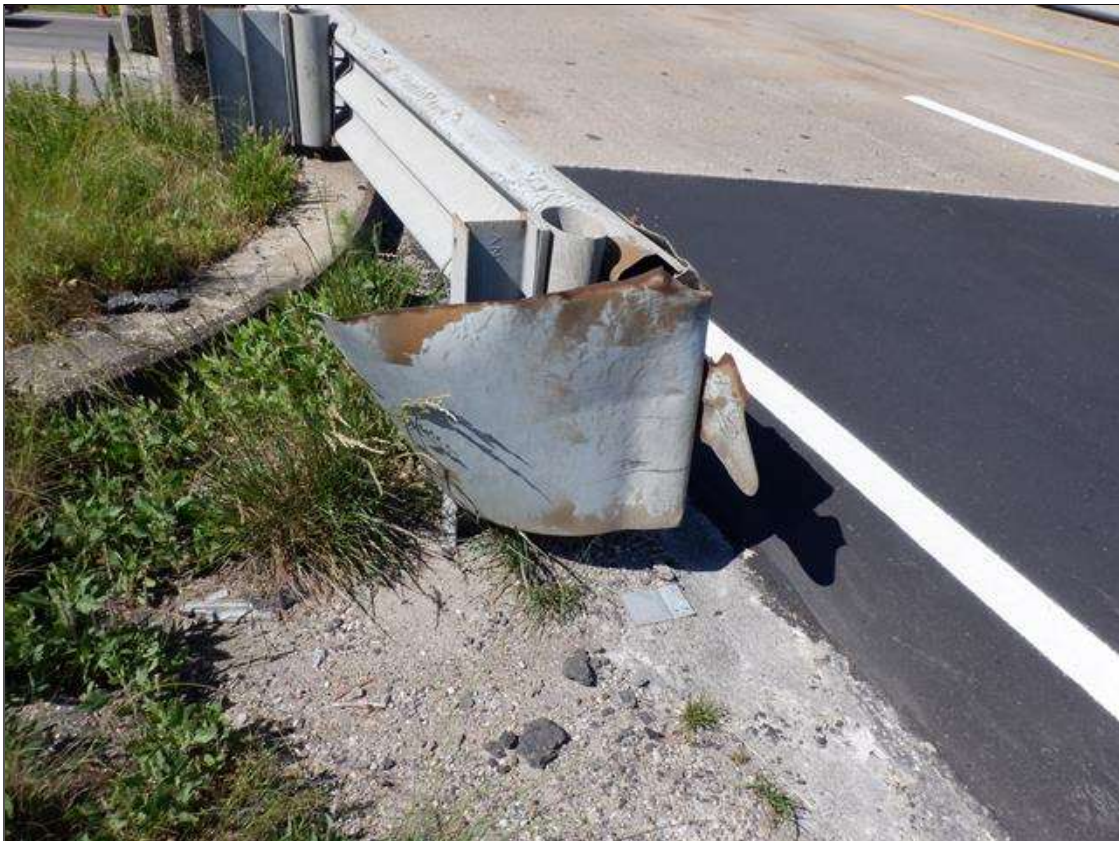
Span 3 Right Bridge Rail: IMPACT DAMAGE TO END OF BRIDGE RAIL PAR

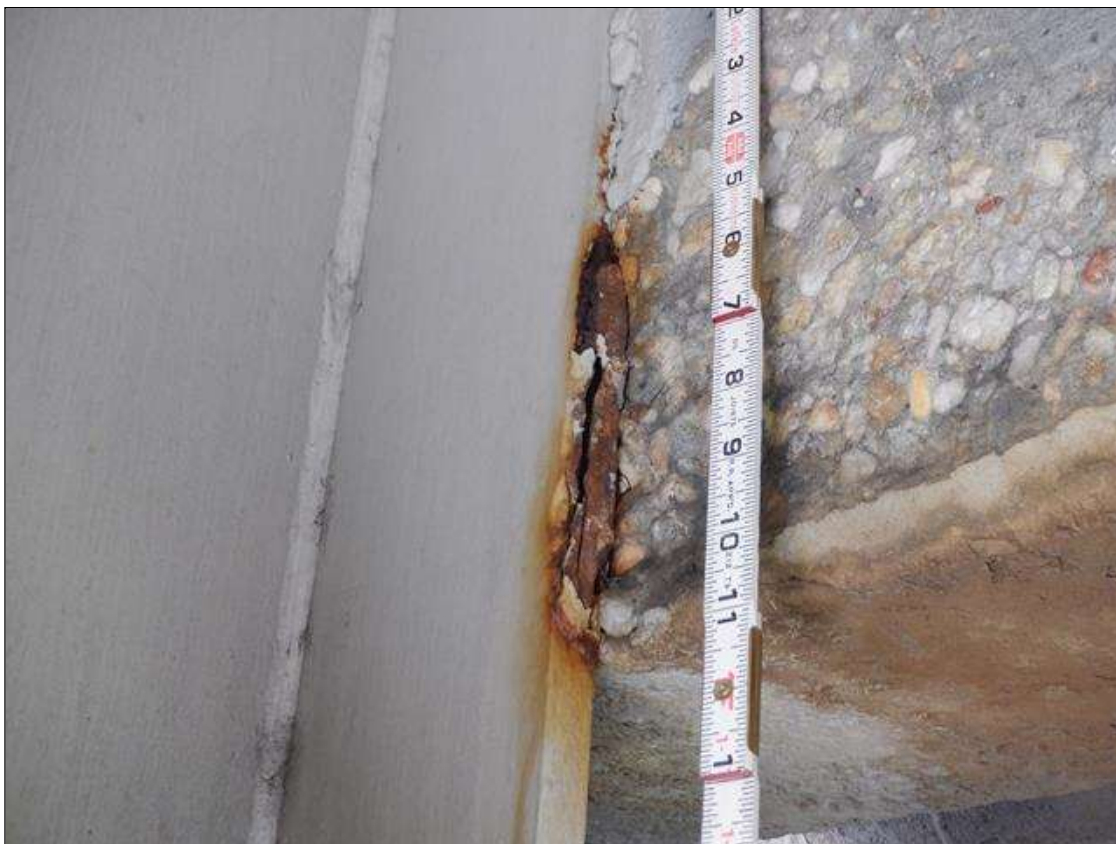
Span 2 Beam 4: 1 FT. OF CORROSION WITH 11/16" REMAINING SECTION IN WEB AROUND END DIAPHRAGM AT BENT 2 PAR

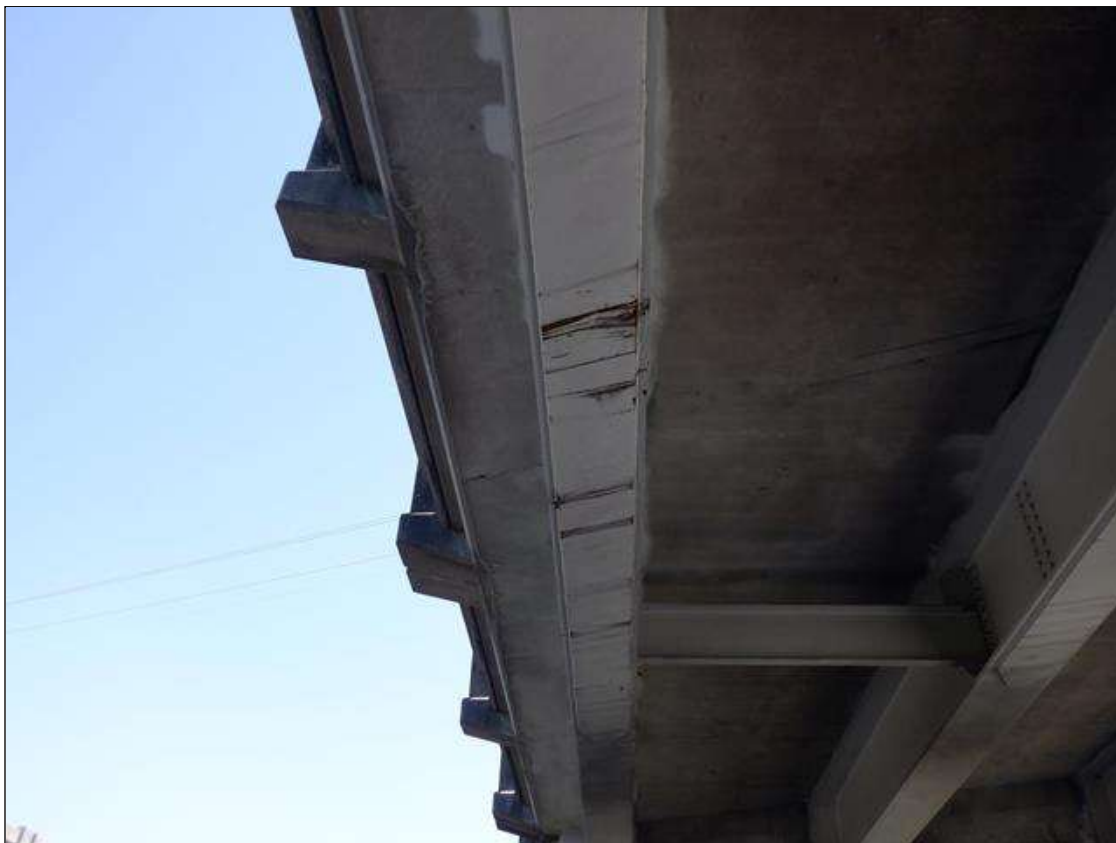
Span 2 Beam 1: 1 FT. OF VEHICLE SCRAPES IN BOTTOM FLANGE AND BOTTOM FLANGE COVER PLATE 25 FT. FROM BENT 1

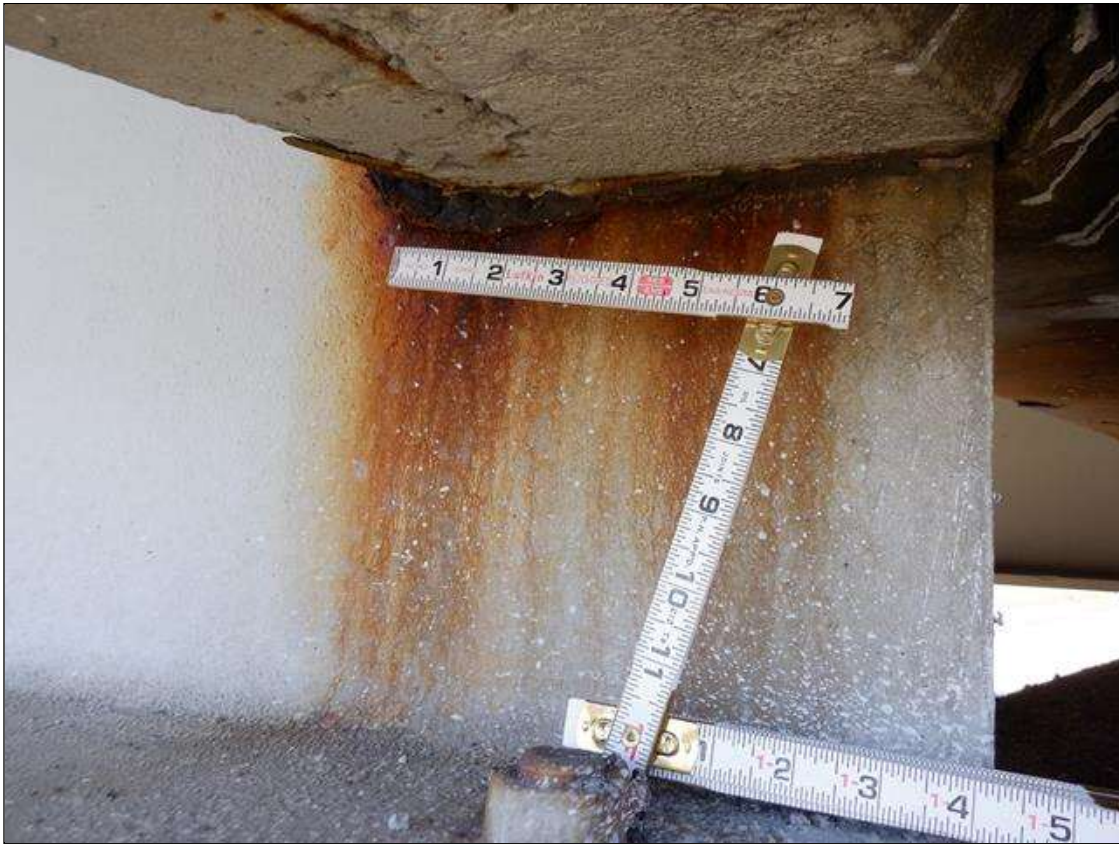
Span 2 Beam 4: 1 FT. OF CORROSION WITH 11/16" REMAINING SECTION IN WEB AROUND END DIAPHRAGM AT BENT 2 PAR

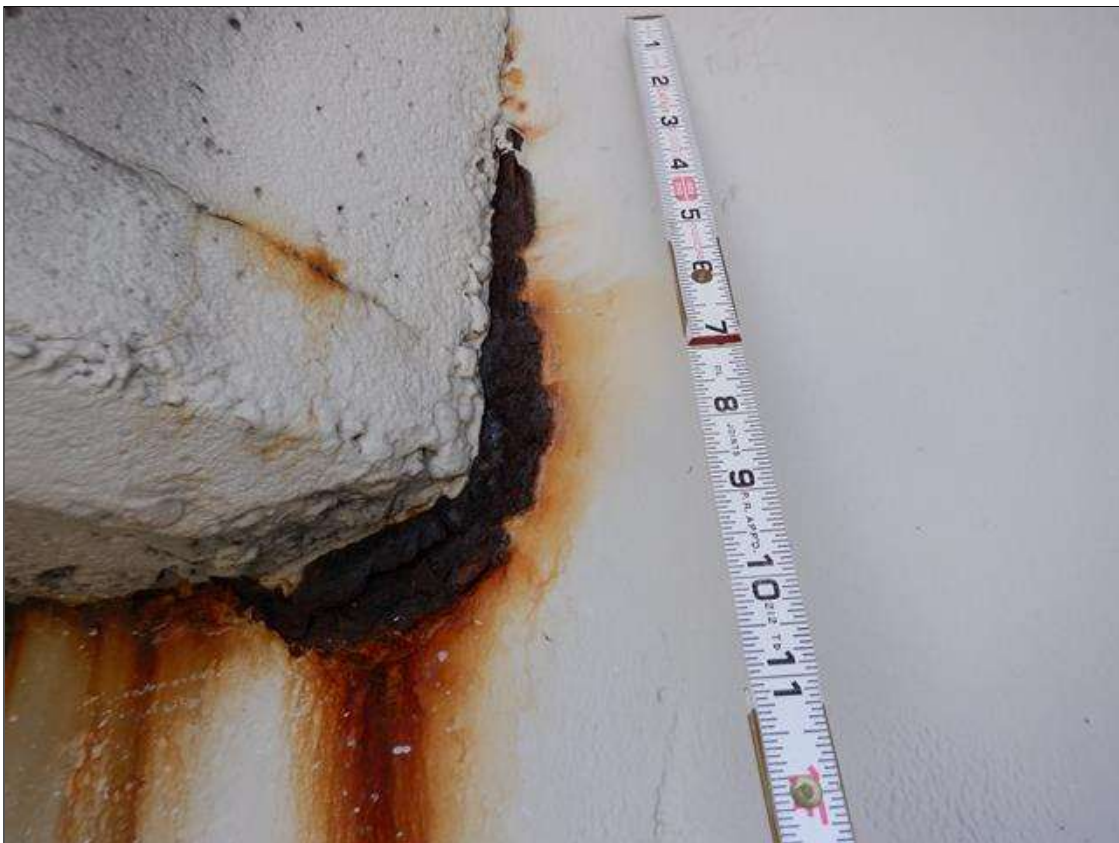
Span 2 Beam 1: 1 FT. OF CORROSION WITH 11/16" REMAINING SECTION IN WEB AROUND END DIAPHRAGM AT BENT 2 PAR

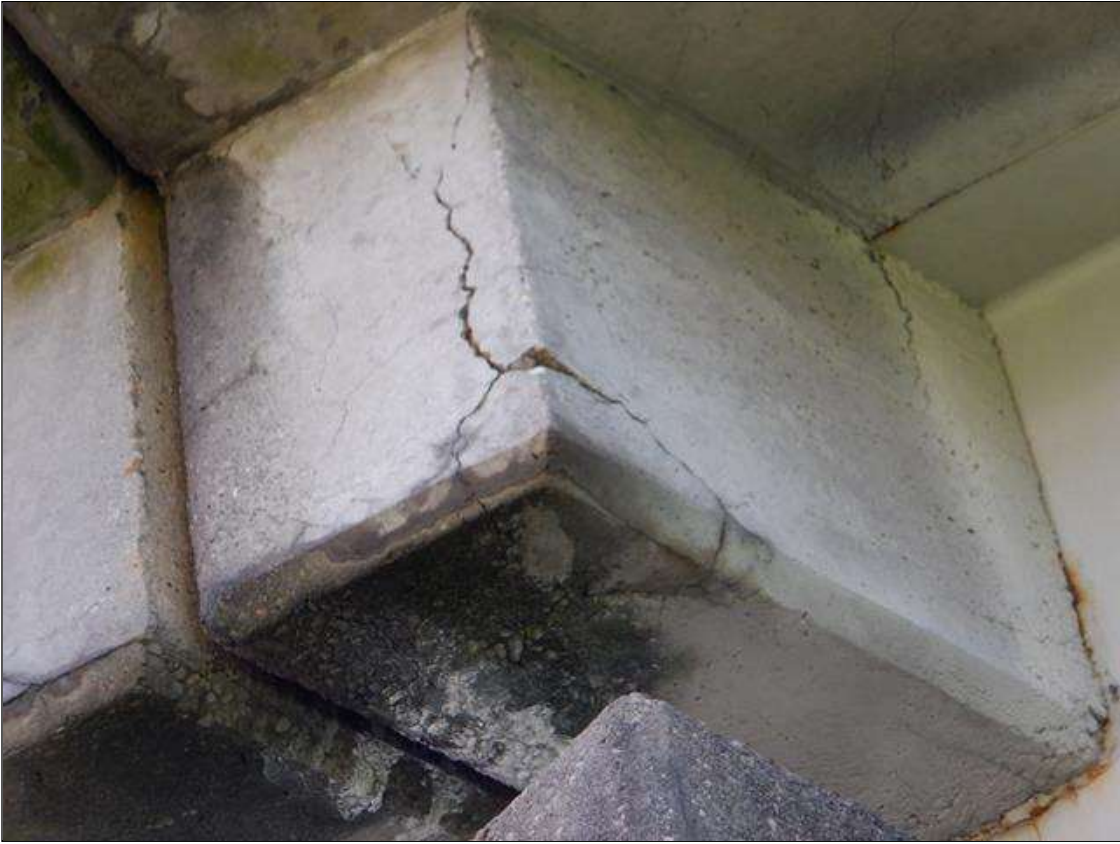
END DIAPHRAGM WEST OVERHANG AT BENT 1: 12" X 6" DELAMINATION IN SOUTH FACE

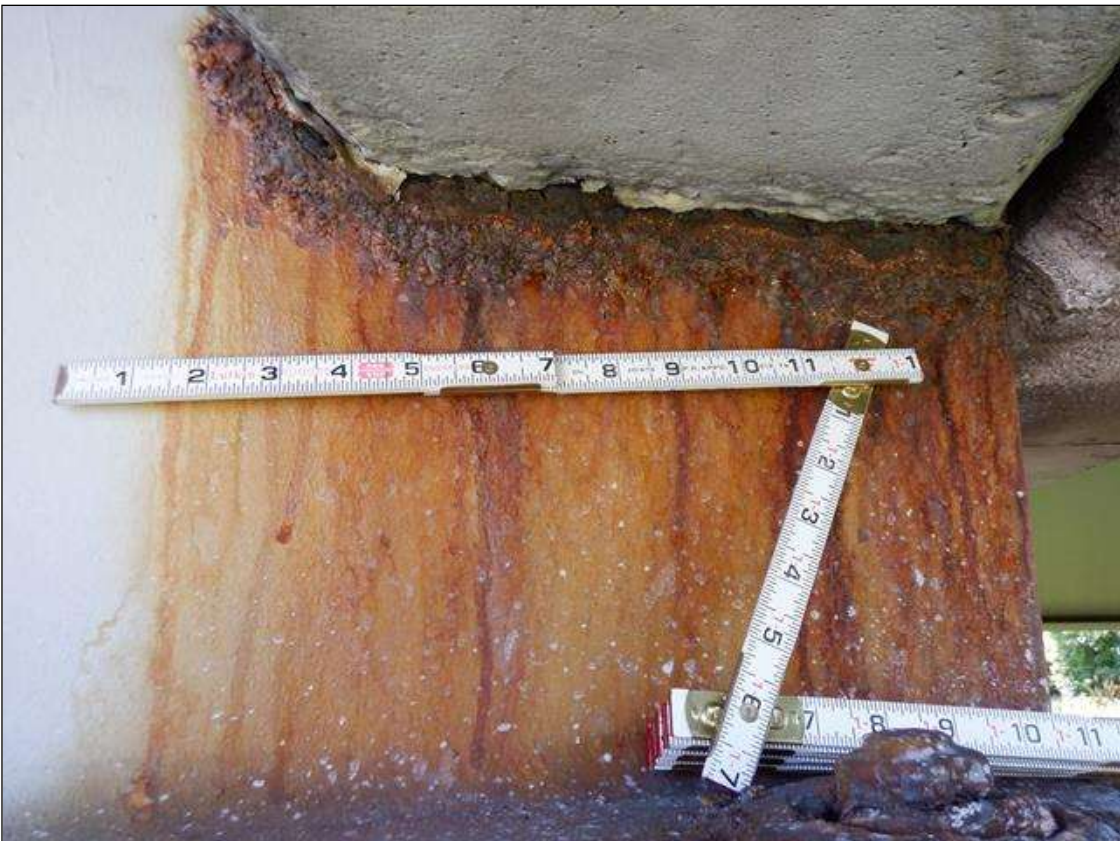
Span 2 Beam 1: 1 FT. OF CORROSION WITH 11/16" REMAINING SECTION IN WEB AROUND END DIAPHRAGM AT BENT 1 PAR

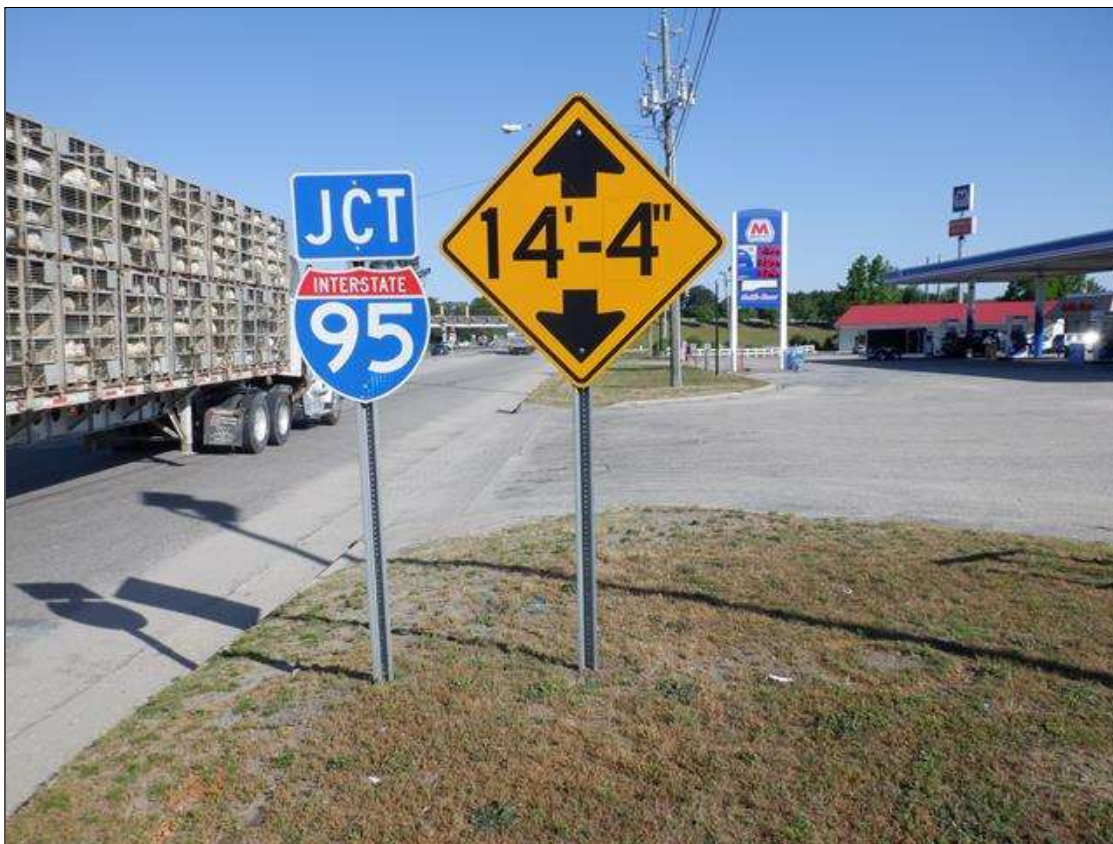
VERTICAL CLEARANCE SIGN 1000 FT EAST OF BRIDGE. VERICAL CLEARANCE UPDATED FROM PERVIOUS INSPECTION.
