NC DEPARTMENT OF TRANSPORTATION
 DIVISION OF HIGHWAYS
 STRUCTURE MANAGEMENT UNIT

ATTENTION: PAR ISSUED, UPDATED STRUCTURE DATA WORKSHEET, UPDATED SUPERSTRUCTURE SKETCH, UPDATED SPAN 2 EAST BOUND LANE CLEARANCE SKETCH, UPDATED SPAN 2 WEST BOUND LANE CLEARANCE SKETCH.

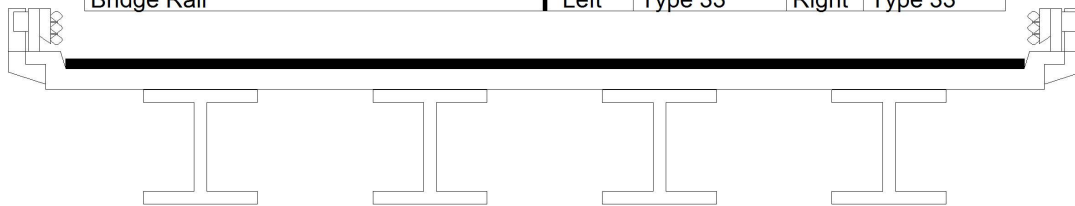
Measurements for Span #	1		
Deck Thickness	0.604	Left Overhang	4.708
Top of Rail to Bottom of Beam	6.229	Right Overhang	4.708

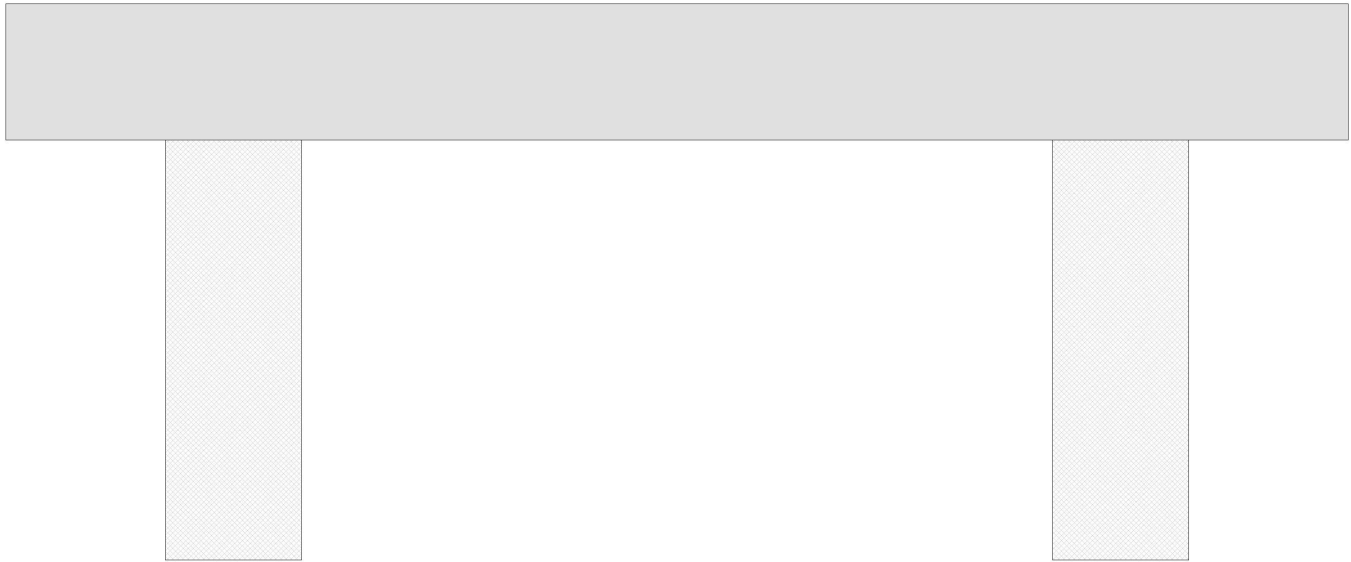
Cap Information			Material Cast-in-Place Concrete							
Length	Width	Height	Left Overhang	Right Overhang	Left Beam to End of Cap.	Right Beam to End of Cap.				
29.500 ft.	2.500 ft.	3.000 ft.	5.000 ft.	5.000 ft.	1.833 ft.	1.833 ft.				
Subcap Information			Material							
Length	Width	Height	Left Overhang	Right Overhang	Left Pile to Splice.					
Sill Information			Material							
Length	Width	Height								
Pile #	Material	Spacing	Width/Dia.	Height	Length	Orientation	Driven?	Replacement?	Removed?	Collar?
1	Concrete	19.5 ft.	3 ft.	2.5 ft.		Vertical	No	No	No	No
2	Concrete		3 ft.	2.5 ft.		Vertical	No	No	No	No
MEASUREMENTS VERIFIED 5/15/2019 BY JTE										
Bent/Abutment #: 1			Similar Bents: 2
