NC DEPARTMENT OF TRANSPORTATION
 DIVISION OF HIGHWAYS
 STRUCTURE MANAGEMENT UNIT

ATTENTION: **Changes to Structure Data**

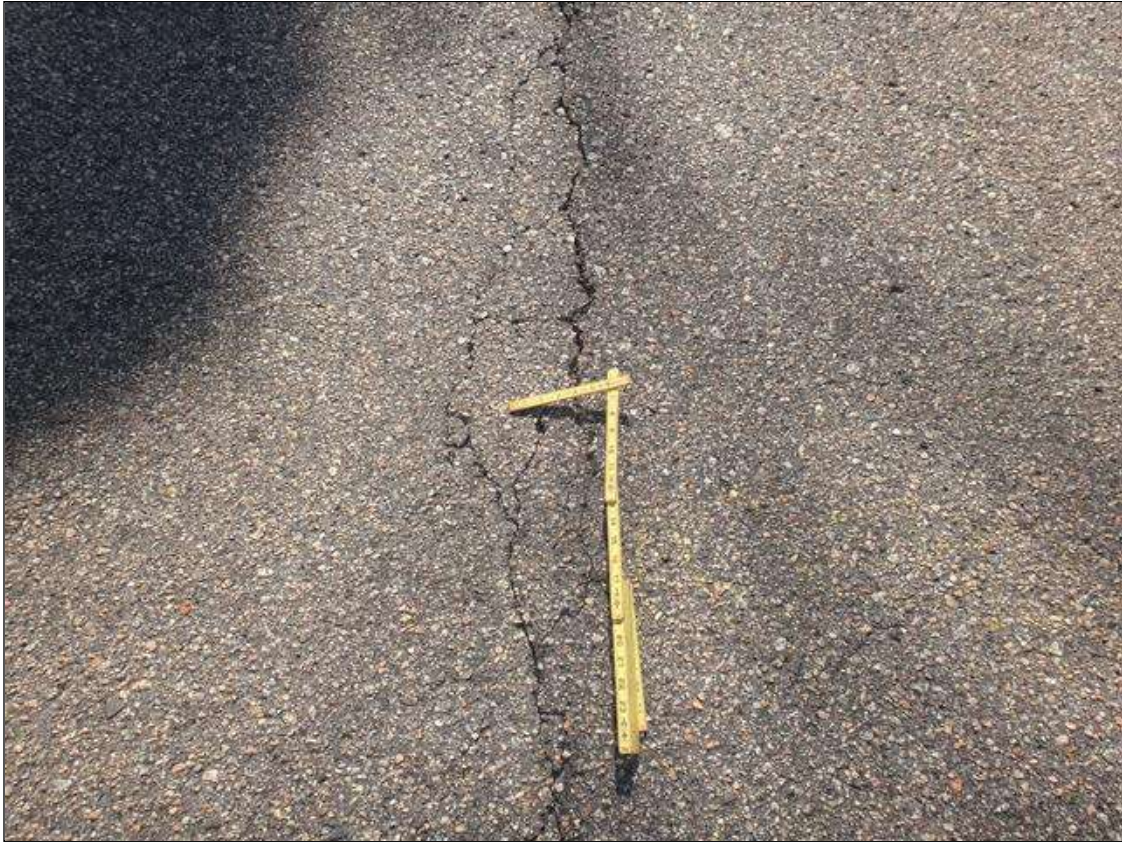
Span 4 Wearing Surface: asphalt over End Bent 2, multiple transverse cracks [up to full width x up to 1/4in] with edge spalling [up to 1in]

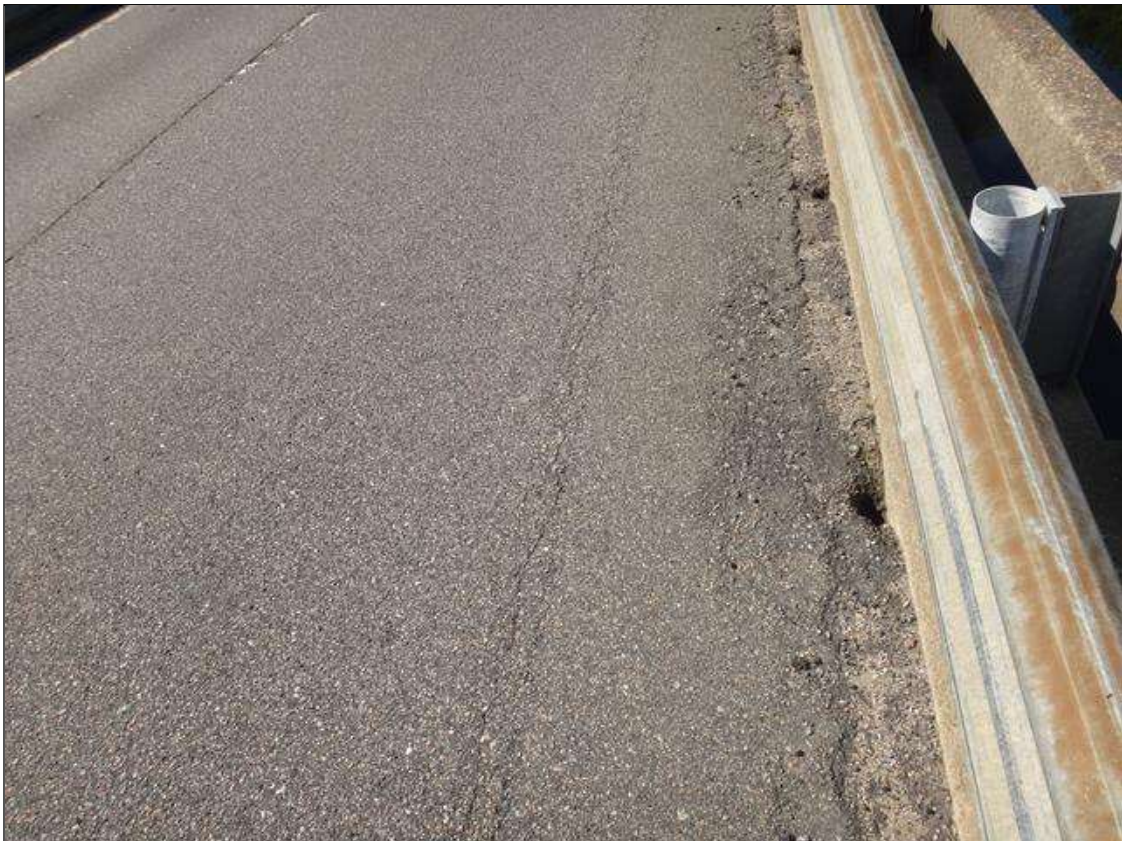
Span 4 Wearing Surface: 3ft from left shoulder, longitudinal crack [full length x up to 1/8in]

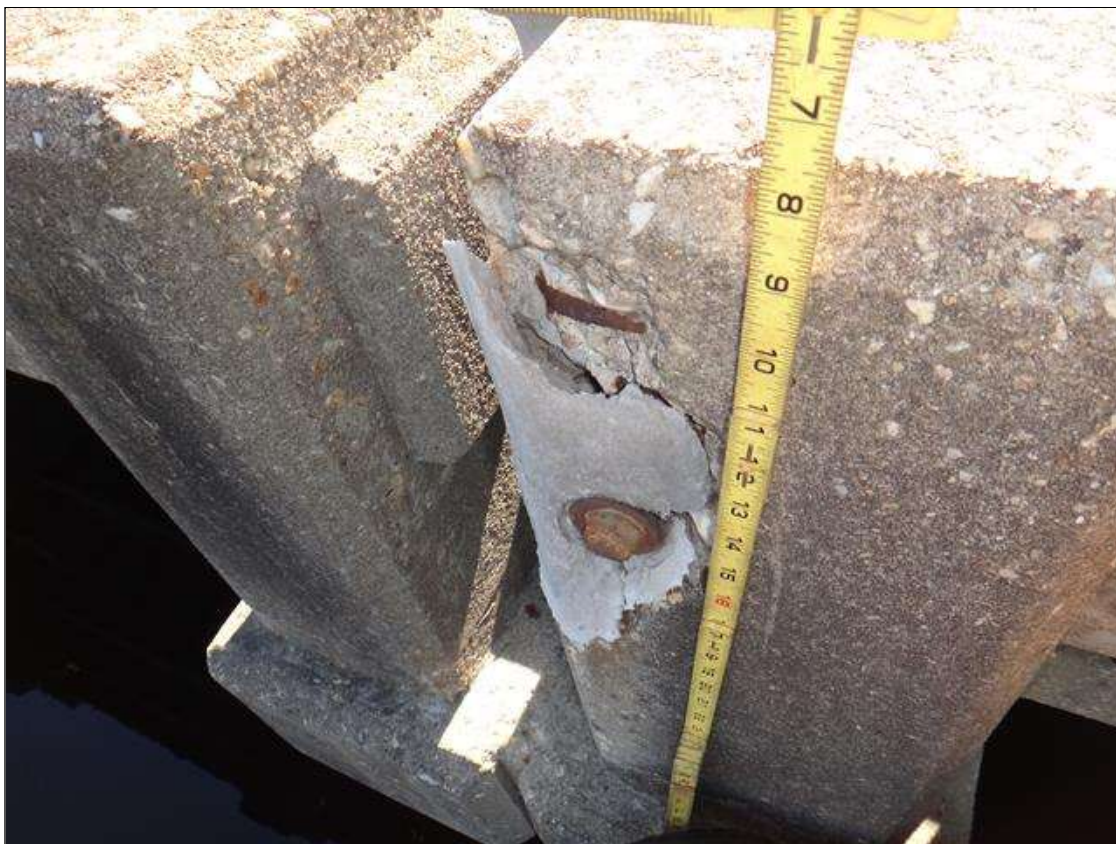
Span 3 Left Bridge Rail: West face at rail post 3, unsound patch [14in x 5in]

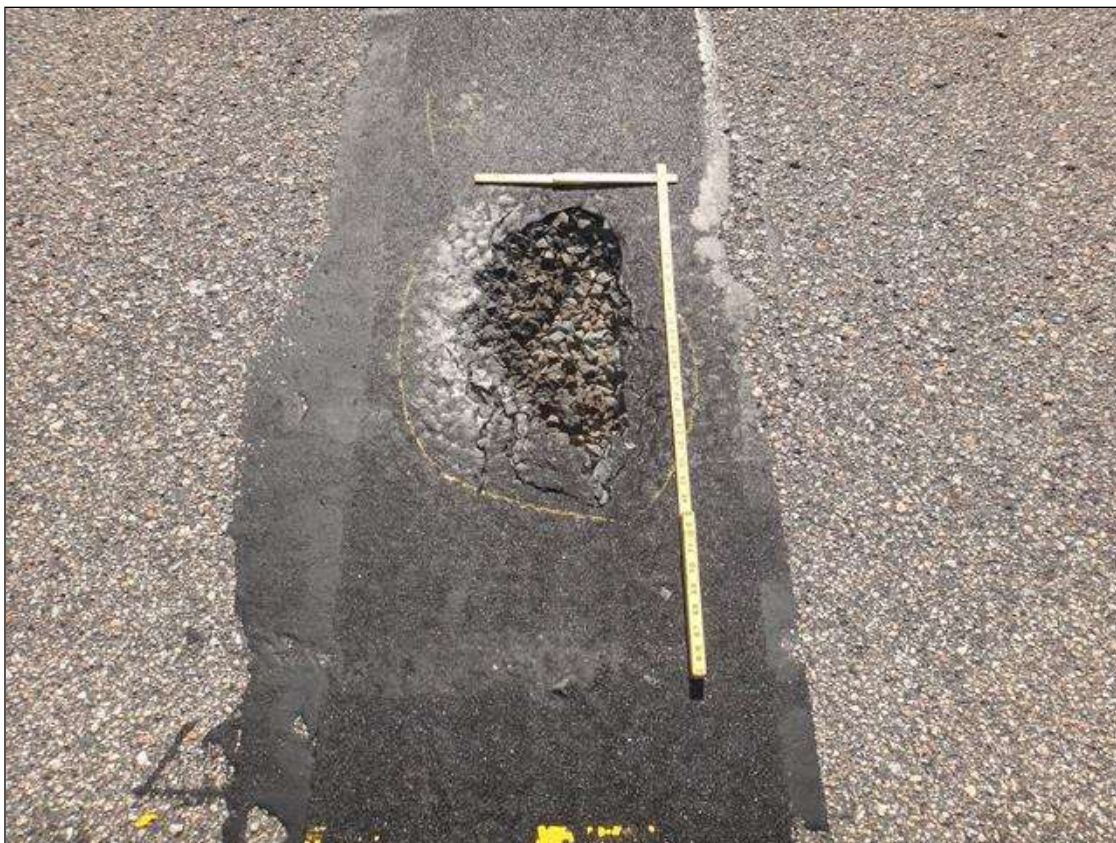
Span 2 Wearing Surface: asphalt over bent 2, one [1] pothole in left travel lane and one [1] pothole in right travel lane [18in x up to 12in x up to 2-1/2in deep]

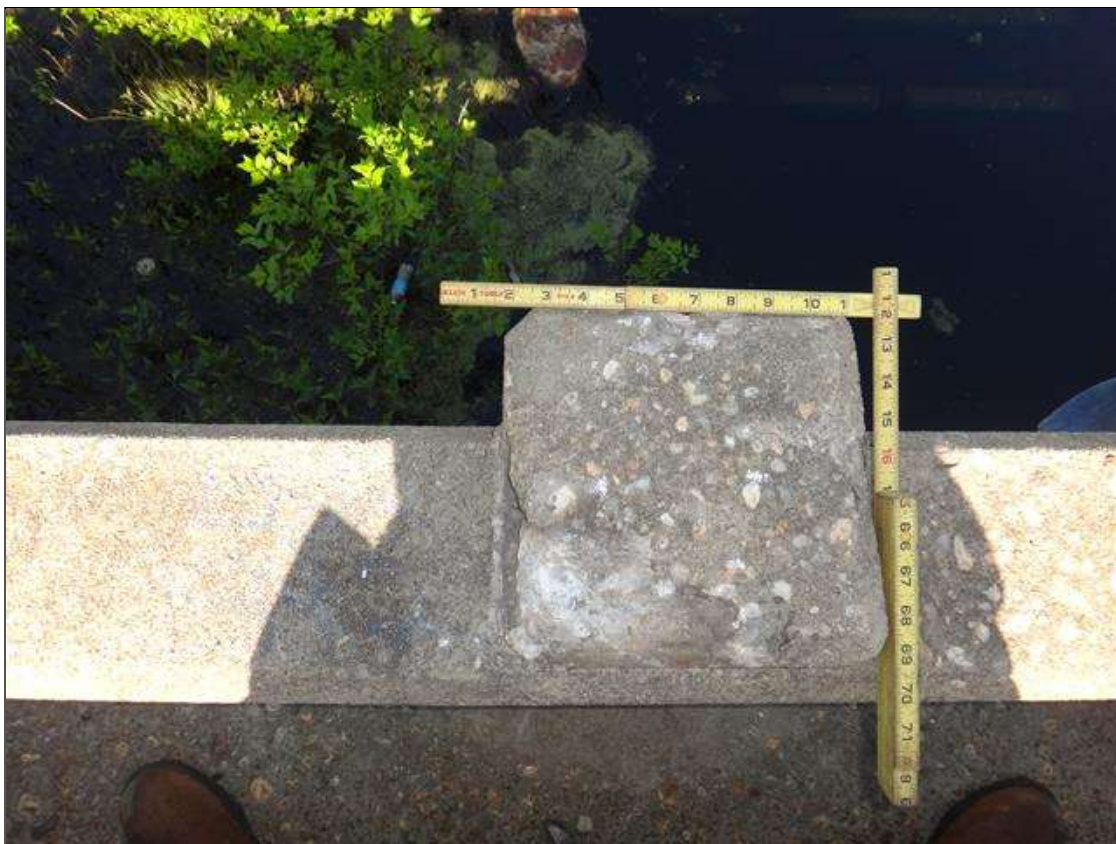
Span 2 Left Bridge Rail: top face at rail post 2, spall/delamination [8in x 8in x up to 1/4in deep]

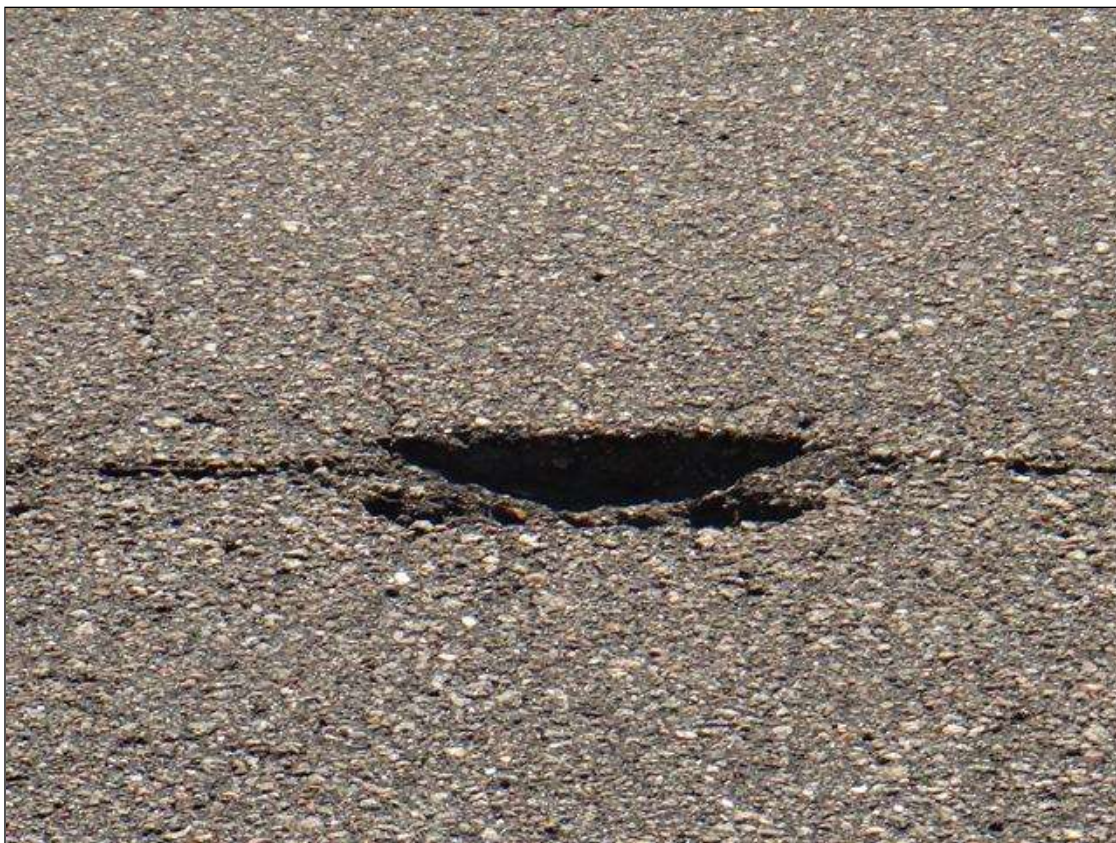
Span 1 Wearing Surface: centerline near midspan, pothole [11in x 5in x up to 2in deep]

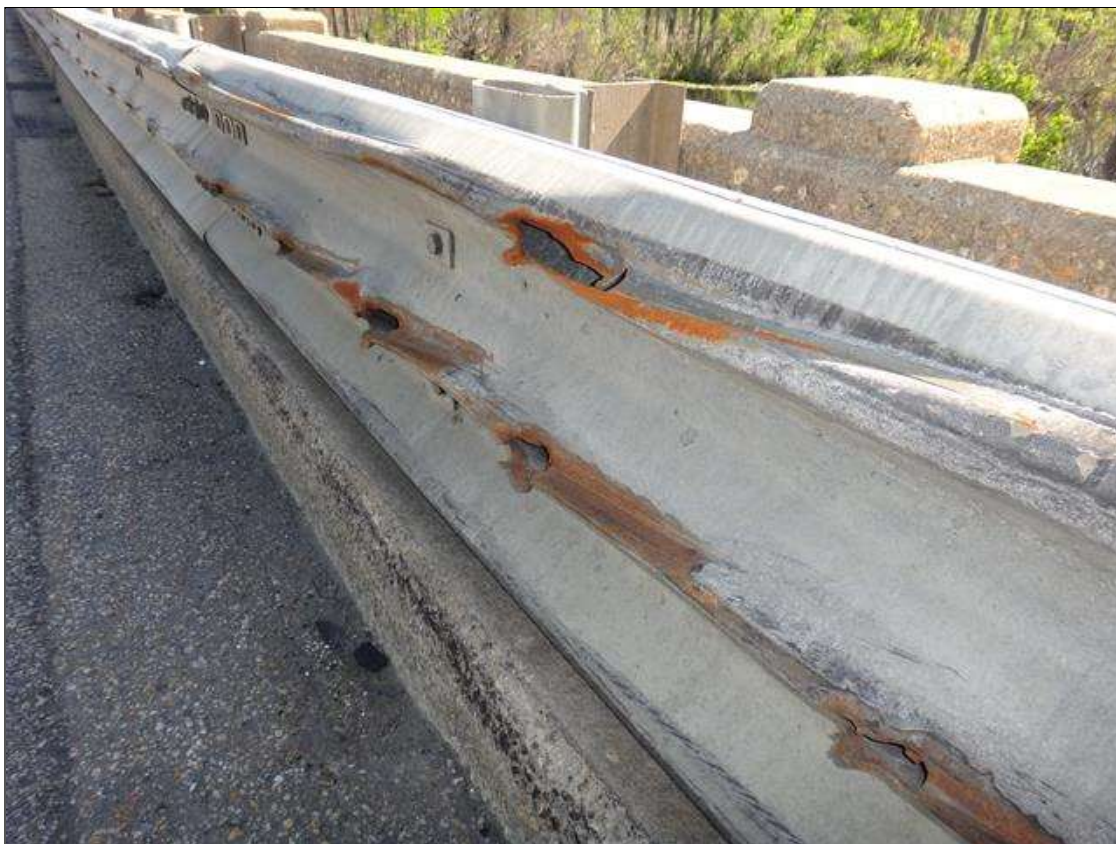
Span 1 Right Bridge Rail: along length of attached metal guardrail, vehicular impact damage with scrapes and tears [up to 12in x up to 3in]

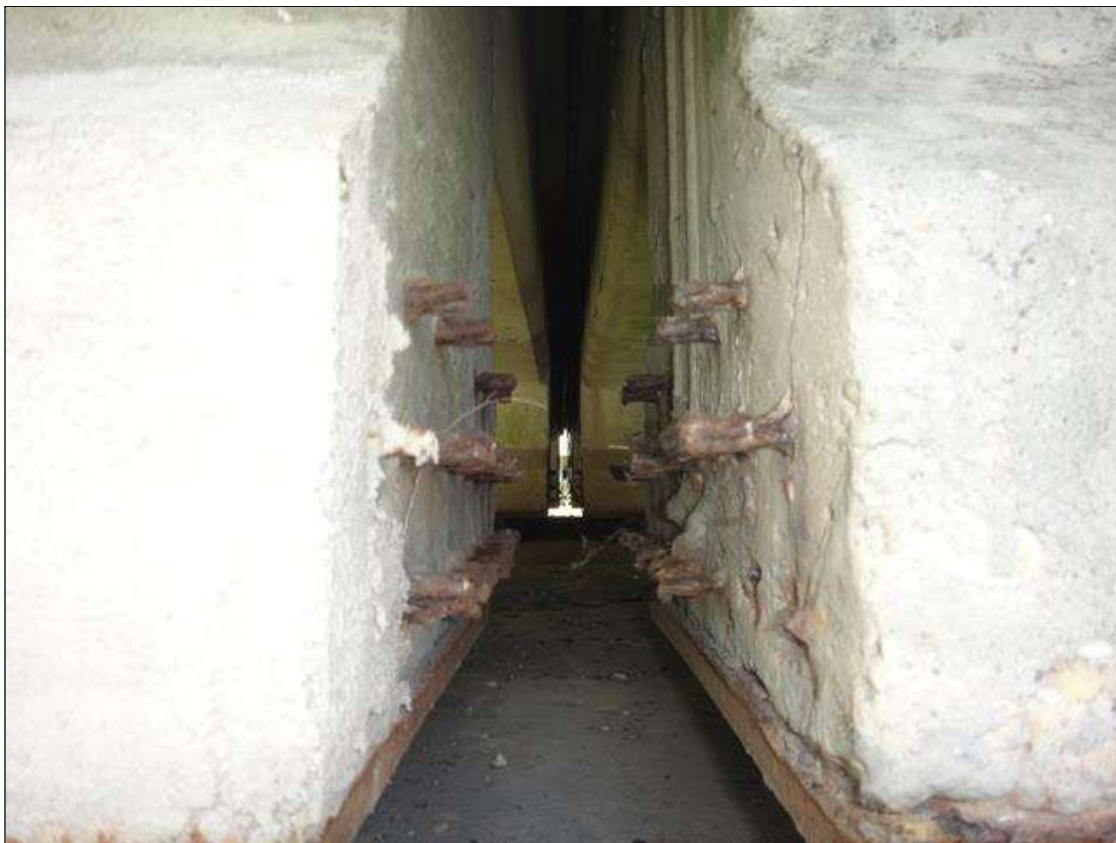
Exposed prestressing ends [similar at all beams at interior bents]

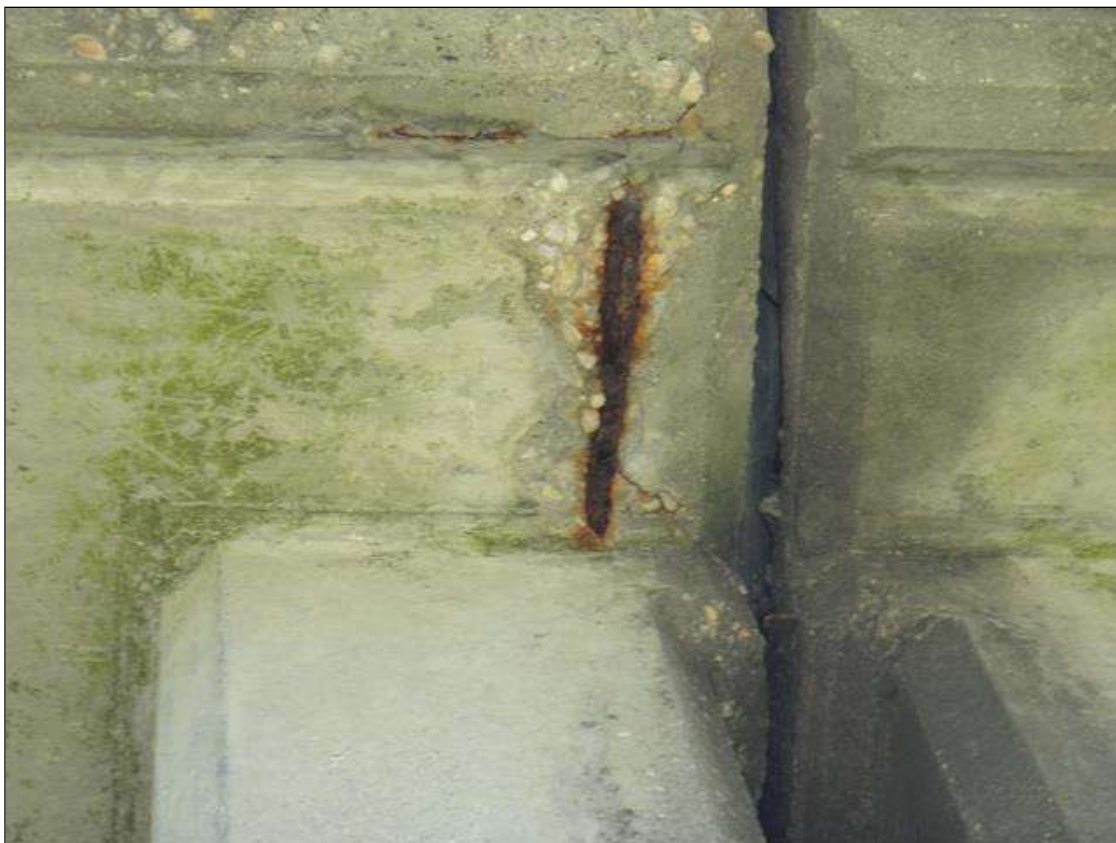
Span 3 Deck: at right overhang over bent 3, spall [10in x 4in x up to 1-1/2in deep] with one [1] exposed rusted reinforcing [section loss up to 1/16in]

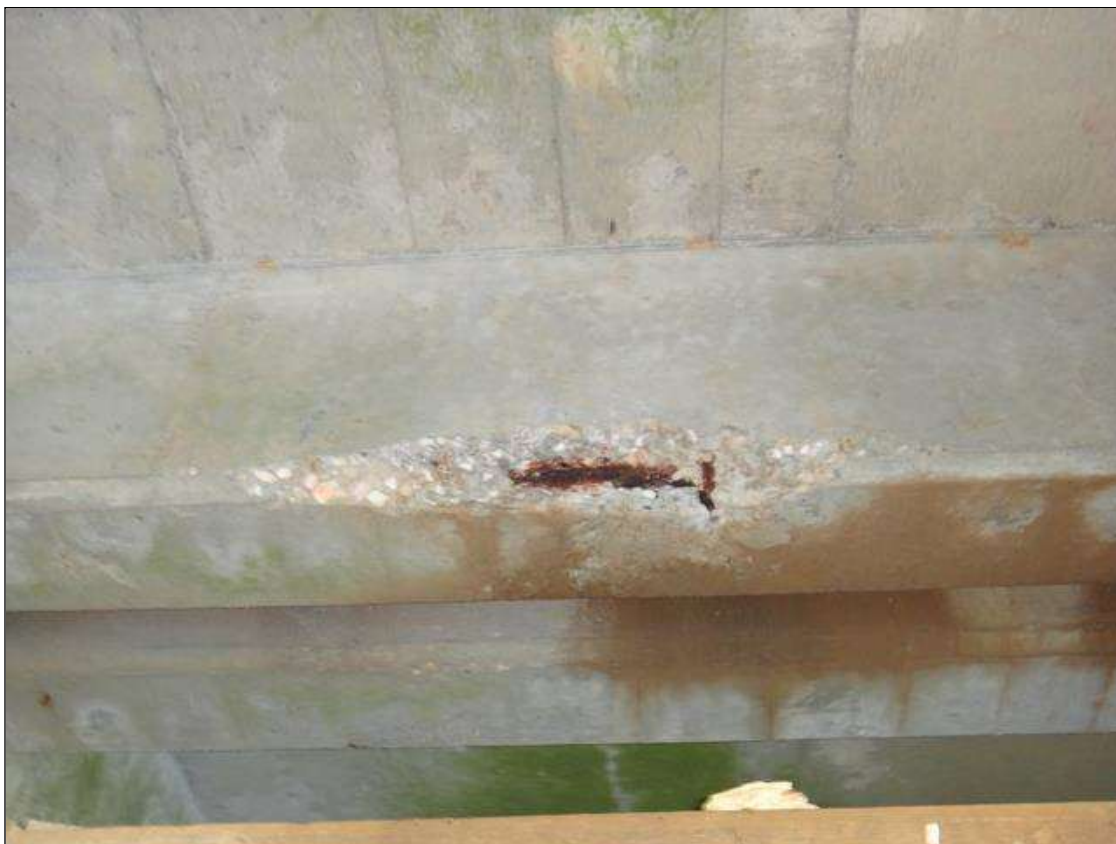
Span 3 Beam 1: North face at lower edge of diaphragm between beams 1 and 2 at near end, spall [24in x 6in x up to 3in deep] with one [1] exposed rusted reinforcing [section loss up to 1/16in]

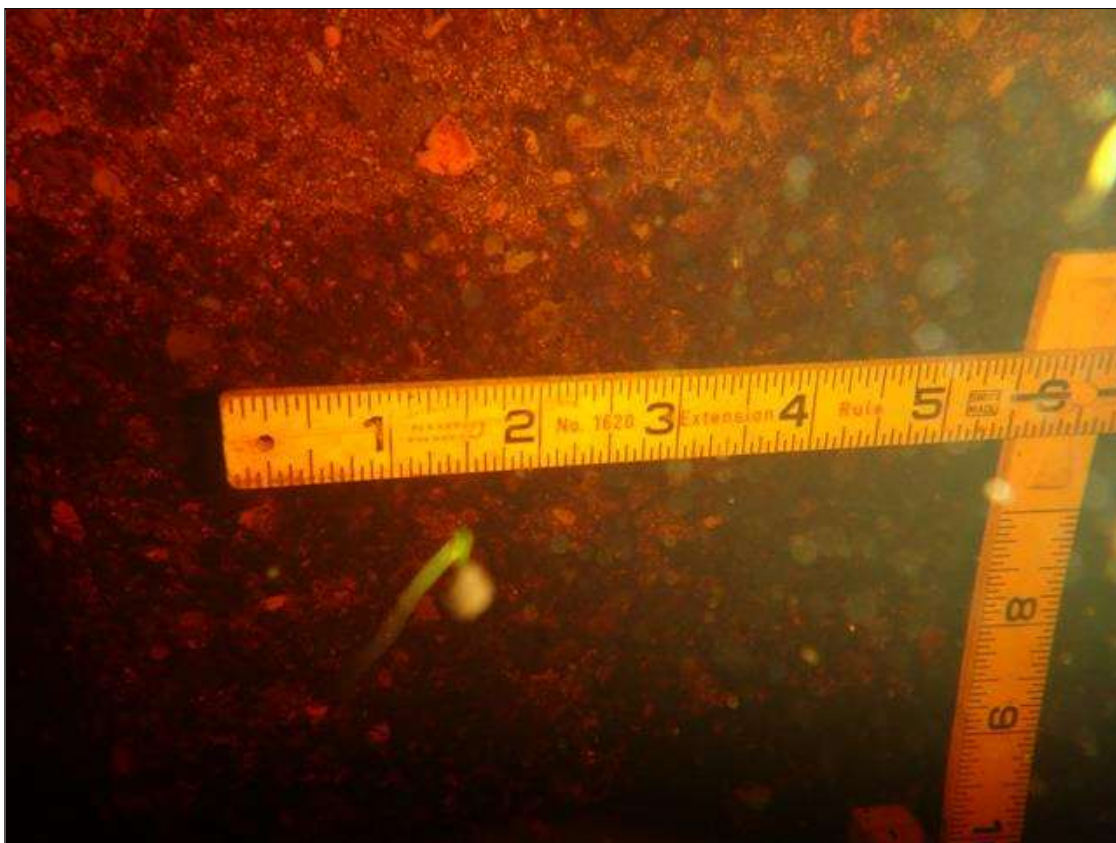
Bent 2 Pile 2: at waterline down 18in, minor abrasion [up to 1/16in deep]

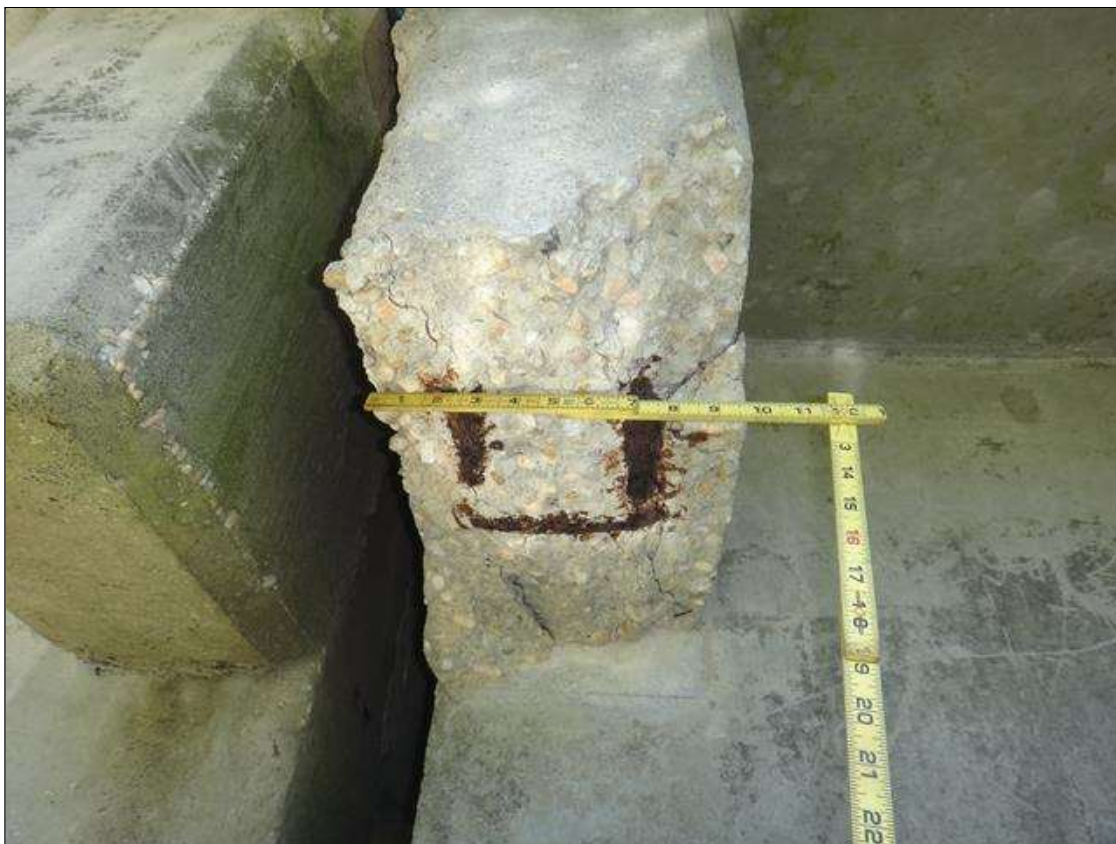
Span 2 Deck: at right overhange over bent 1, spall/delamination [20in x 10in x up to 3in deep] with three [3] exposed rusted reinforcing [section loss < 1/16in]

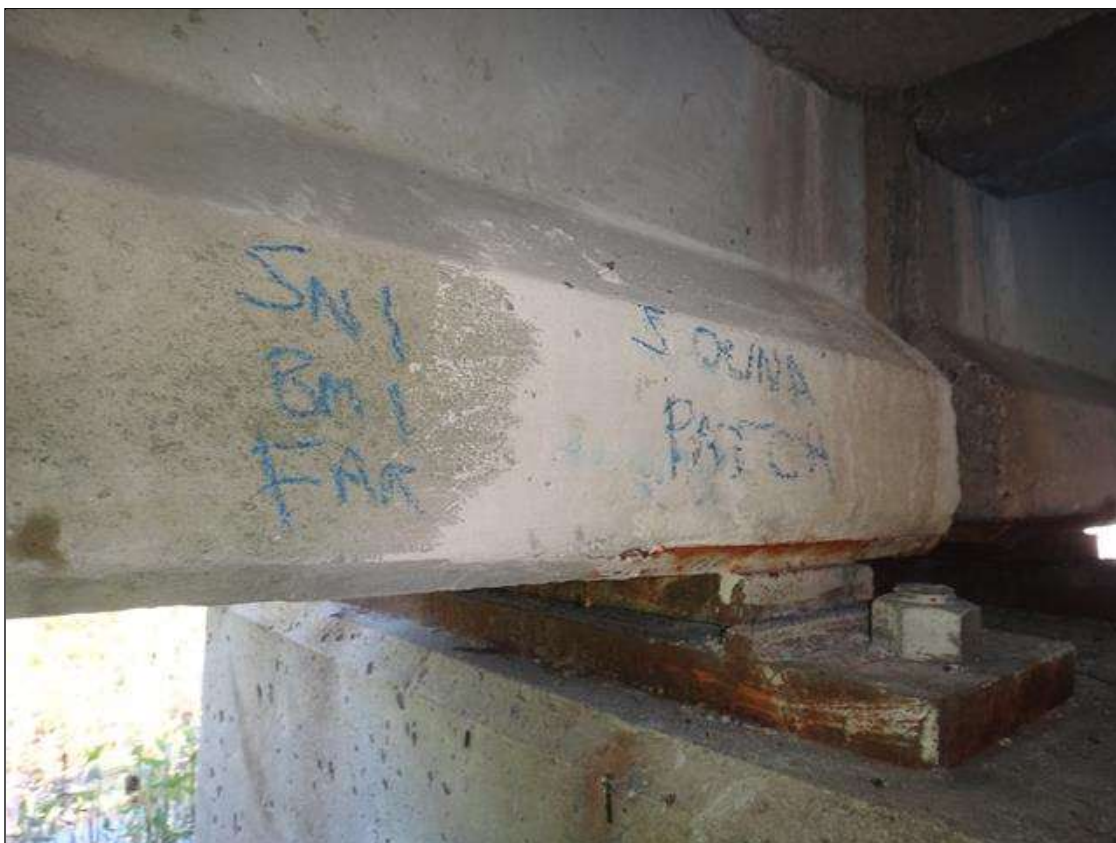
Span 1 Beam 1: at far end 1ft from bent 1, sound patch [4in diameter]

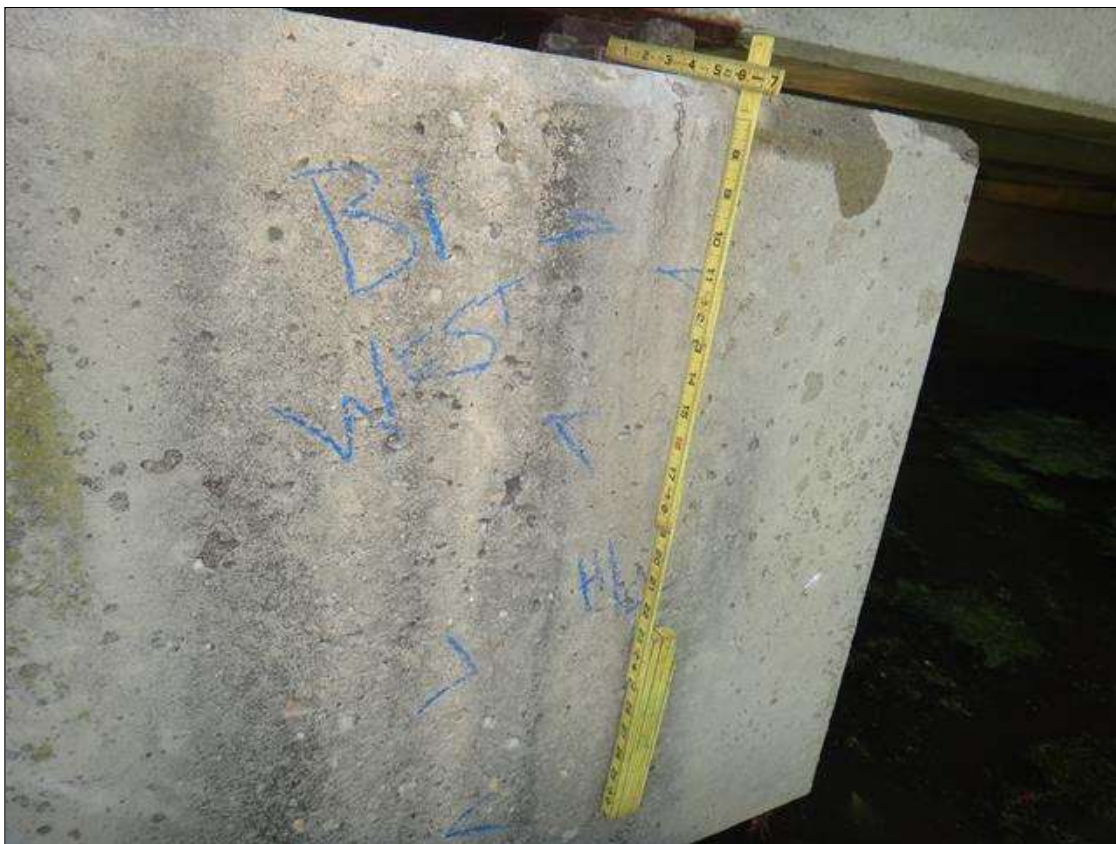
Bent 1 Cap 1: West face of cap, one [1] vertical crack [full height x hairline]

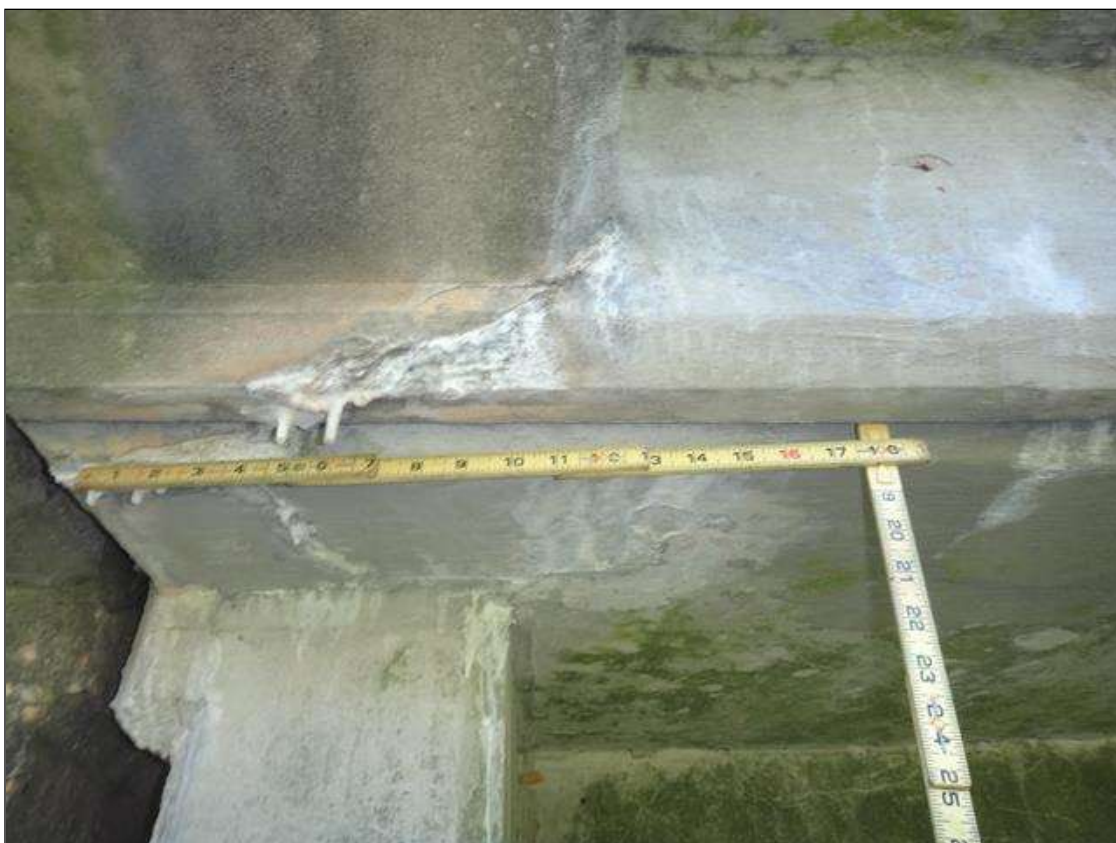
Span 1 Deck: left overhang at bent 1, efflorescence buildup

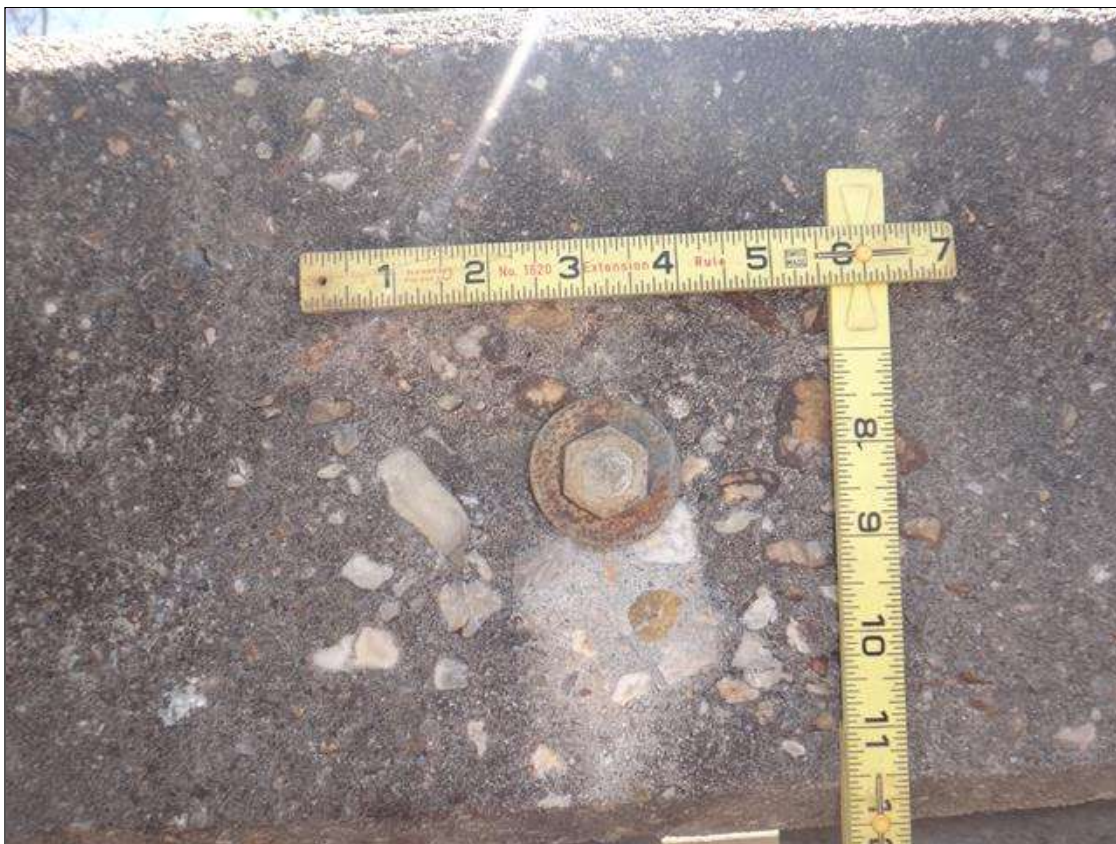
Span 4 Left Bridge Rail: along length of rail at steel rail connections, multiple spalls [up to 5in diameter x up to 1in deep]

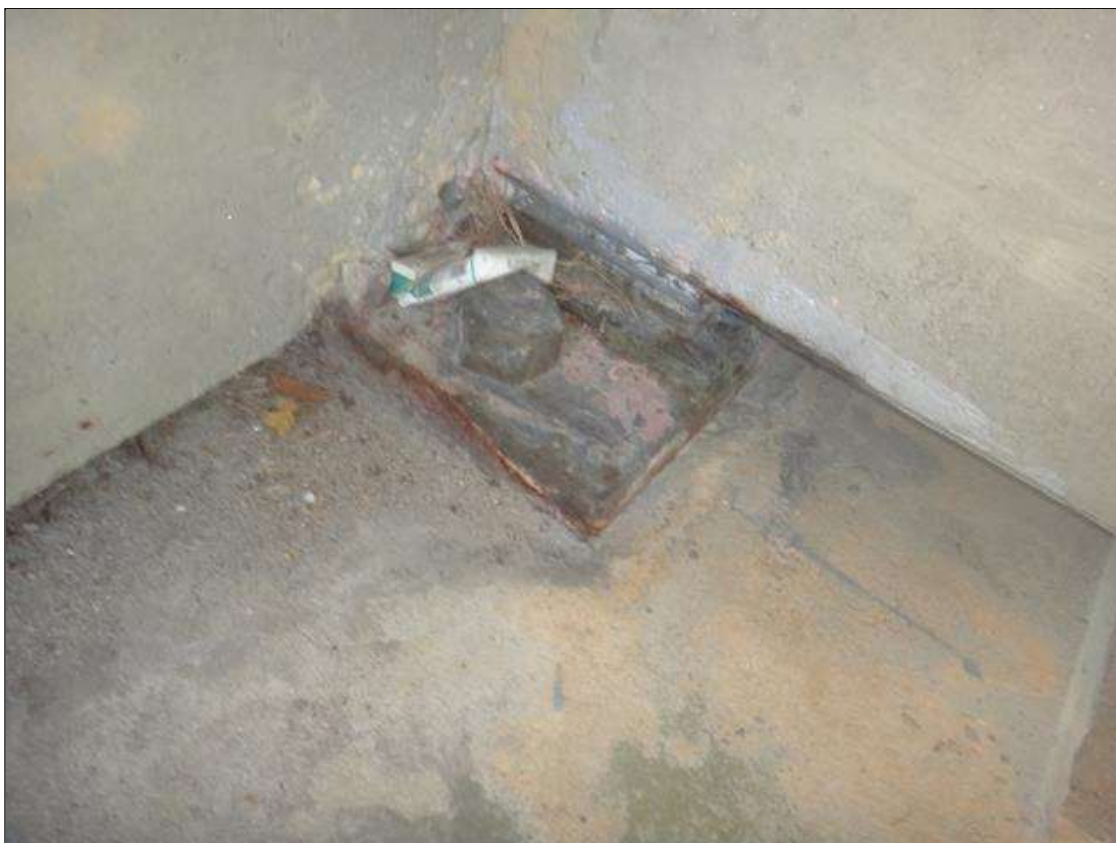
Span 4 Beam 1 Far Bearing: active surface corrosion [no section loss noted]

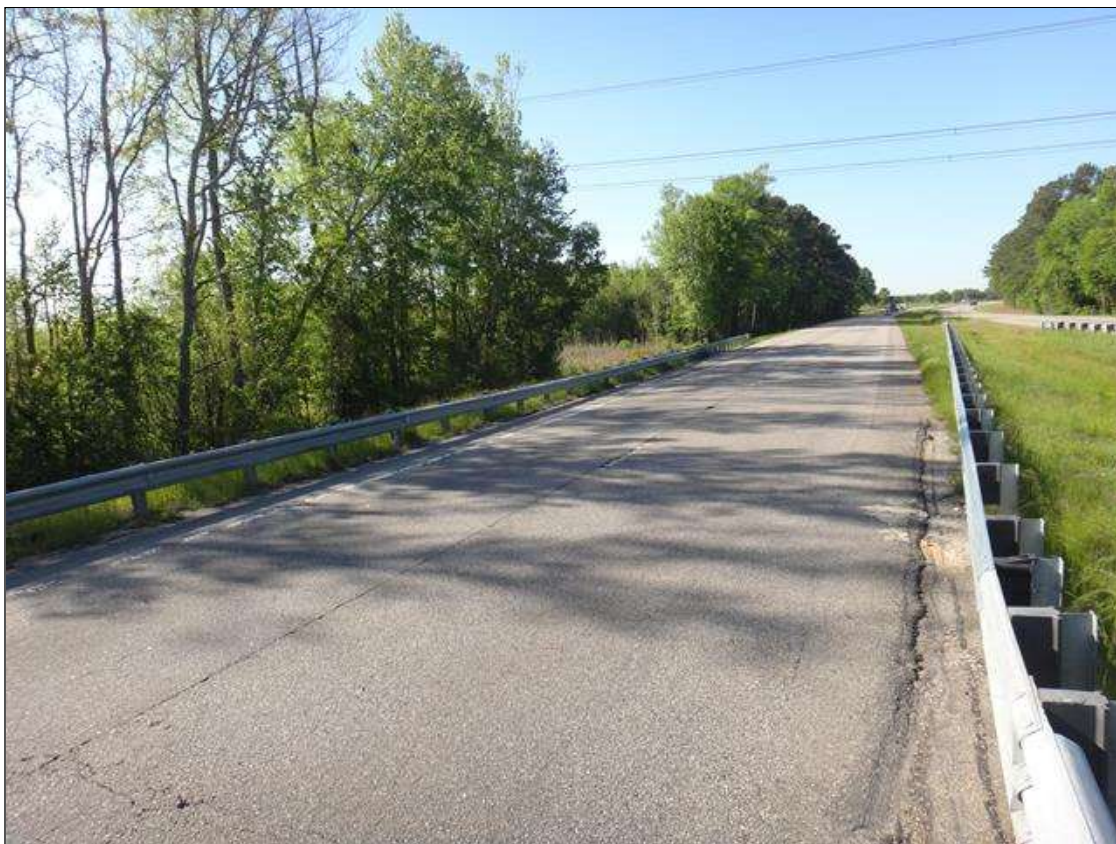
South approach looking South

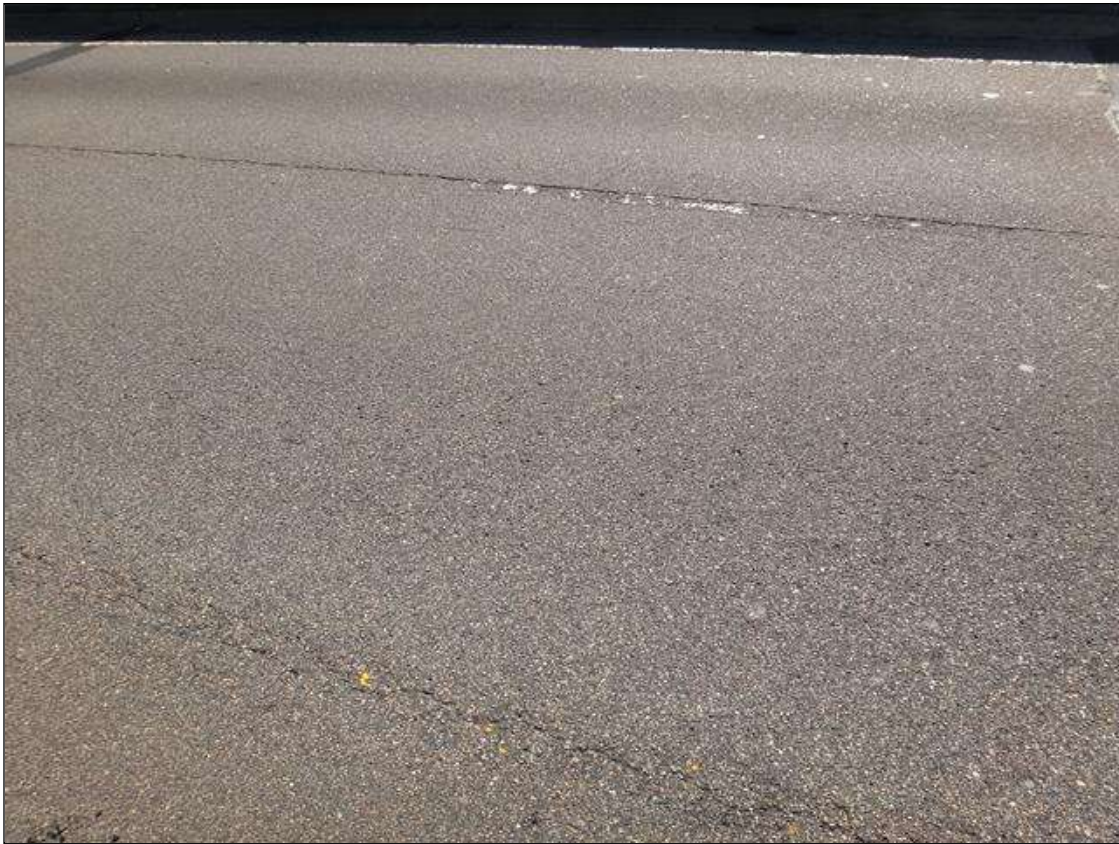
typical wearing surface

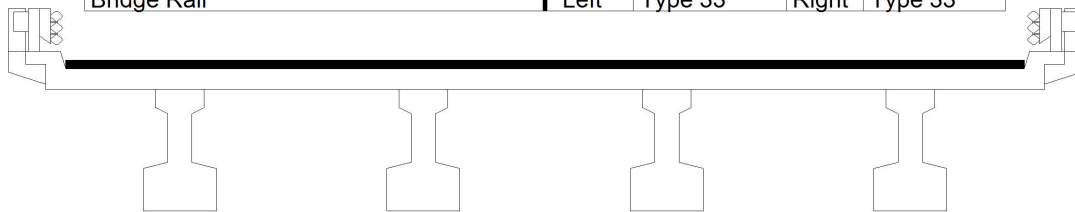
Measurements for Span #	1		
Deck Thickness	0.604ft	Left Overhang	3.75ft
Top of Rail to Bottom of Beam	6.104ft	Right Overhang	3.75ft

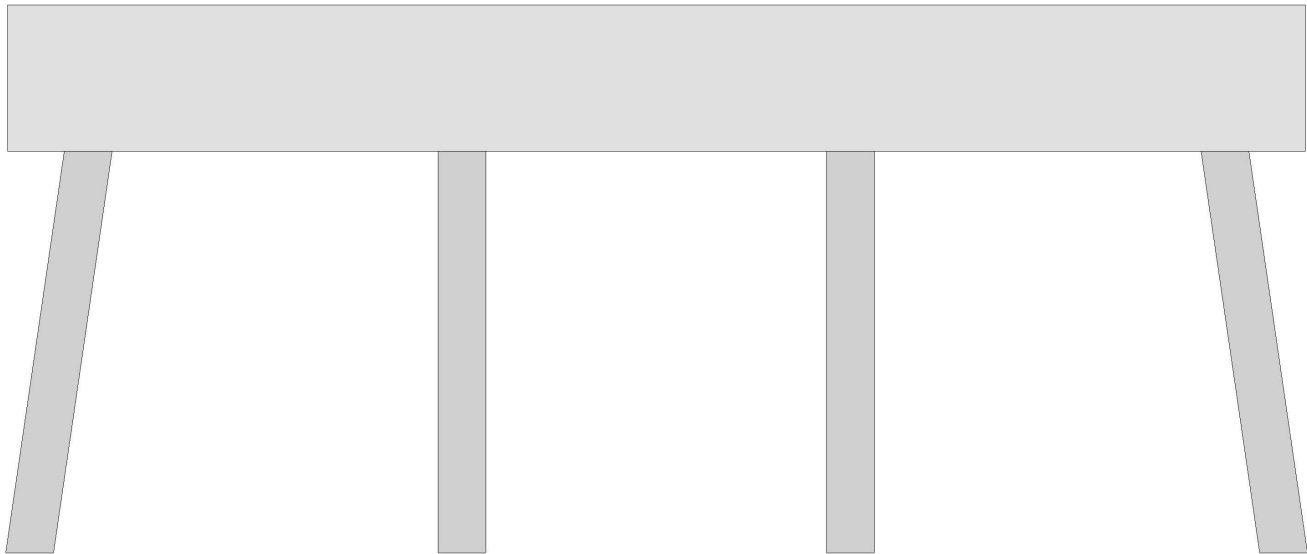
Cap Information			Material Cast-in-Place Concrete							
Length	Width	Height	Left Overhang	Right Overhang	Left Beam to End of Cap.	Right Beam to End of Cap.				
28 ft.	3 ft.	2.5 ft.	2.000 ft.	2.000 ft.	2 ft.	2 ft.				
Subcap Information			Material							
Length	Width	Height	Left Overhang	Right Overhang	Left Pile to Splice.					
Sill Information			Material							
Length	Width	Height								
Pile #	Material	Spacing	Width/Dia.	Height	Length	Orientation	Driven?	Replacement?	Removed?	Collar?
1	Concrete	8 ft.	1.833 ft.			Battered	No	No	No	No
2	Concrete	8 ft.	1.833 ft.			Vertical	No	No	No	No
3	Concrete	8 ft.	1.833 ft.			Vertical	No	No	No	No
4	Concrete		1.833 ft.			Battered	No	No	No	No
Bent #: 1		Similar Bents: 2, 3
