NC DEPARTMENT OF TRANSPORTATION  
 DIVISION OF HIGHWAYS  
 STRUCTURE MANAGEMENT UNIT

# Structure Safety Report

## 2 Year Complete Topside and Underwater Element Inspection

COUNTY: ROBESON STRUCTURE NUMBER: 770168 FREQUENCY: 24 MONTHS

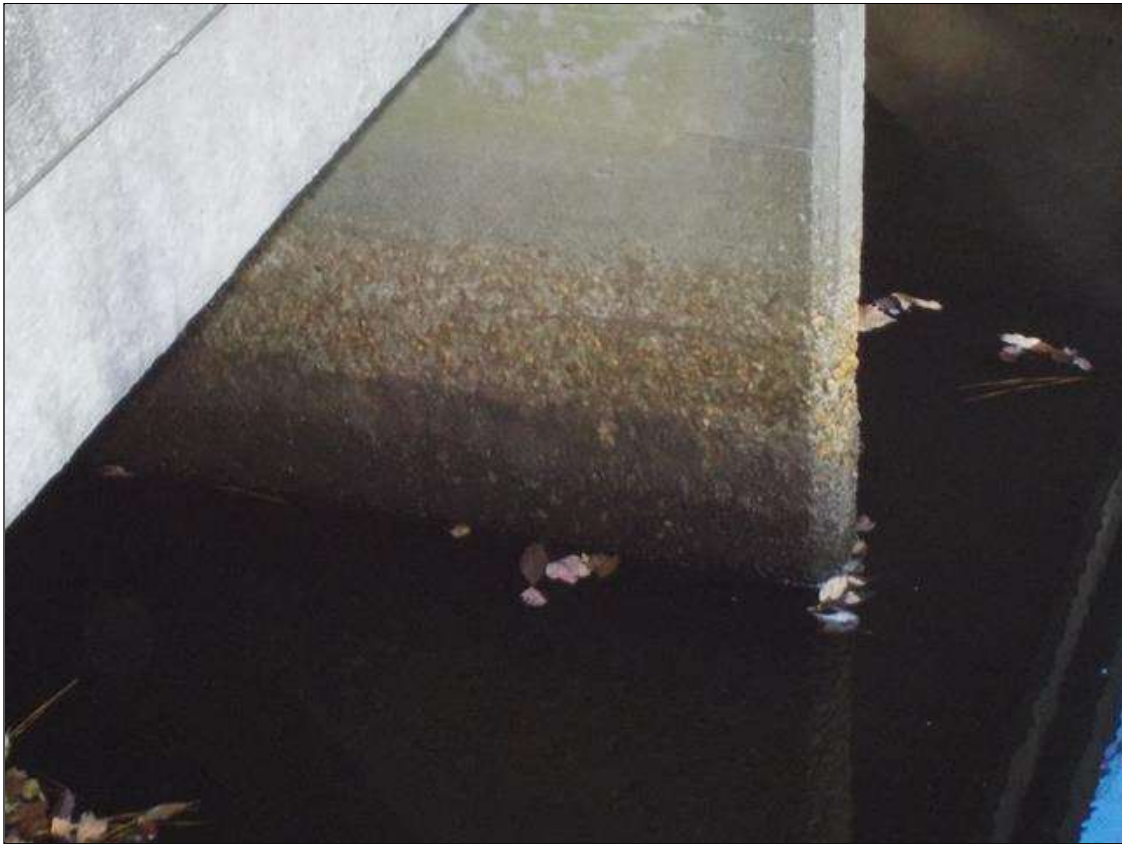
COARSE AGG EXPOSED ON INTERIOR WALL

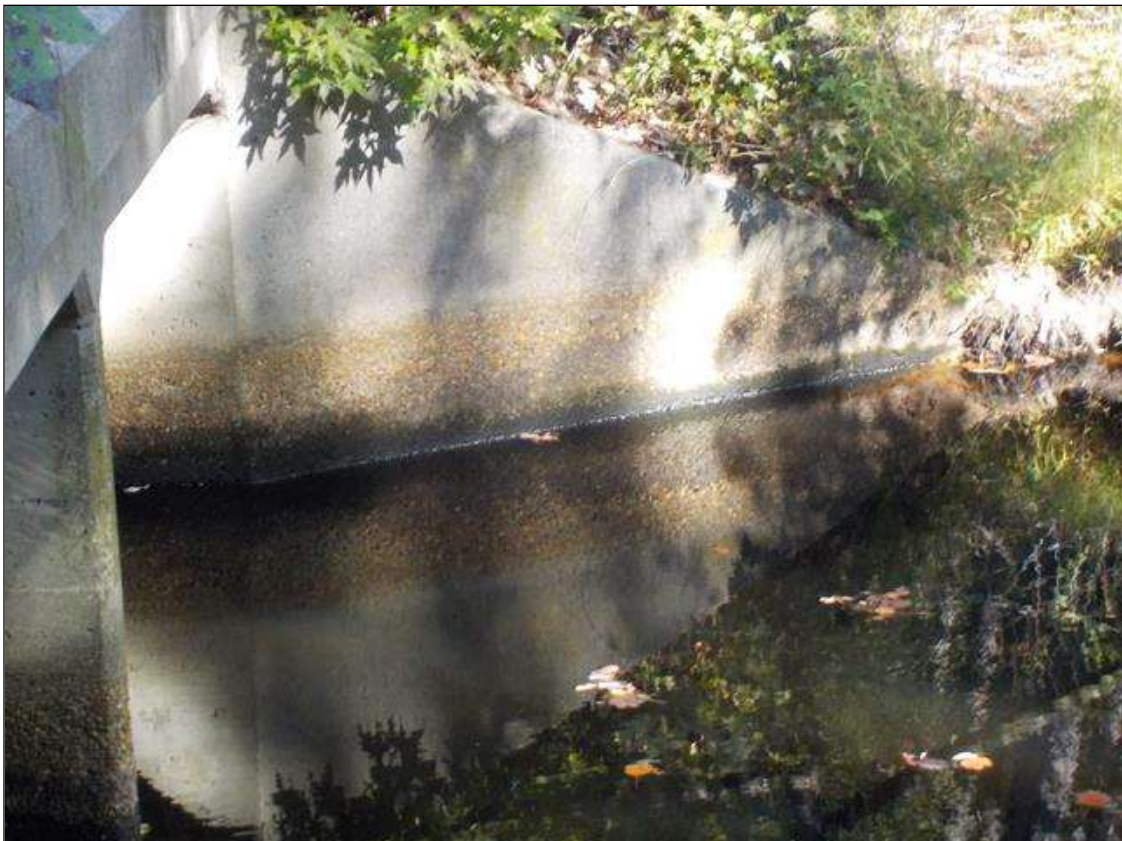
COARSE AGG EXPOSED ON WINGWALL

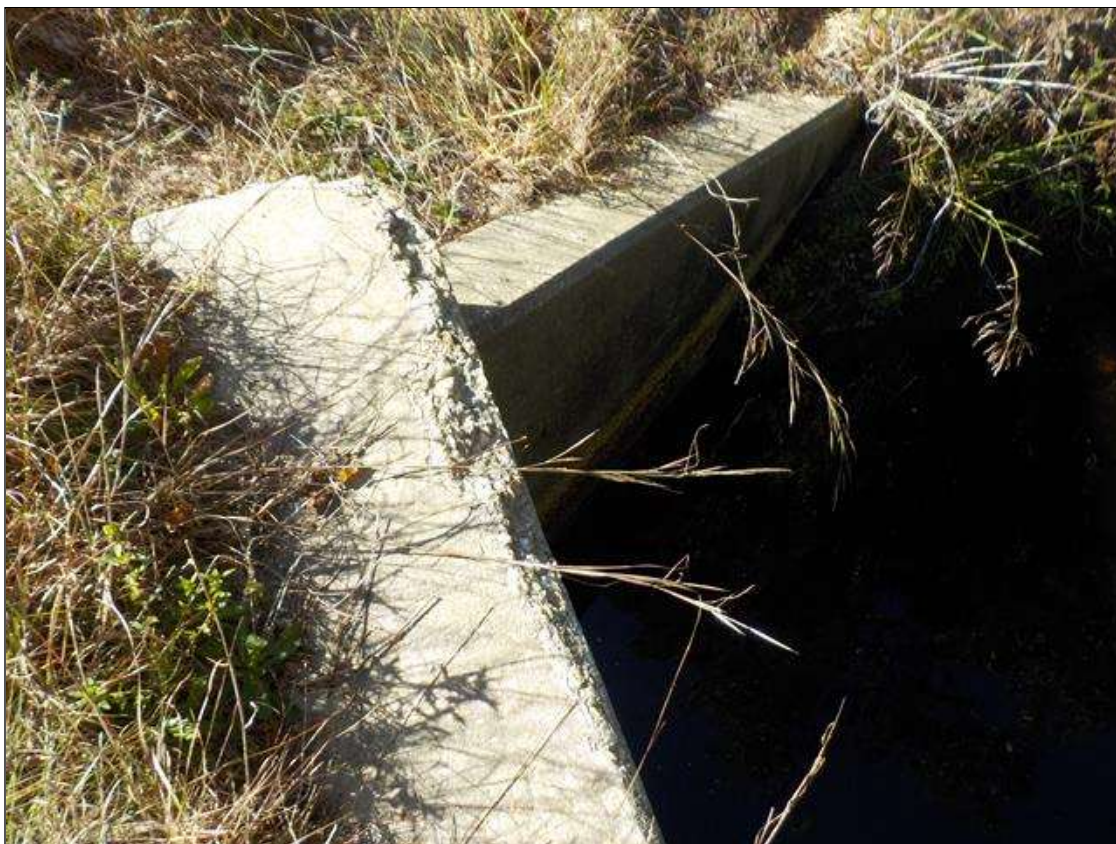
SPALL, SW CORNER HEADWALL, 3'L X 5"W X 2"D

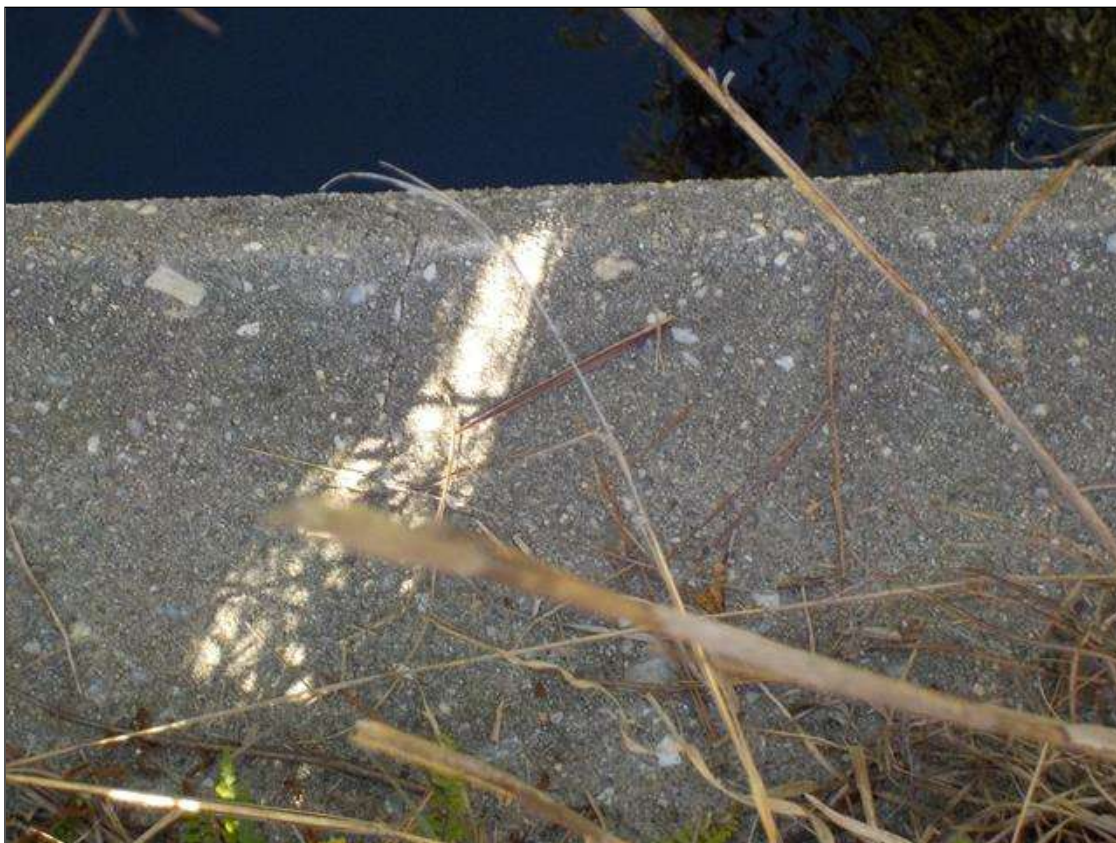
HEADWALL, H/L CRACK

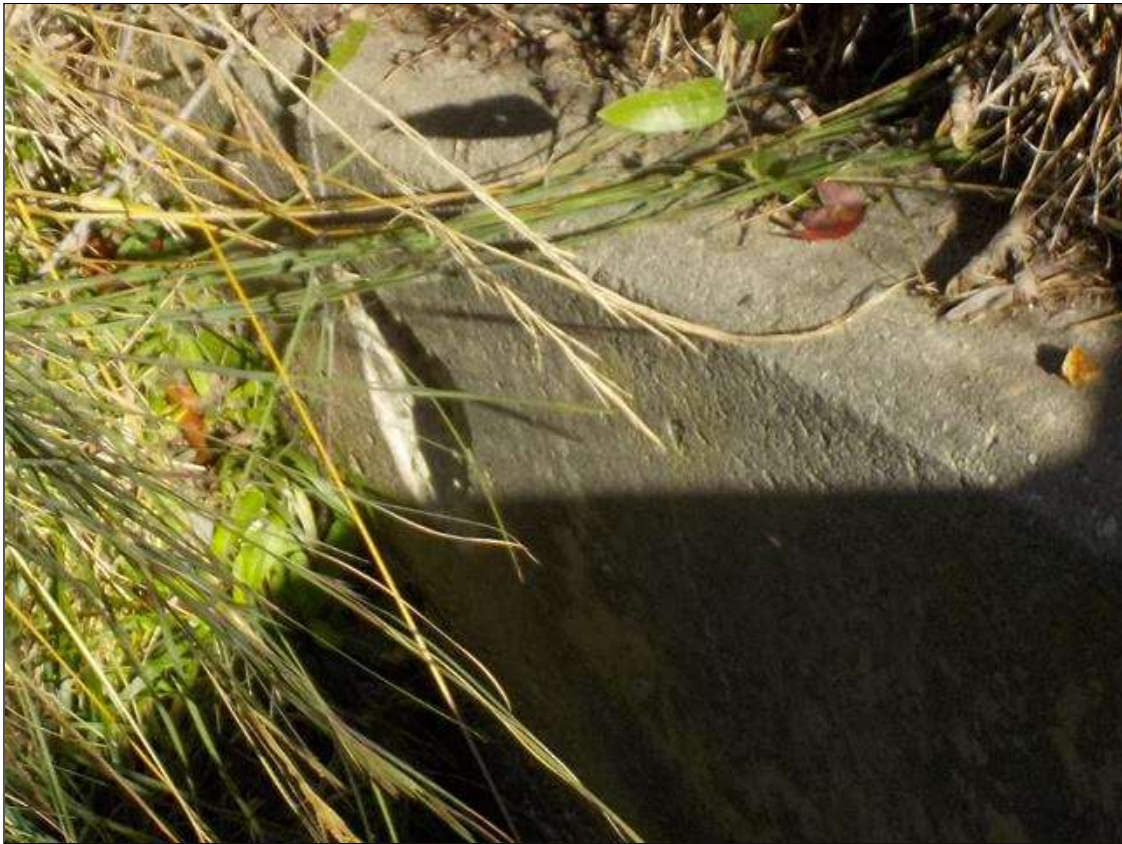
SPALL, NW WINGWALL, 6"DIA. X 1"D

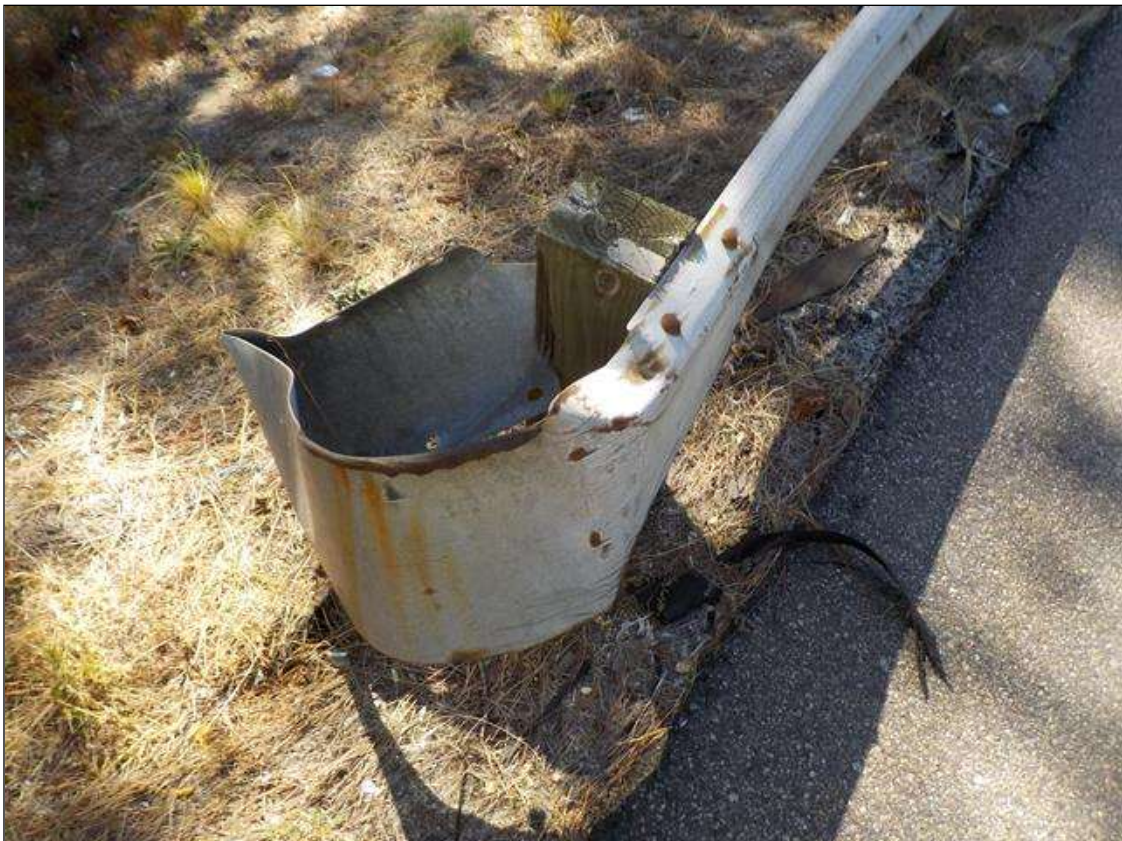
NE GUARDRAIL DAMAGED

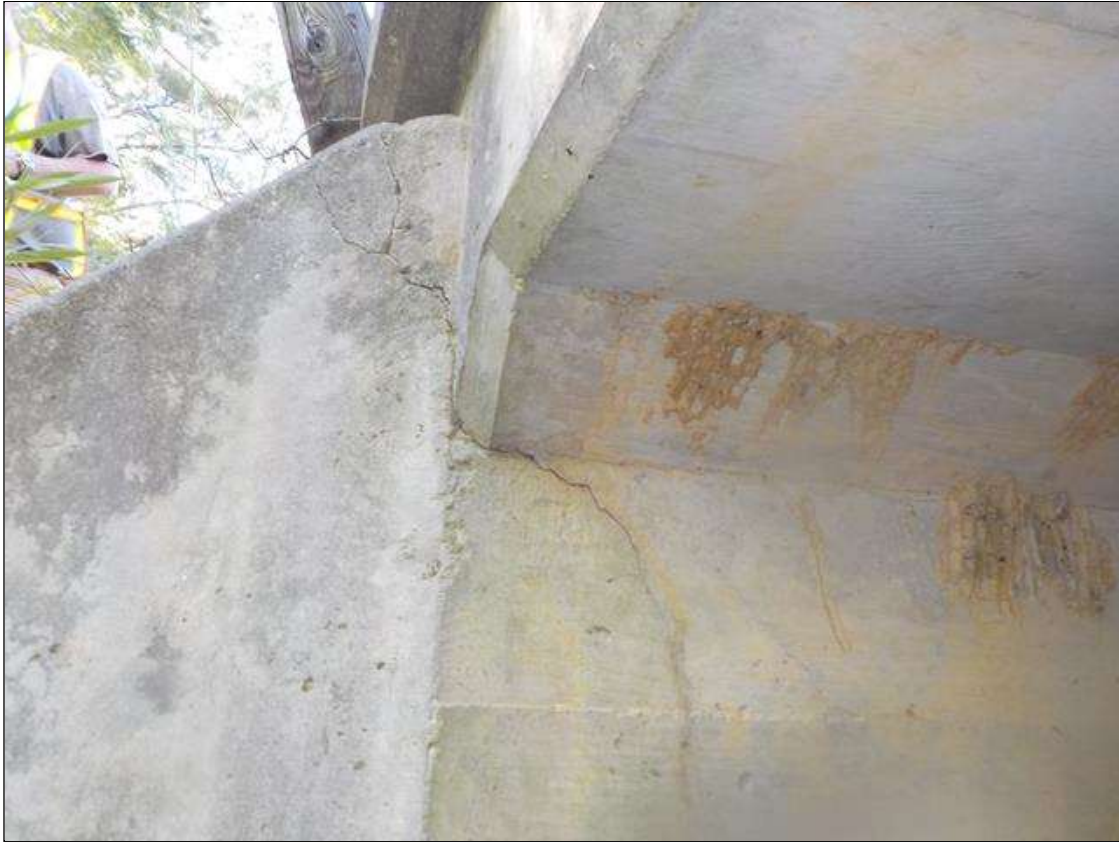
CRACK AT SE WING TO 1/16"

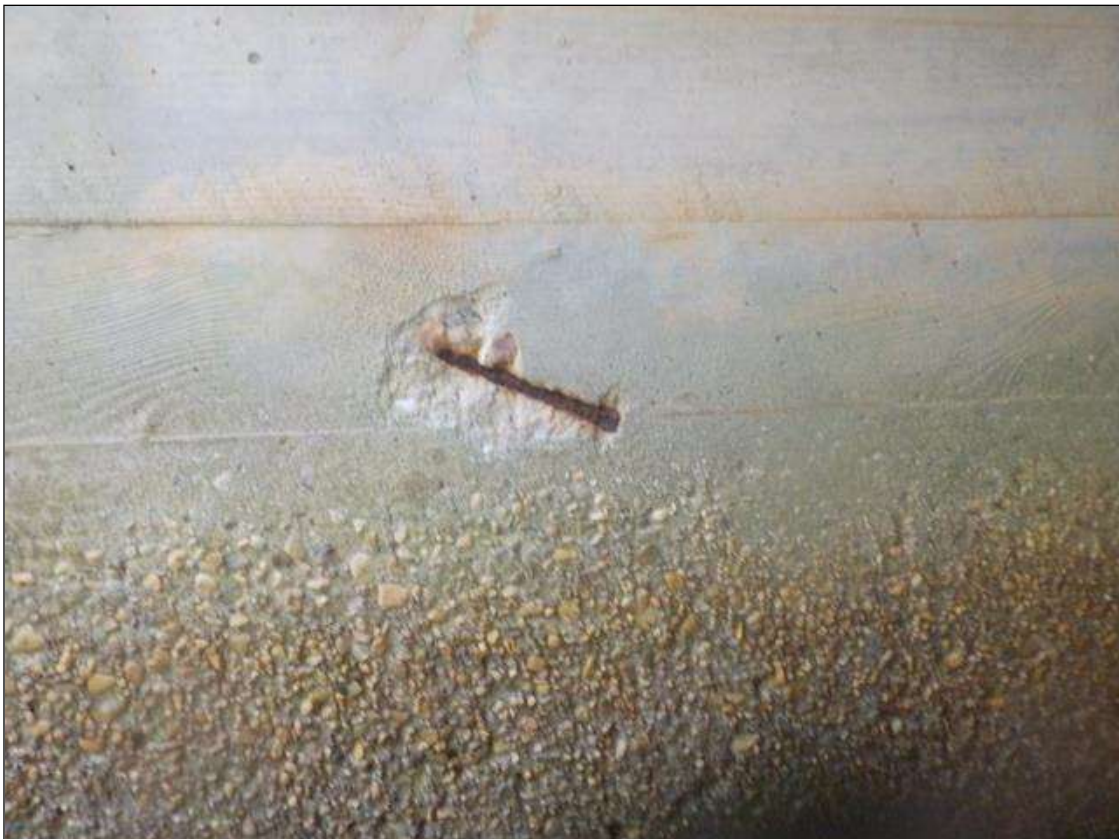
Element Number	Defect Type	Defect Description	CS	CS Qty	Maint Qty
241	Cracking (RC and Other)	(1') CONSTRUCTION JOINT OPEN TO 1/4" WITH WATER LEAKAGE	3	1	1 Feet
241	Cracking (RC and Other)	(9') VERTICAL H/L - 1/32" CRACKS W/ EFFLO.	3	9	9 Feet
241	Exposed Rebar	1.5' FROM EAST ON EXTERIOR WALL - 3' BELOW TOP SLAB - REBAR EXPOSED - 6" LONG X 4.5" VERTICAL X 1" DEEP(1/16" LOSS ON REBAR).	3	1	1 Feet
241	Scour	1.5' CURTAINWALL EXPOSURE AT THE WEST END OF BARREL 1	3	1	Feet
241	Abrasion/Wear (PSC/RC)	COARSE AGGREGATE EXPOSED TO 3/8"	2	114	Feet
241	Cracking (RC and Other)	(9') VERTICAL H/L CRACKS	2	9	Feet

BARREL 1: SPALL NEAR EAST END, W/REBAR

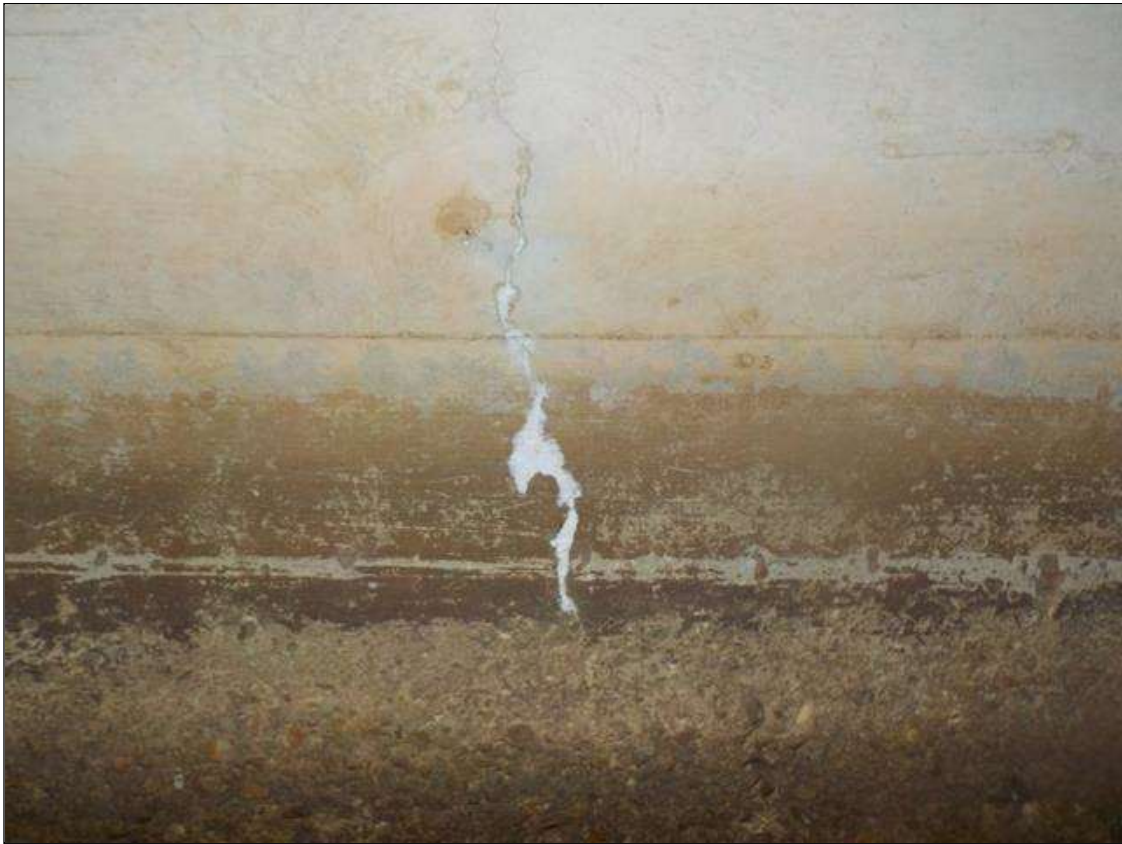
CRACK W/EFFLO, BARREL 1

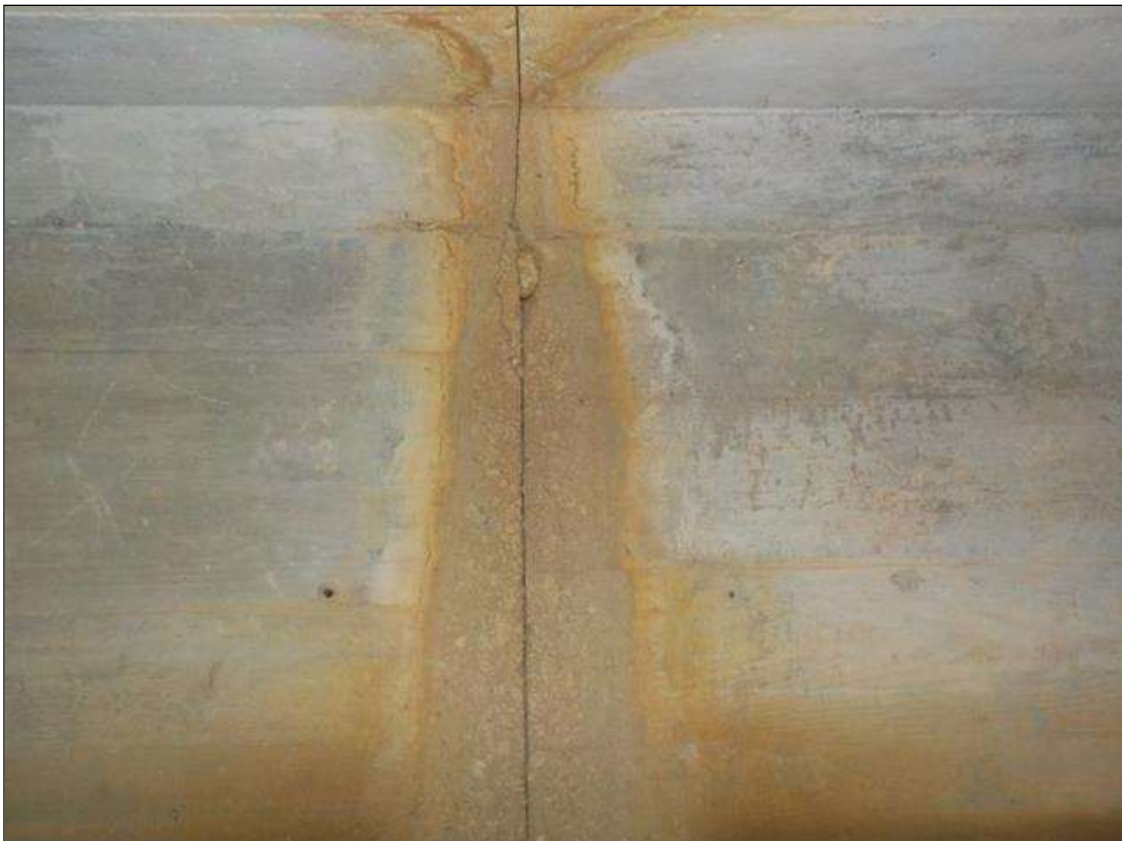
BARREL 1: CONSTRUCTION JOINT W/RUST

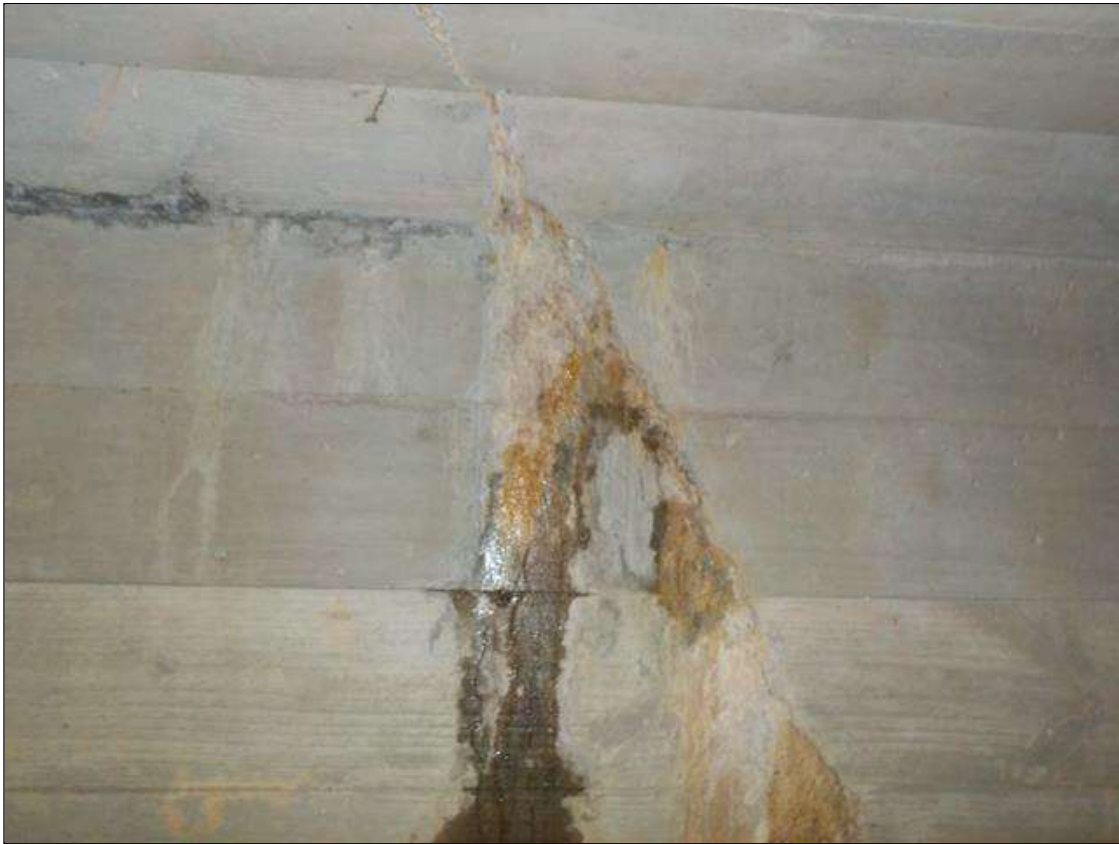
BARREL 2: CRACK W/EFFLO

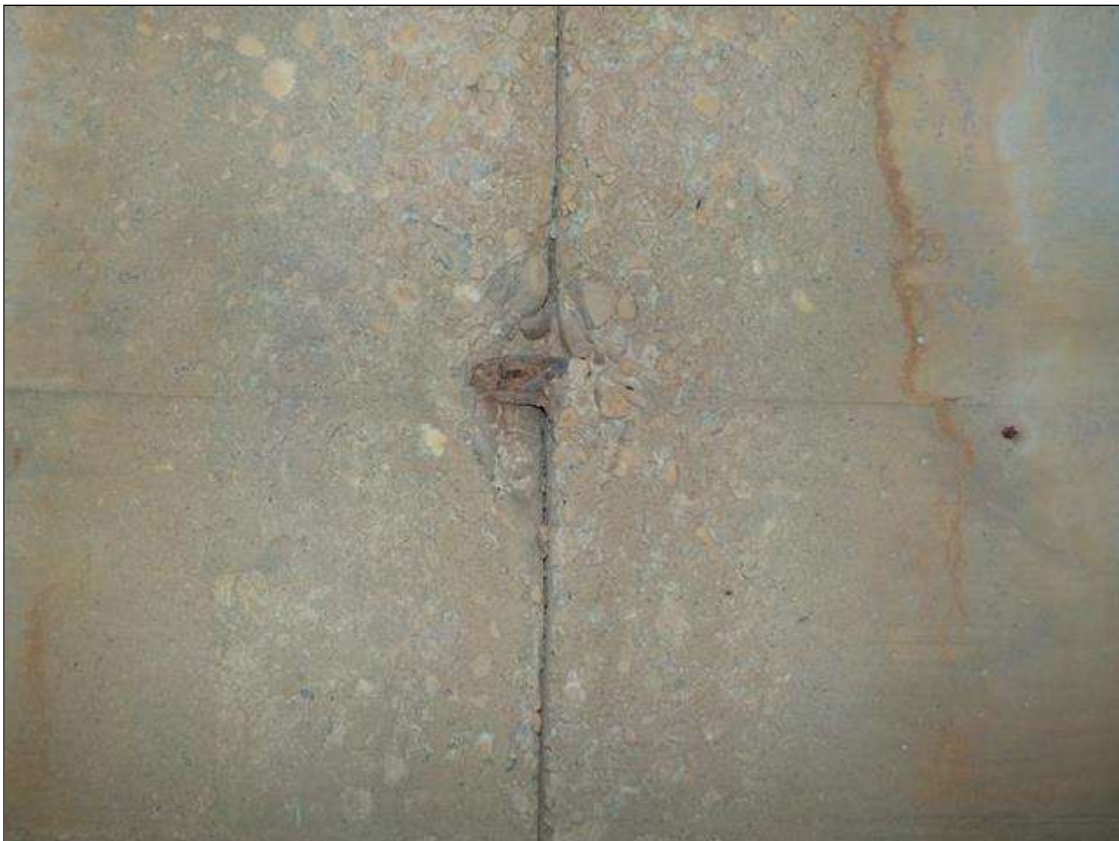
CONSTRUCTION JOINT OPEN TO 1/4" W/EXPOSED REBAR. NO SECTION LOSS IN SPALL, 3"V X 3"W X 1"D

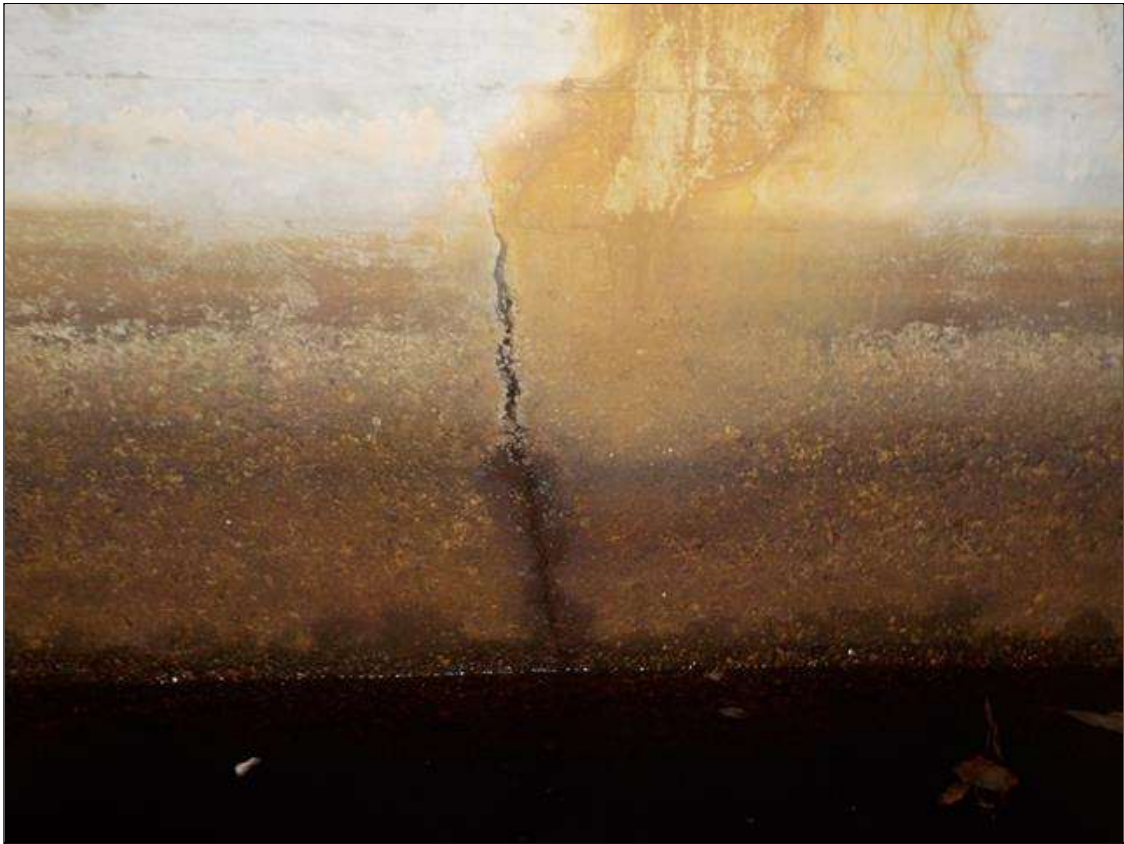
BAREL 3: H/L CRACK W/EFFLO

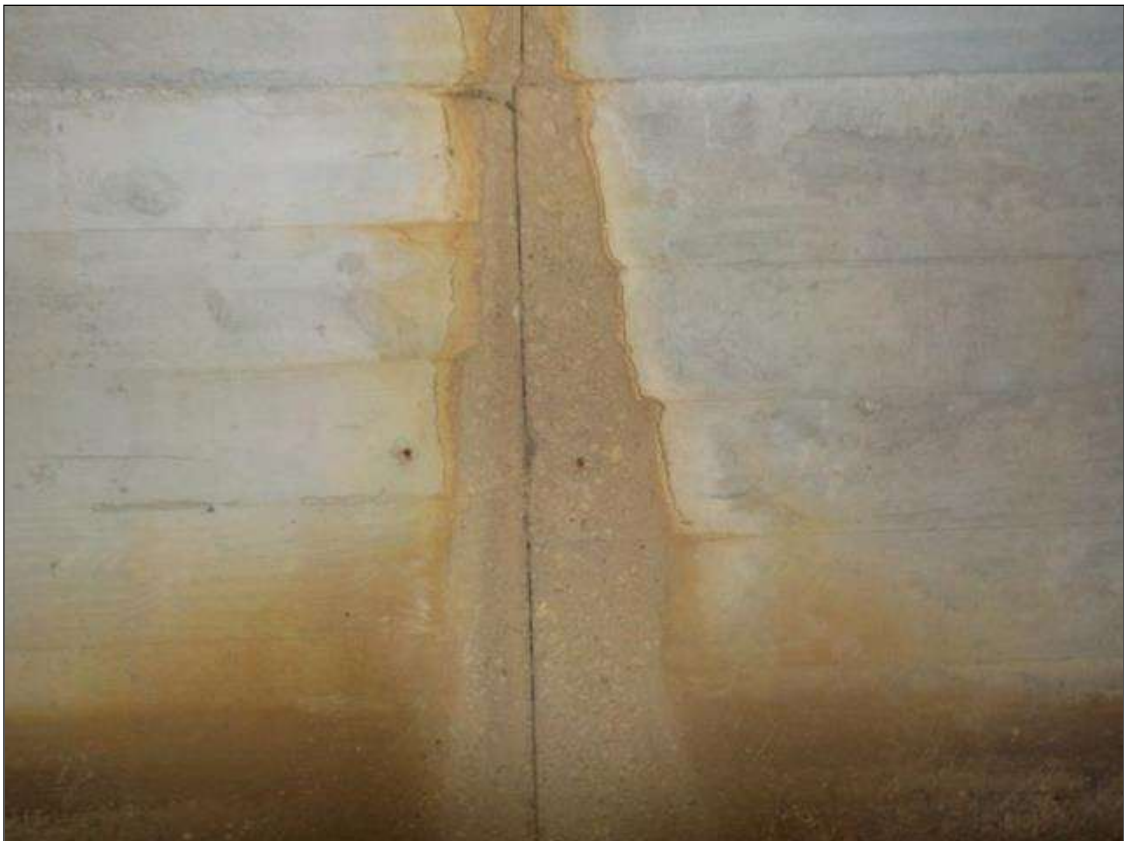
BARREL 3: CONSTRUCTION JOINT OPEN TO 1/4"

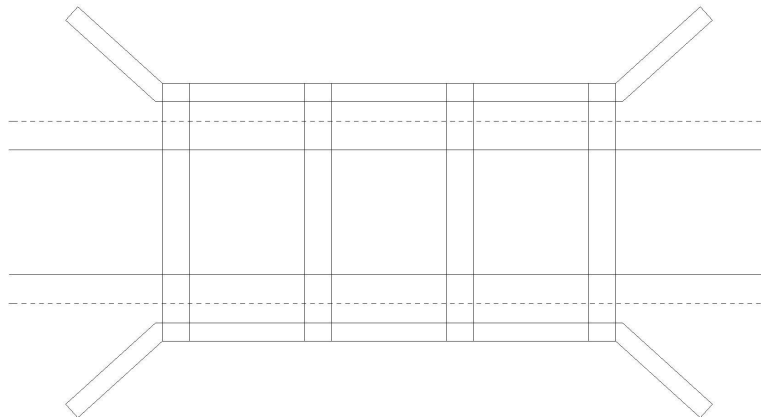
**Title**  
CULVERT ELEVATION

Barrel #	Width	Height	Wall Thickness	Scour at Inlet	Scour at Outlet
1	9ft	8ft	.67ft	1.5' C/W EXP.	
2	9ft	8ft	.67ft	2.0' C/W EXP.	
3	9ft	8ft	.67ft	2.0' C/W EXP.

MMS Code	Description of Function	Unit	Quantity	Remarks	Est. Cost
3370	Maintenance and Repair of NBIS Pipes and Culverts	LF	0	Barrel 1 Section 1: 1.5' CURTAINWALL EXPOSURE AT THE WEST END OF BARREL 1	
3370	Maintenance and Repair of NBIS Pipes and Culverts	LF	1	Barrel 2 Section 1: 2.0' CURTAINWALL EXPOSURE AT THE WEST END.	
3370	Maintenance and Repair of NBIS Pipes and Culverts	LF	1	Barrel 3 Section 1: 2.0' CURTAINWALL EXPOSURE AT THE WEST END
