I-5997 PROJECT NO.____ WAKE COUNTY 910242

BRIDGE NO. _

ACB8082119D74CD... DEPARTMENT OF TRANSPORTATION
RALEIGH

RESET BEARING DETAILS

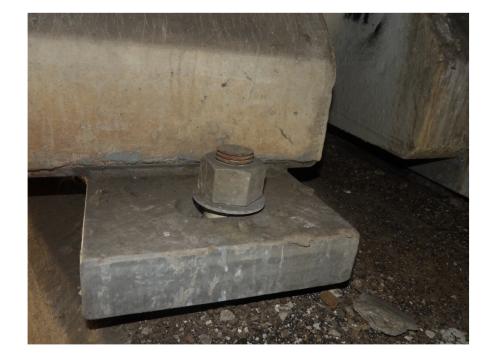
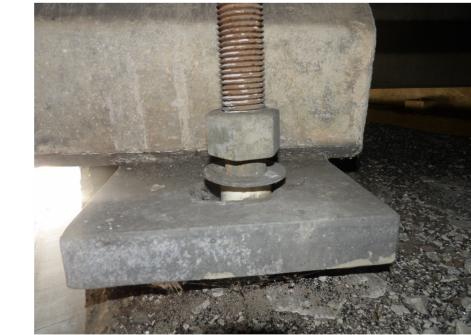
EXISTING CONDITIONS PHOTOS SHOW POSITION OF ANCHOR BOLTS AT EXPANSION END OF SPAN B (BENT 1). AIR TEMPERATURE IS 91° F.

WITH GIRDERS IN A JACKED AND SUPPORTED CONDITION, DETACH EXISTING SOLE PLATES. FOR JACKING DETAILS, SEE "JACKING DETAILS" SHEET. RESET SOLE PLATE AS SHOWN AND LOWER GIRDER ONTO THE EXISTING SOLE PLATE AND ELASTOMERIC BEARING.
