PROJECT NO. **HI-0007**  
**WILSON** COUNTY  
 BRIDGE NO. **970287**

**SLOPE PROTECTION  
 REPAIR DETAILS**

| REVISIONS | | | | | | SHEET NO.<br>S4-8<br>TOTAL SHEETS<br>8 |

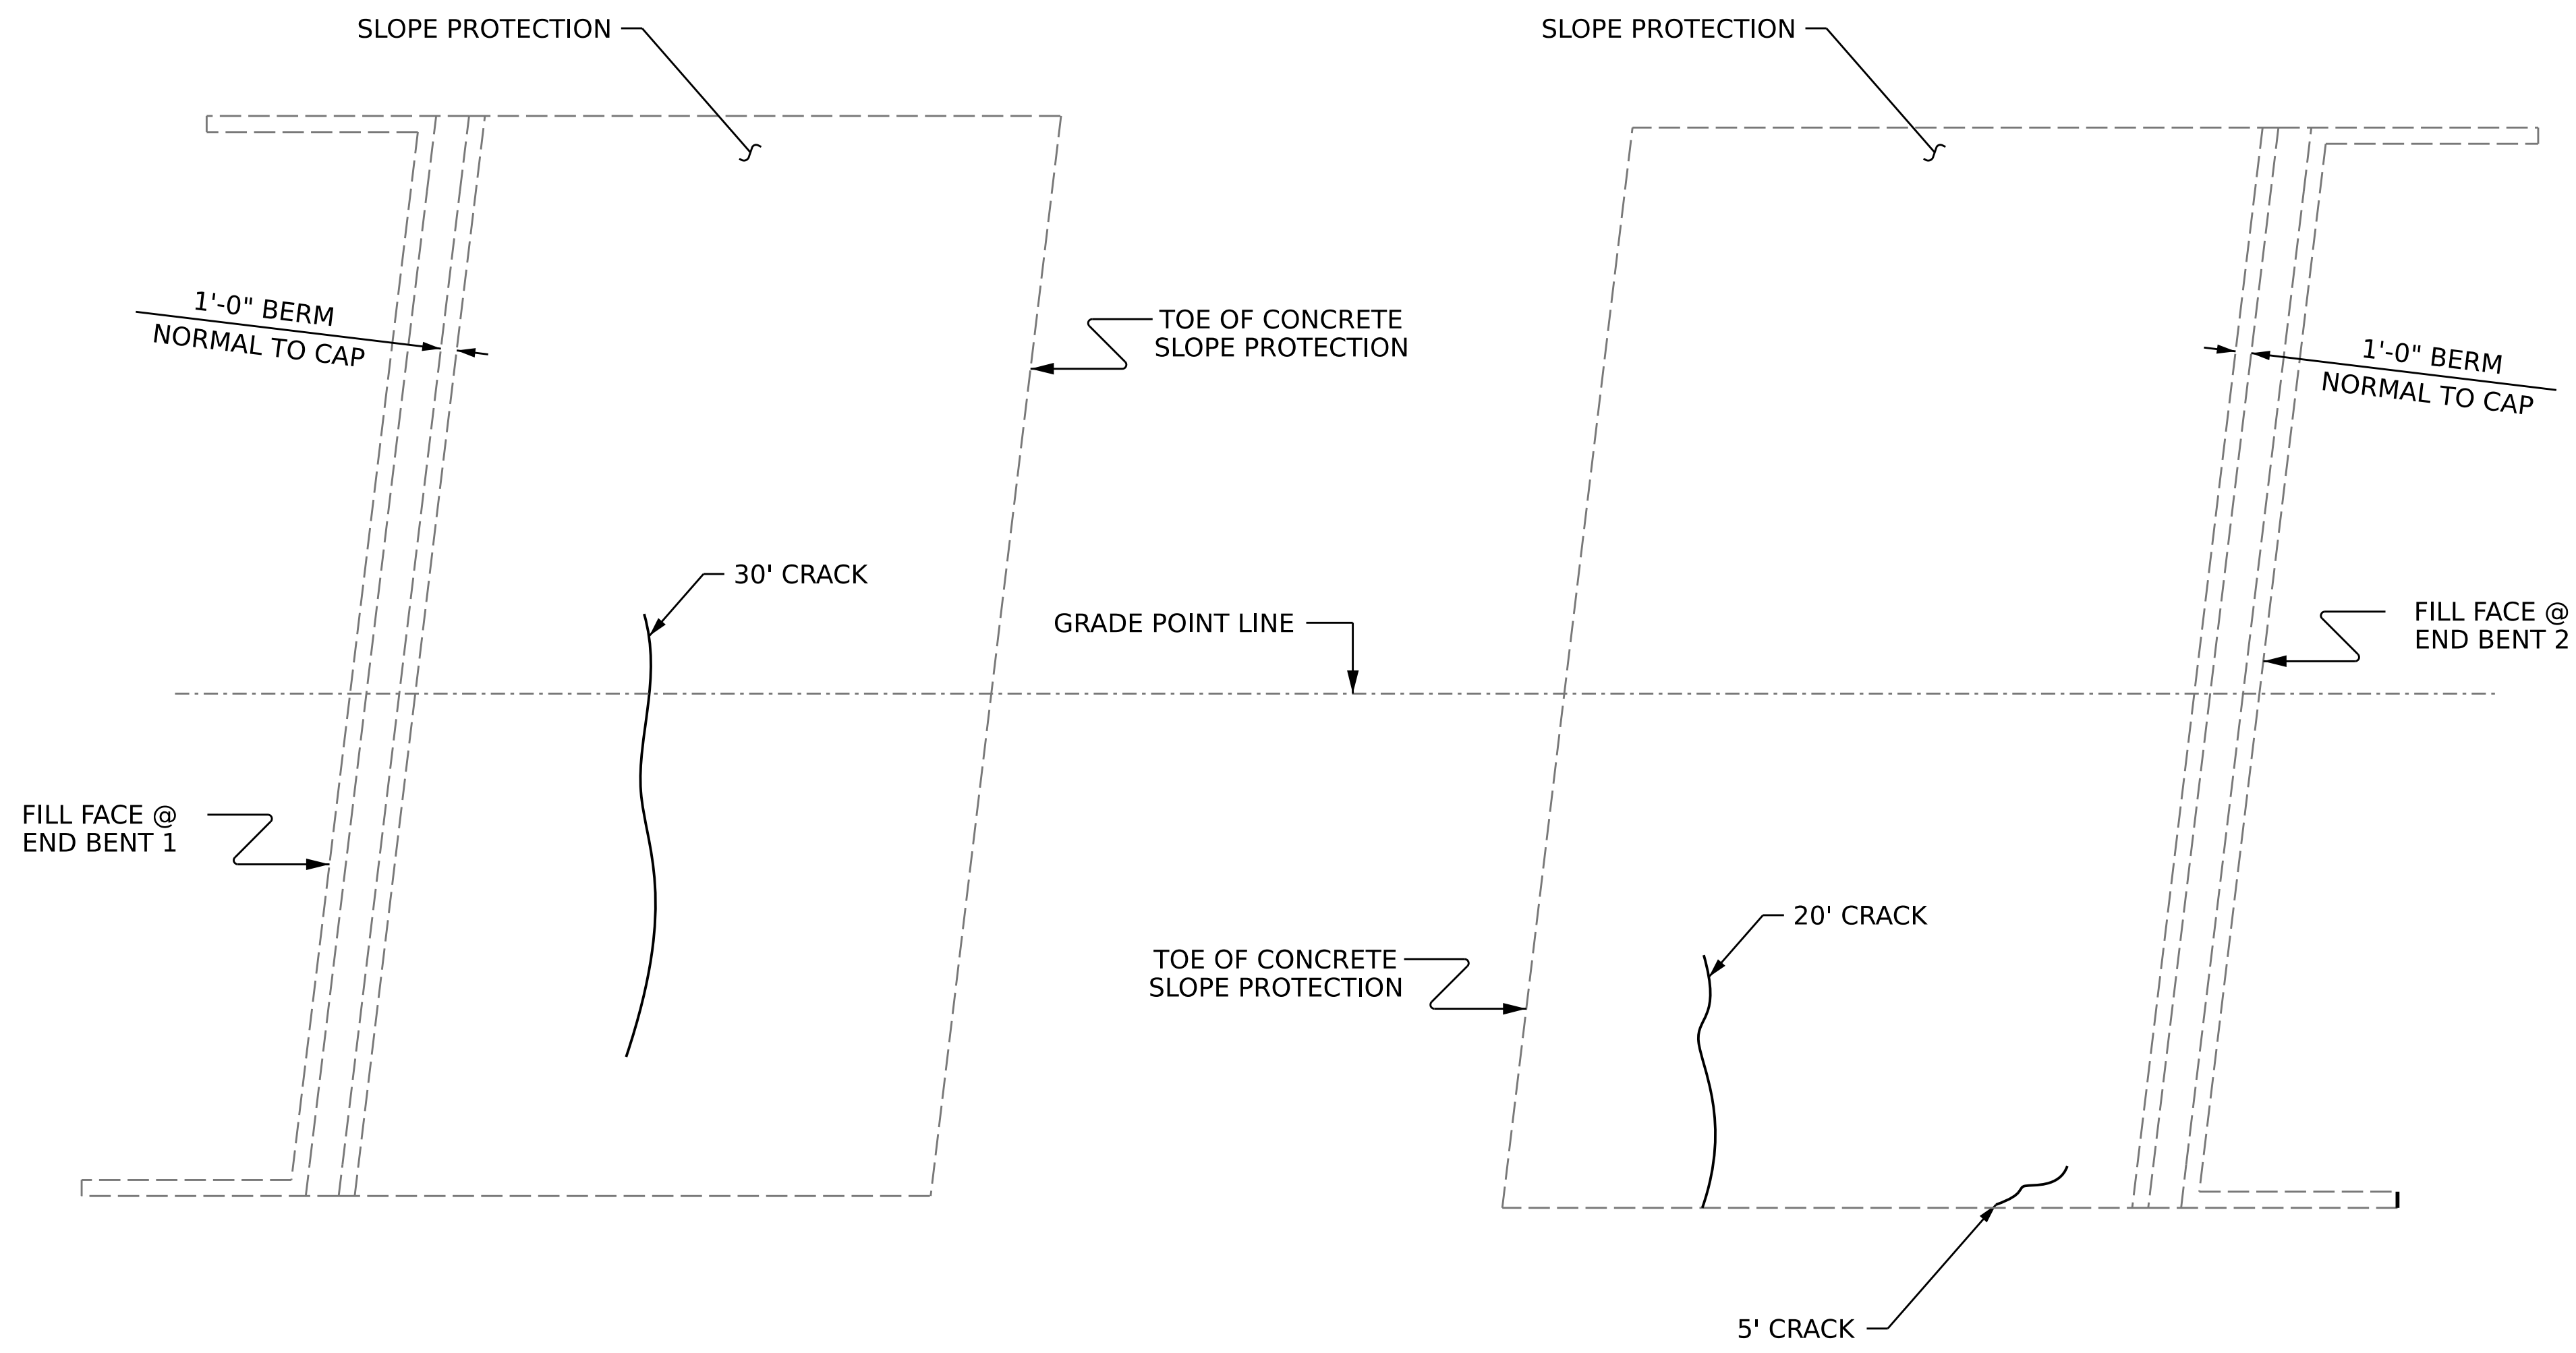
SLOPE PROTECTION REPAIR LOCATIONS

~~~~~ SLOPE PROTECTION CRACKS

SEAL CRACKS IDENTIFIED AND JOINTS ALONG THE TOP OF SLOPE PROTECTION AND BERM WITH POURABLE SILICONE JOINT SEALANT. FOR DETAILS SEE PROPOSED JOINT SEAL DETAILS, SHEET S2-6.
