AS-BUILT REPAIR QUANTITY TABLE

PROJECT NO. HB-0017  
DARE COUNTY  
BRIDGE NO. 270009

BENT 7 & BENT 8

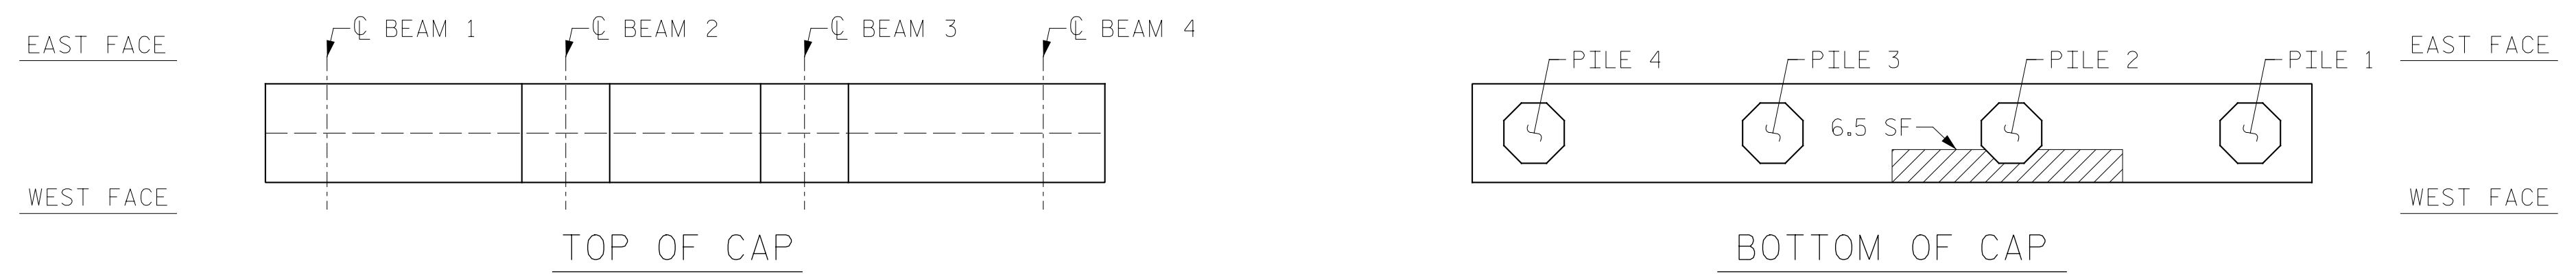
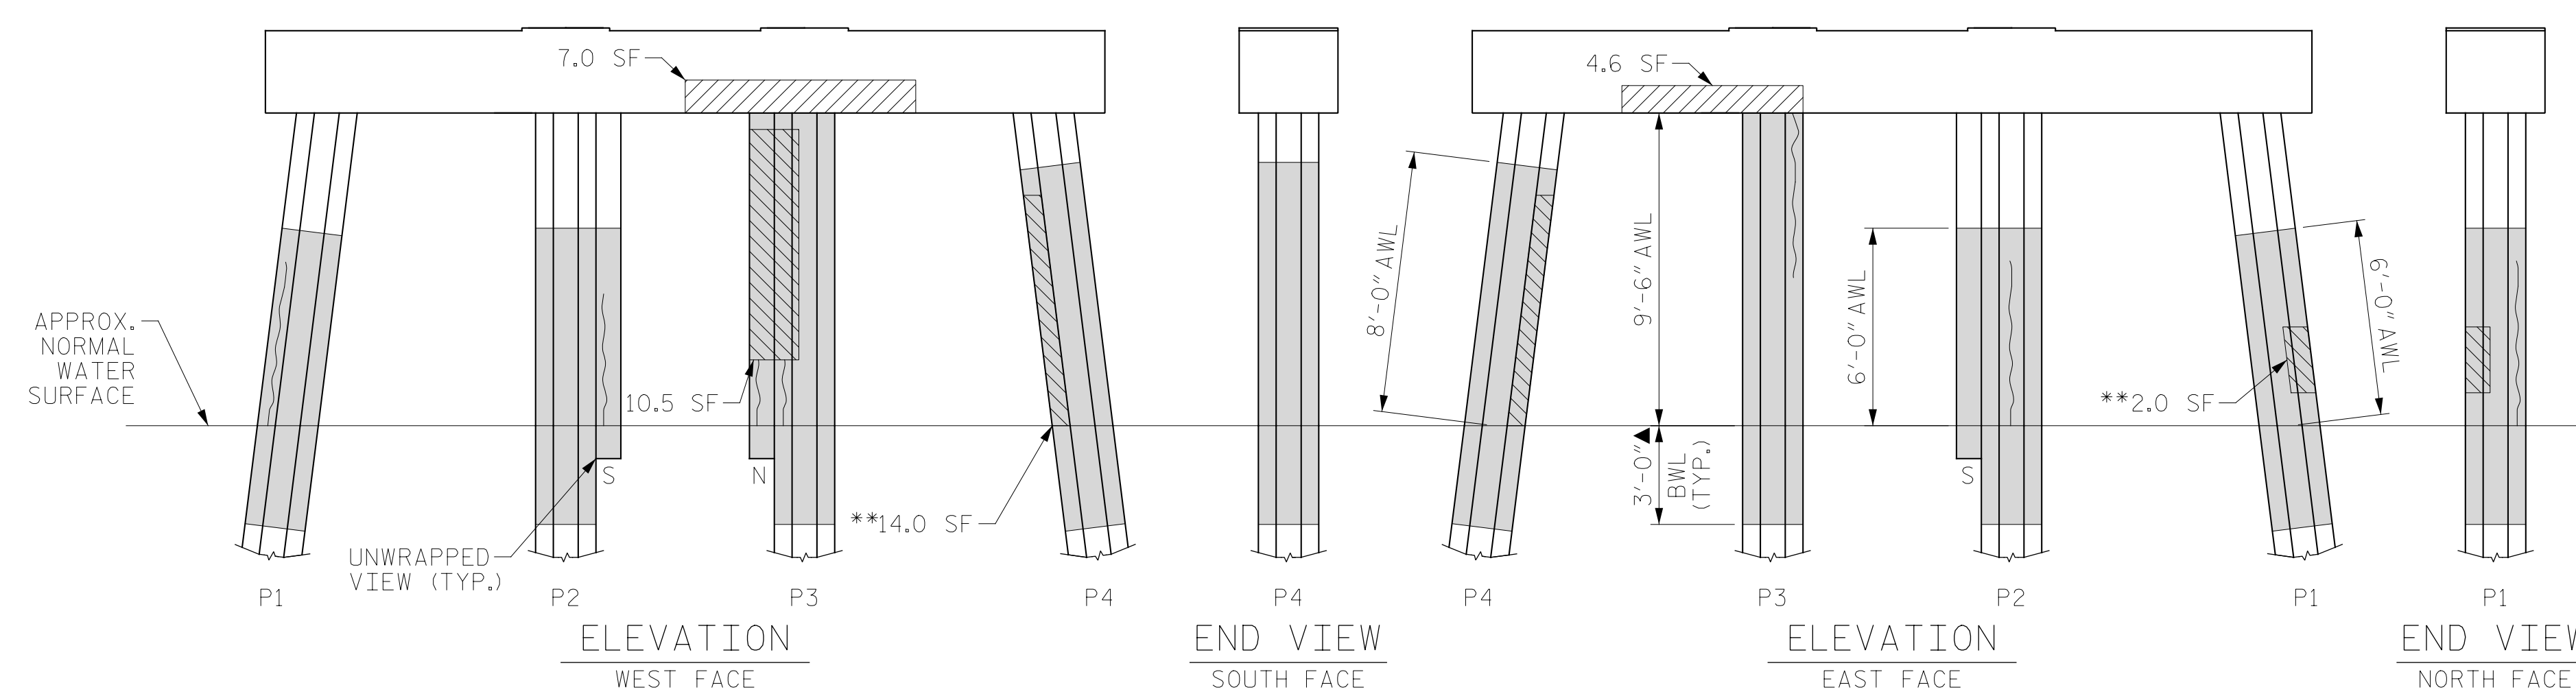
BENT 7

CAP REPAIRS		ESTIMATE			
SHOTCRETE REPAIRS	18.1 SF	9.1 CF	SF	CF	
EPOXY RESIN INJECTION	- LF				LF
PILE REPAIRS		ESTIMATE			
PILE CONCRETE RESTORATION	26.5 SF	11.0 CF	SF	CF	
FRP PROTECTIVE SYSTEM AWL	163.2 SF				
FRP PROTECTIVE SYSTEM BWL	66.0 SF

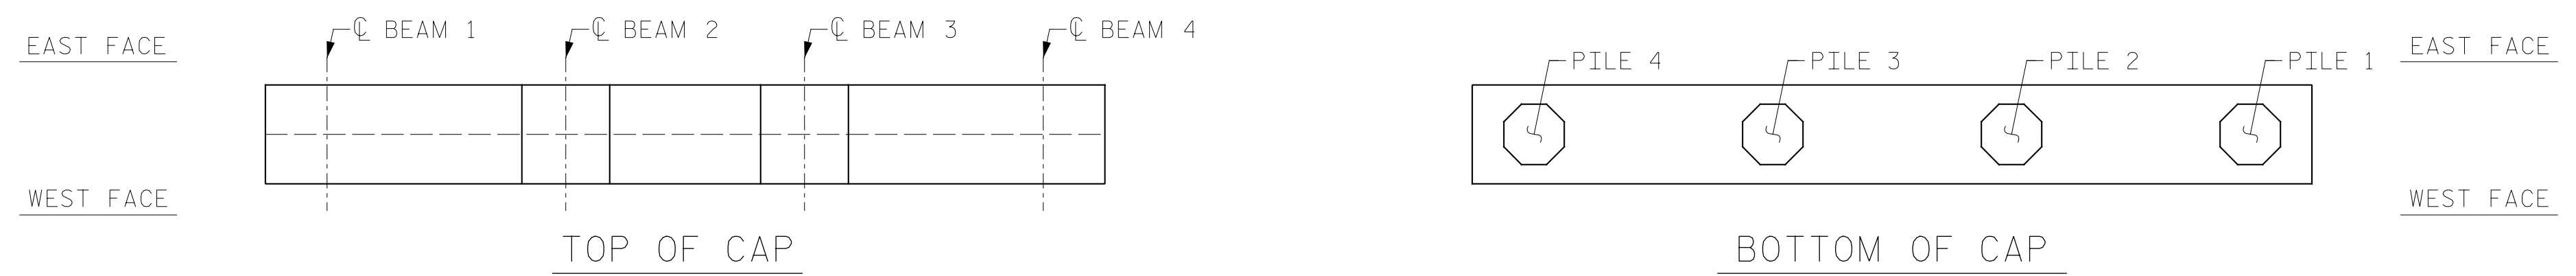
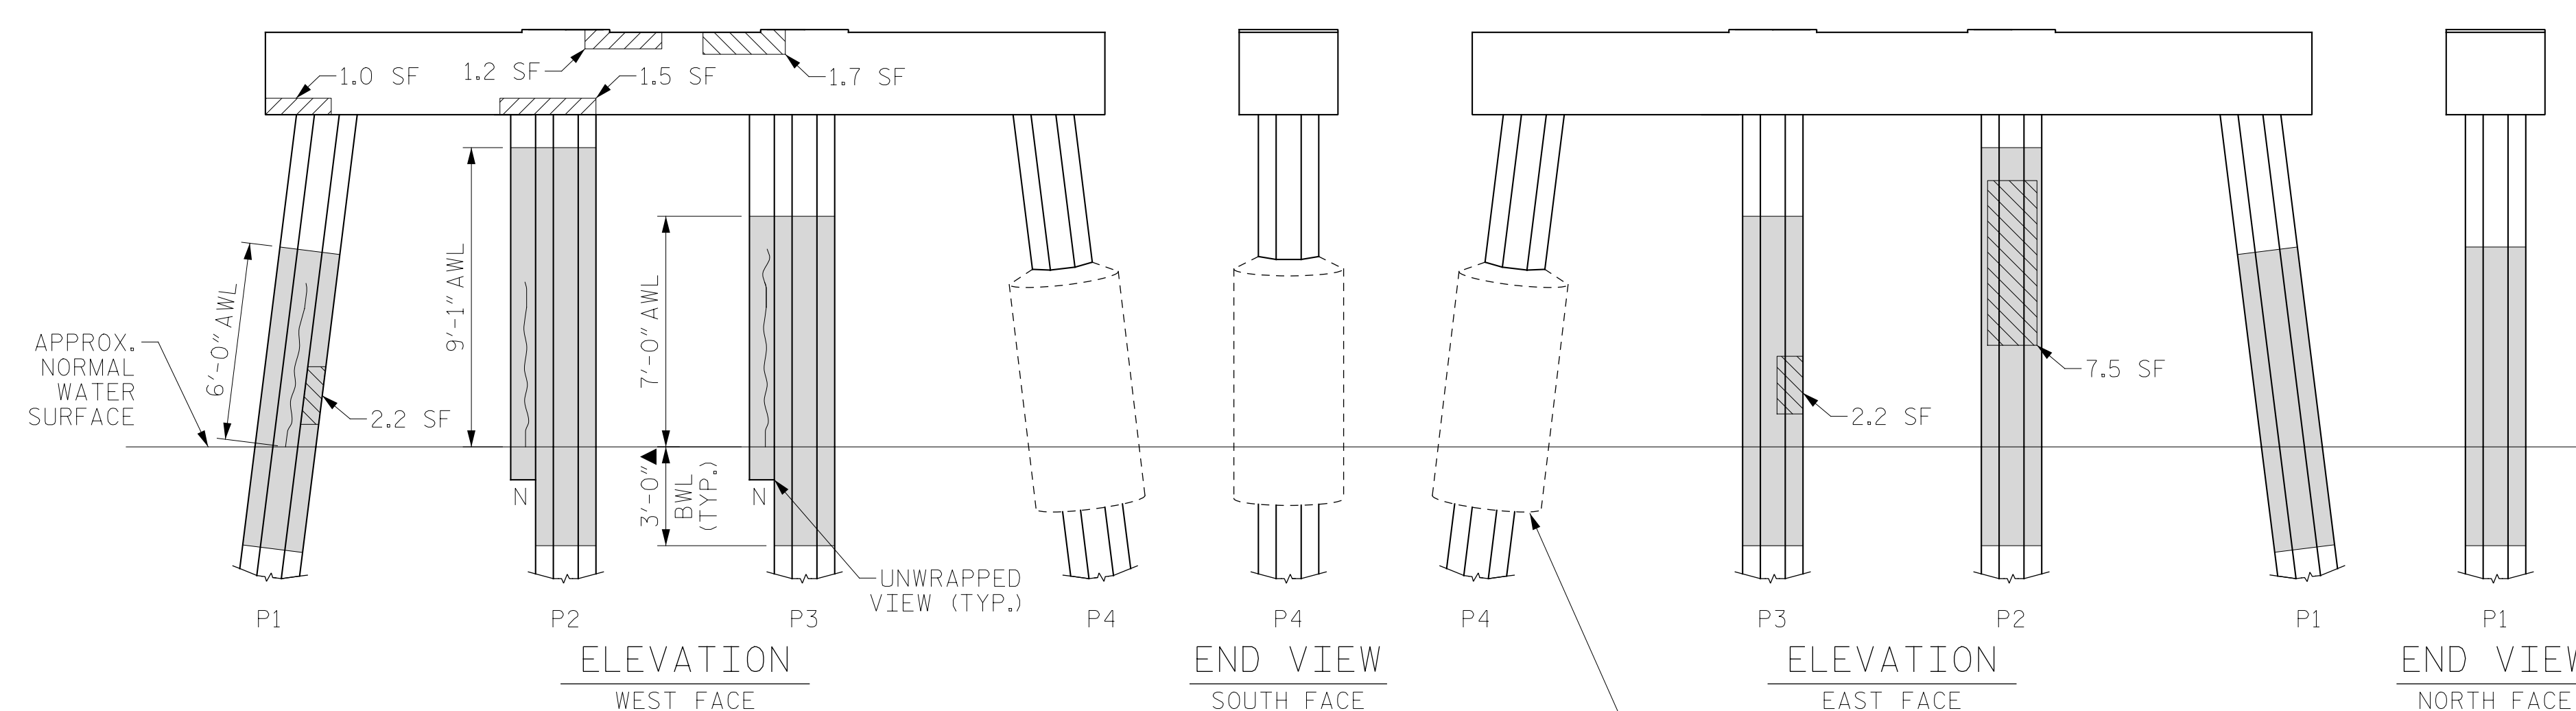
BENT 8

CAP REPAIRS		ESTIMATE			
SHOTCRETE REPAIRS	5.4 SF	2.7 CF	SF	CF	
EPOXY RESIN INJECTION	- LF				LF
PILE REPAIRS		ESTIMATE			
PILE CONCRETE RESTORATION	11.9 SF	5.1 CF	SF	CF	
FRP PROTECTIVE SYSTEM AWL	121.9 SF				
FRP PROTECTIVE SYSTEM BWL	49.5 SF
