AS-BUILT REPAIR QUANTITY TABLE

PROJECT NO. HB-0017
DARE COUNTY
 BRIDGE NO. 270009

BENT 21 & BENT 22

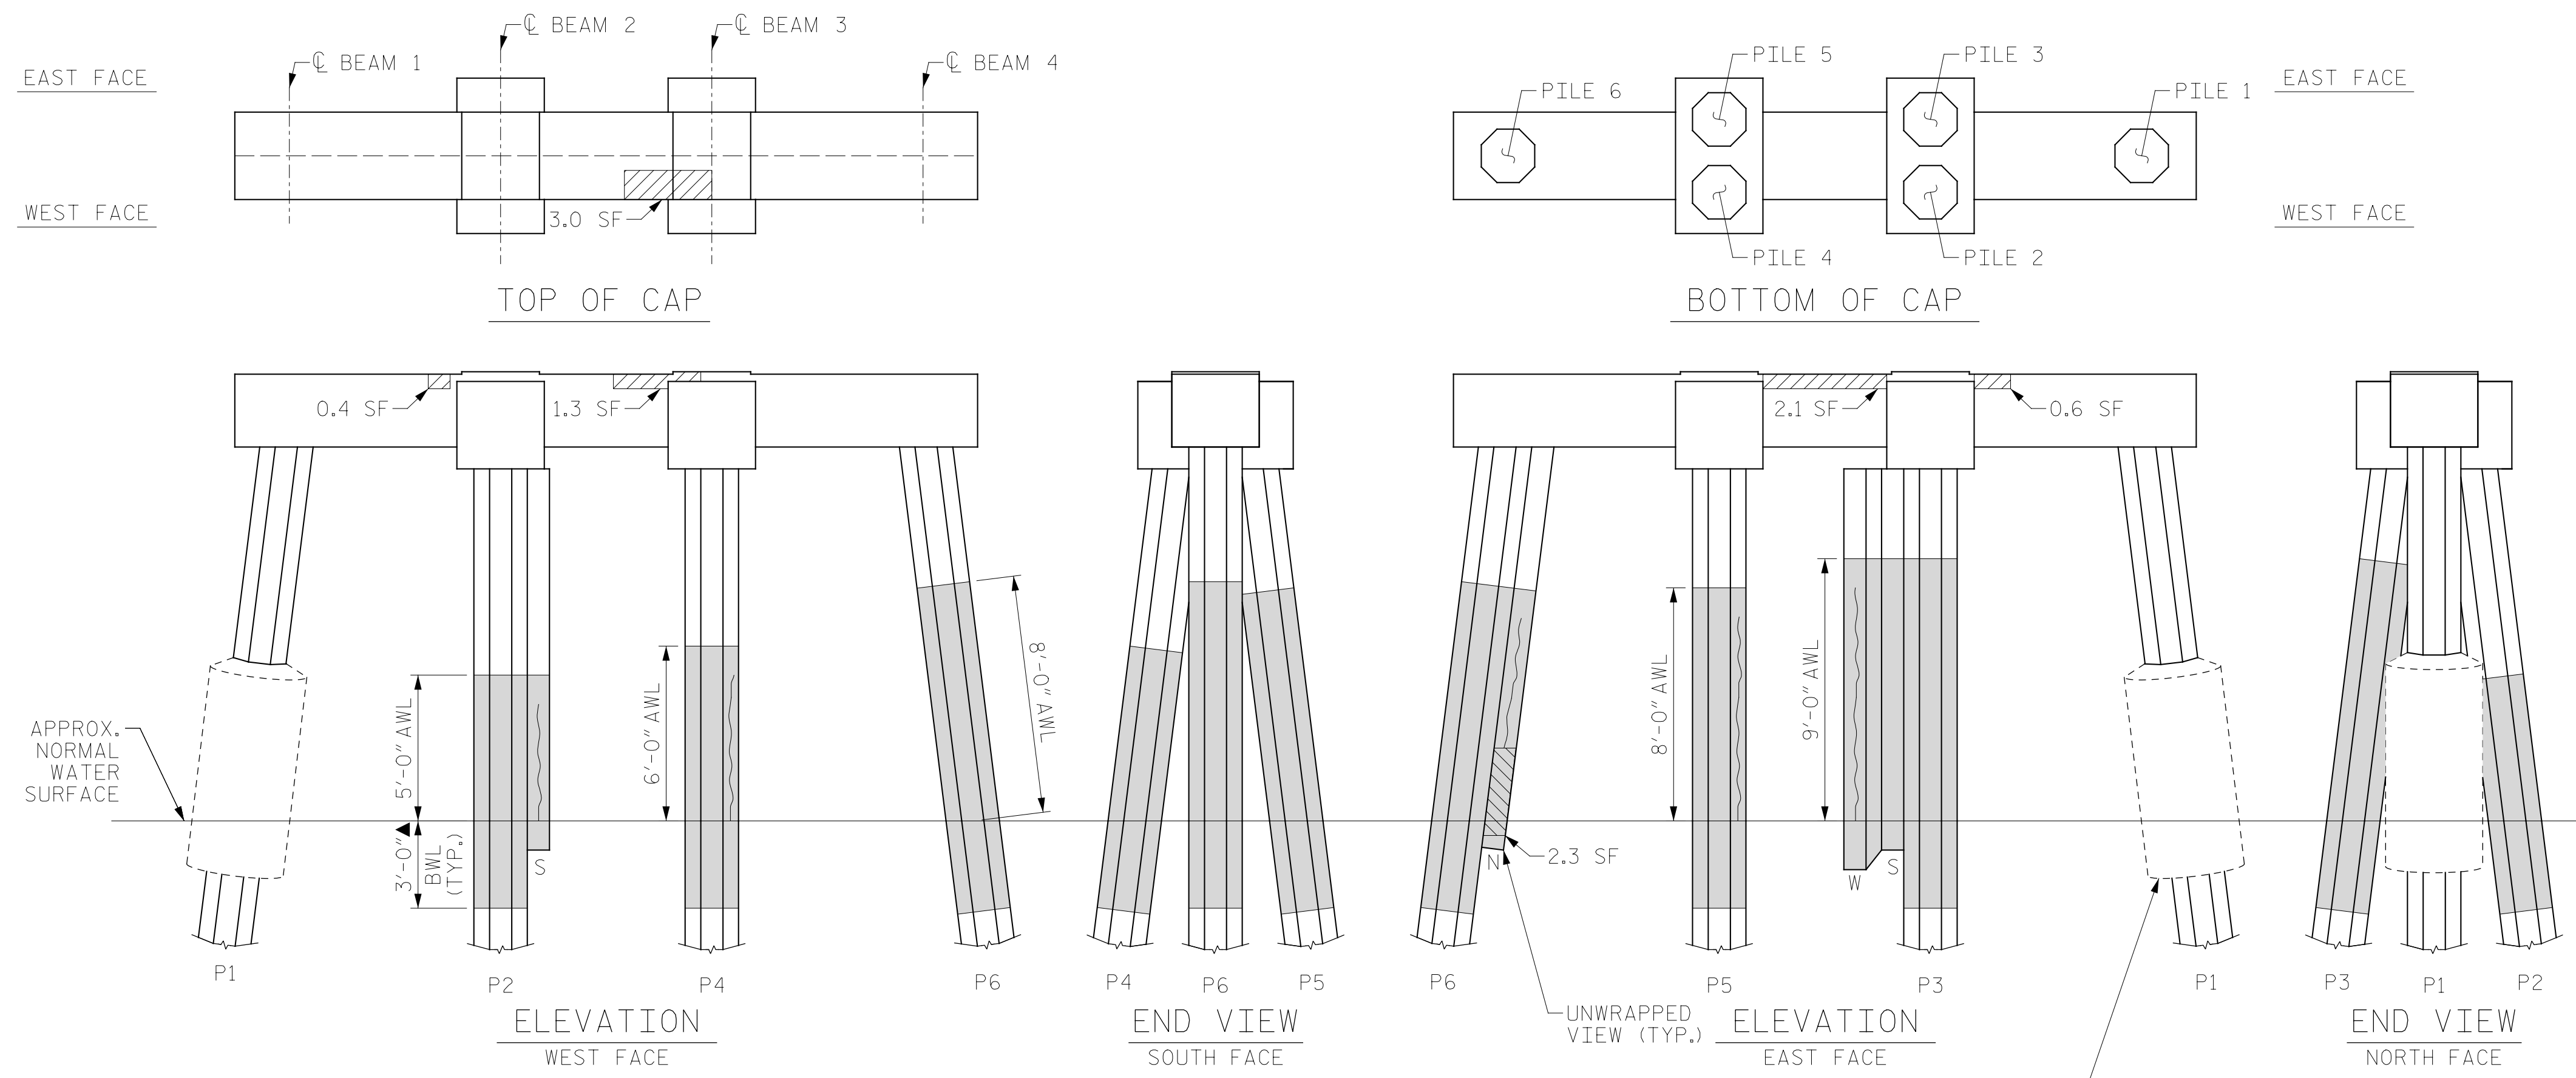
BENT 21			
CAP REPAIRS		ESTIMATE	
SHOTCRETE REPAIRS	7.4 SF	3.7 CF	SF CF
EPOXY RESIN INJECTION	- LF		LF
PILE REPAIRS		ESTIMATE	
PILE CONCRETE RESTORATION	2.3 SF	1.2 CF	SF CF
FRP PROTECTIVE SYSTEM AWL	198.5 SF		
FRP PROTECTIVE SYSTEM BWL	82.5 SF

NW	W	SW	S	SE	E	NE	N
BENT 21	PILE 1	-	-	-	-	-	-	-	-
	PILE 2	-	-	-	4	-	-	-	-
	PILE 3	-	8	-	-	-	-	-	-
	PILE 4	-	-	5	-	-	-	-	-
BENT 22	PILE 1	-	2	-	-	-	-	-	3
	PILE 2	-	-	-	6	-	-	7	-
	PILE 3	-	5	-	-	-	-	5	-
	PILE 4	5	2	-	-	-	5	-	-

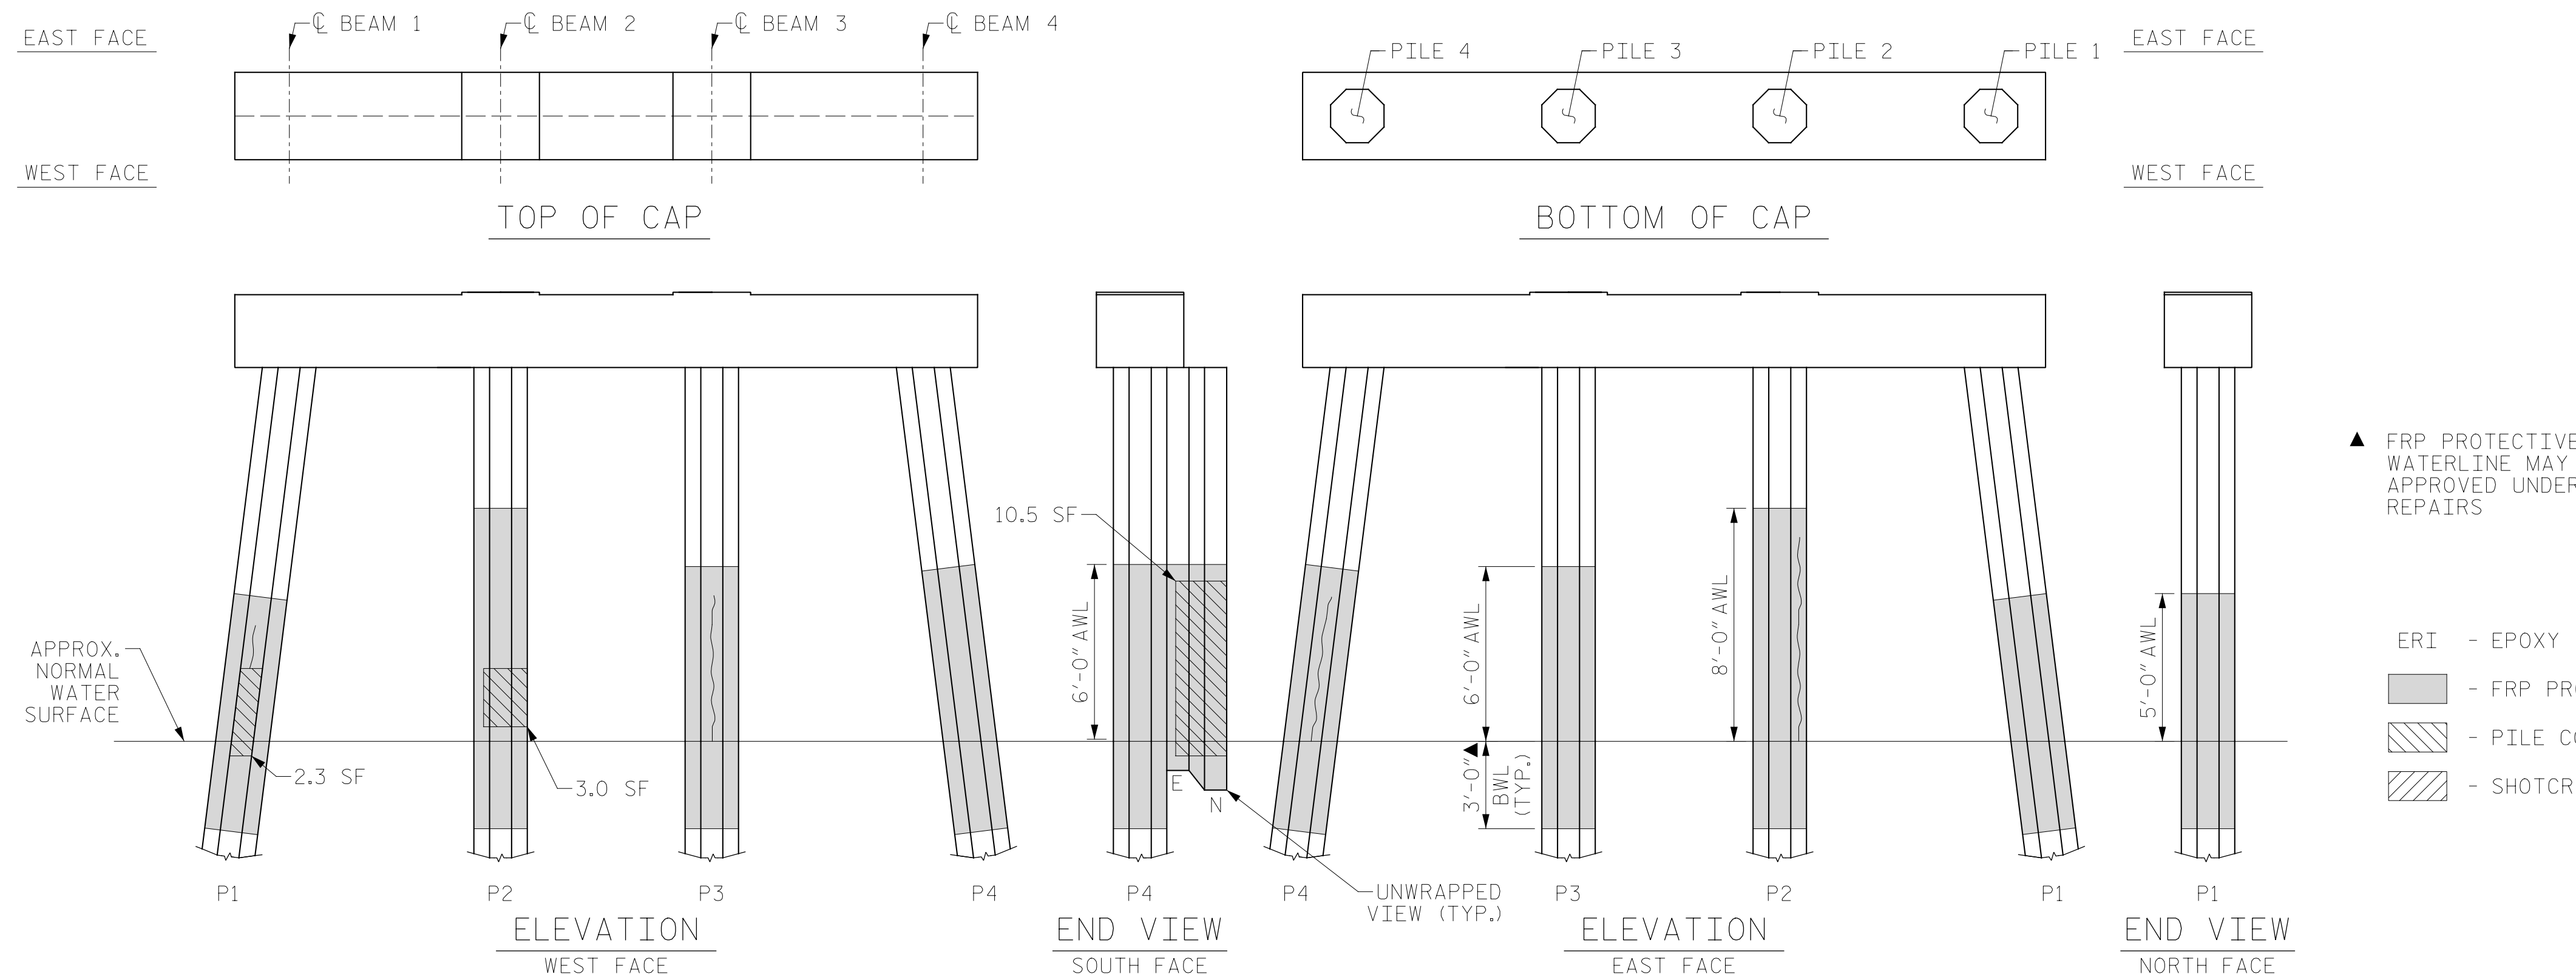
BENT 22			
CAP REPAIRS		ESTIMATE	
SHOTCRETE REPAIRS	- SF	- CF	SF CF
EPOXY RESIN INJECTION	- LF		LF
PILE REPAIRS		ESTIMATE	
PILE CONCRETE RESTORATION	15.8 SF	7.2 CF	SF CF
FRP PROTECTIVE SYSTEM AWL	138.4 SF		
FRP PROTECTIVE SYSTEM BWL	66.0 SF
