COUNTY 270009

STATE OF NORTH CAROLINA DEPARTMENT OF TRANSPORTATION RALEIGH

BENT 23 & BENT 24

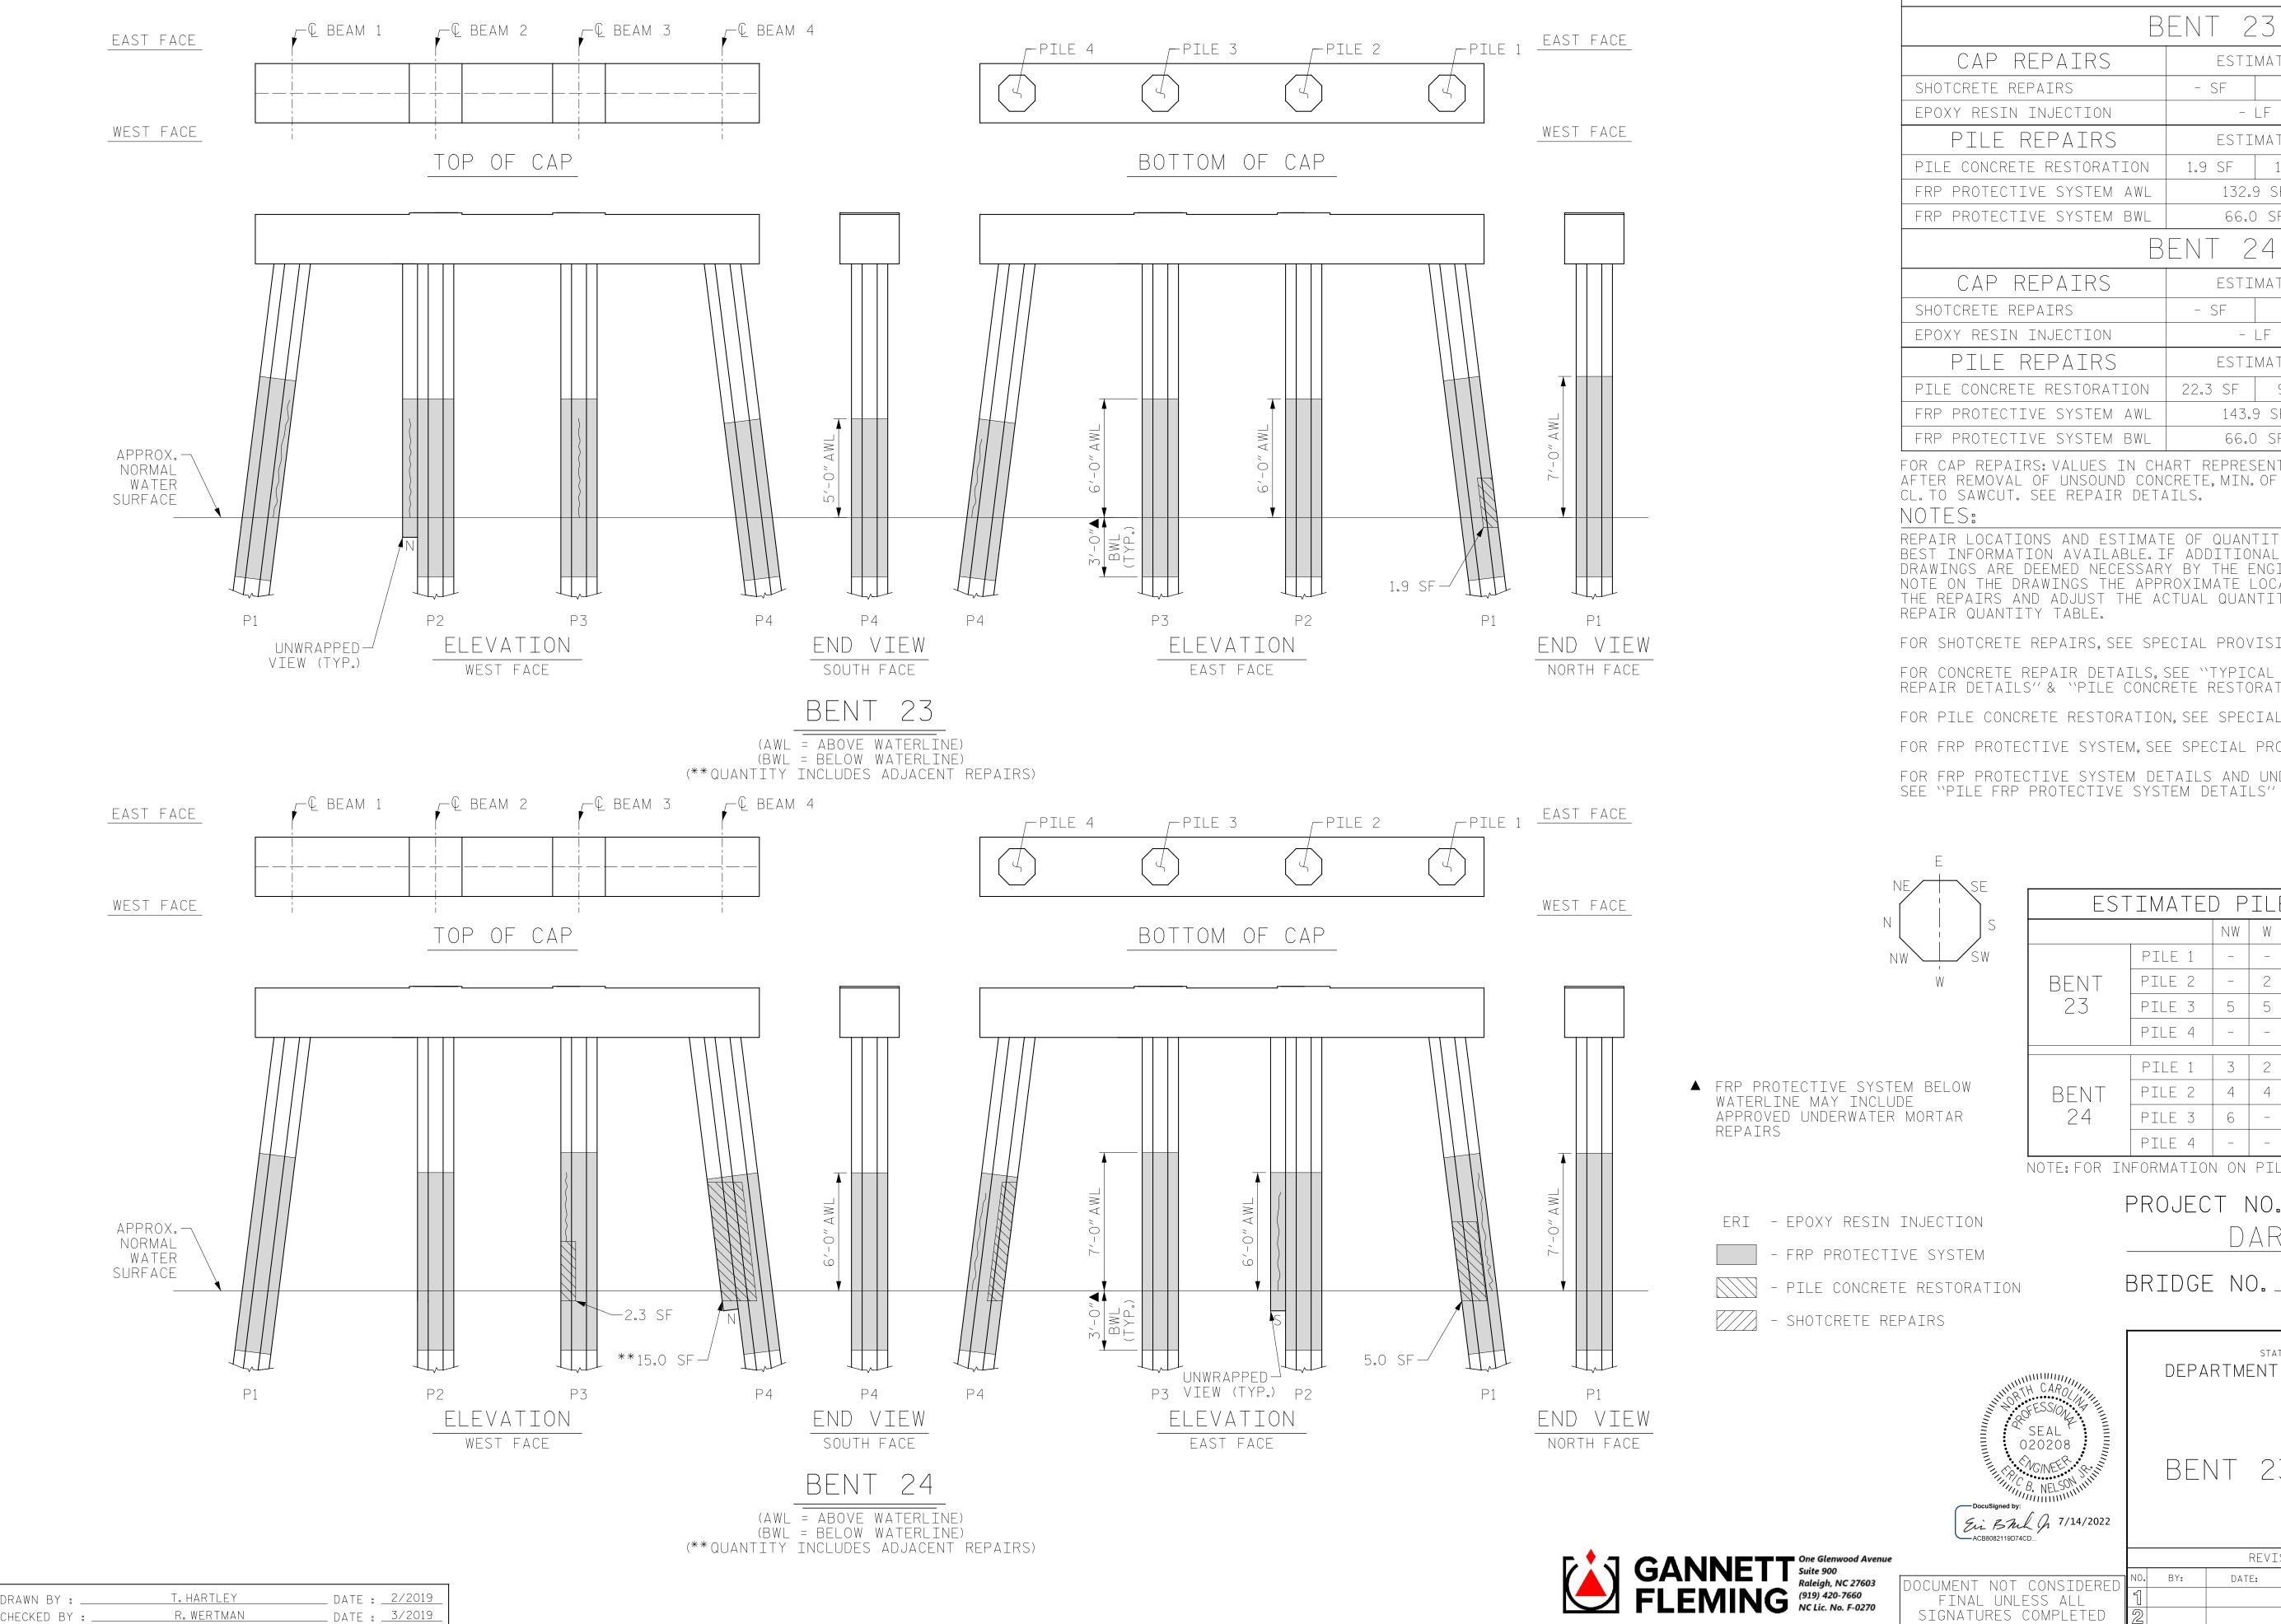
BENT 24										
CAP REPAIRS	ESTI	MATE								
SHOTCRETE REPAIRS	- SF	- CF	SF	CF						
EPOXY RESIN INJECTION	_	LF		LF						
PILE REPAIRS	ESTI	MATE								
PILE CONCRETE RESTORATION	22.3 SF	9.1 CF	SF	CF						
FRP PROTECTIVE SYSTEM AWL	143.9	9 SF								
FRP PROTECTIVE SYSTEM BWL	66.0) SF

ESTIMATED PILE CRACK QTY.										
		NW	W	SW	S	SE	E	NE	N	
BENT 23	PILE 1	_	_	6	_	_	_	3	_	
	PILE 2	_	2	_	2	_	_	_	5	
	PILE 3	5	5	_	_	_	_	_	5	
	PILE 4	_	_	_	_	4	_	_	_	
BENT 24	PILE 1	3	2	_	_	_	_	6	_	
	PILE 2	4	4	-	5	-	3	_	_	
	PILE 3	6	-	-	-	3	-	-	_	
	PILE 4	_	_	_	_	_	5	_	_	
NOTE FOR INFORMATION ON PILE CONDITION ONLY

FOR CAP REPAIRS: VALUES IN CHART REPRESENT ESTIMATED REPAIR TOTALS AFTER REMOVAL OF UNSOUND CONCRETE, MIN. OF 1"BEHIND REBAR AND MIN. 2 CL. TO SAWCUT. SEE REPAIR DETAILS.

FOR CONCRETE REPAIR DETAILS, SEE "TYPICAL CAP, COLUMN & UNDERDECK REPAIR DETAILS" & "PILE CONCRETE RESTORATION DETAILS" SHEETS.

FOR FRP PROTECTIVE SYSTEM DETAILS AND UNDERWATER MORTAR REPAIRS, SEE "PILE FRP PROTECTIVE SYSTEM DETAILS" SHEET.
