AS-BUILT REPAIR QUANTITY TABLE

PROJECT NO. HB-0017
DARE COUNTY
 BRIDGE NO. 270009

BENT 37 & BENT 38

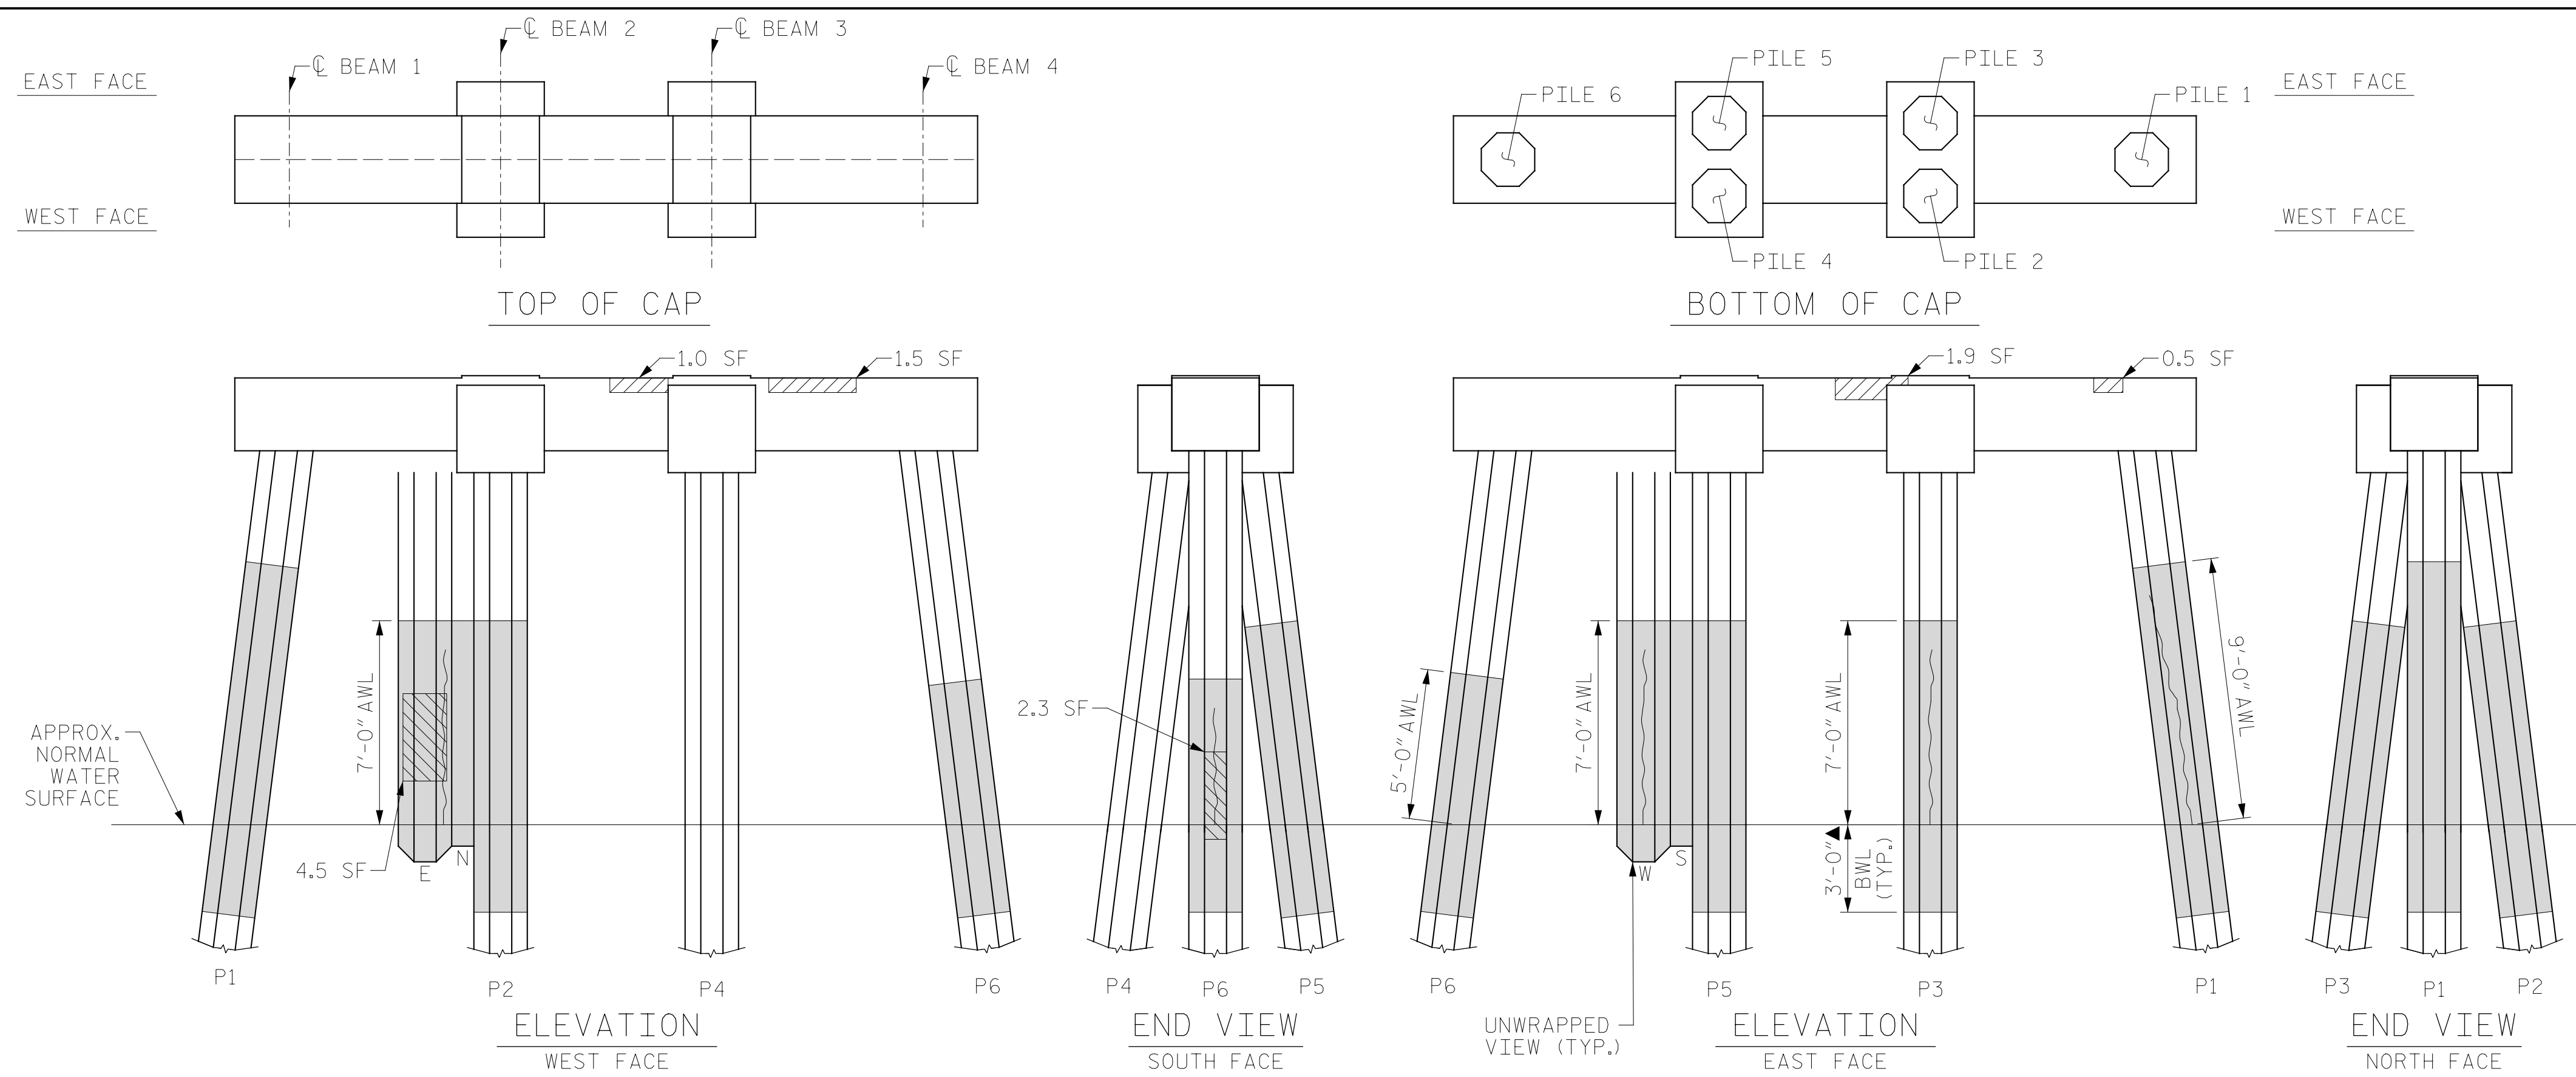
BENT 37			
CAP REPAIRS		ESTIMATE	
SHOTCRETE REPAIRS	4.9 SF	2.5 CF	SF CF
EPOXY RESIN INJECTION	- LF		LF
PILE REPAIRS		ESTIMATE	
PILE CONCRETE RESTORATION	6.8 SF	3.2 CF	SF CF
FRP PROTECTIVE SYSTEM AWL	193.4 SF		
FRP PROTECTIVE SYSTEM BWL	82.5 SF

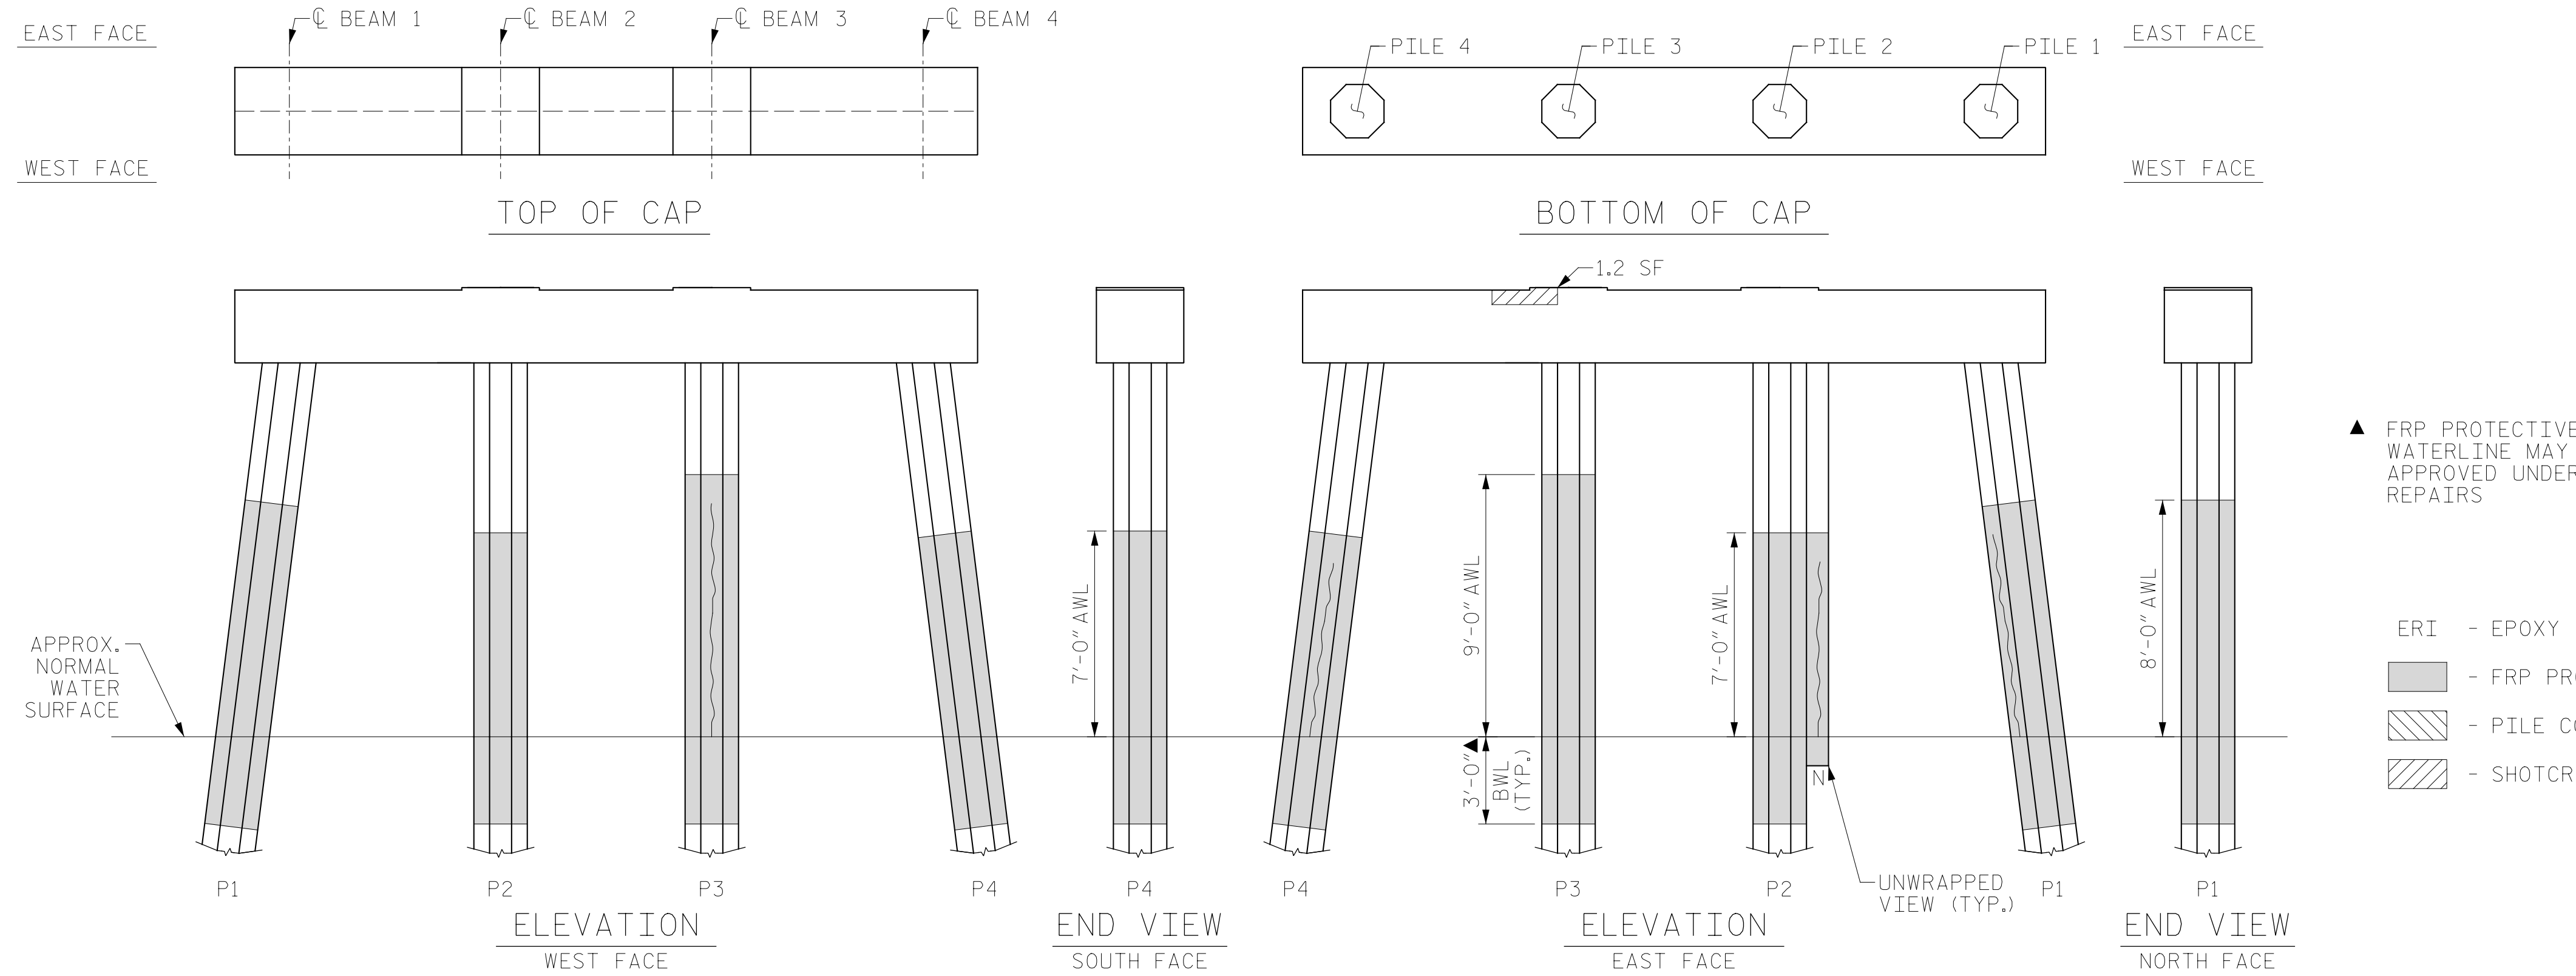
BENT 38			
CAP REPAIRS		ESTIMATE	
SHOTCRETE REPAIRS	1.2 SF	0.6 CF	SF CF
EPOXY RESIN INJECTION	- LF		LF
PILE REPAIRS		ESTIMATE	
PILE CONCRETE RESTORATION	- SF	- CF	SF CF
FRP PROTECTIVE SYSTEM AWL	171.4 SF		
FRP PROTECTIVE SYSTEM BWL	66.0 SF
