AS-BUILT REPAIR QUANTITY TABLE BENT 39 CAP REPAIRS ESTIMATE SF 1.9 SF | 1.0 CF EPOXY RESIN INJECTION - LF PILE REPAIRS ESTIMATE SF PILE CONCRETE RESTORATION 7.5 SF | 2.9 CF FRP PROTECTIVE SYSTEM AWL 143.9 SF FRP PROTECTIVE SYSTEM BWL 66.0 SF RENT 10

270009 BRIDGE NO.

> STATE OF NORTH CAROLINA DEPARTMENT OF TRANSPORTATION RALEIGH

> BENT 39 & BENT 40

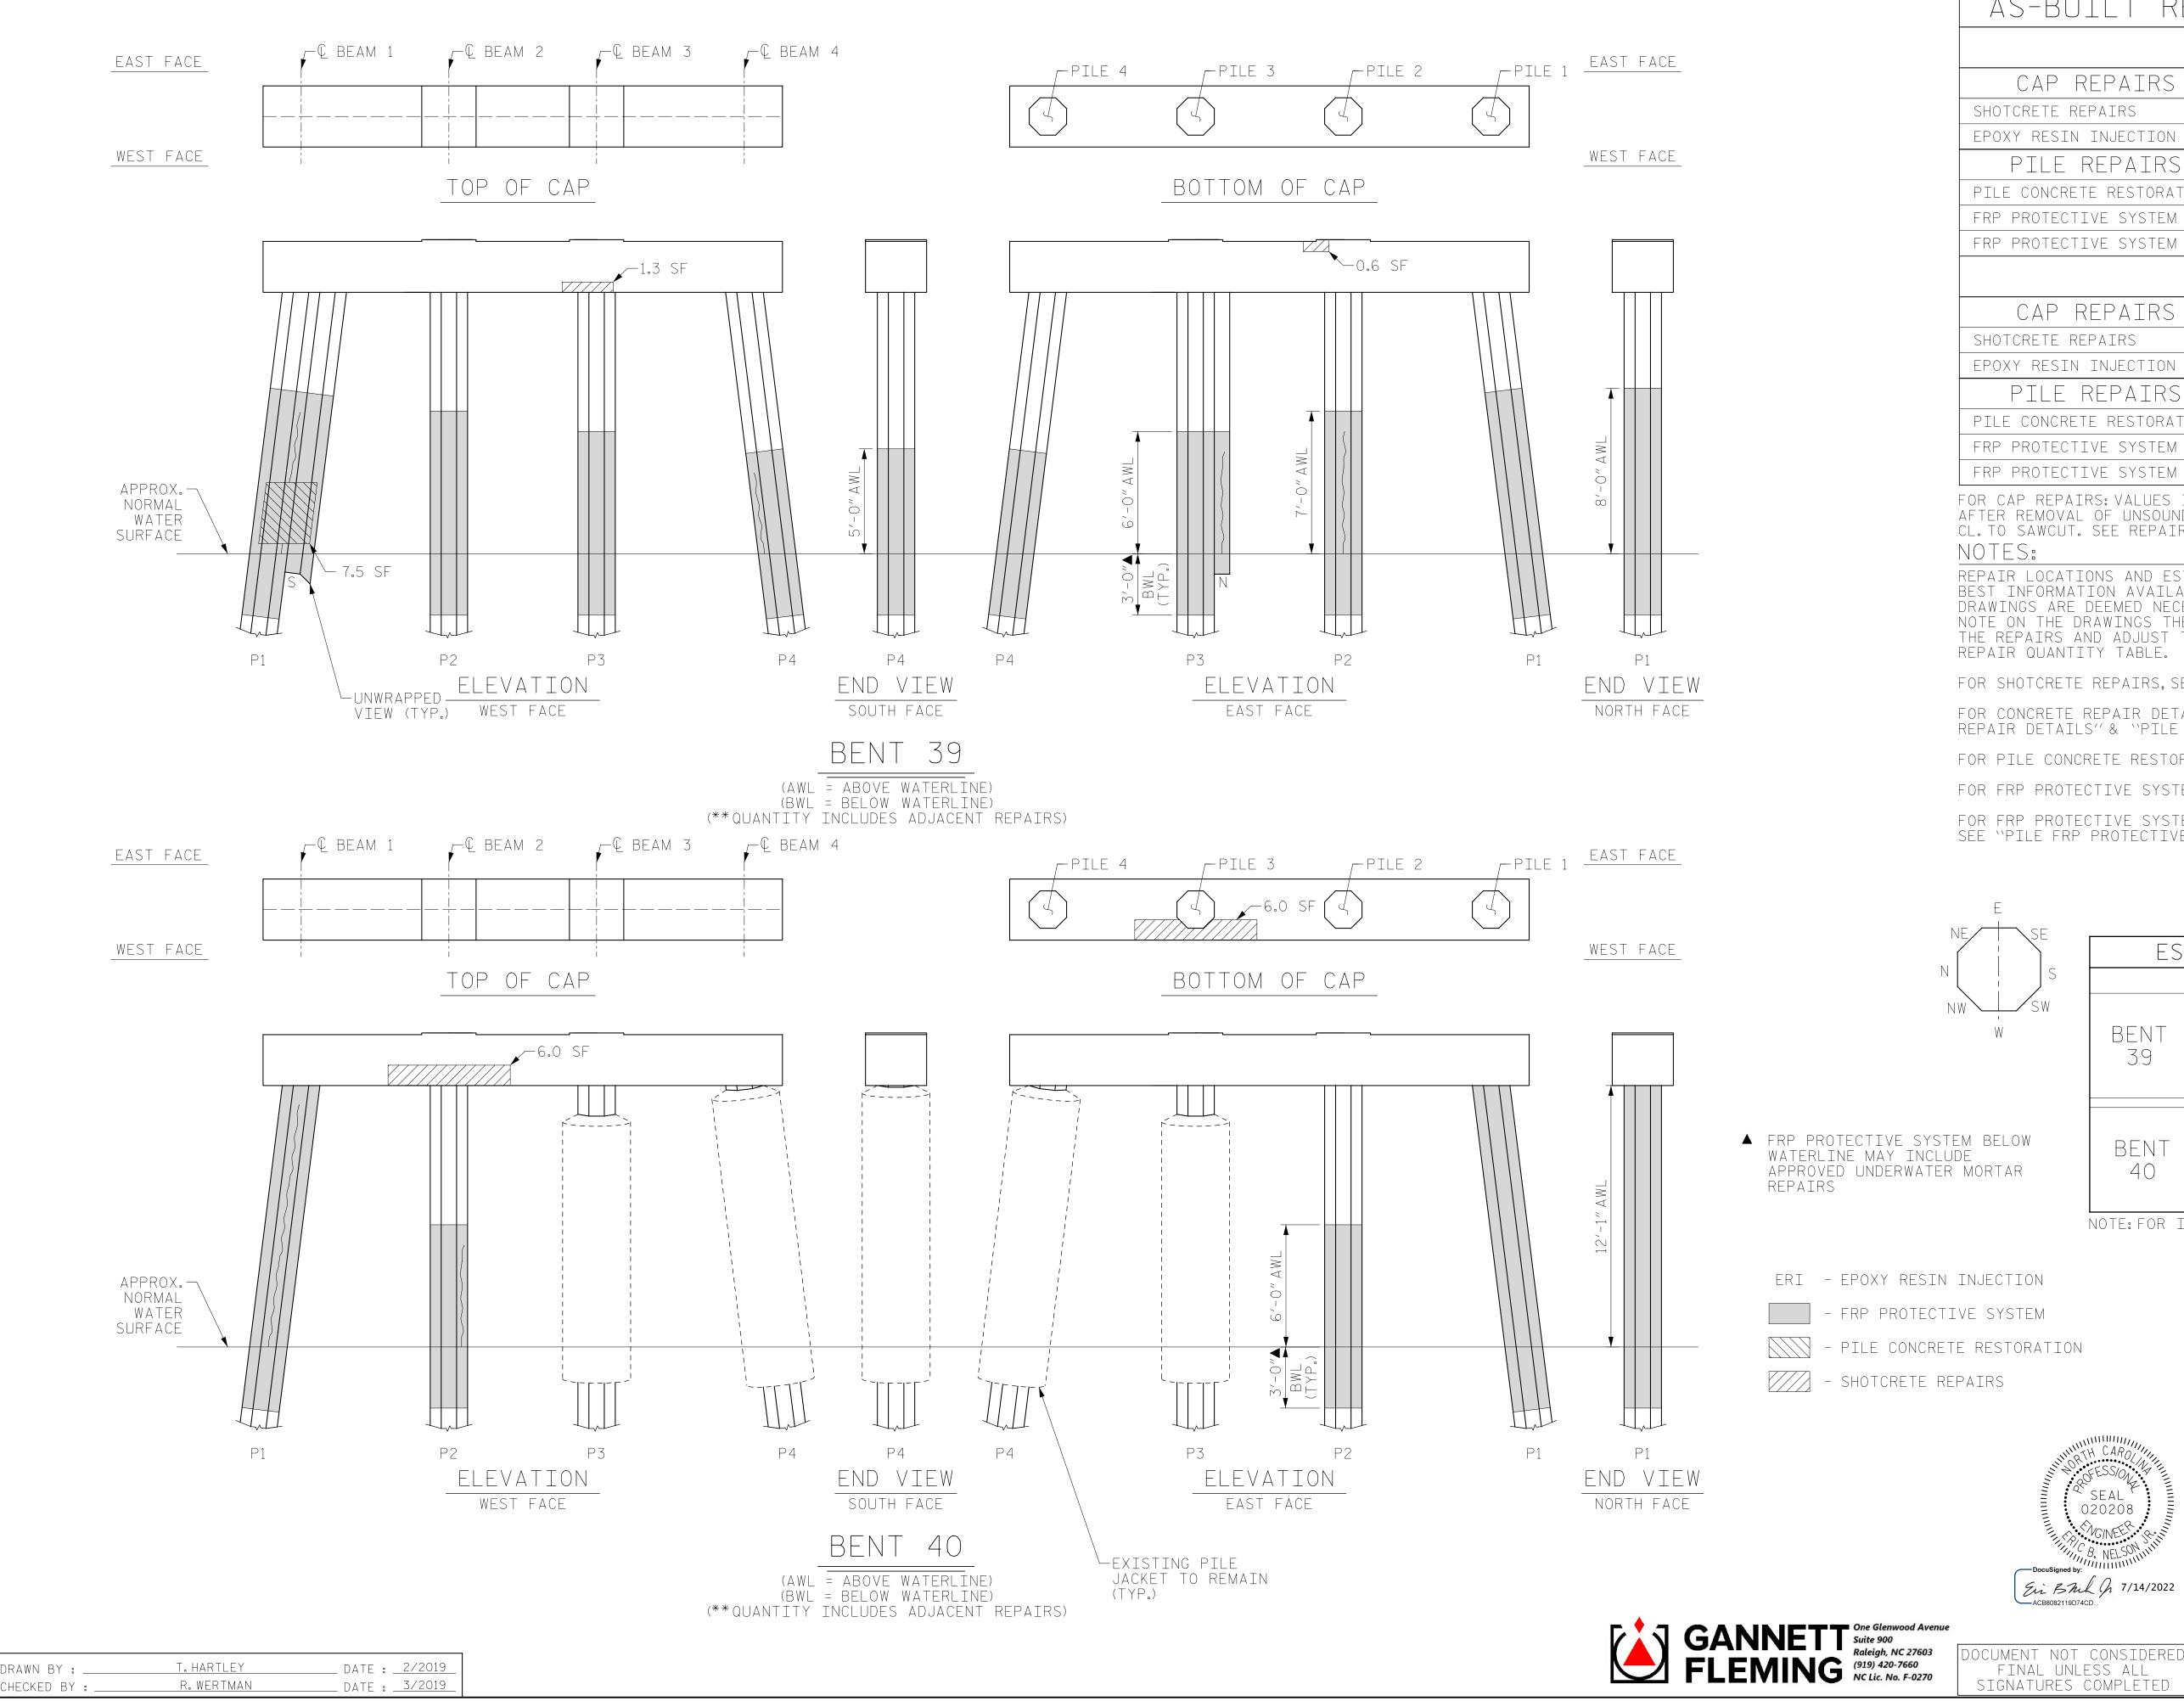
ł U		
CAP REPAIRS	ESTI	MATE		
SHOTCRETE REPAIRS	12.0 SF	6.0 CF	SF	CF
EPOXY RESIN INJECTION	_	LF		LF
PILE REPAIRS	ESTI	MATE		
PILE CONCRETE RESTORATION	- SF	- CF	SF	CF
FRP PROTECTIVE SYSTEM AWL	99.5	S F		
FRP PROTECTIVE SYSTEM BWL	33.0 SF

ESTIMATED PILE CRACK QTY.										
		NW	W	SW	S	SE	E	NE	Z	
BENT 39	PILE 1	_	_	4	_	_	_	_	_	
	PILE 2	_	_	_	_	_	6	6	6	
	PILE 3	_	=	_	2	_	-	_	5	
	PILE 4	_	4	_	_	_	3	-	-	
BENT 40			10		10					
	PILE 1	_	12	_	12	_	_	_	6	
	PILE 2	_	_	5	2	_	_	_	-	
	PILE 3	_	_	_	_	_	_	_	_	
	PILE 4	_	_	_	_	_	-	_	-	
JOTE: FOR THEORMATTON ON PTLE CONDITTON ONLY

FOR CAP REPAIRS: VALUES IN CHART REPRESENT ESTIMATED REPAIR TOTALS AFTER REMOVAL OF UNSOUND CONCRETE, MIN. OF 1"BEHIND REBAR AND MIN. 2 CL. TO SAWCUT. SEE REPAIR DETAILS.

FOR CONCRETE REPAIR DETAILS, SEE "TYPICAL CAP, COLUMN & UNDERDECK REPAIR DETAILS" & "PILE CONCRETE RESTORATION DETAILS" SHEETS.

FOR FRP PROTECTIVE SYSTEM DETAILS AND UNDERWATER MORTAR REPAIRS, SEE "PILE FRP PROTECTIVE SYSTEM DETAILS" SHEET.
