AS-BUILT REPAIR QUANTITY TABLE

PROJECT NO. HB-0017  
DARE COUNTY  
 BRIDGE NO. 270009

BENT 43 & BENT 44

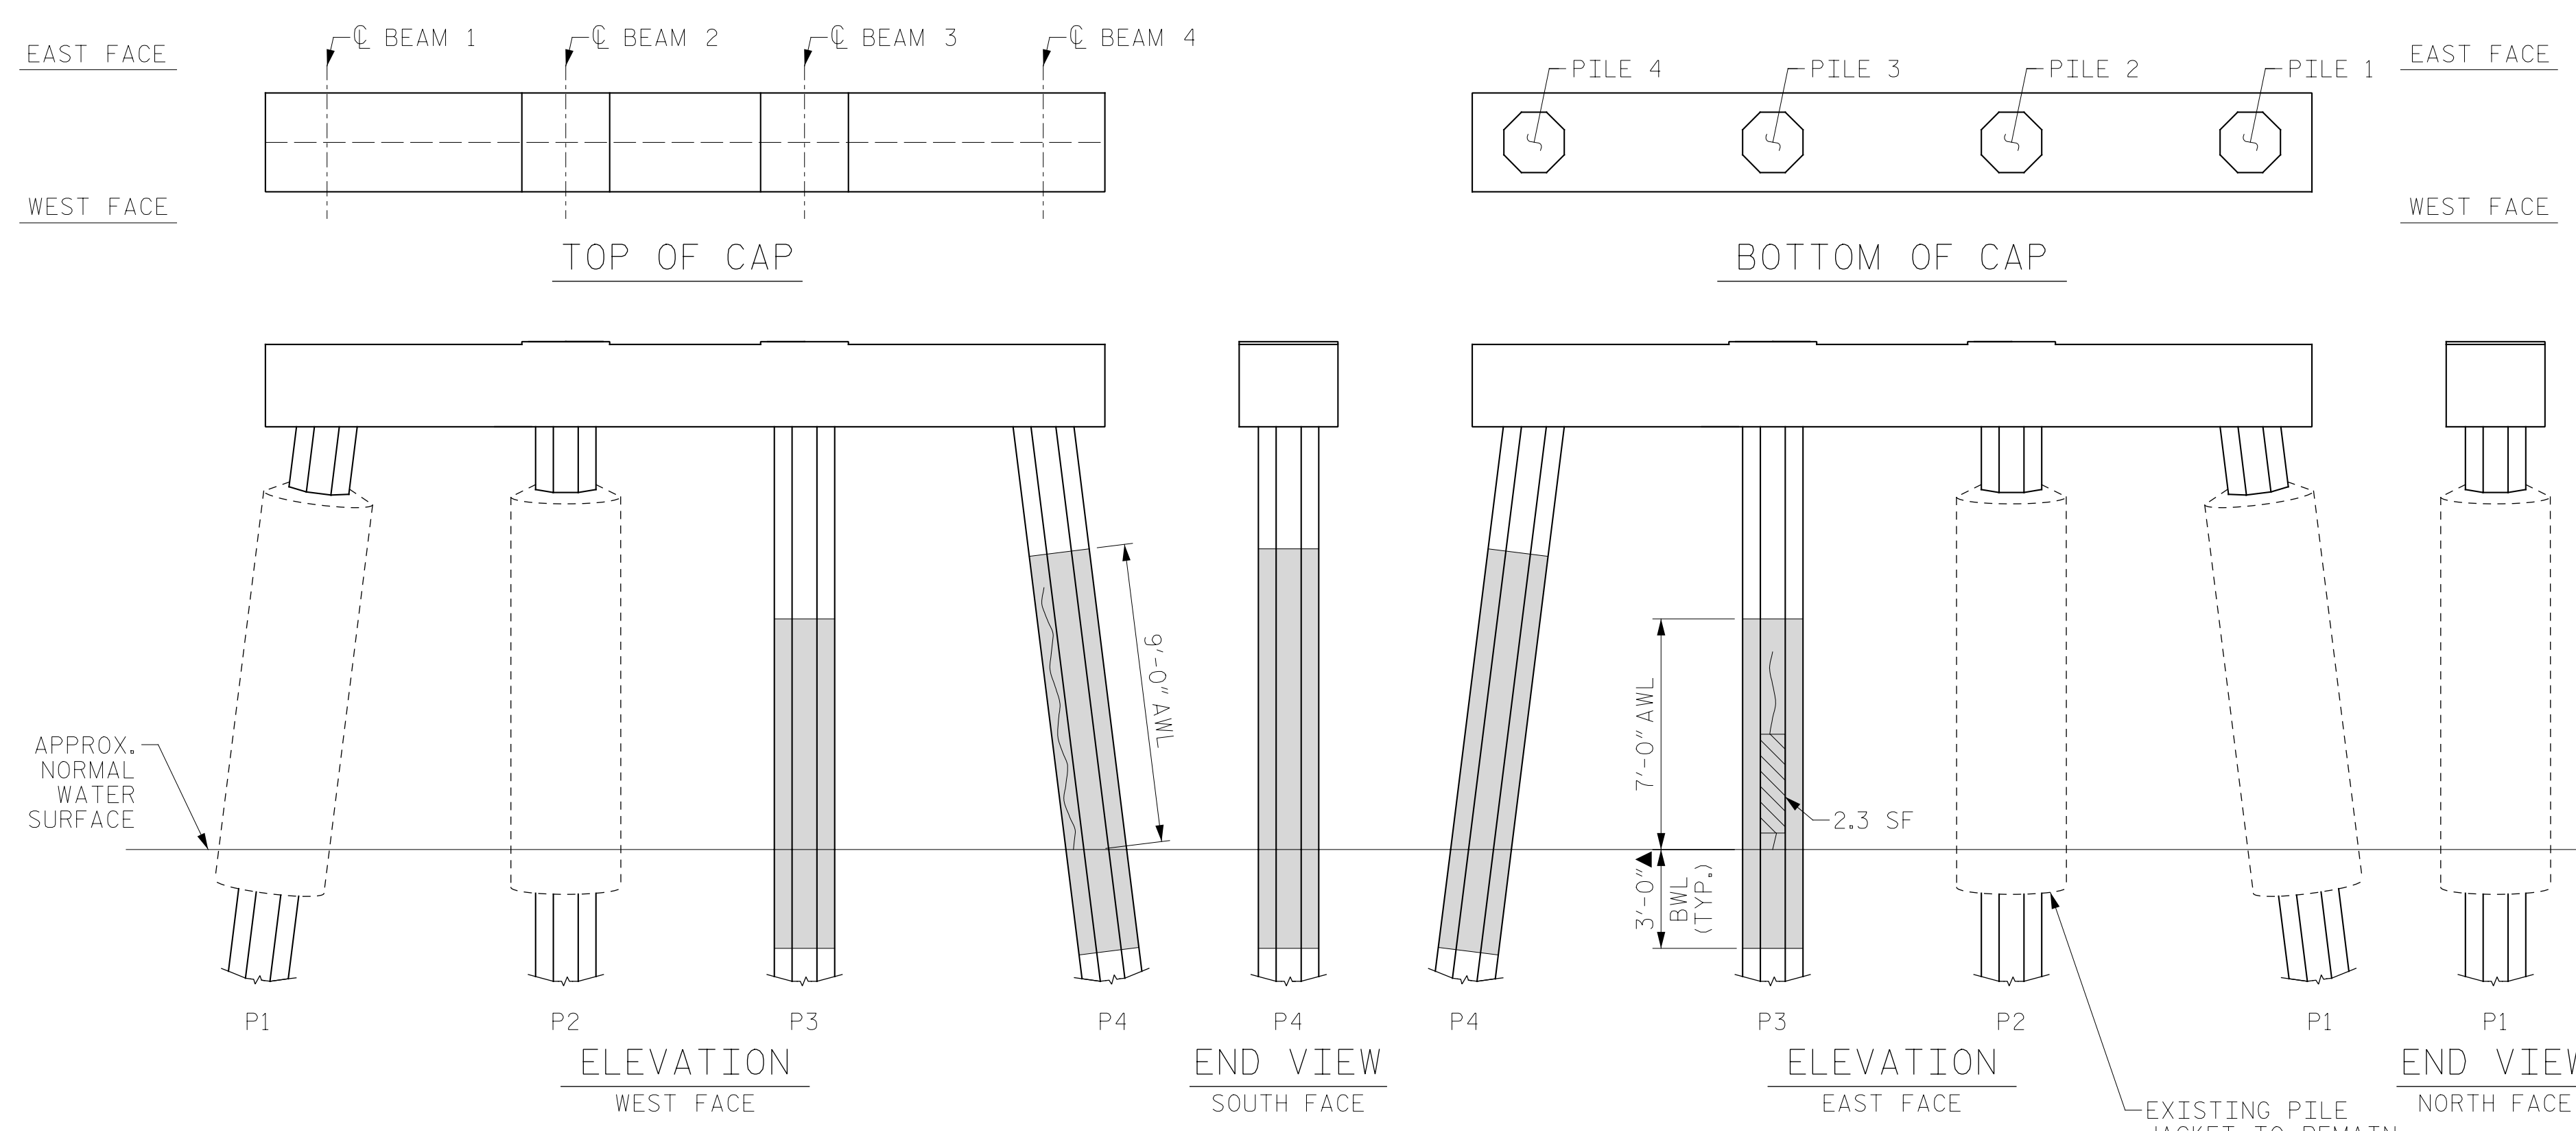
BENT 43

CAP REPAIRS		ESTIMATE			
SHOTCRETE REPAIRS	- SF	- CF	SF	CF	
EPOXY RESIN INJECTION		- LF			LF
PILE REPAIRS		ESTIMATE			
PILE CONCRETE RESTORATION	2.3 SF	1.2 CF	SF	CF	
FRP PROTECTIVE SYSTEM AWL	88.5 SF				
FRP PROTECTIVE SYSTEM BWL	33.0 SF

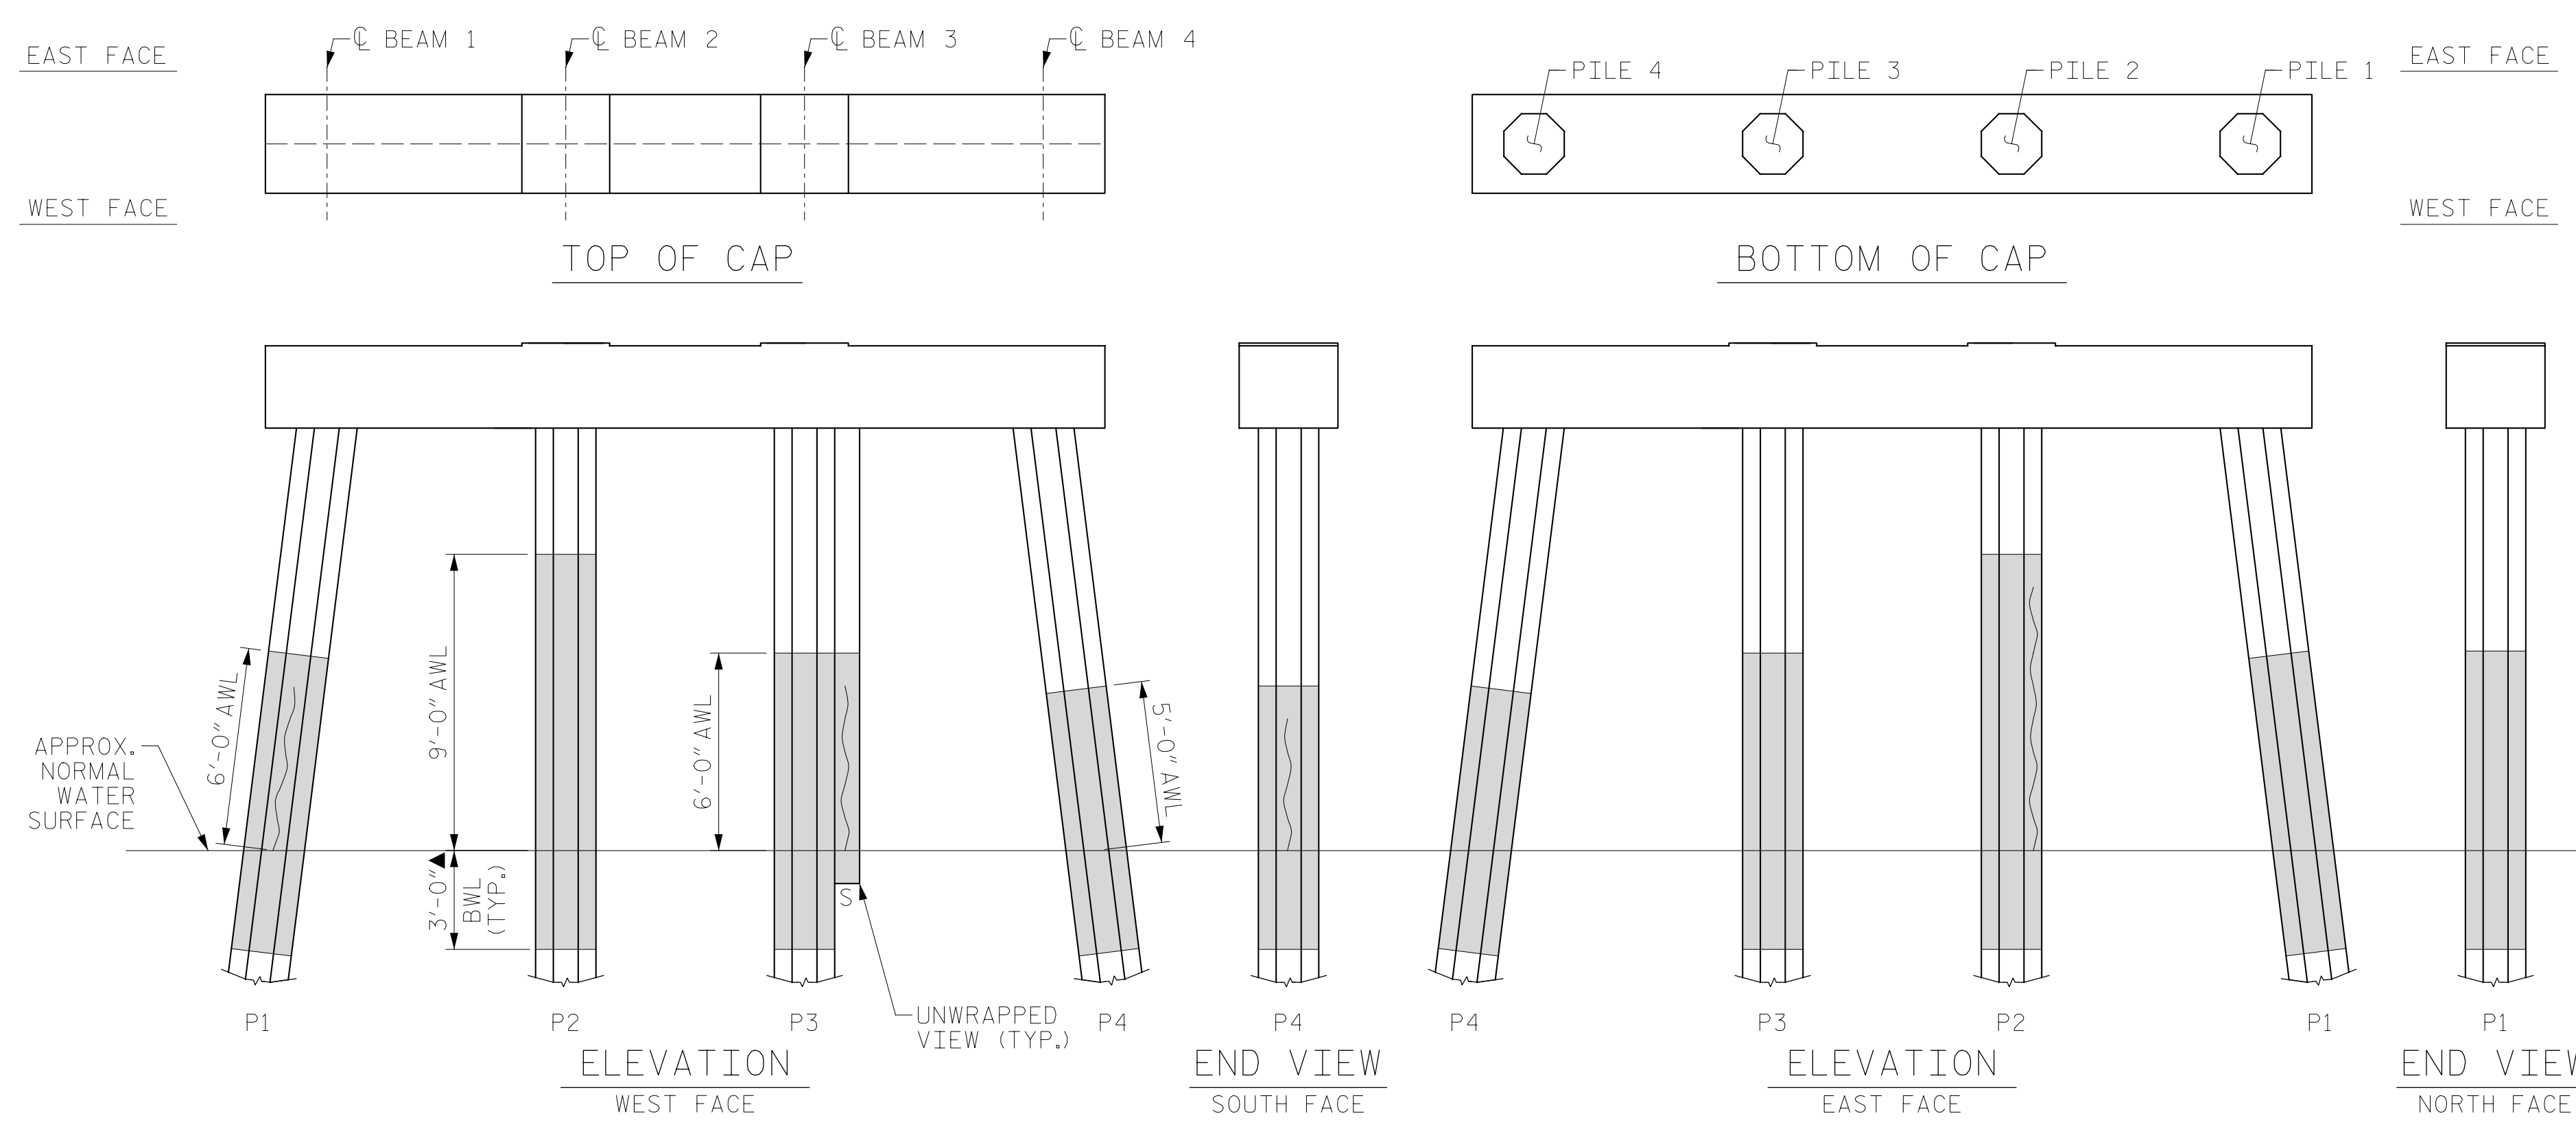
BENT 44

CAP REPAIRS		ESTIMATE			
SHOTCRETE REPAIRS	- SF	- CF	SF	CF	
EPOXY RESIN INJECTION		- LF			LF
PILE REPAIRS		ESTIMATE			
PILE CONCRETE RESTORATION	- SF	- CF	SF	CF	
FRP PROTECTIVE SYSTEM AWL	143.9 SF				
FRP PROTECTIVE SYSTEM BWL	66.0 SF
