AS-BUILT REPAIR QUANTITY TABLE

PROJECT NO. HB-0017
DARE COUNTY
 BRIDGE NO. 270009

BENT 51 & BENT 52

REVISIONS						SHEET NO.
NO.	BY:	DATE:	NO.	BY:	DATE:	S-141
1			3			TOTAL SHEETS
2			4			355

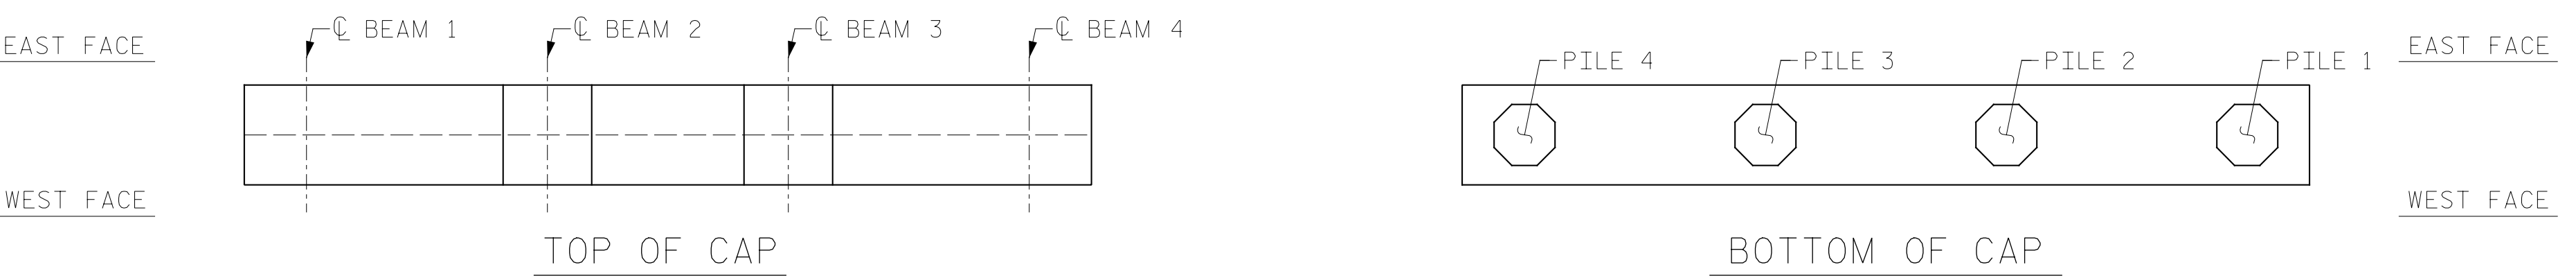
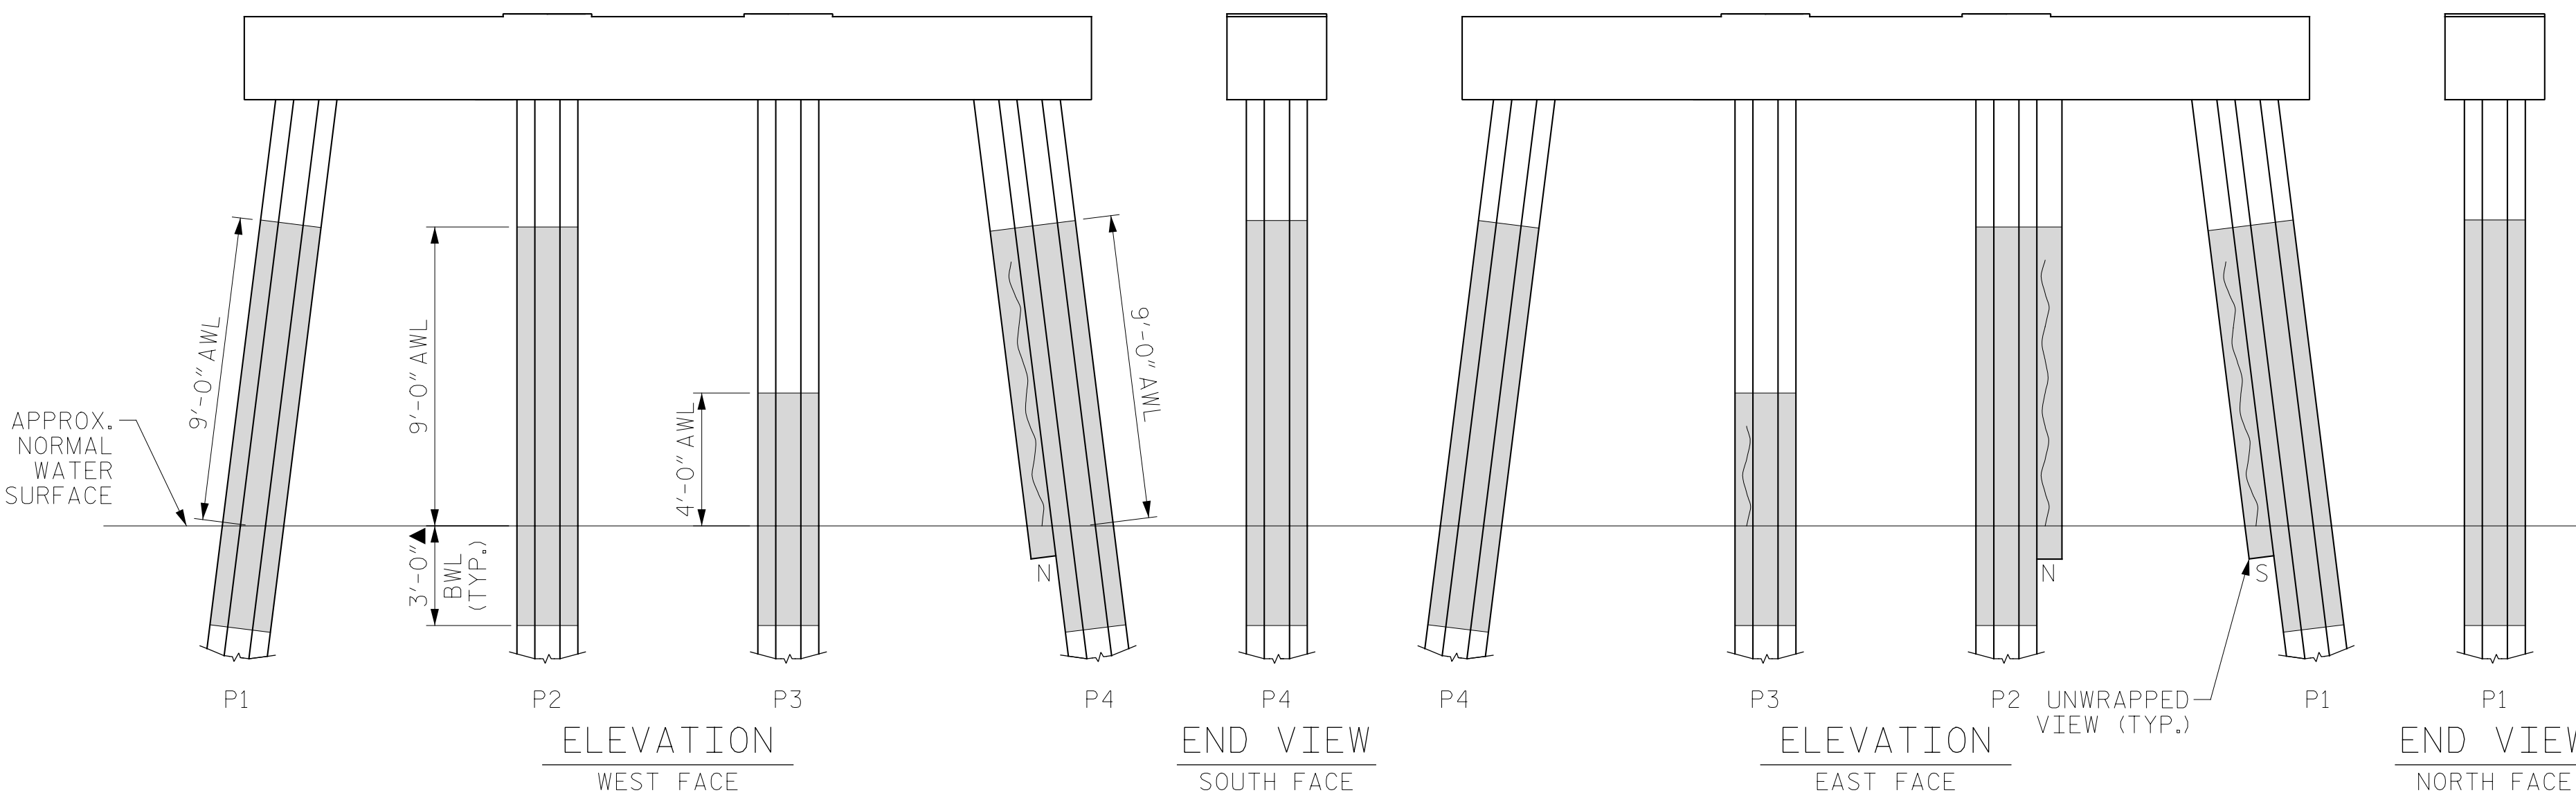
BENT 51				
CAP REPAIRS				
SHOTCRETE REPAIRS	- SF	- CF	SF	CF
EPOXY RESIN INJECTION	- LF			LF
PILE REPAIRS				
PILE CONCRETE RESTORATION	- SF	- CF	SF	CF
FRP PROTECTIVE SYSTEM AWL	171.4 SF			
FRP PROTECTIVE SYSTEM BWL	66.0 SF

ESTIMATED PILE CRACK QTY. TABLE									
		NW	W	SW	S	SE	E	NE	N
BENT 51	PILE 1	-	-	-	8	-	6	6	-
	PILE 2	-	-	-	4	-	-	-	8
	PILE 3	-	2	2	-	3	-	-	-
	PILE 4	-	-	-	-	6	-	6	8
BENT 52	PILE 1	-	1	1	-	-	-	-	-
	PILE 2	-	5	-	-	3	4	7	3
	PILE 3	-	-	4	7	3	3	-	4
	PILE 4	-	-	-	-	-	-	-	5

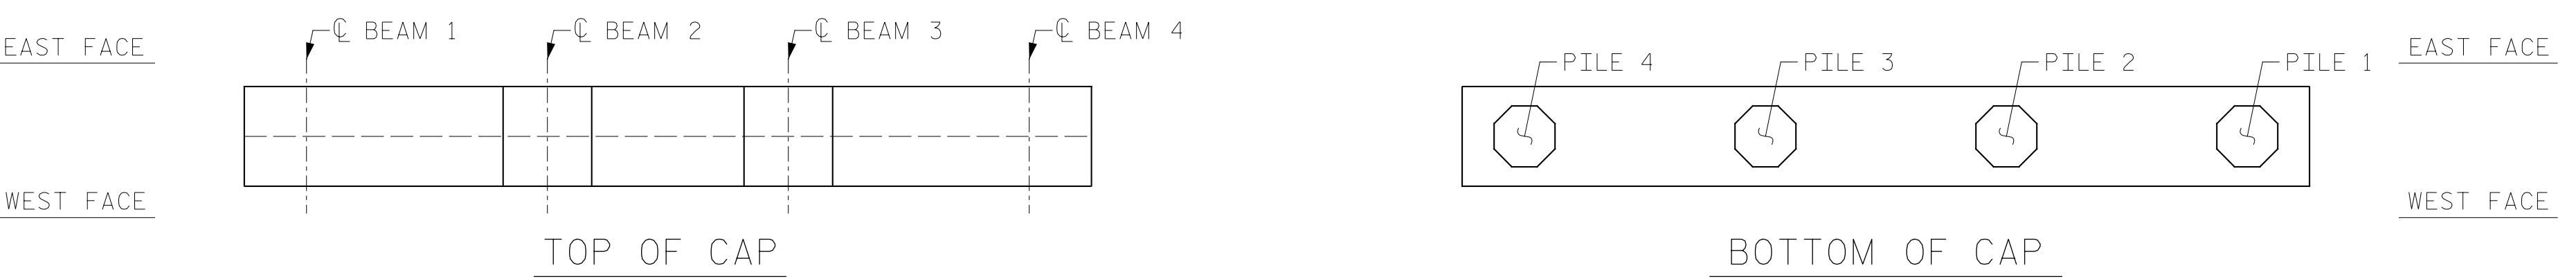
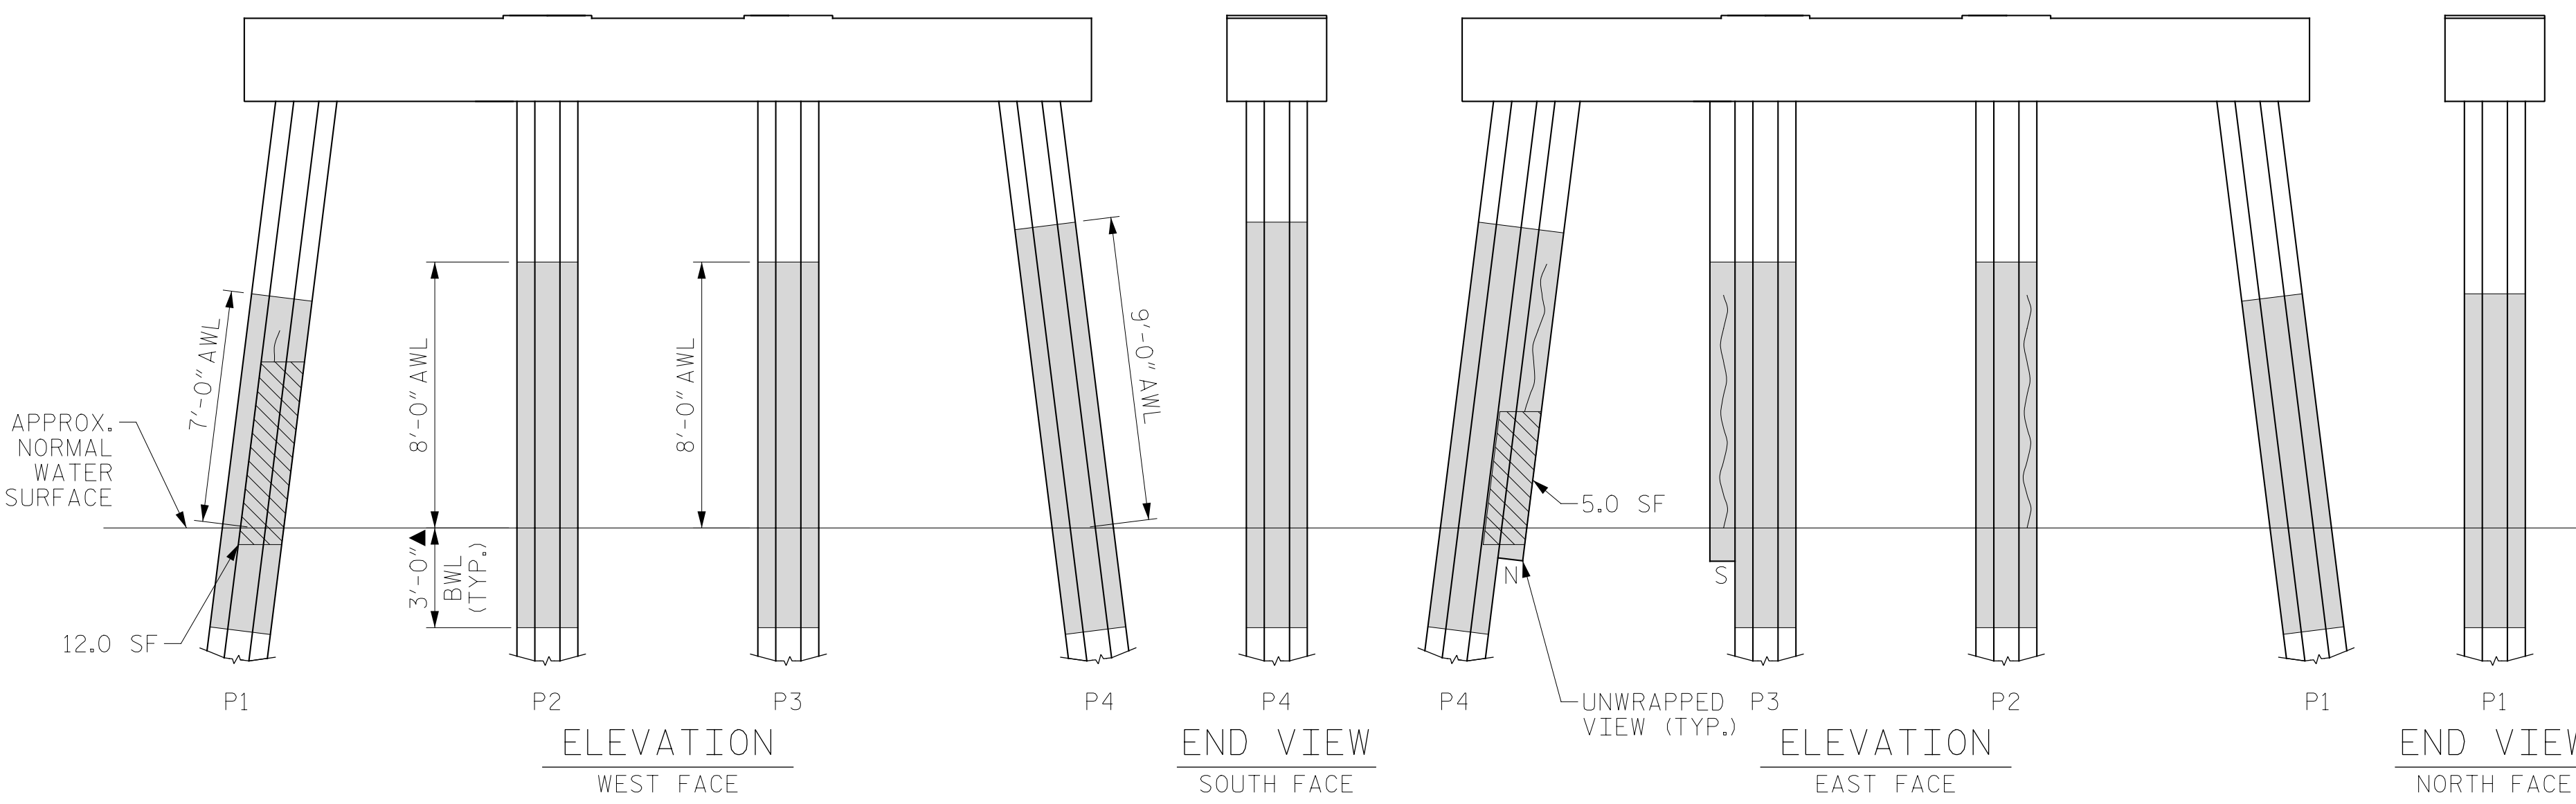
BENT 52				
CAP REPAIRS				
SHOTCRETE REPAIRS	- SF	- CF	SF	CF
EPOXY RESIN INJECTION	- LF			LF
PILE REPAIRS				
PILE CONCRETE RESTORATION	17.0 SF	6.9 CF	SF	CF
FRP PROTECTIVE SYSTEM AWL	176.9 SF			
FRP PROTECTIVE SYSTEM BWL	66.0 SF
