AS-BUILT REPAIR QUANTITY TABLE

PROJECT NO. HB-0017
DARE COUNTY
BRIDGE NO. 270009

STATE OF NORTH CAROLINA
DEPARTMENT OF TRANSPORTATION
RALEIGH

BENT 59 & BENT 60

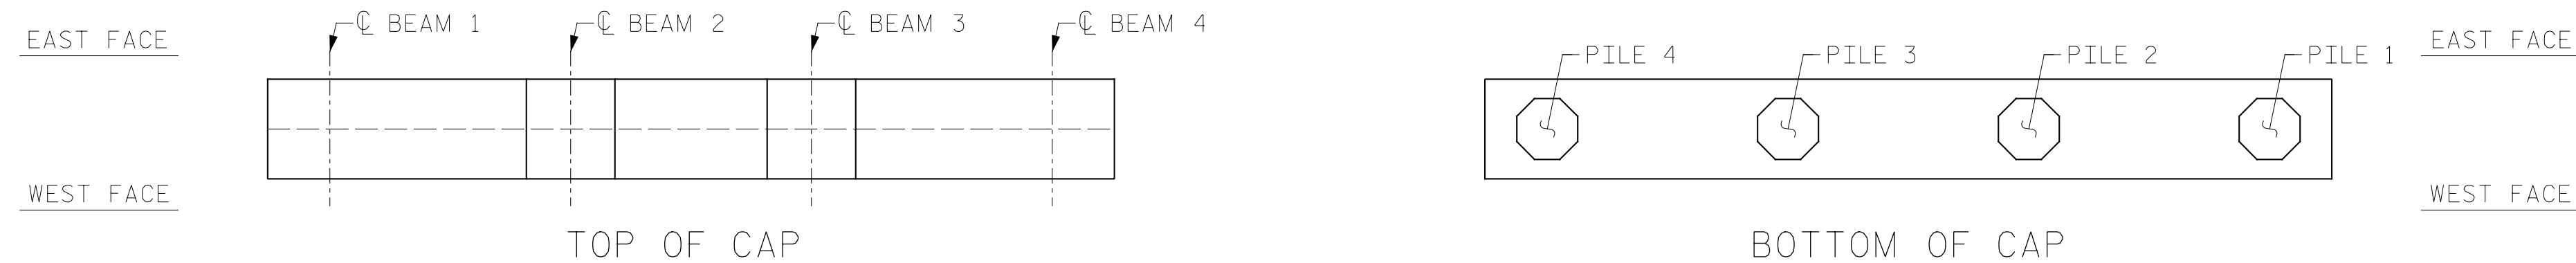
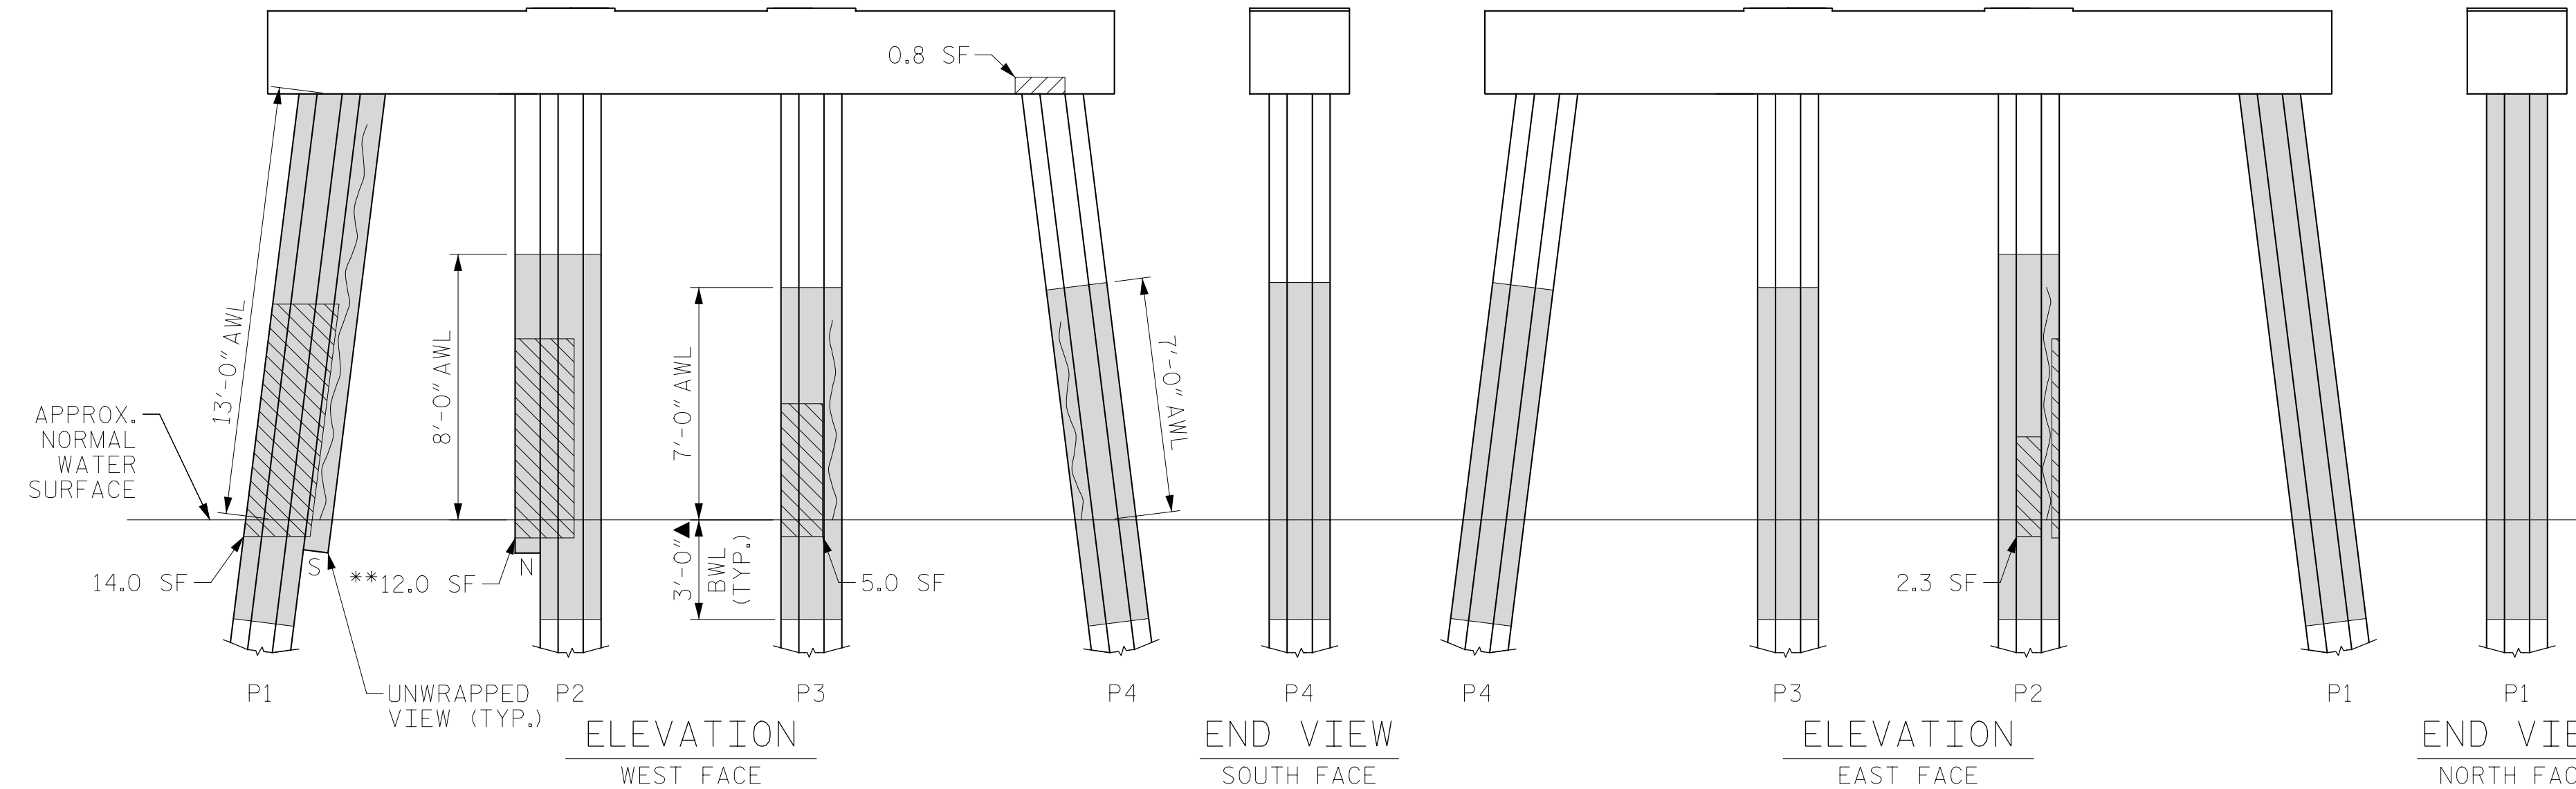
BENT 59

| CAP REPAIRS | | | |
| SHOTCRETE REPAIRS | 0.8 SF | 0.4 CF | SF CF |
| EPOXY RESIN INJECTION | - LF | | LF |
| PILE REPAIRS | | | |
| PILE CONCRETE RESTORATION | 33.3 SF | 13.4 CF | SF CF |
| FRP PROTECTIVE SYSTEM AWL | 193.0 SF | | |
| FRP PROTECTIVE SYSTEM BWL | 66.0 SF | | |

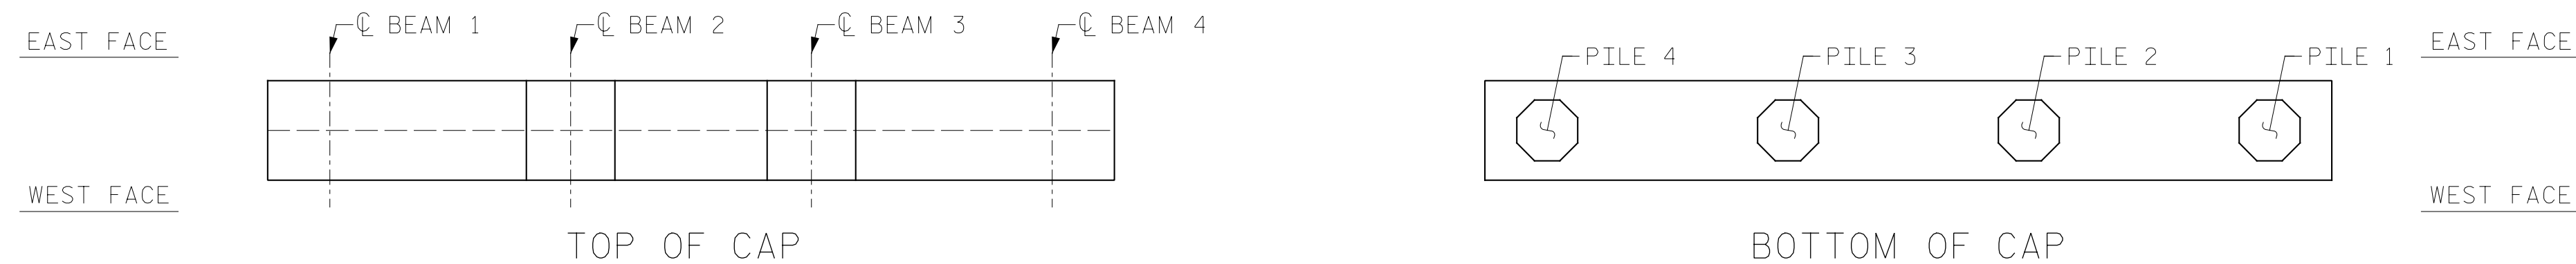
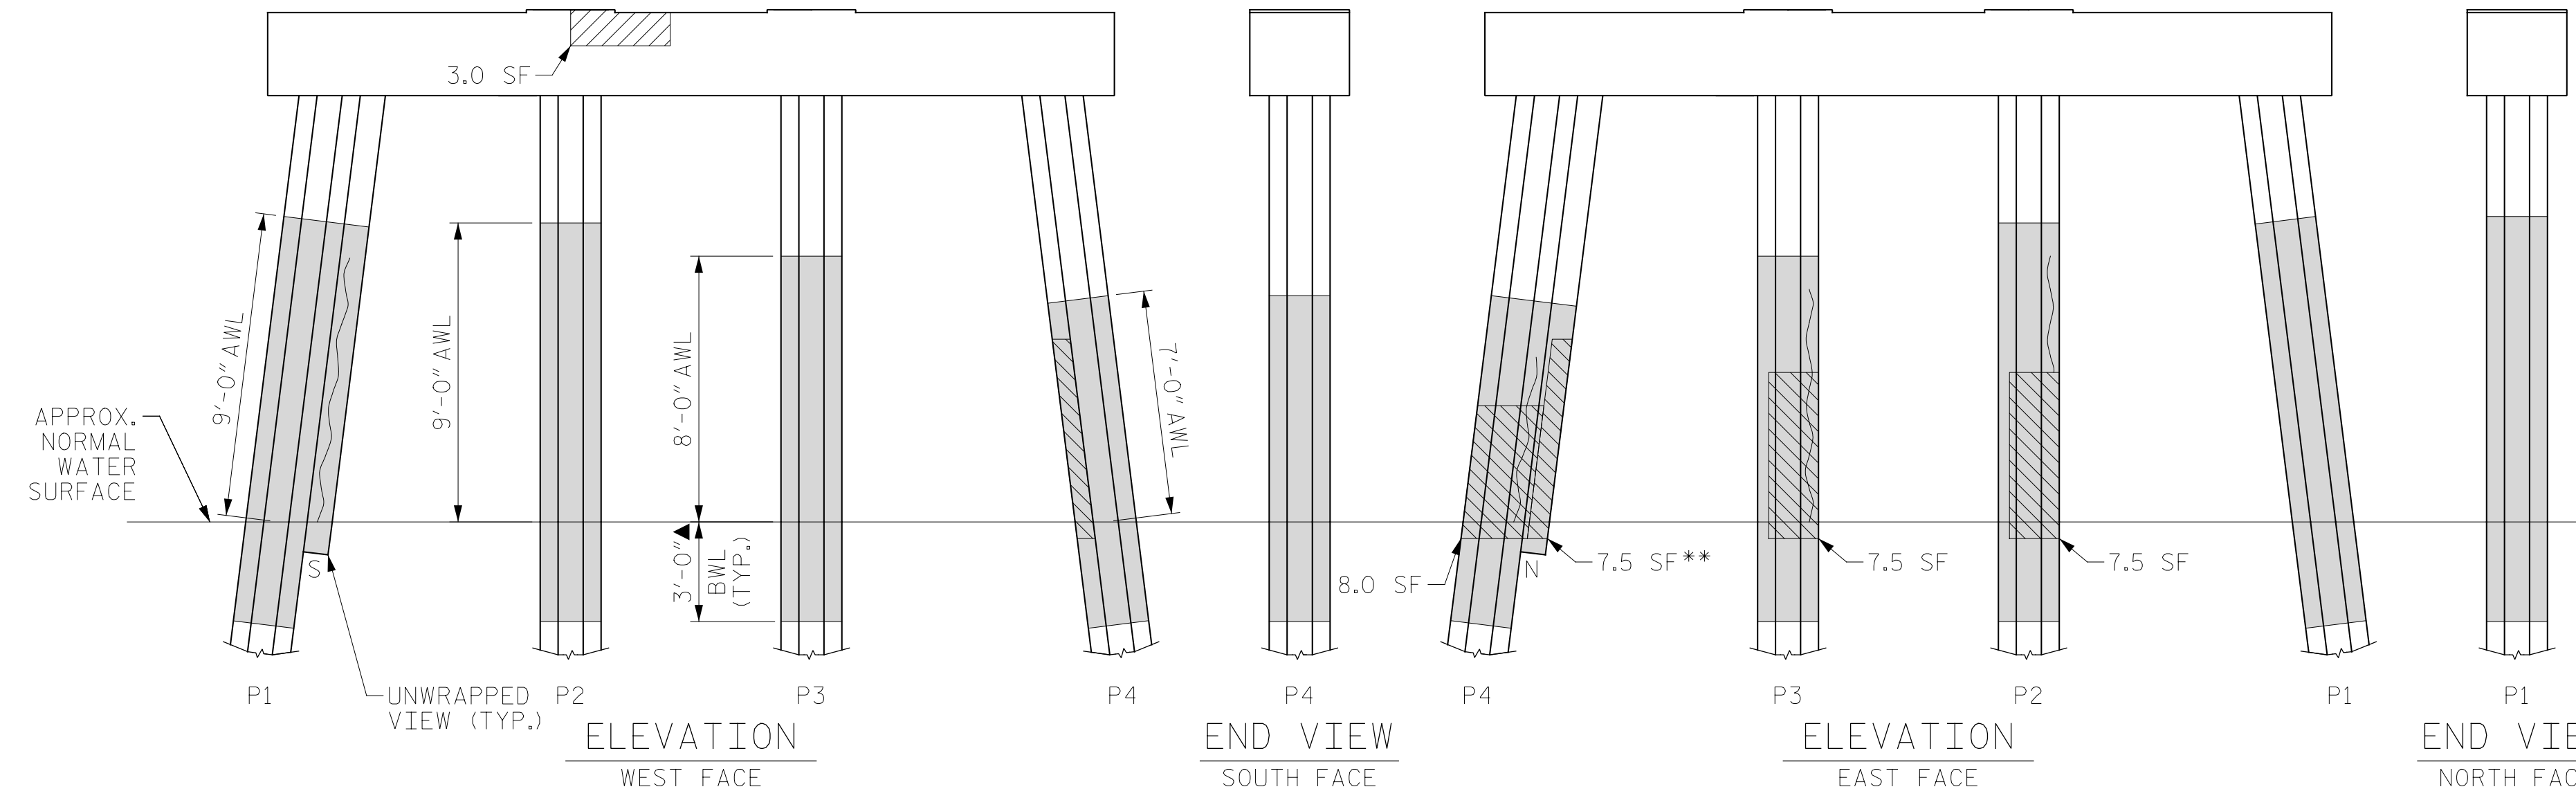
BENT 60

| CAP REPAIRS | | | |
| SHOTCRETE REPAIRS | 3.0 SF | 1.5 CF | SF CF |
| EPOXY RESIN INJECTION | - LF | | LF |
| PILE REPAIRS | | | |
| PILE CONCRETE RESTORATION | 30.5 SF | 12.9 CF | SF CF |
| FRP PROTECTIVE SYSTEM AWL | 182.4 SF | | |
| FRP PROTECTIVE SYSTEM BWL | 66.0 SF | | |
