AS-BUILT REPAIR QUANTITY TABLE

PROJECT NO. HB-0017
DARE COUNTY
 BRIDGE NO. 270009

BENT 65 & BENT 66

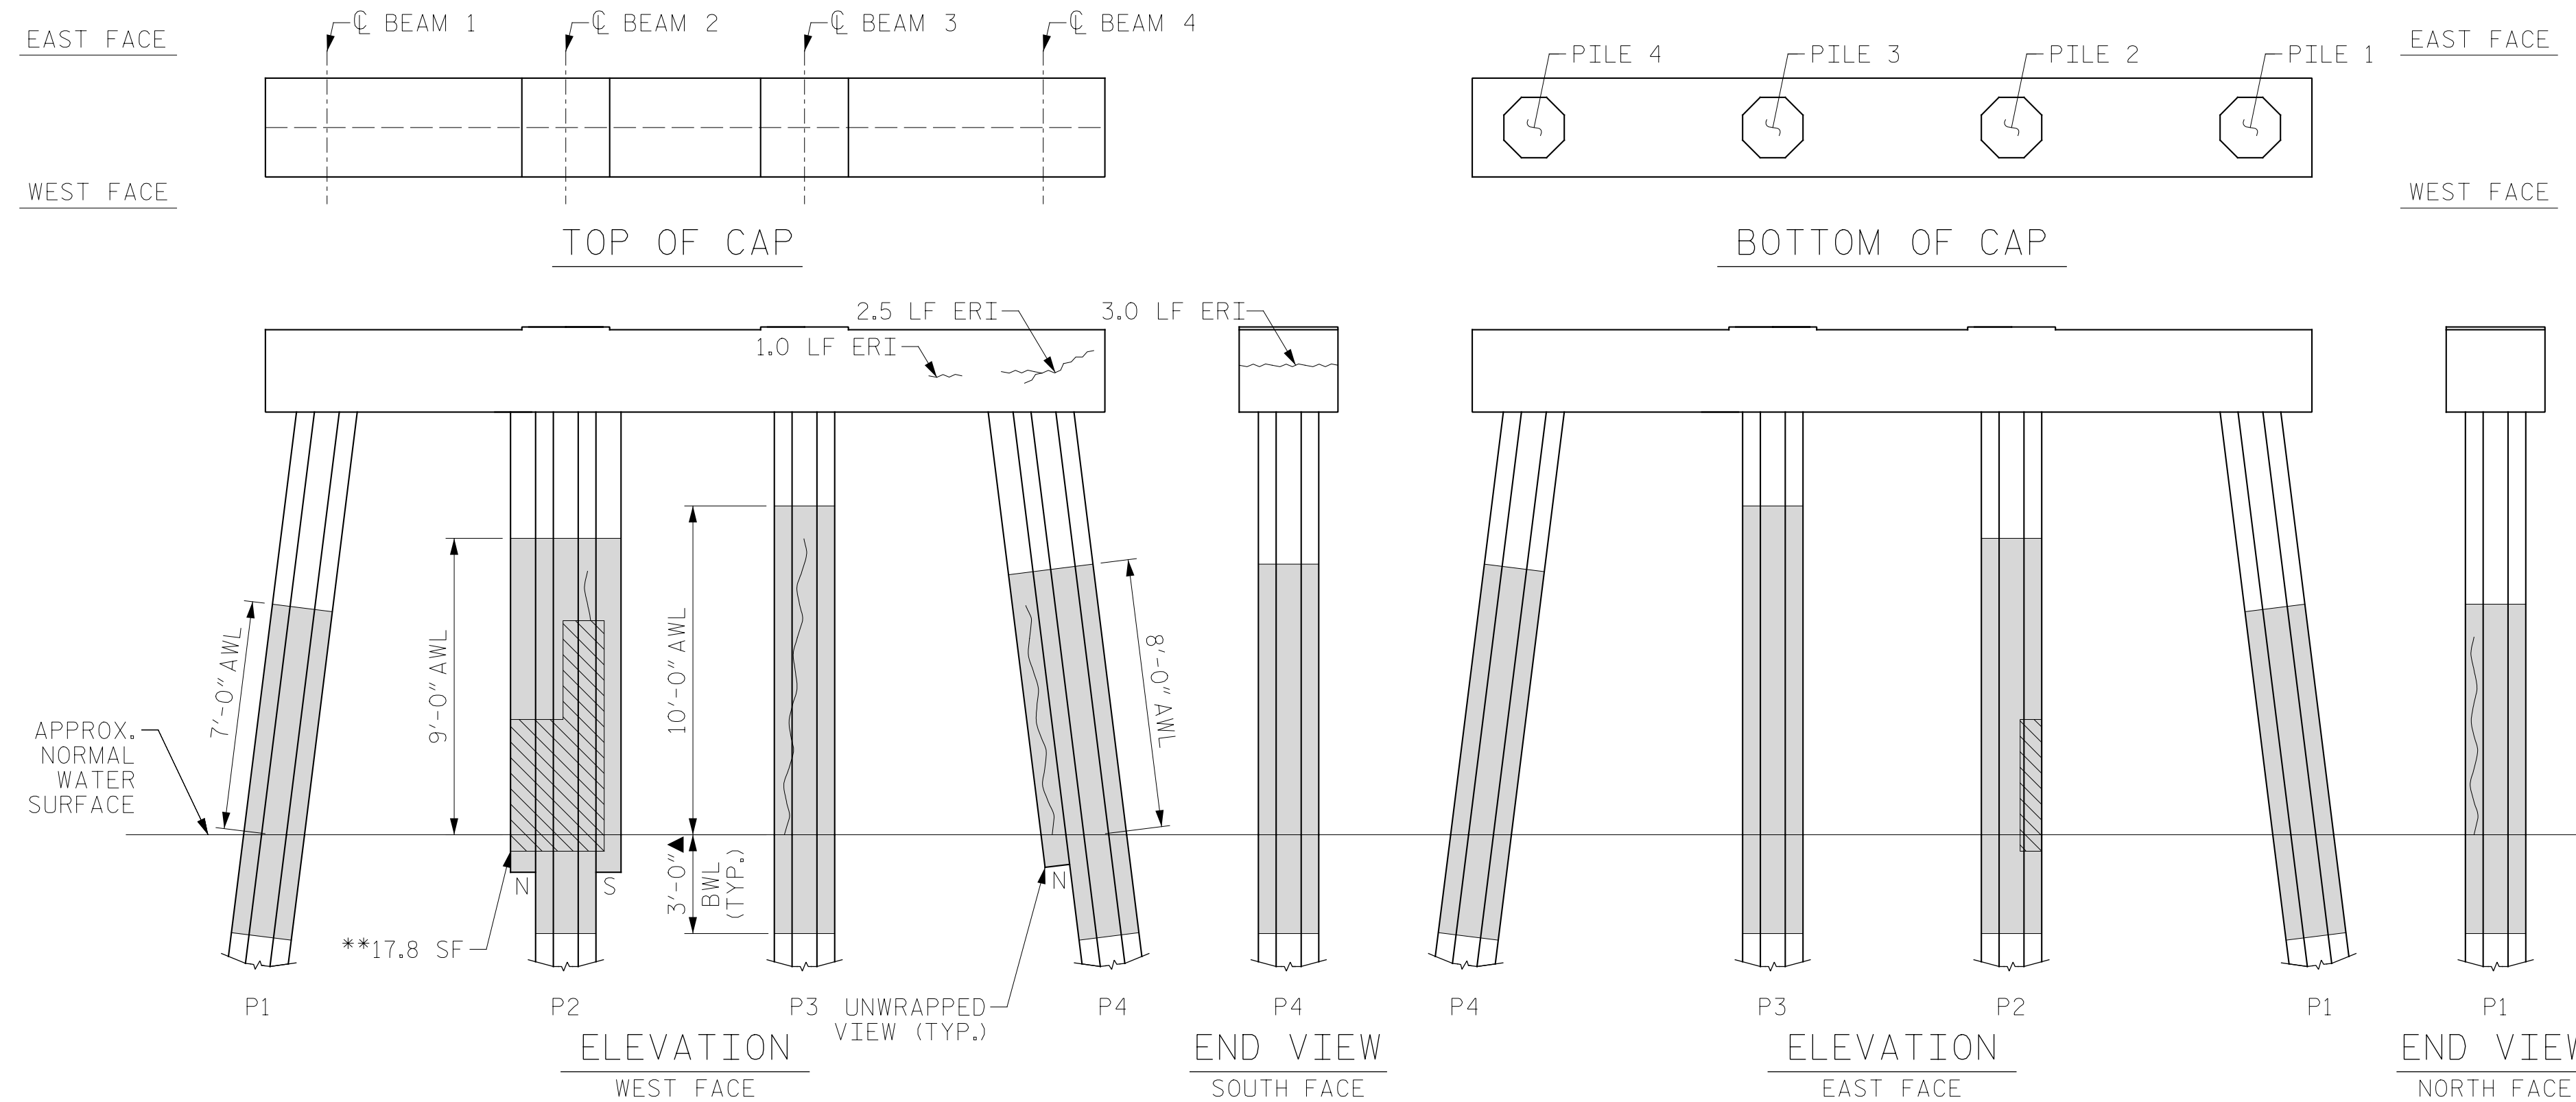
CAP REPAIRS			
SHOTCRETE REPAIRS	- SF	- CF	SF CF
EPOXY RESIN INJECTION	6.5 LF		LF
PILE REPAIRS			
PILE CONCRETE RESTORATION	17.8 SF	7.4 CF	SF CF
FRP PROTECTIVE SYSTEM AWL	187.9 SF		
FRP PROTECTIVE SYSTEM BWL	66.0 SF

NW	W	SW	S	SE	E	NE	N
BENT 65	PILE 1	3	-	-	-	5	3	6	-
	PILE 2	3	-	2	-	-	5	3	-
	PILE 3	9	-	6	-	-	4	-	8
	PILE 4	-	-	3	-	3	-	4	7
BENT 66	PILE 1	-	3	5	-	2	1	-	-
	PILE 2	1	-	-	-	-	-	-	-
	PILE 3	-	-	-	2	-	-	-	2
	PILE 4	3	-	3	-	-	3	3	-

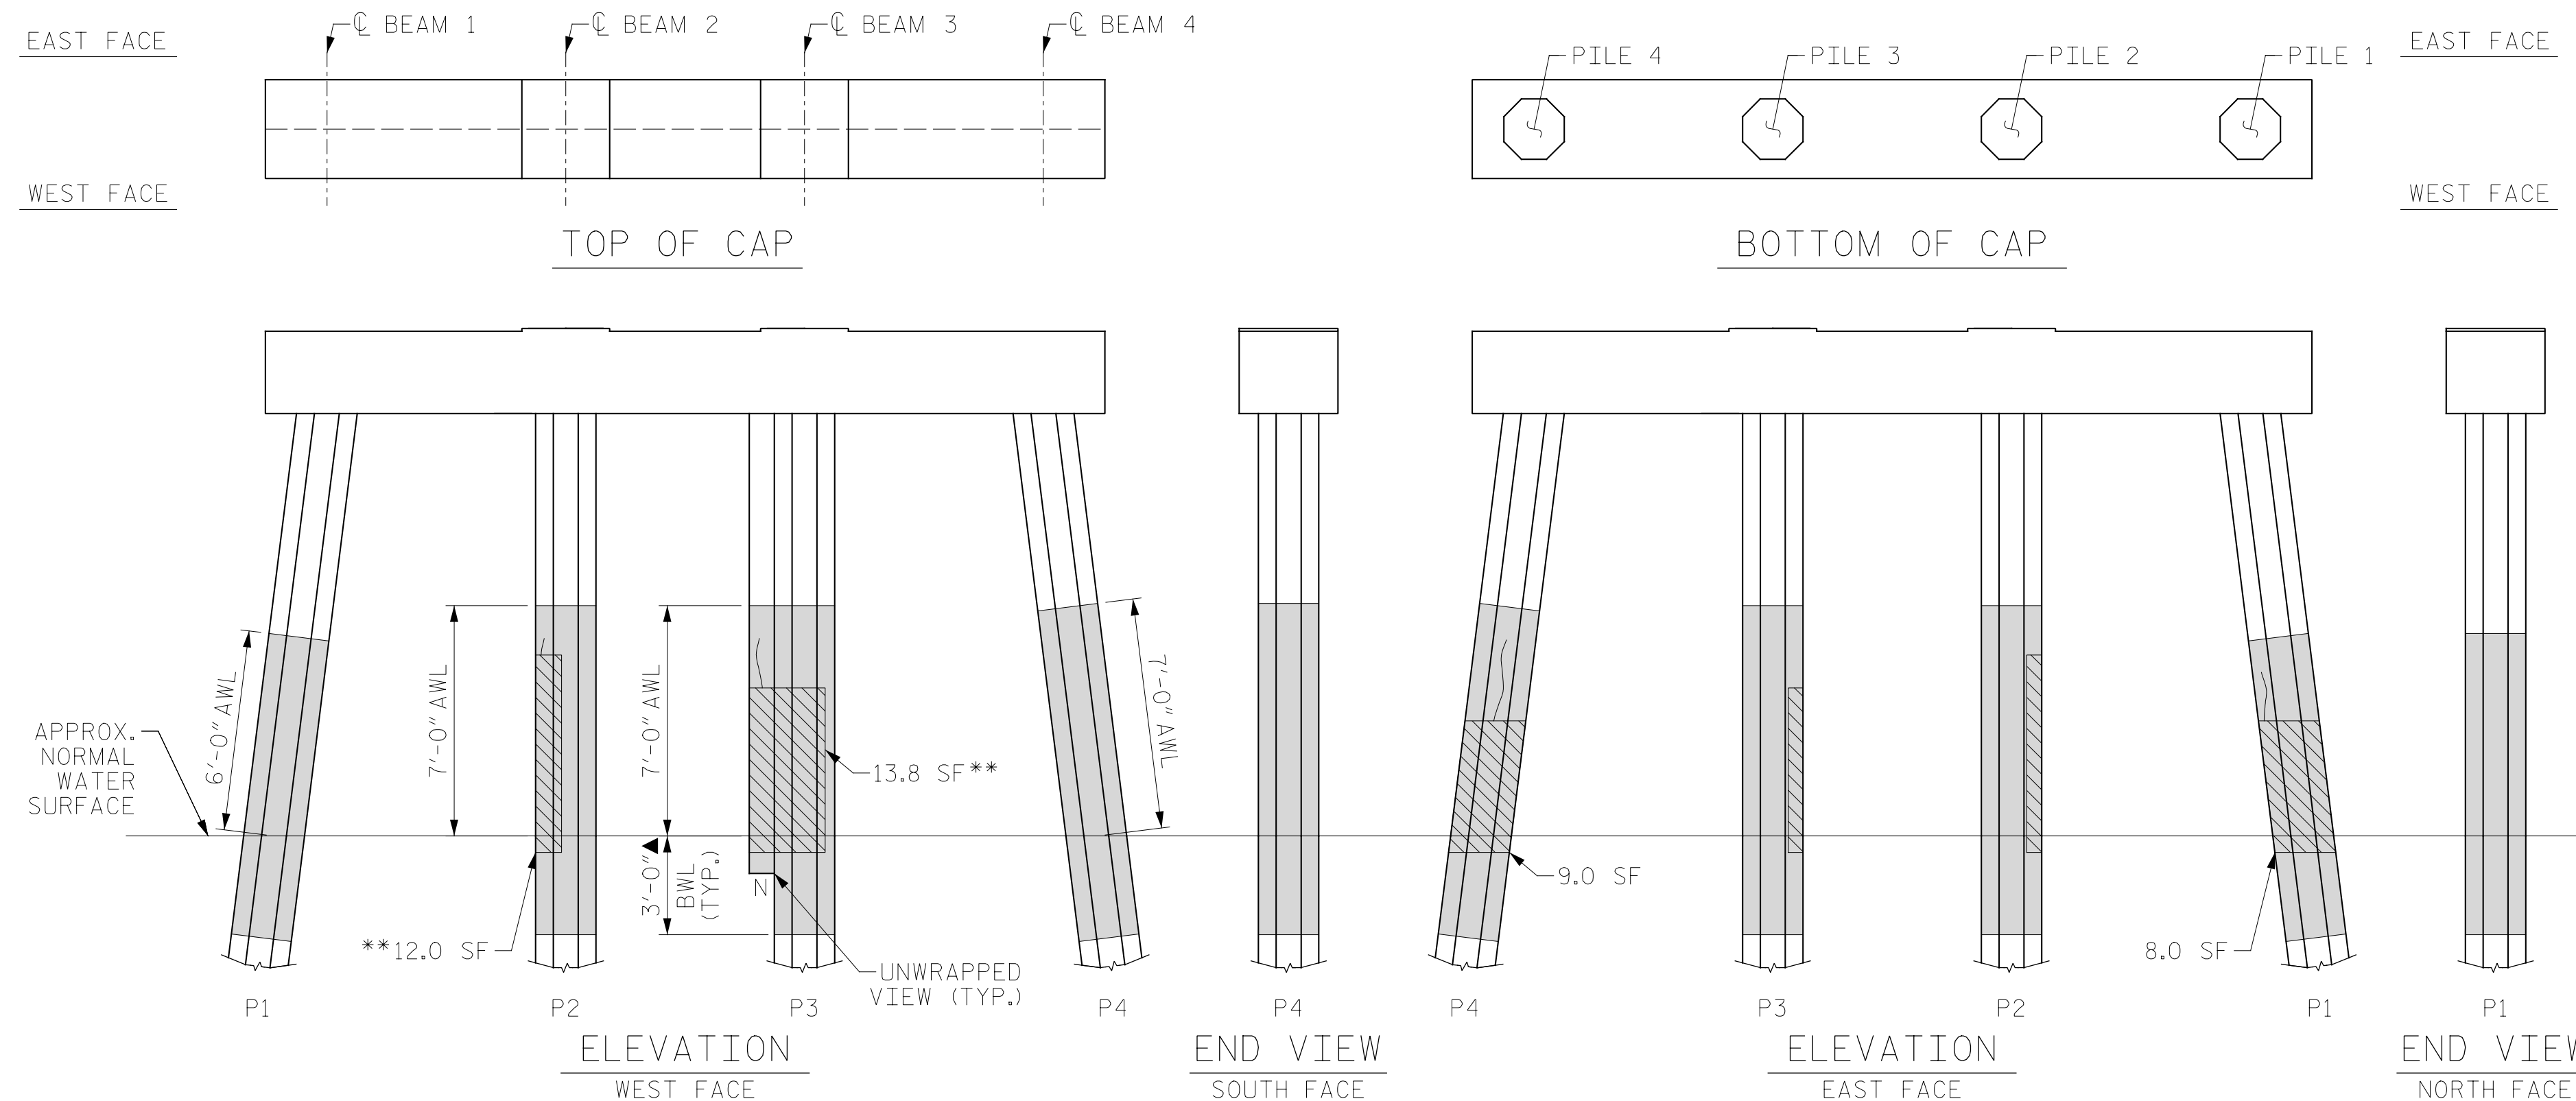
BENT 66

CAP REPAIRS			
SHOTCRETE REPAIRS	- SF	- CF	SF CF
EPOXY RESIN INJECTION	- LF		LF
PILE REPAIRS			
PILE CONCRETE RESTORATION	42.8 SF	17.0 CF	SF CF
FRP PROTECTIVE SYSTEM AWL	149.4 SF		
FRP PROTECTIVE SYSTEM BWL	66.0 SF
