PROJECT NO. DARE

270009 BRIDGE NO.

STATE OF NORTH CAROLINA DEPARTMENT OF TRANSPORTATION RALEIGH

BENT 71 & BENT 72

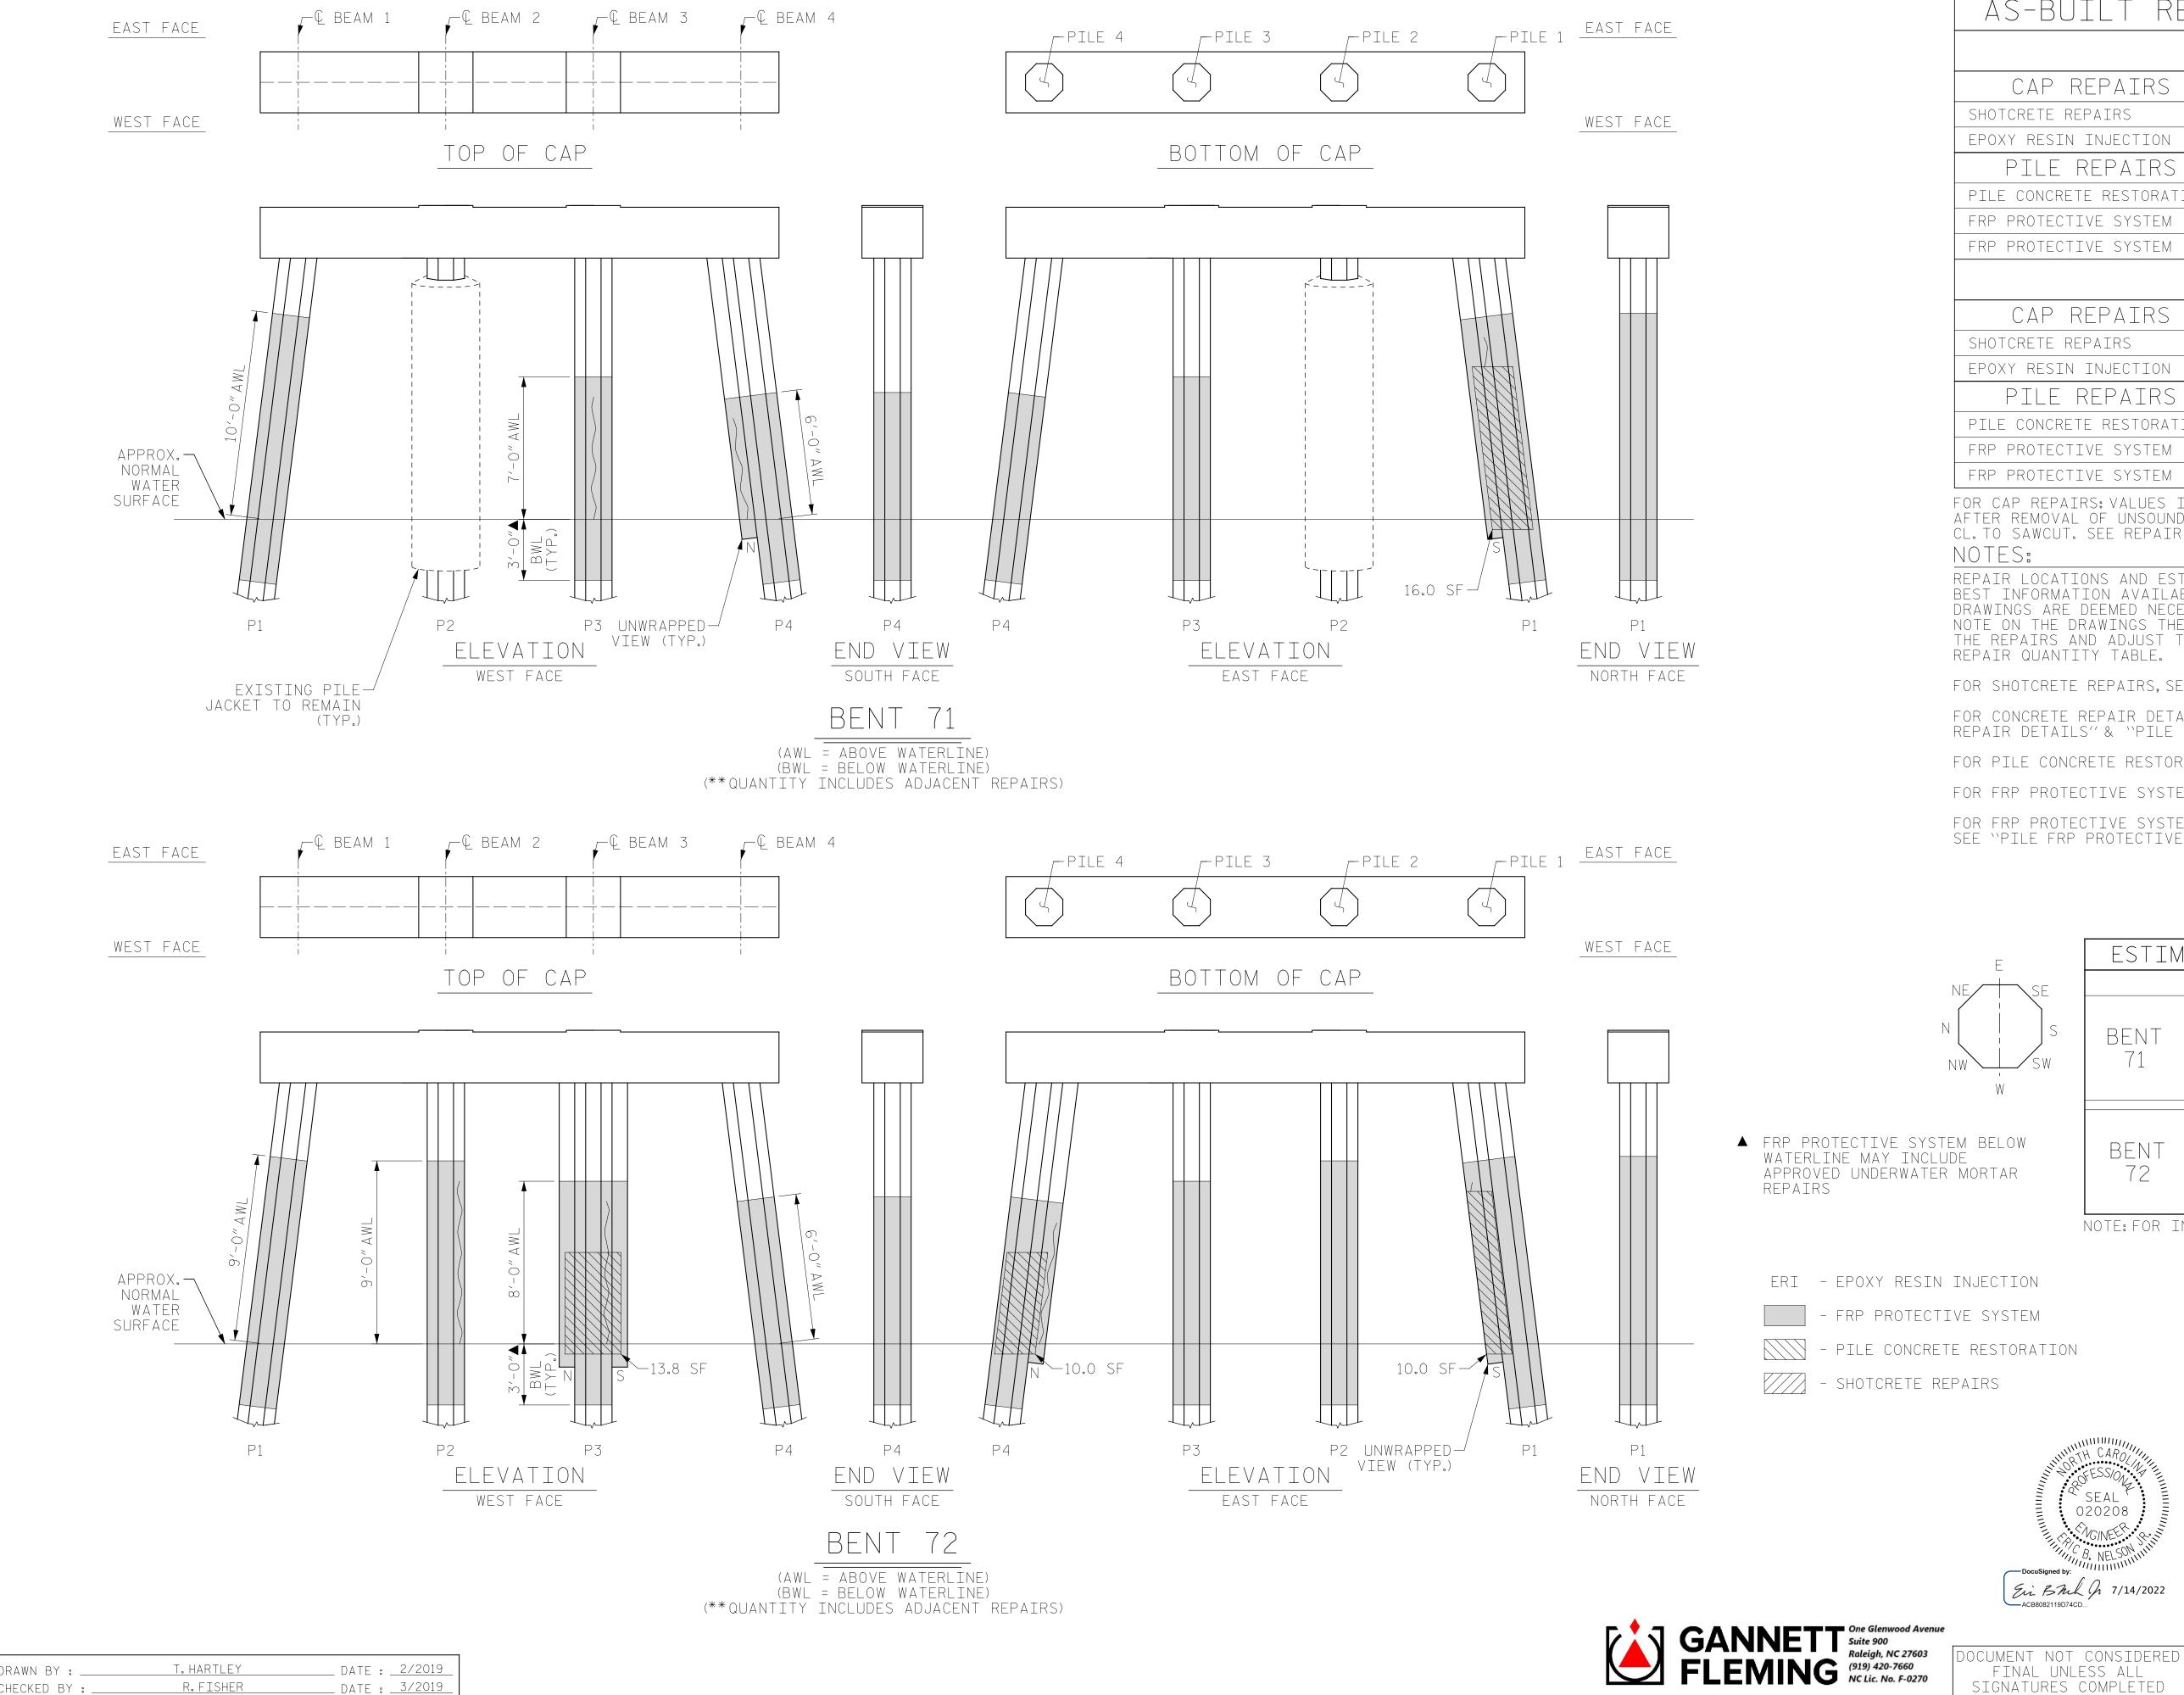
AS-BUILT REPAIR QUANTITY TABLE BENT 71 SF - SF - CF - LF SF PILE CONCRETE RESTORATION 16.0 SF | 6.3 CF FRP PROTECTIVE SYSTEM AWL 126.5 SF FRP PROTECTIVE SYSTEM BWL 49.5 SF DENIT 70

BEN1 (2							
CAP REPAIRS							
SHOTCRETE REPAIRS	- SF	- CF	SF	CF			
EPOXY RESIN INJECTION	_	LF		LF			
PILE REPAIRS							
PILE CONCRETE RESTORATION	33.8 SF	13.6 CF	SF	CF			
FRP PROTECTIVE SYSTEM AWL	176.	0 SF					
FRP PROTECTIVE SYSTEM BWL	66.0 SF

ESTIMATED PILE CRACK QTY. TABLE									
		NW	W	SW	S	SE	E	NE	Ν
BENT 71	PILE 1	_	_	_	_	2	_	5	_
	PILE 2	_	_	_	_	_	_	_	-
	PILE 3	_	6	_	6	6	=	_	_
	PILE 4	_	3	2	_	_	-	_	5
	5 = 1 = 4								
	PILE 1	_	-	_	1	_	2	4	_
BENT 72	PILE 2	_	_	8	6	_	6	_	4
	PILE 3	_	_	3	_	6	_	_	4
	PILE 4	_	-	3	-	_	-	_	5
OTE, EAR THEARMATTAN AND RIF CANDITTAN AND V

NOTE: FOR INFORMATION ON PILE CONDITION ONLY.
