AS-BUILT REPAIR QUANTITY TABLE

PROJECT NO. HB-0017  
DARE COUNTY  
 BRIDGE NO. 270009

BENT 79 & BENT 80

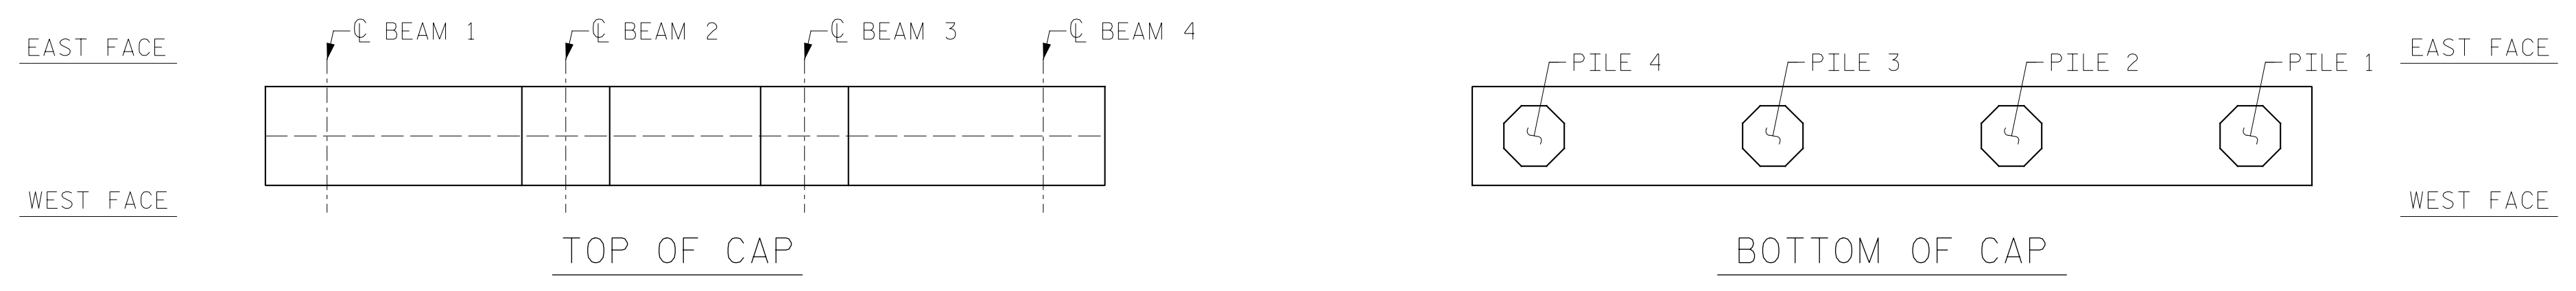
BENT 79

CAP REPAIRS			
SHOTCRETE REPAIRS	- SF	- CF	SF CF
EPOXY RESIN INJECTION	- LF		LF
PILE REPAIRS			
PILE CONCRETE RESTORATION	18.5 SF	7.0 CF	SF CF
FRP PROTECTIVE SYSTEM AWL	165.0 SF		
FRP PROTECTIVE SYSTEM BWL	66.0 SF

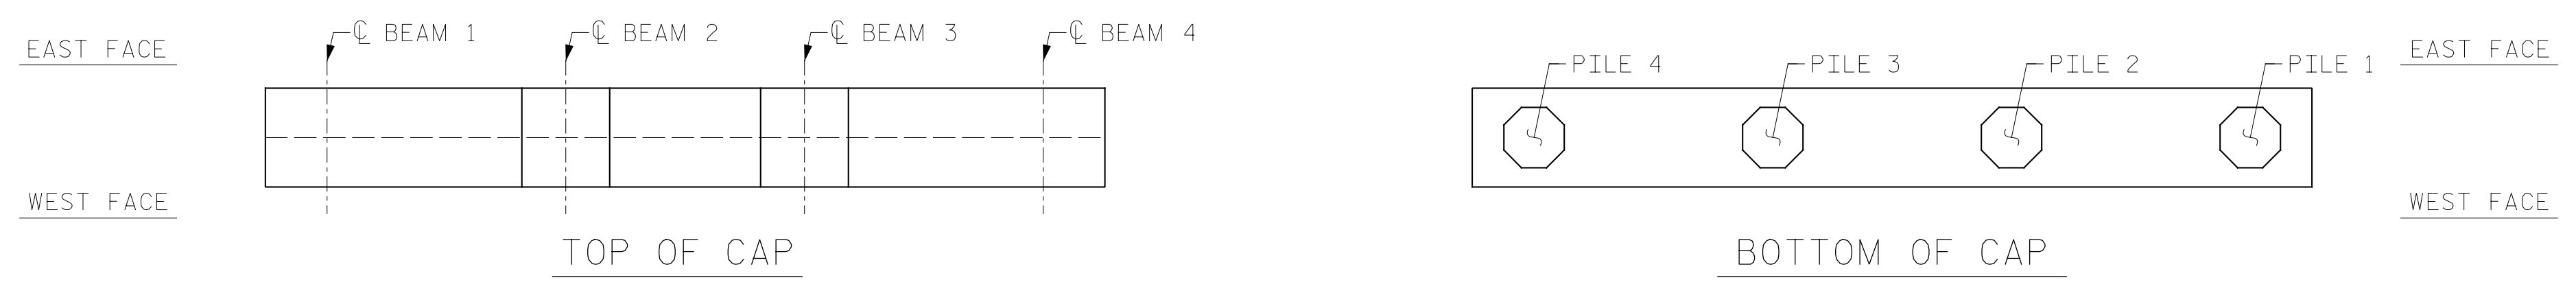
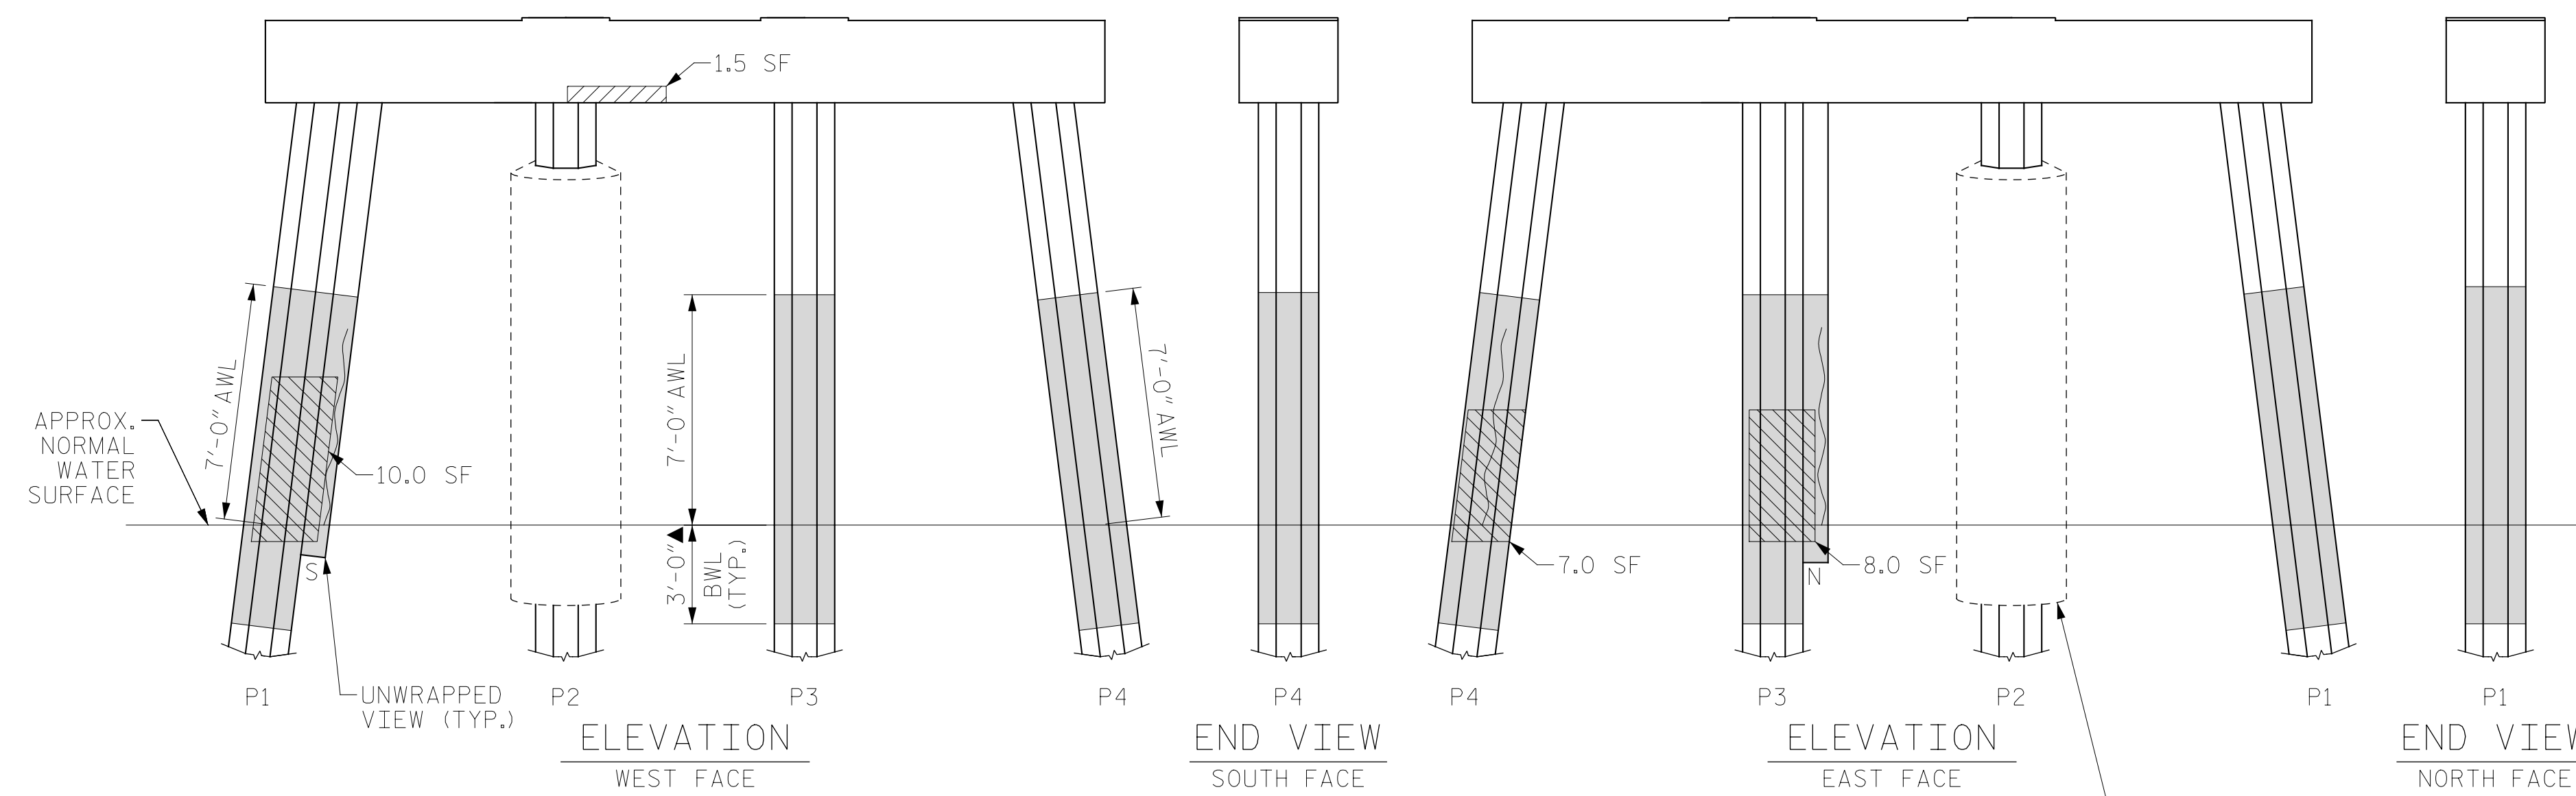
BENT 80

CAP REPAIRS			
SHOTCRETE REPAIRS	1.5 SF	0.8 CF	SF CF
EPOXY RESIN INJECTION	- LF		LF
PILE REPAIRS			
PILE CONCRETE RESTORATION	25.0 SF	10.0 CF	SF CF
FRP PROTECTIVE SYSTEM AWL	115.5 SF		
FRP PROTECTIVE SYSTEM BWL	49.5 SF
