AS-BUILT REPAIR QUANTITY TABLE

PROJECT NO. HB-0017
DARE COUNTY
BRIDGE NO. 270009

BENT 87 & BENT 88

REVISIONS						SHEET NO.
NO.	BY:	DATE:	NO.	BY:	DATE:	S-159
1			3			TOTAL SHEETS
2			4			355

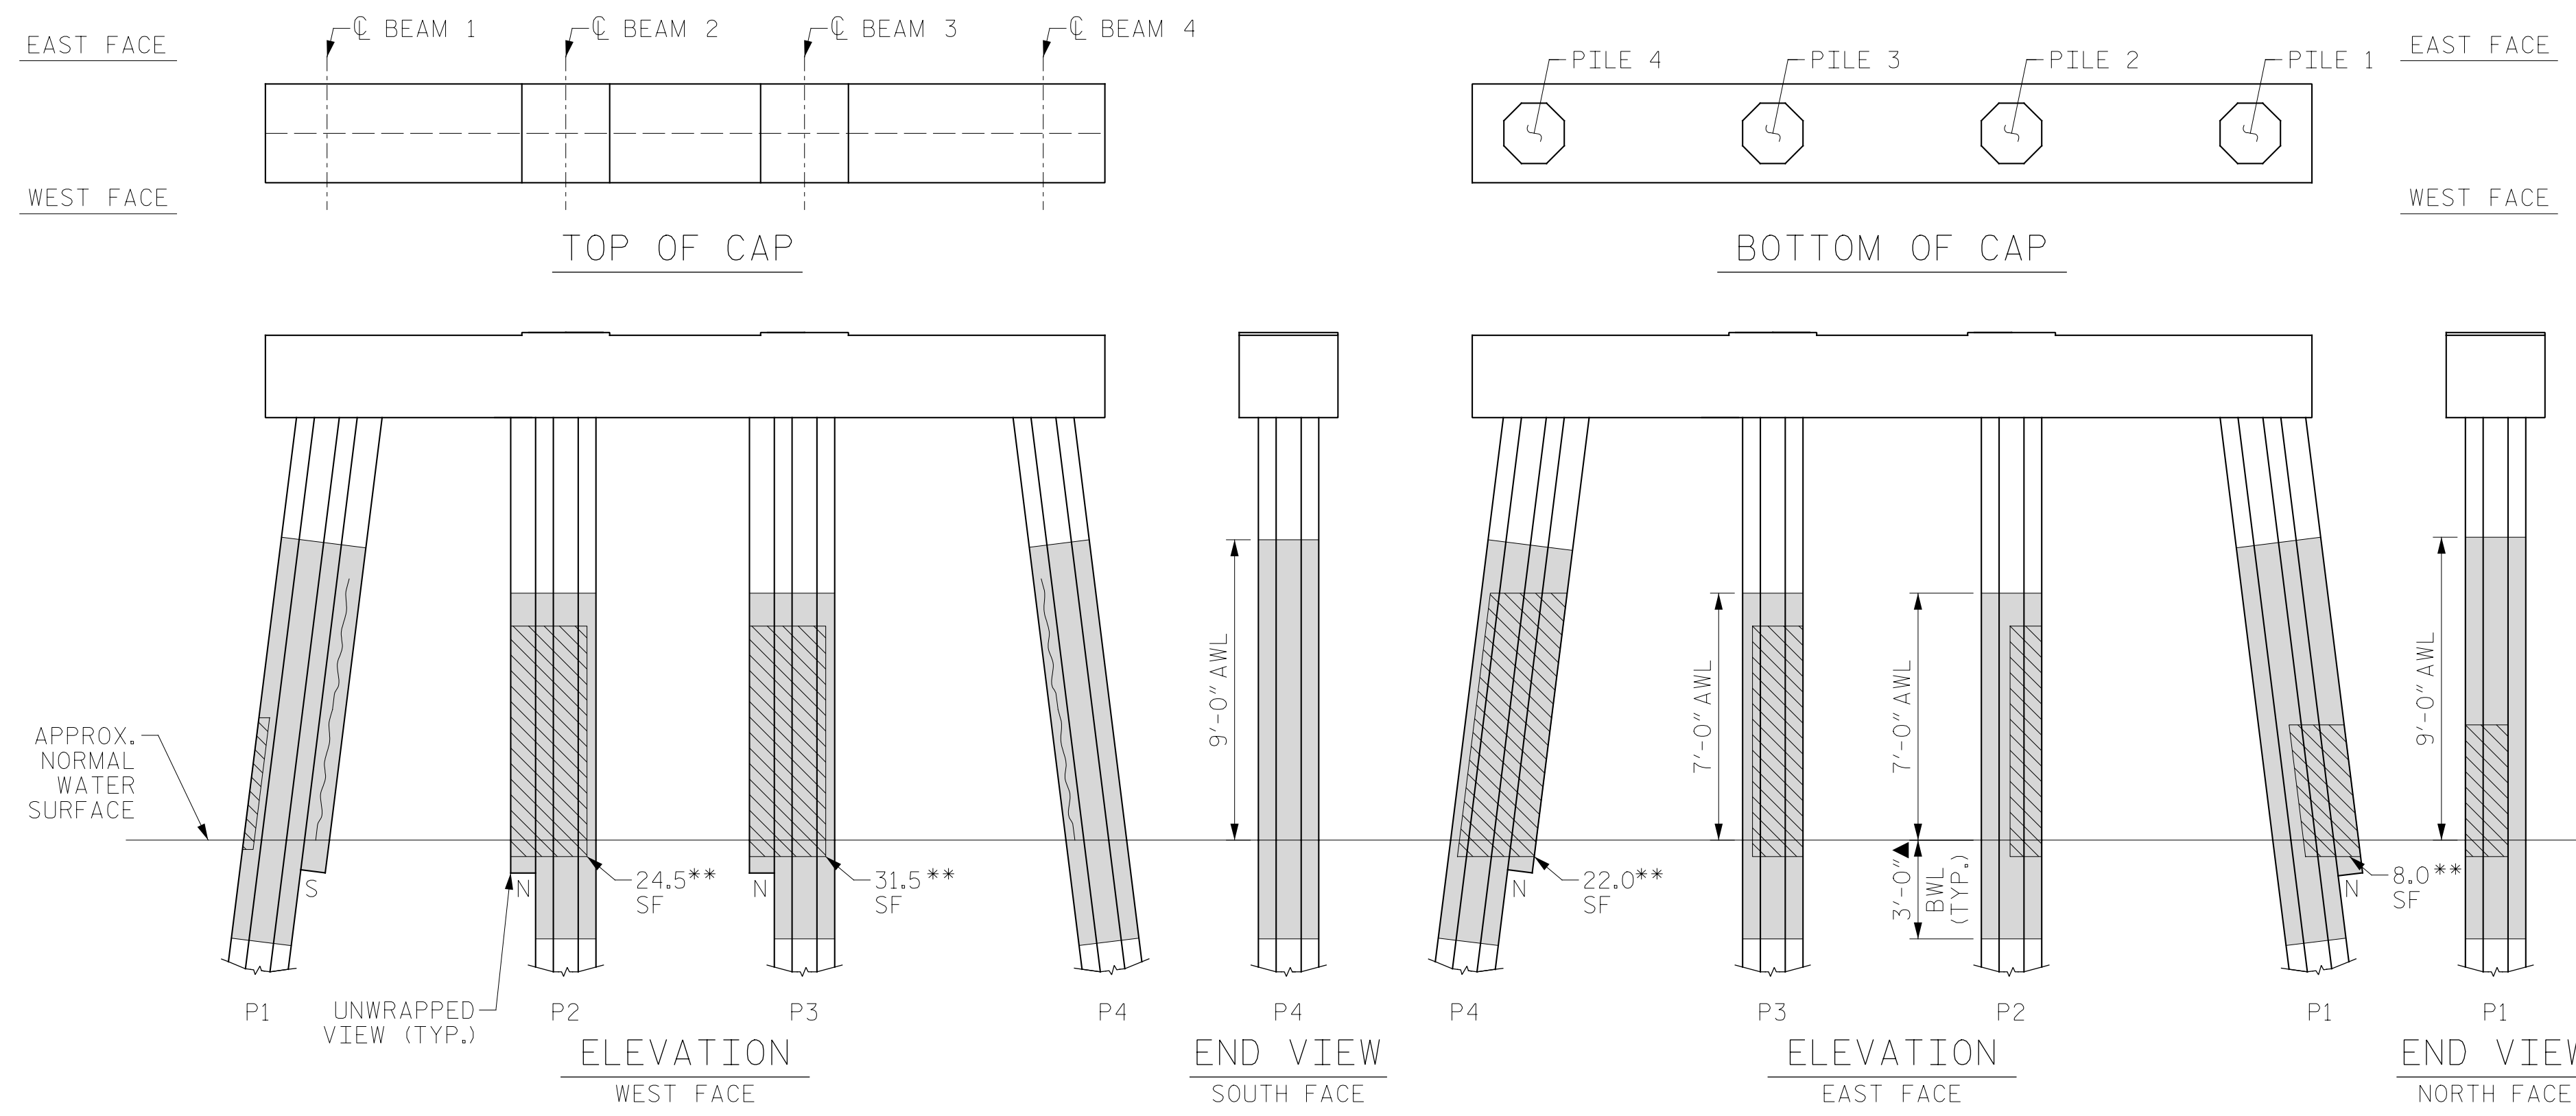
BENT 87

CAP REPAIRS			
SHOTCRETE REPAIRS	- SF	- CF	SF CF
EPOXY RESIN INJECTION	- LF		LF
PILE REPAIRS			
PILE CONCRETE RESTORATION	86.0 SF	33.1 CF	SF CF
FRP PROTECTIVE SYSTEM AWL	176.0 SF		
FRP PROTECTIVE SYSTEM BWL	66.0 SF

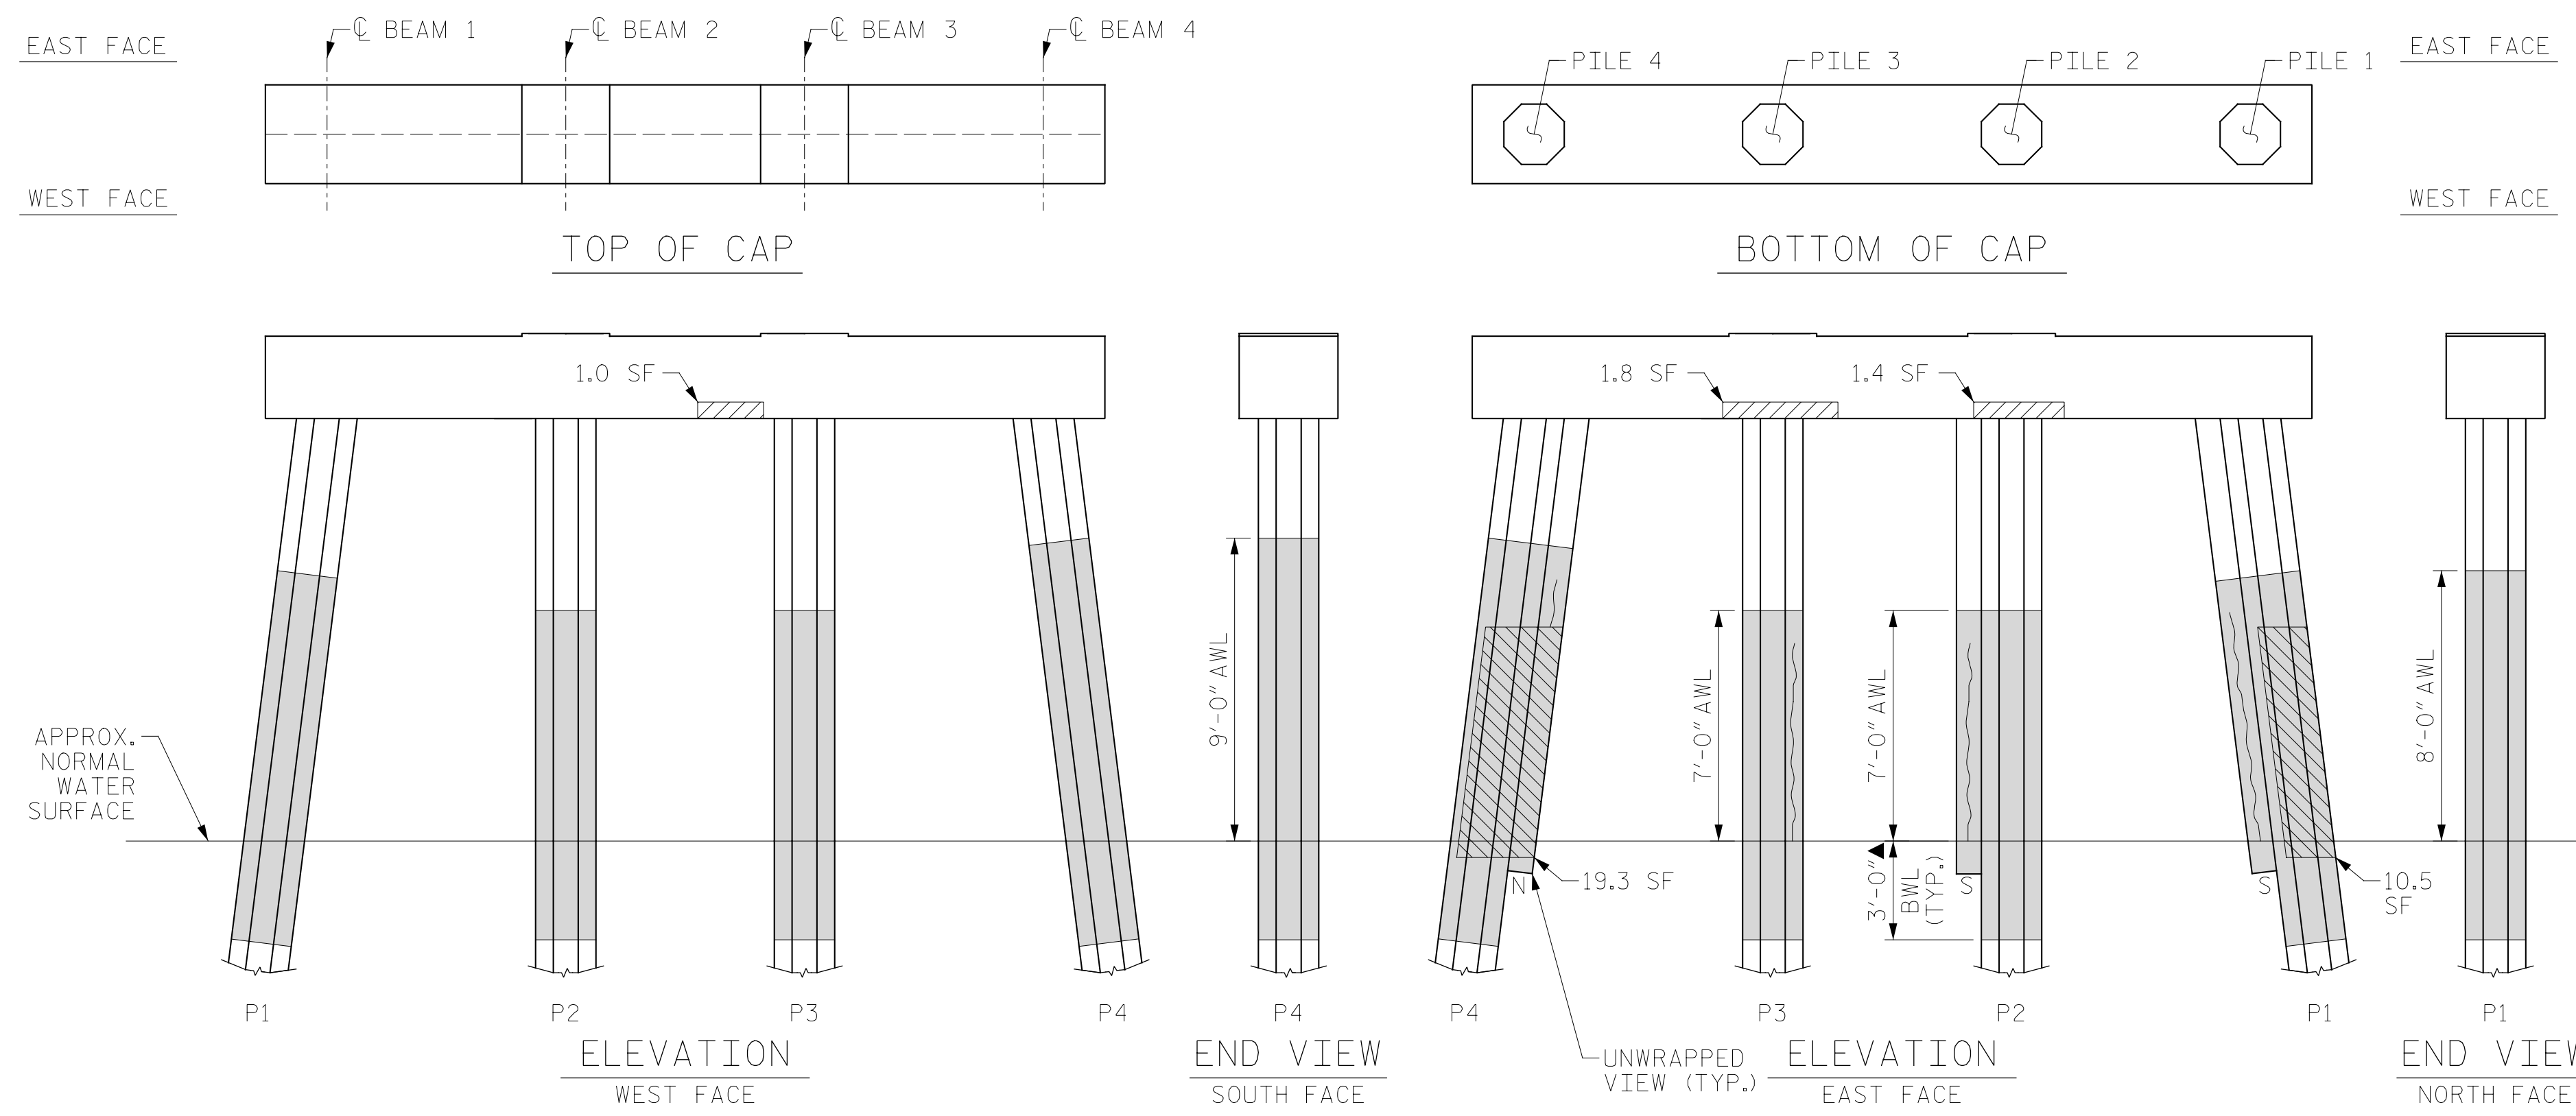
BENT 88

CAP REPAIRS			
SHOTCRETE REPAIRS	4.2 SF	2.1 CF	SF CF
EPOXY RESIN INJECTION	- LF		LF
PILE REPAIRS			
PILE CONCRETE RESTORATION	29.8 SF	12.2 CF	SF CF
FRP PROTECTIVE SYSTEM AWL	170.5 SF		
FRP PROTECTIVE SYSTEM BWL	66.0 SF
