AS-BUILT REPAIR QUANTITY TABLE

PROJECT NO. HB-0017
DARE COUNTY
BRIDGE NO. 270009

STATE OF NORTH CAROLINA
DEPARTMENT OF TRANSPORTATION
RALEIGH

BENT 89 & BENT 90

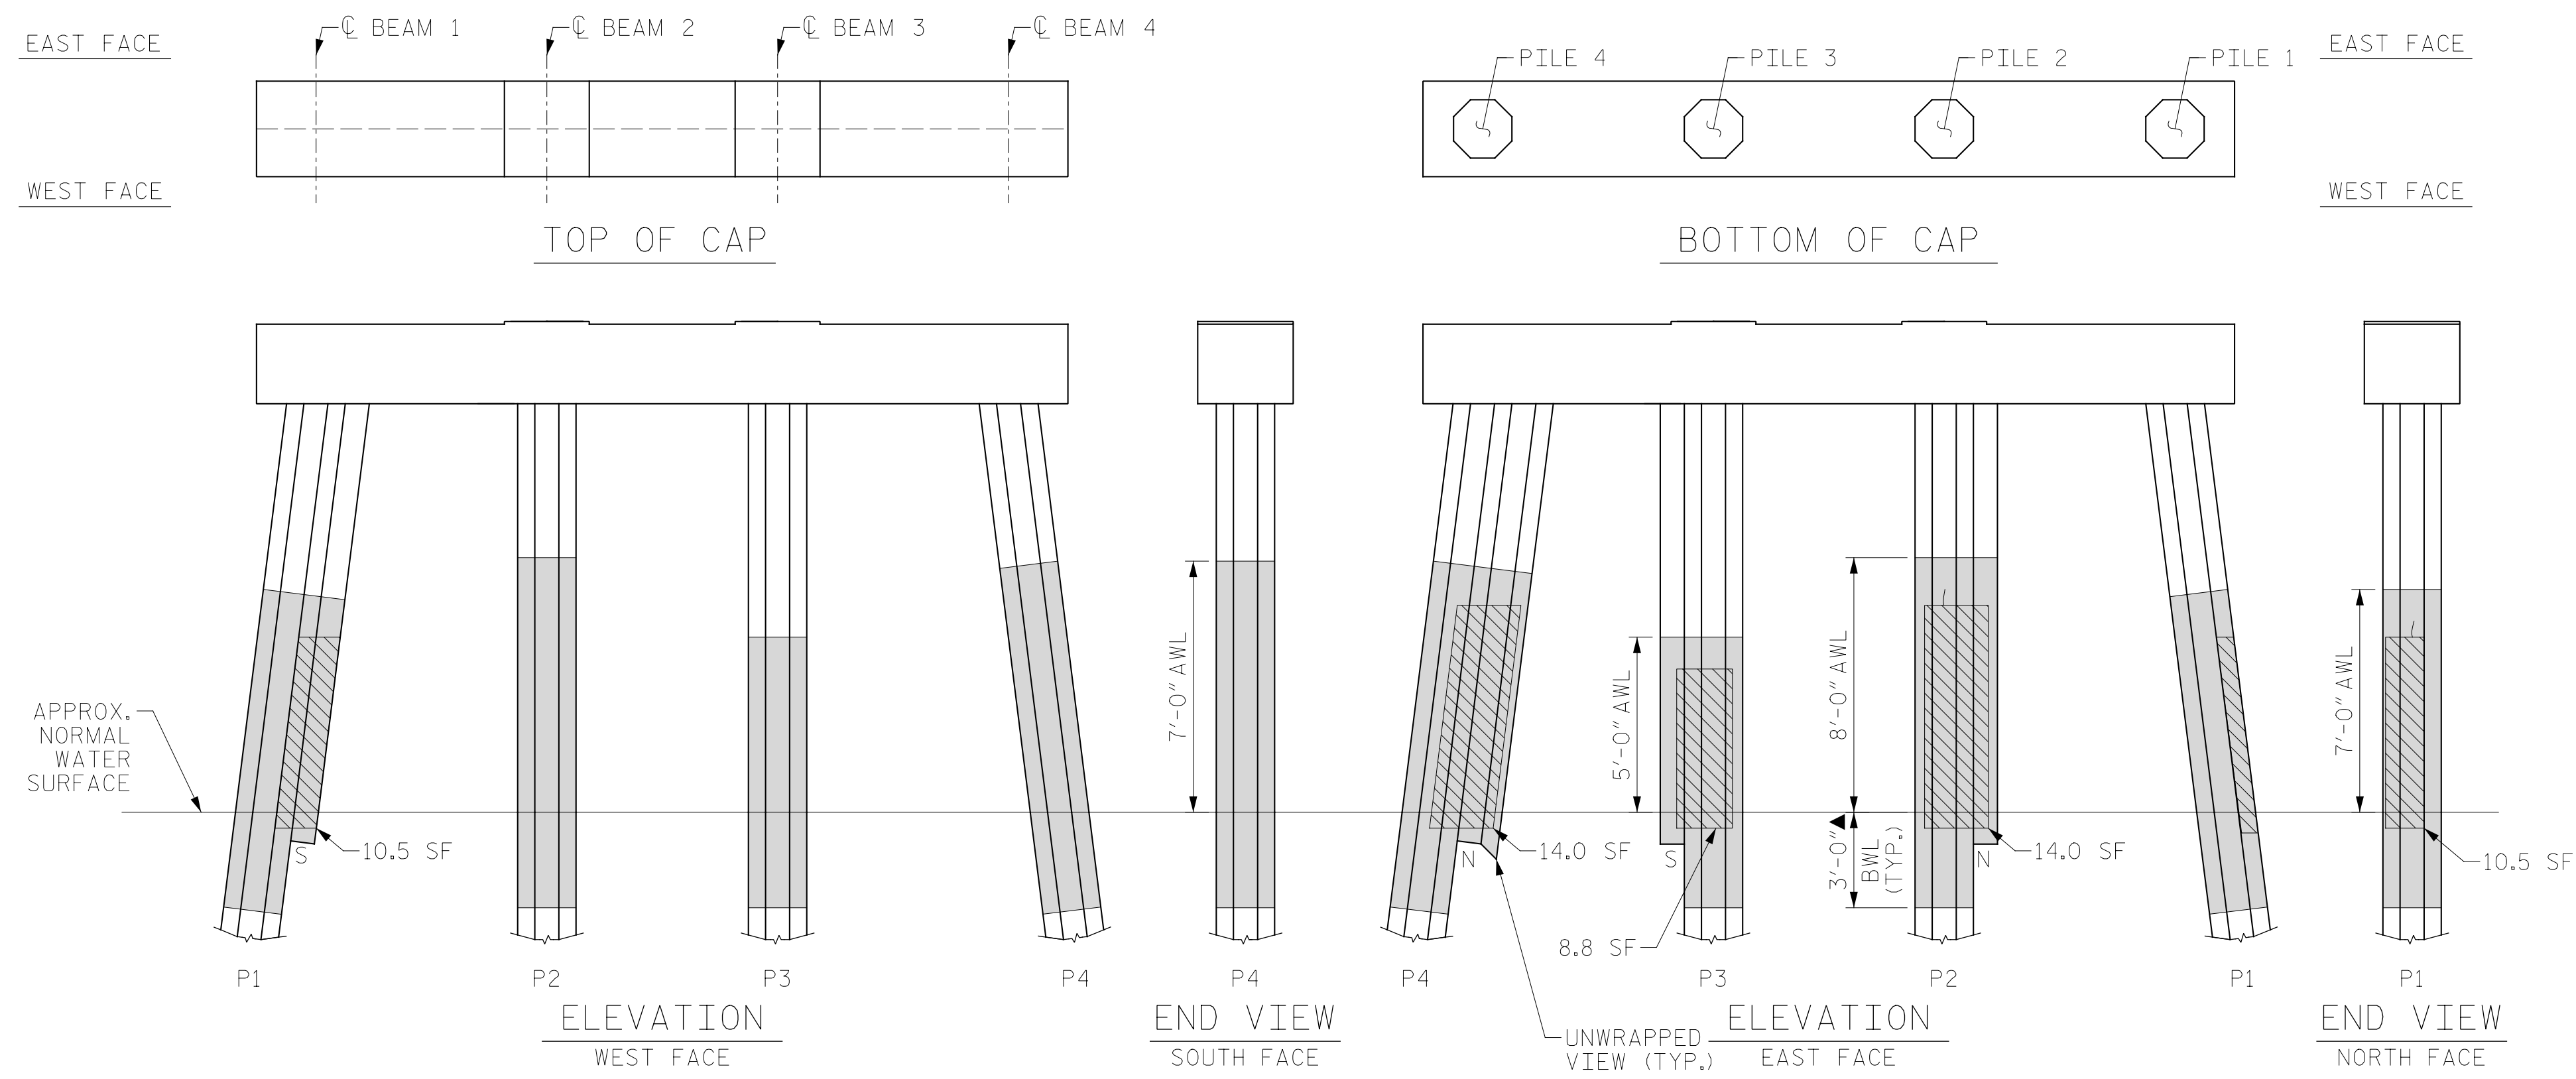
BENT 89

CAP REPAIRS			
SHOTCRETE REPAIRS	- SF	- CF	SF CF
EPOXY RESIN INJECTION	- LF		LF
PILE REPAIRS			
PILE CONCRETE RESTORATION	57.8 SF	23.4 CF	SF CF
FRP PROTECTIVE SYSTEM AWL	148.5 SF		
FRP PROTECTIVE SYSTEM BWL	66.0 SF

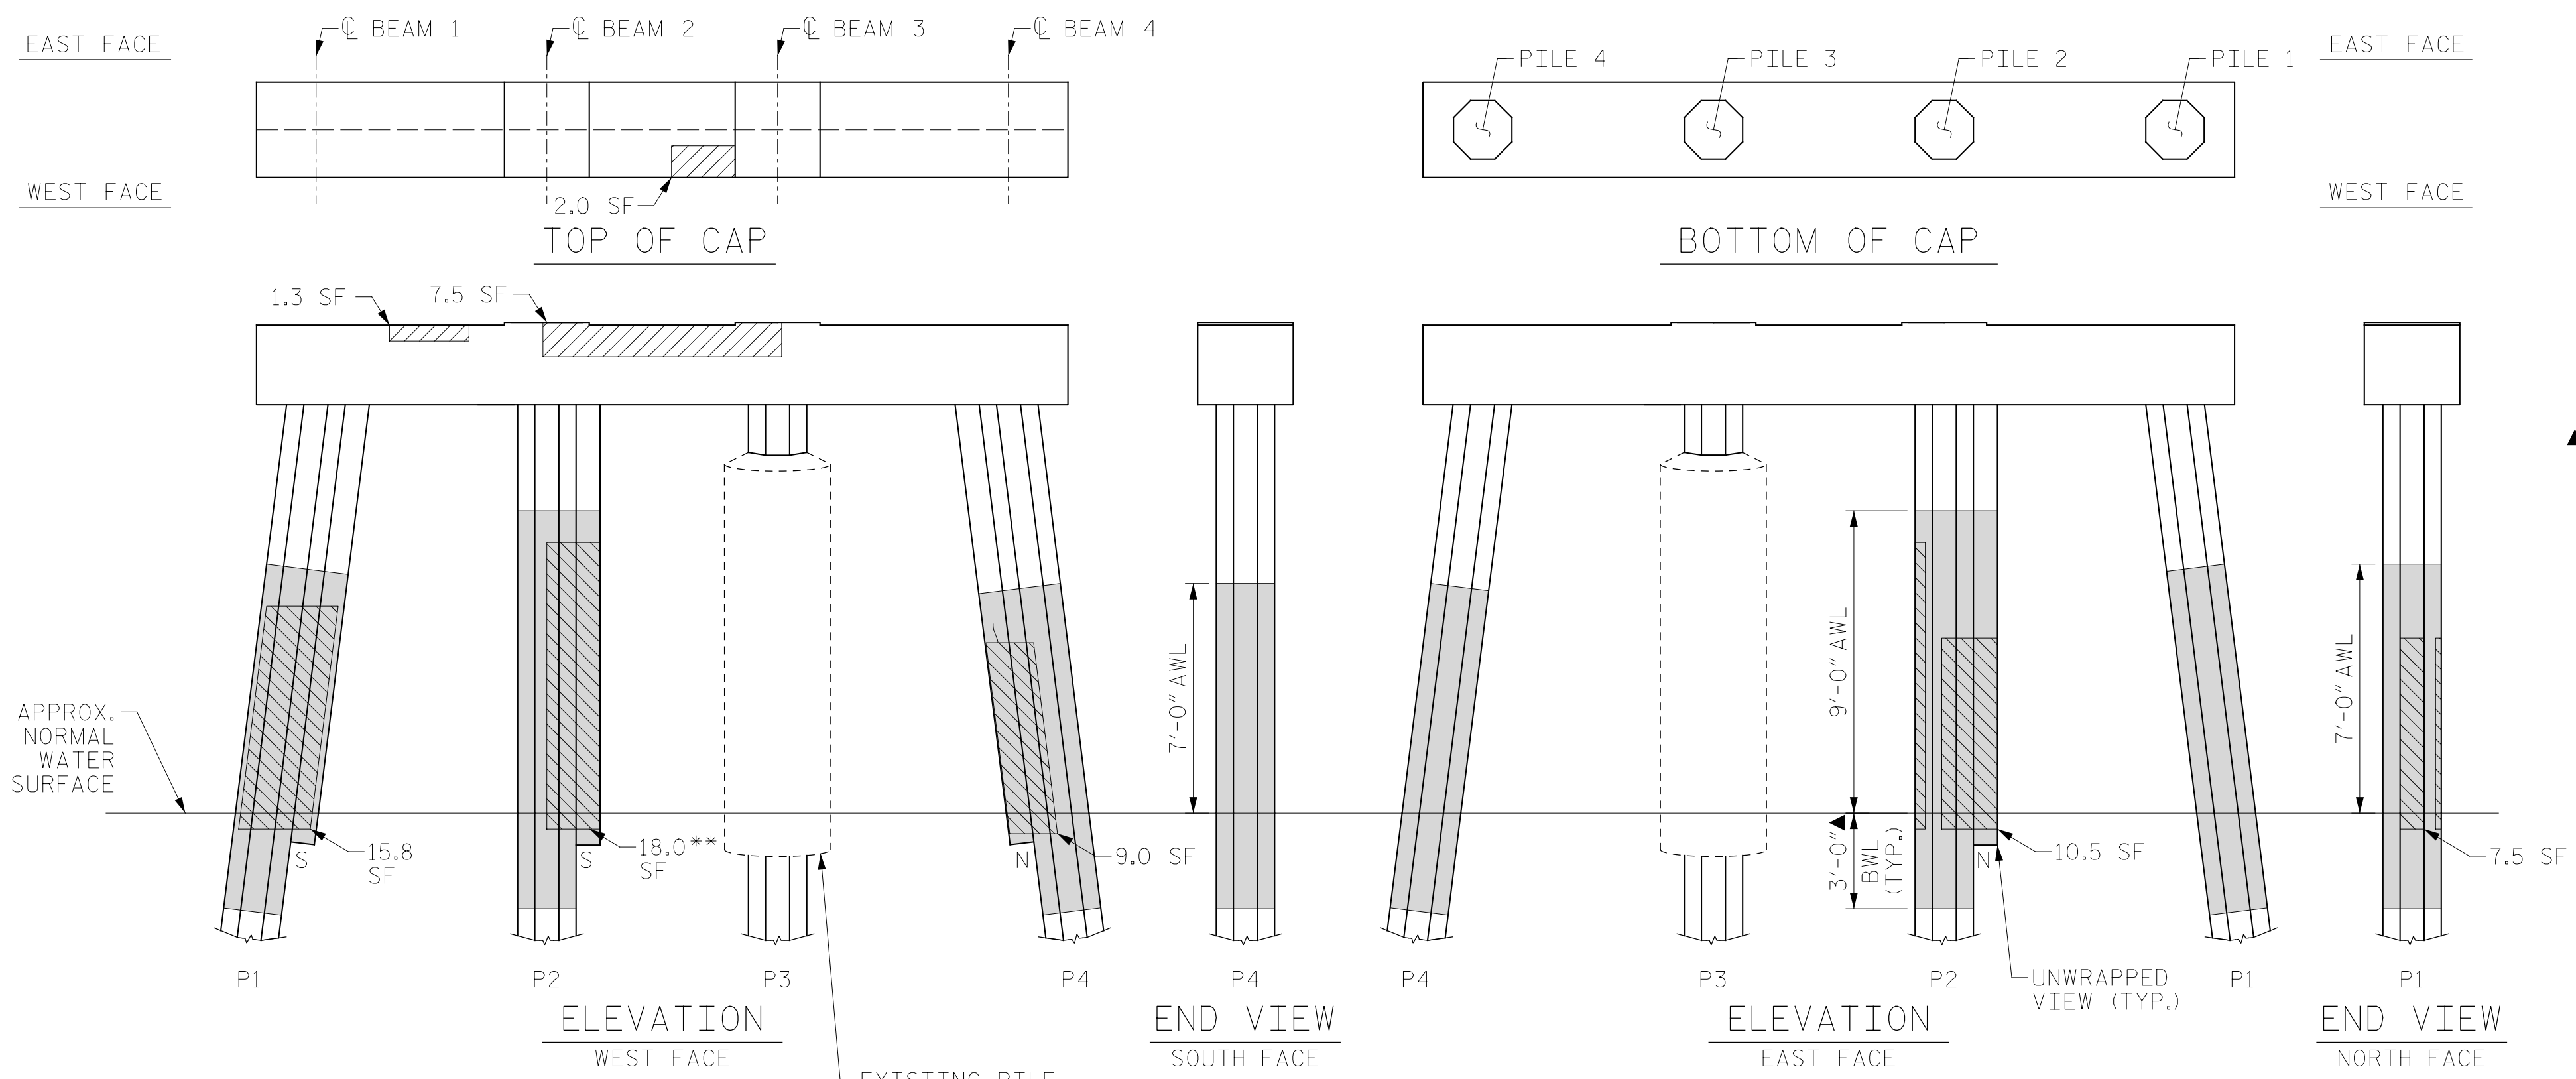
BENT 90

CAP REPAIRS			
SHOTCRETE REPAIRS	10.8 SF	5.4 CF	SF CF
EPOXY RESIN INJECTION	- LF		LF
PILE REPAIRS			
PILE CONCRETE RESTORATION	60.8 SF	25.1 CF	SF CF
FRP PROTECTIVE SYSTEM AWL	126.5 SF		
FRP PROTECTIVE SYSTEM BWL	49.5 SF
