AS-BUILT REPAIR QUANTITY TABLE

PROJECT NO. HB-0017
DARE COUNTY
 BRIDGE NO. 270009

STATE OF NORTH CAROLINA
 DEPARTMENT OF TRANSPORTATION
 RALEIGH

BENT 93 & BENT 94

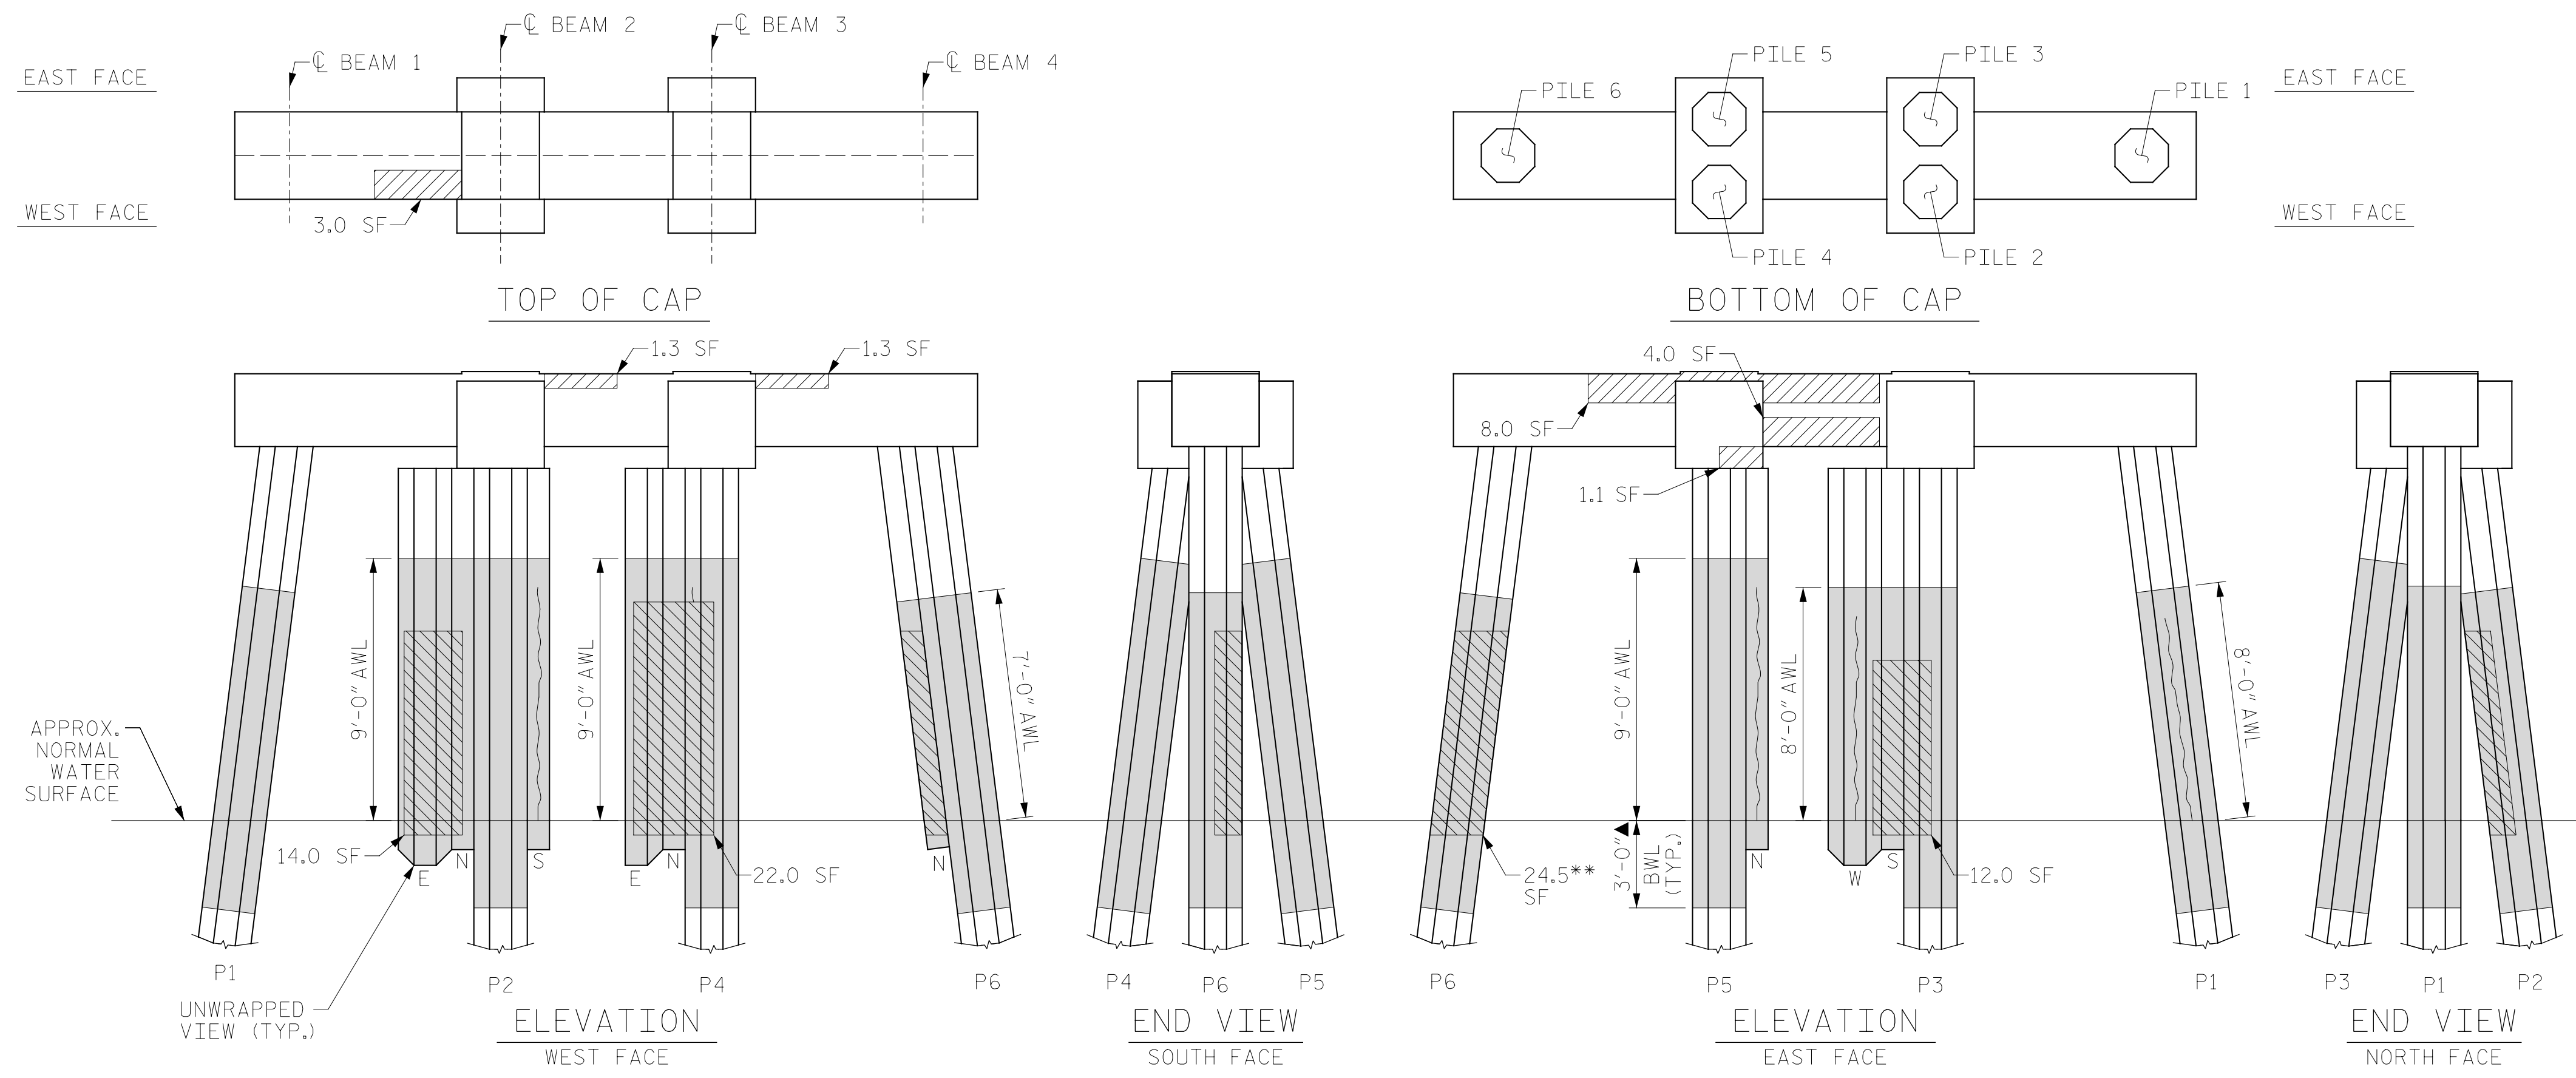
BENT 93

CAP REPAIRS			
SHOTCRETE REPAIRS	18.7 SF	9.4 CF	SF CF
EPOXY RESIN INJECTION	- LF		LF
PILE REPAIRS			
PILE CONCRETE RESTORATION	72.5 SF	28.0 CF	SF CF
FRP PROTECTIVE SYSTEM AWL	275.0 SF		
FRP PROTECTIVE SYSTEM BWL	99.0 SF

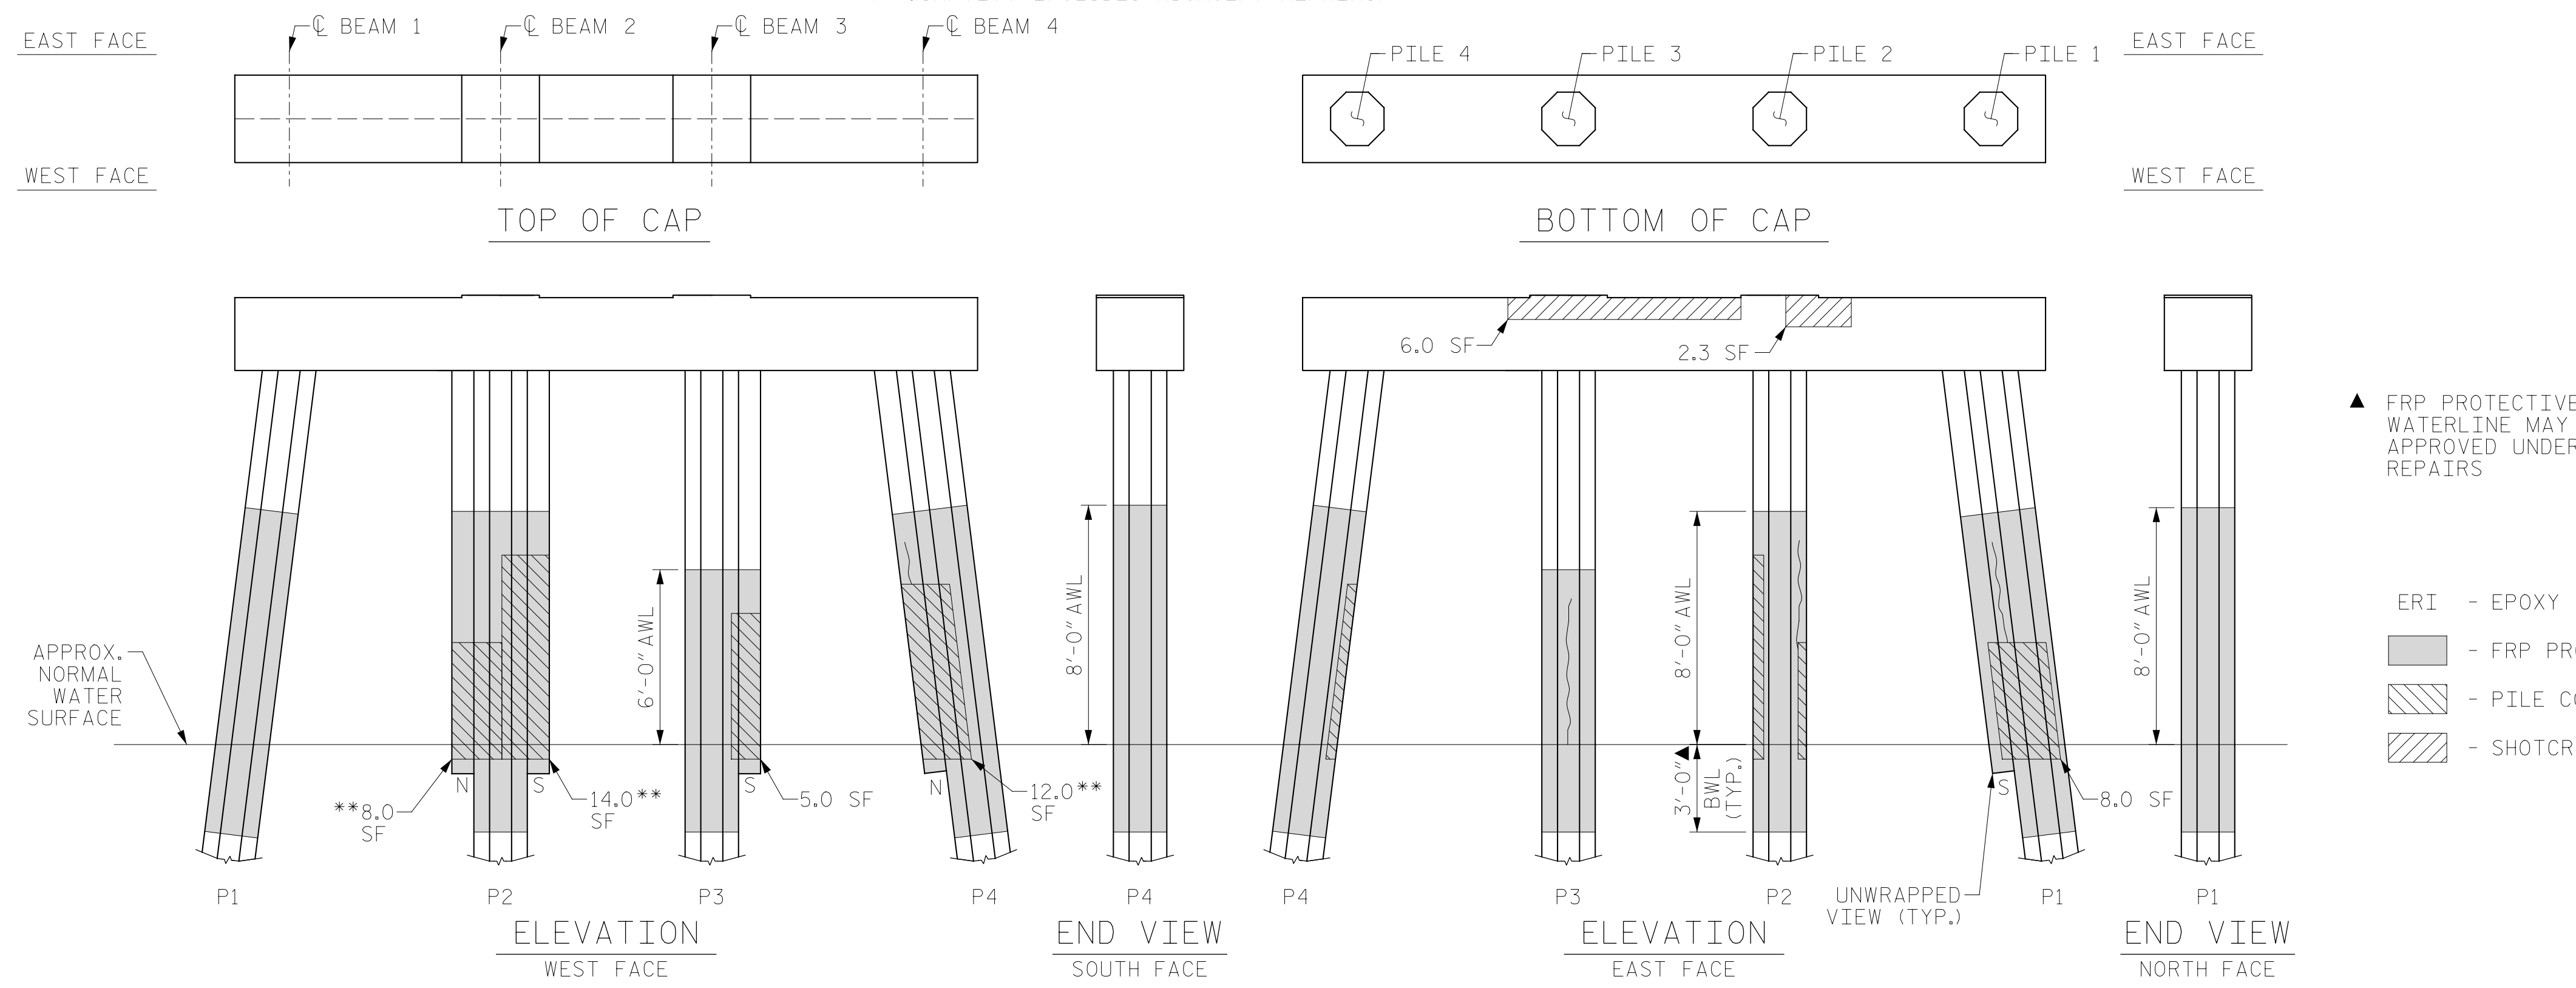
BENT 94

CAP REPAIRS			
SHOTCRETE REPAIRS	8.3 SF	4.1 CF	SF CF
EPOXY RESIN INJECTION	- LF		LF
PILE REPAIRS			
PILE CONCRETE RESTORATION	47.0 SF	18.6 CF	SF CF
FRP PROTECTIVE SYSTEM AWL	165.0 SF		
FRP PROTECTIVE SYSTEM BWL	66.0 SF
