AS-BUILT REPAIR QUANTITY TABLE

PROJECT NO. HB-0017  
DARE COUNTY  
BRIDGE NO. 270009

STATE OF NORTH CAROLINA  
DEPARTMENT OF TRANSPORTATION  
RALEIGH  
BENT 95 & BENT 96

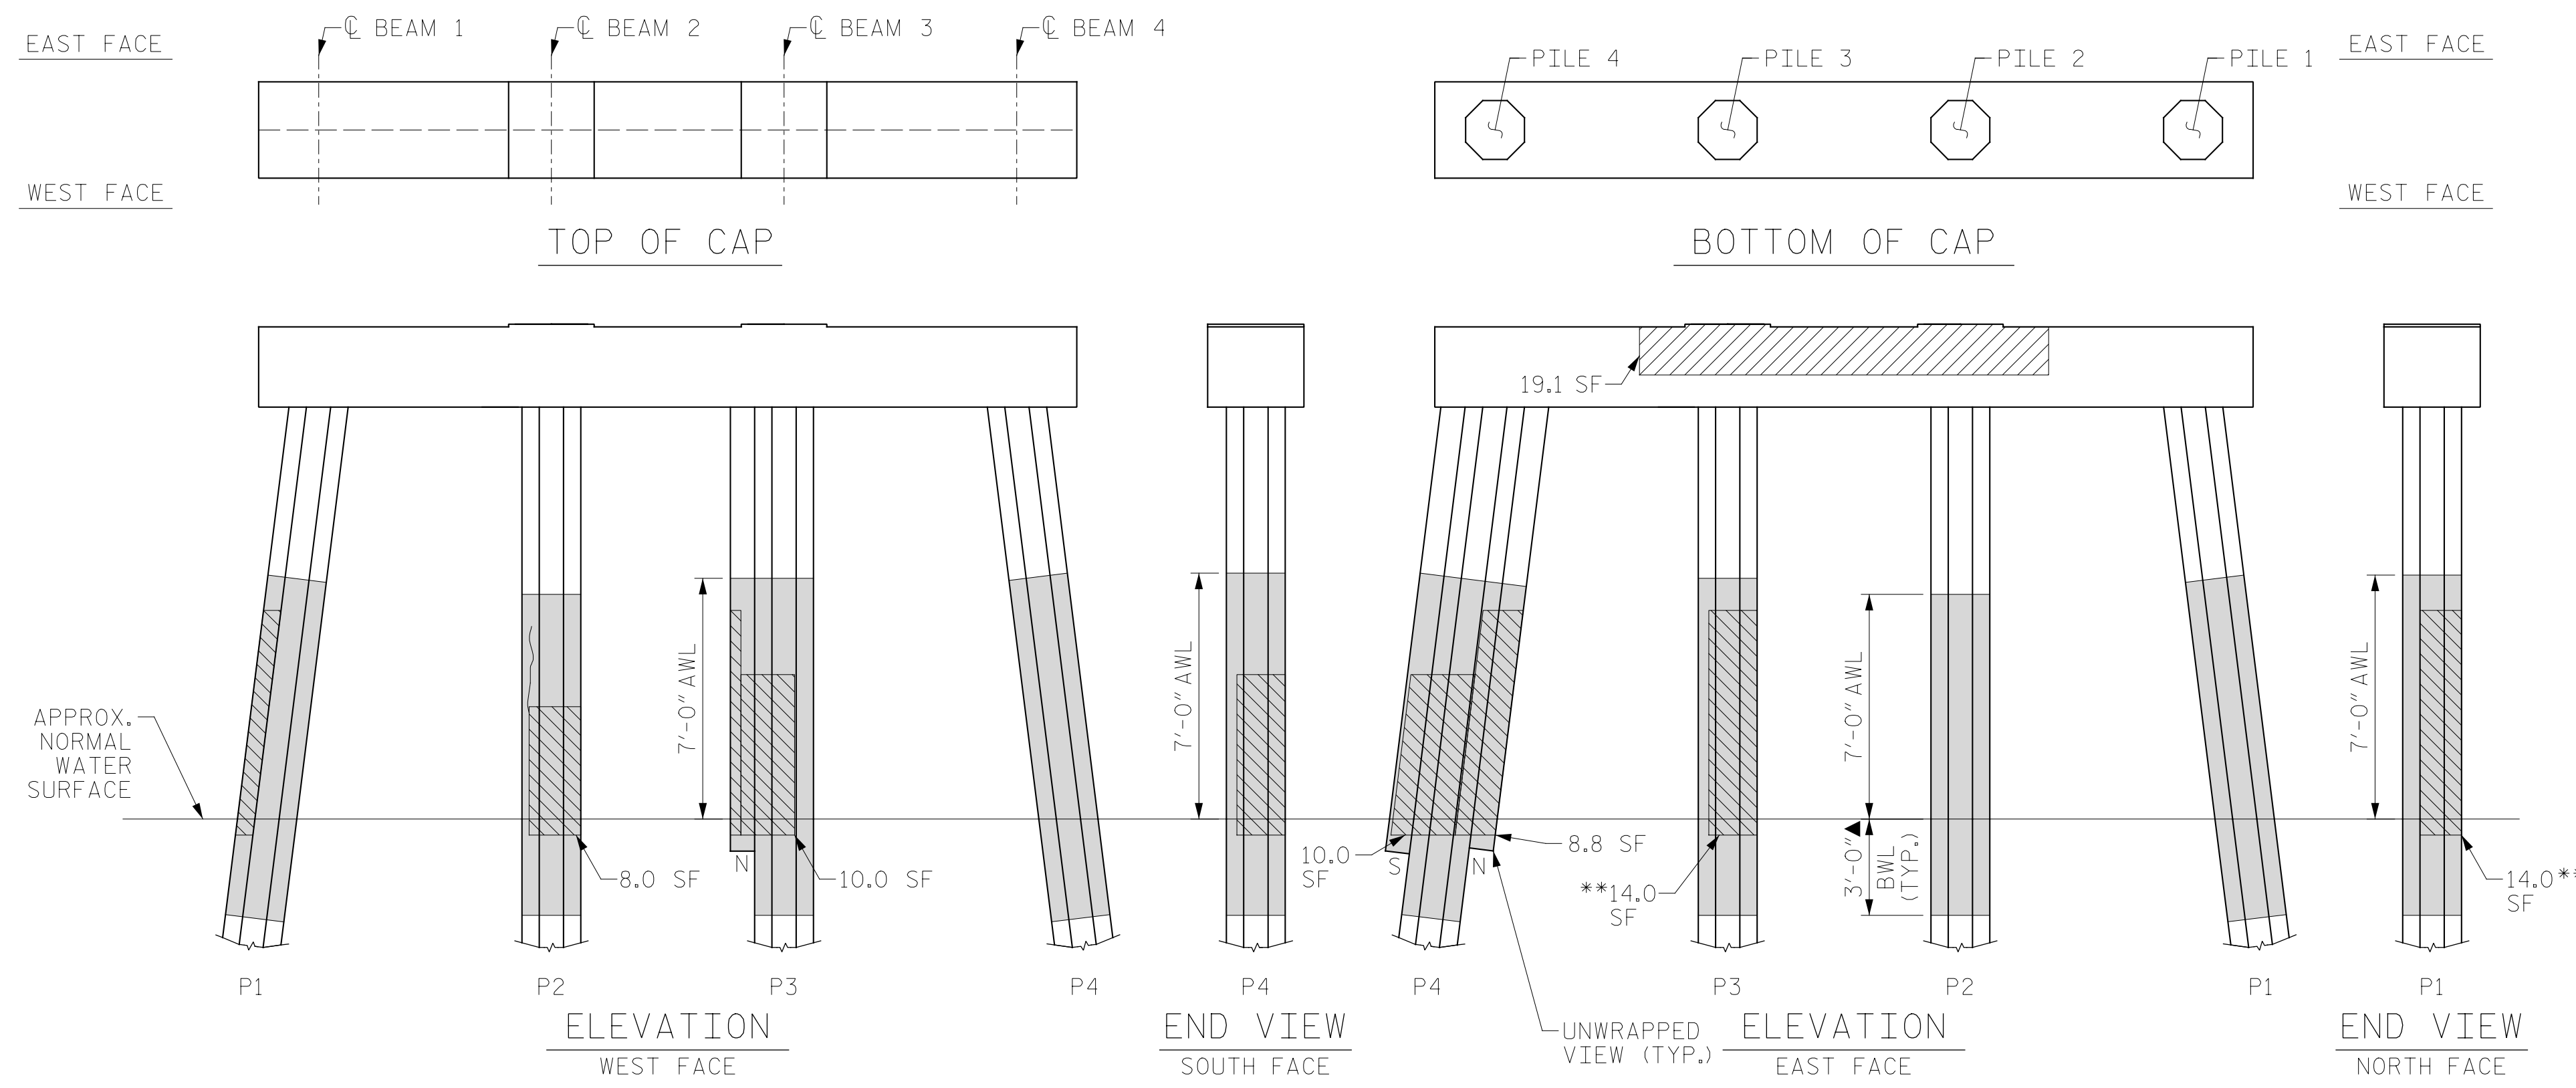
BENT 95

CAP REPAIRS			
SHOTCRETE REPAIRS	19.1 SF	9.6 CF	SF CF
EPOXY RESIN INJECTION	- LF		LF
PILE REPAIRS			
PILE CONCRETE RESTORATION	64.8 SF	25.8 CF	SF CF
FRP PROTECTIVE SYSTEM AWL	154.0 SF		
FRP PROTECTIVE SYSTEM BWL	66.0 SF

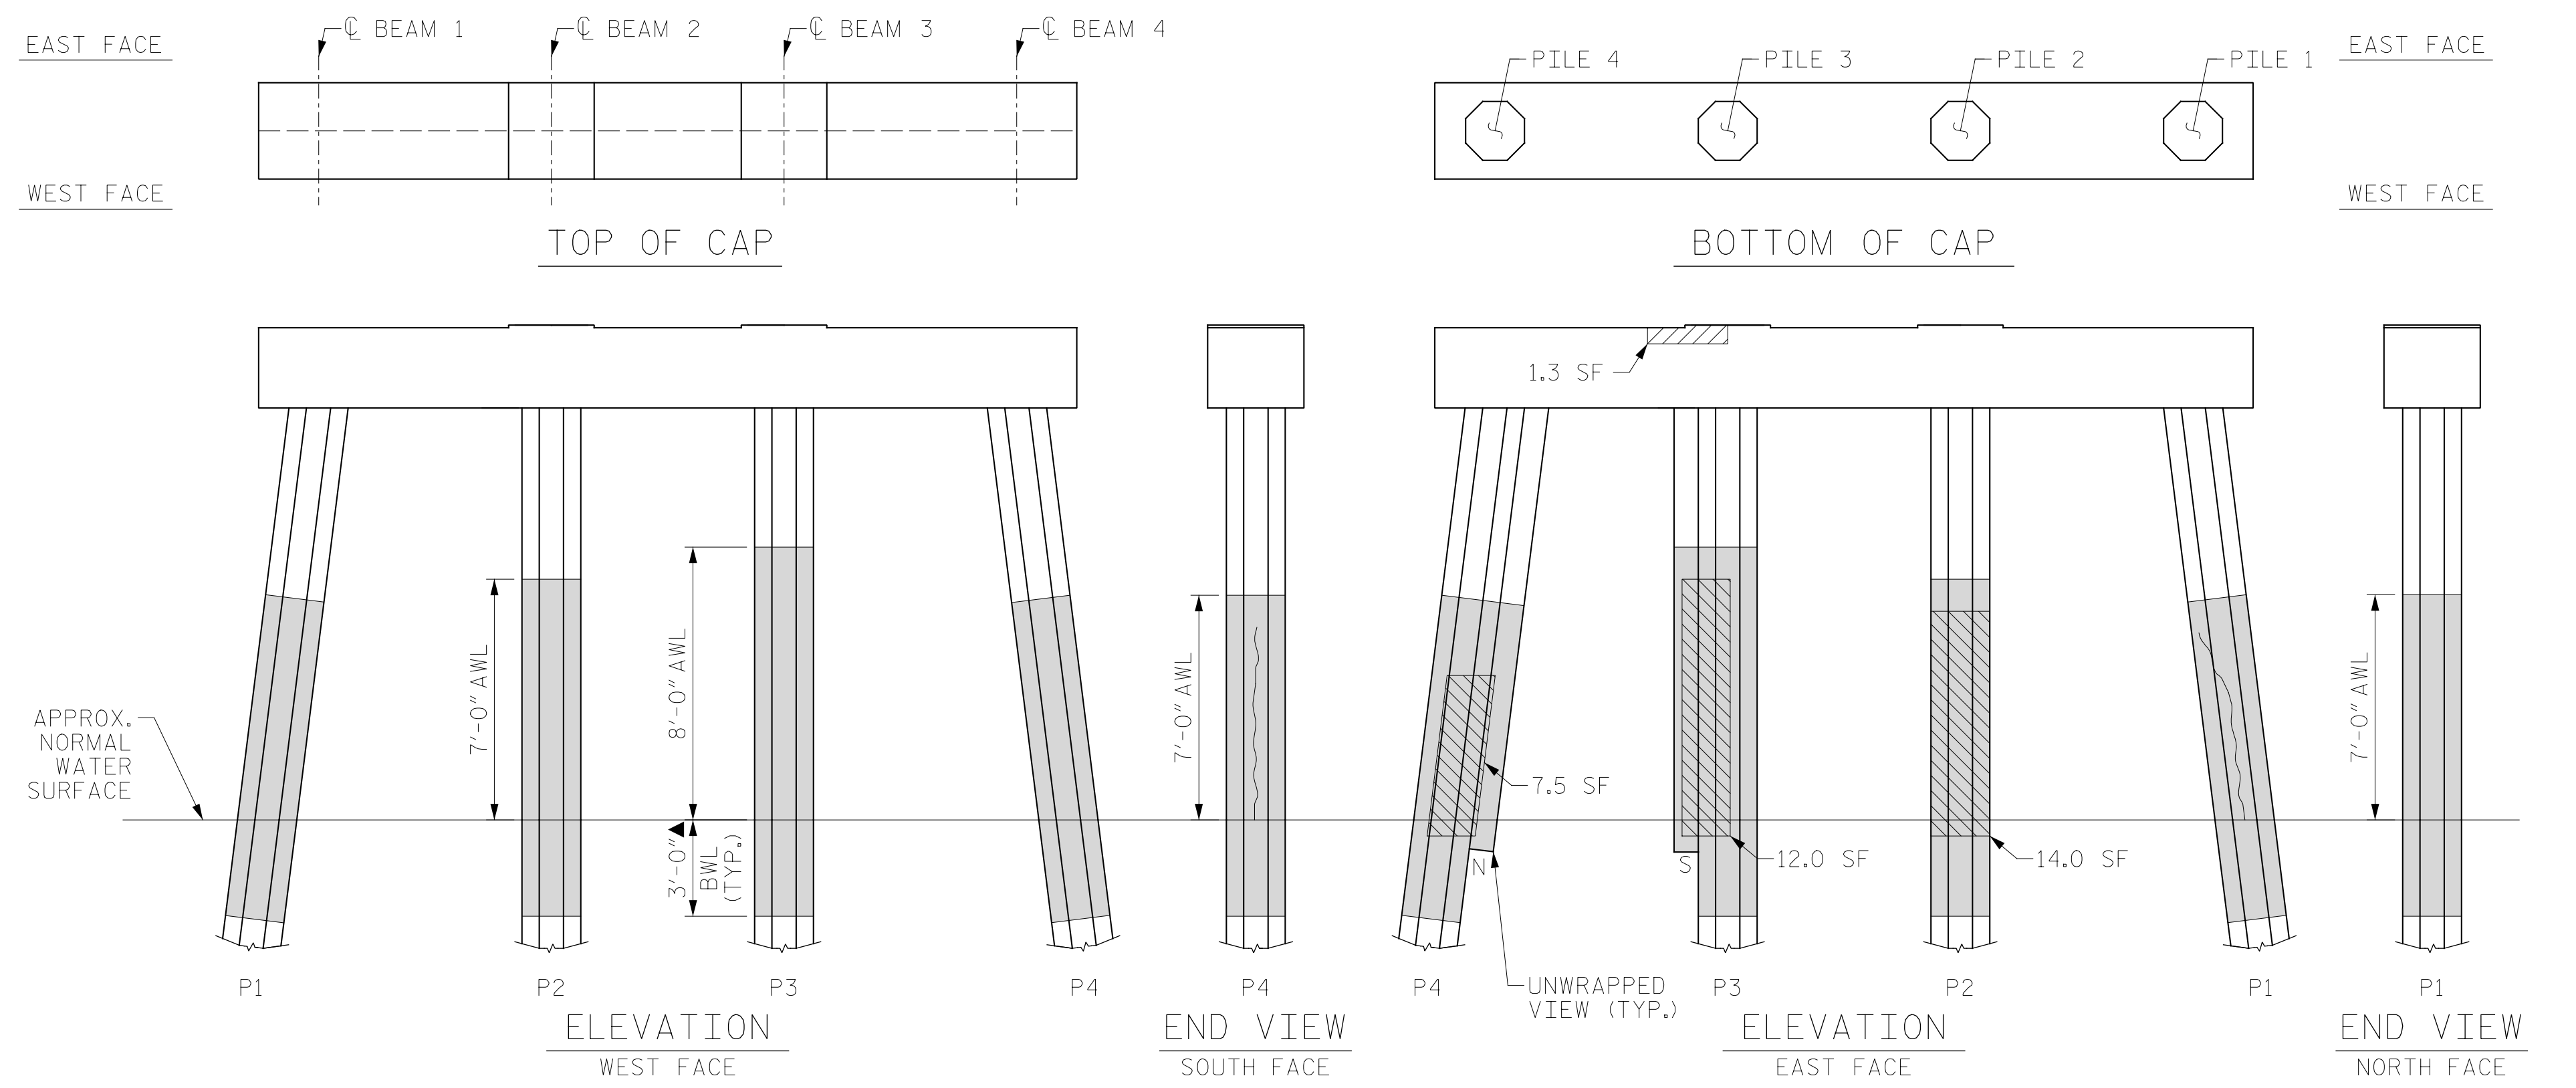
BENT 96

CAP REPAIRS			
SHOTCRETE REPAIRS	1.3 SF	0.7 CF	SF CF
EPOXY RESIN INJECTION	- LF		LF
PILE REPAIRS			
PILE CONCRETE RESTORATION	33.5 SF	14.1 CF	SF CF
FRP PROTECTIVE SYSTEM AWL	159.5 SF		
FRP PROTECTIVE SYSTEM BWL	66.0 SF
