AS-BUILT REPAIR QUANTITY TABLE

NOTE: FOR INFORMATION ON PILE CONDITION ONLY.
PROJECT NO. HB-0017
DARE COUNTY
BRIDGE NO. 270009

STATE OF NORTH CAROLINA
DEPARTMENT OF TRANSPORTATION
RALEIGH
BENT 97 & BENT 98

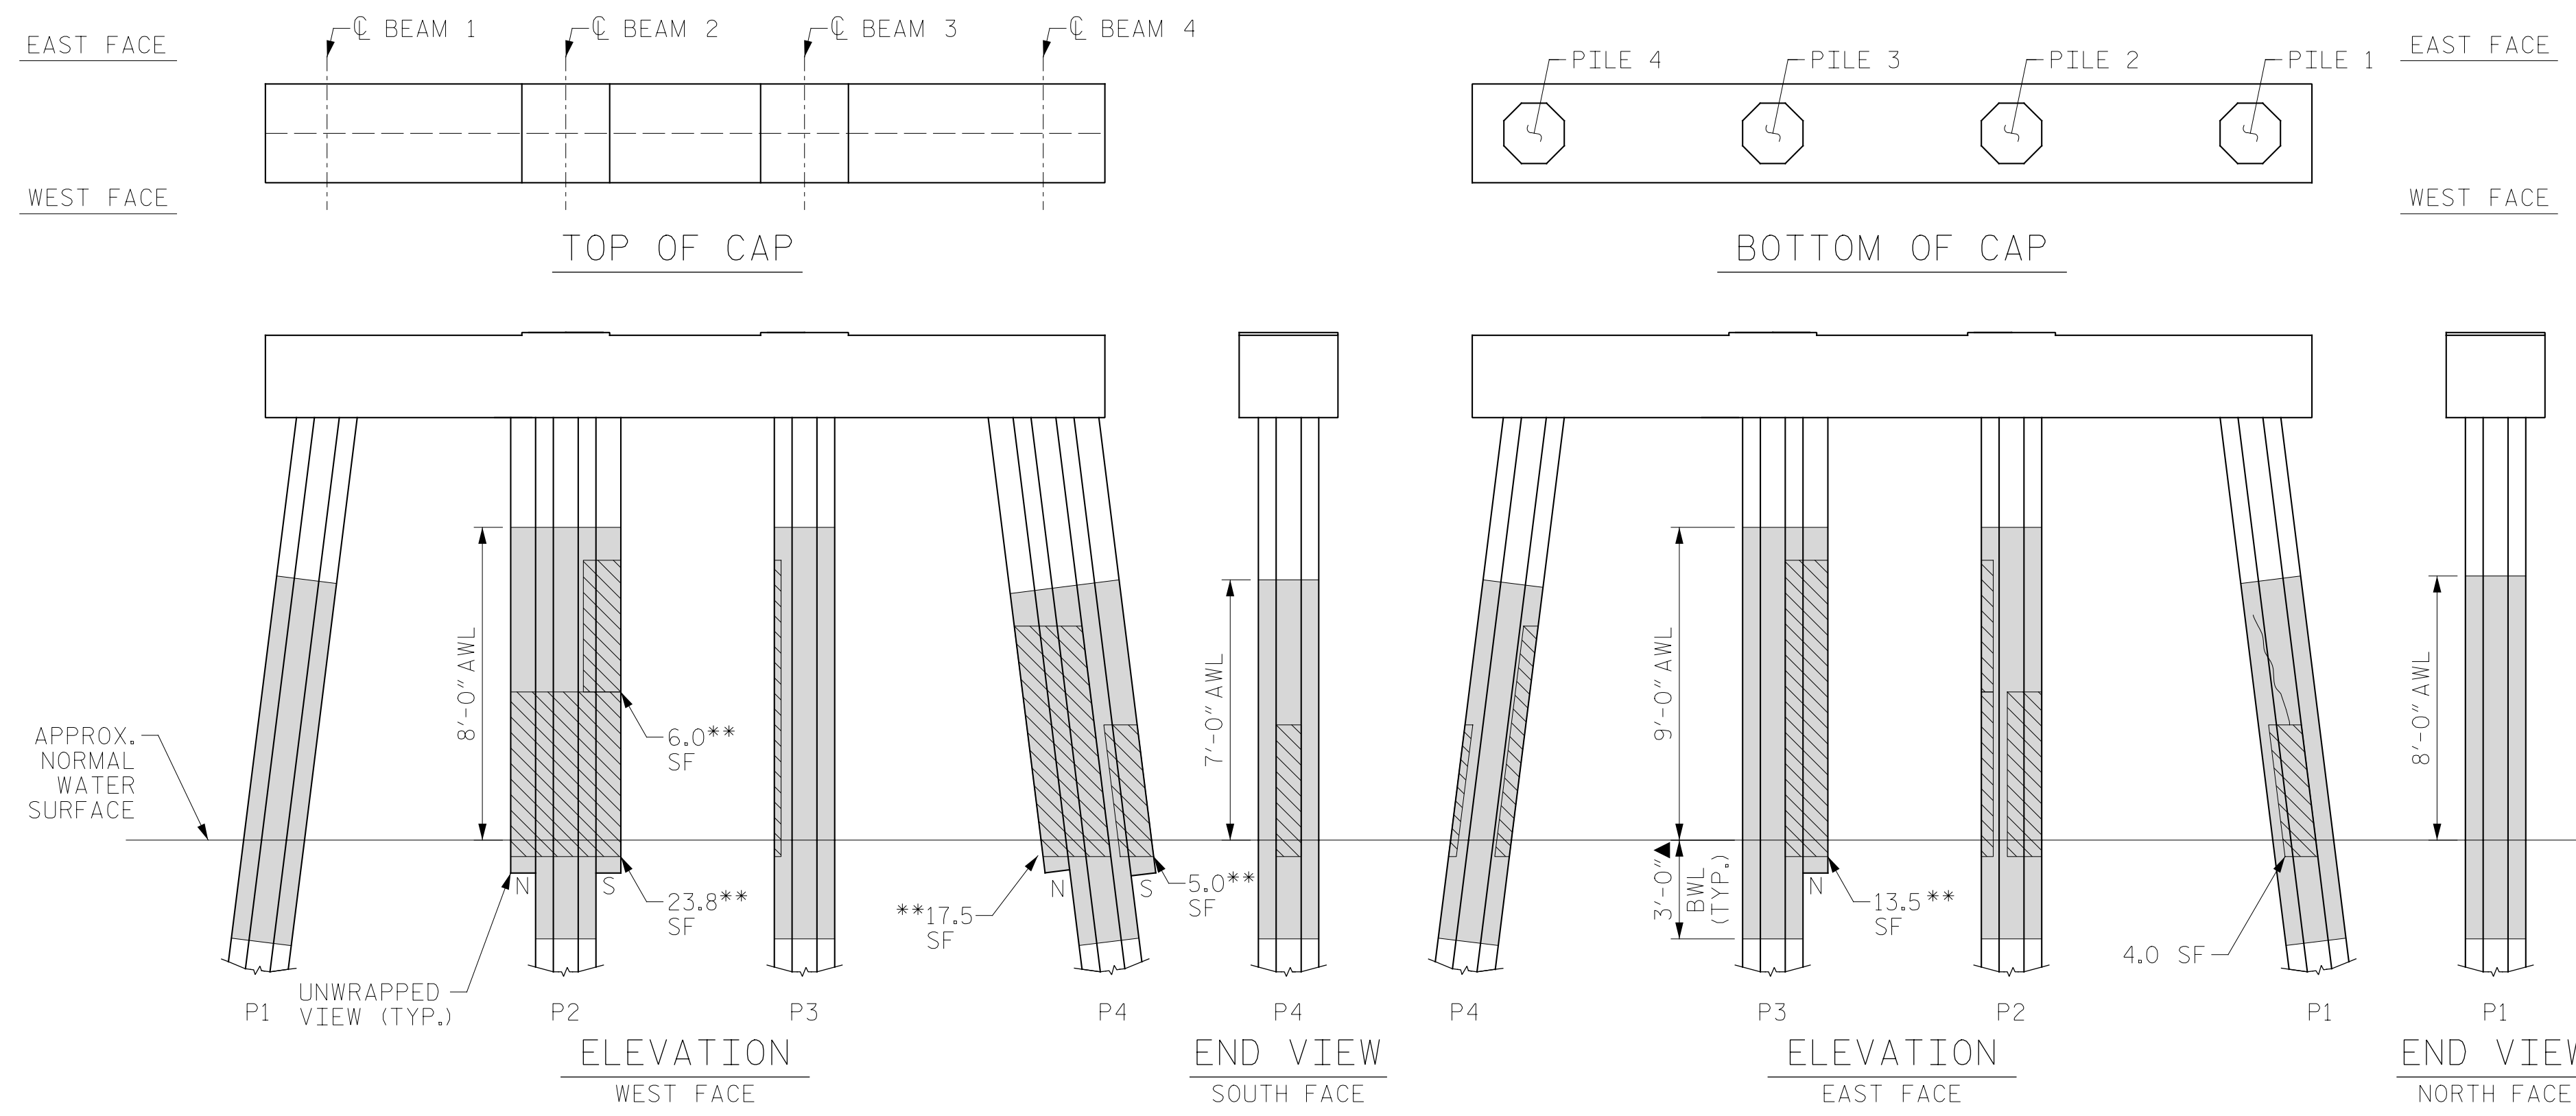
BENT 97

CAP REPAIRS			
SHOTCRETE REPAIRS	- SF	- CF	SF CF
EPOXY RESIN INJECTION	- LF		LF
PILE REPAIRS			
PILE CONCRETE RESTORATION	69.8 SF	28.1 CF	SF CF
FRP PROTECTIVE SYSTEM AWL	176.0 SF		
FRP PROTECTIVE SYSTEM BWL	66.0 SF

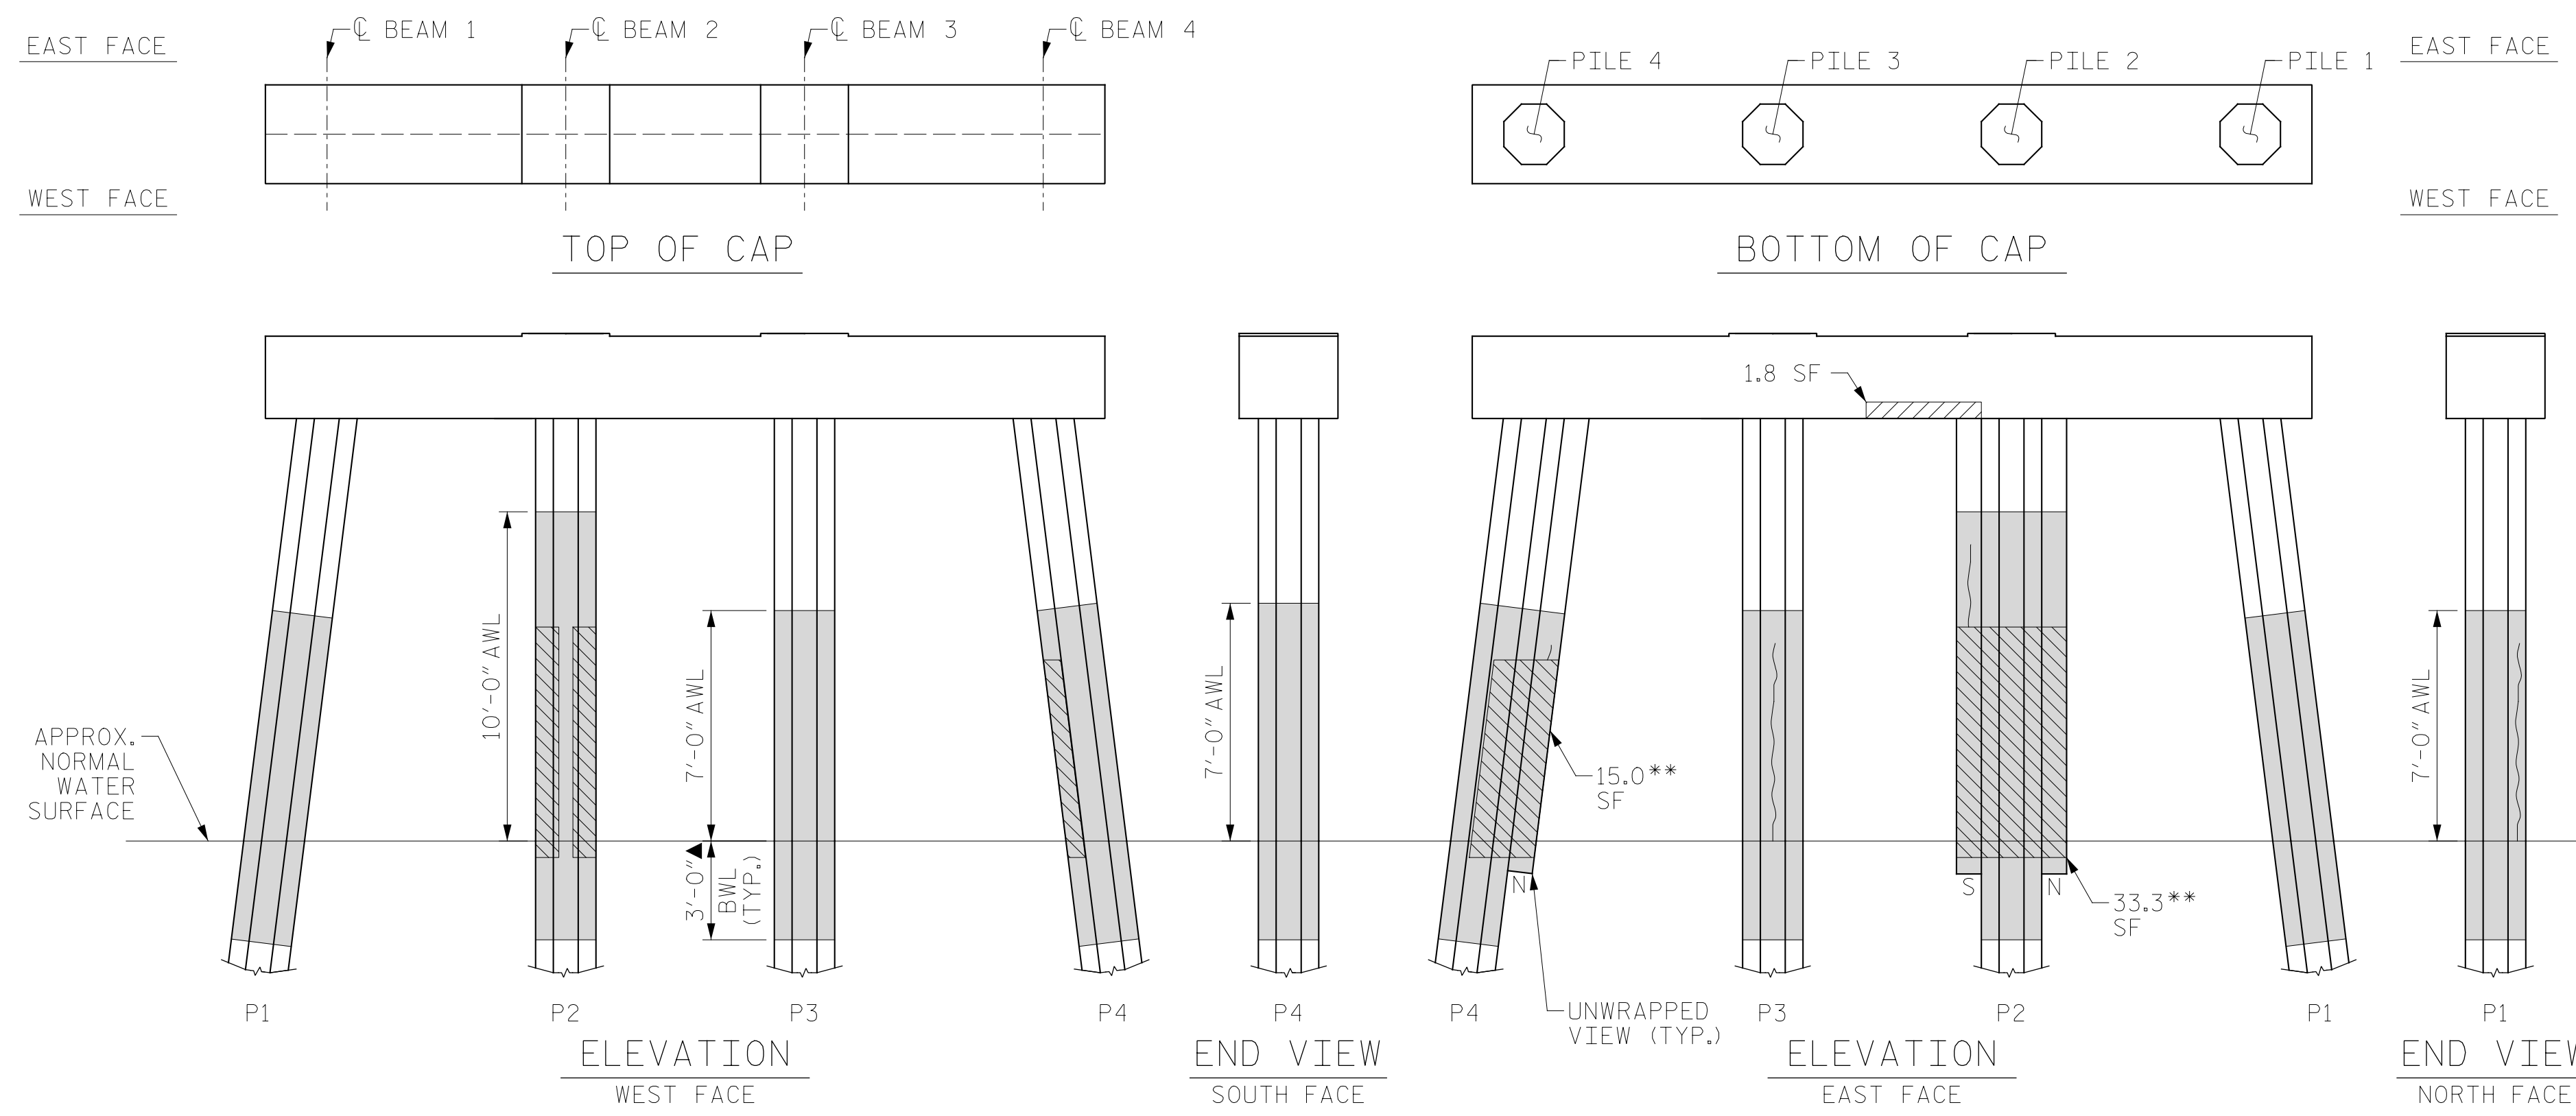
BENT 98

CAP REPAIRS			
SHOTCRETE REPAIRS	1.8 SF	0.9 CF	SF CF
EPOXY RESIN INJECTION	- LF		LF
PILE REPAIRS			
PILE CONCRETE RESTORATION	48.3 SF	18.4 CF	SF CF
FRP PROTECTIVE SYSTEM AWL	170.5 SF		
FRP PROTECTIVE SYSTEM BWL	66.0 SF
