AS-BUILT REPAIR QUANTITY TABLE

NOTE: FOR INFORMATION ON PILE CONDITION ONLY.
PROJECT NO. HB-0017
DARE COUNTY
BRIDGE NO. 270009

BENT 101 & BENT 102

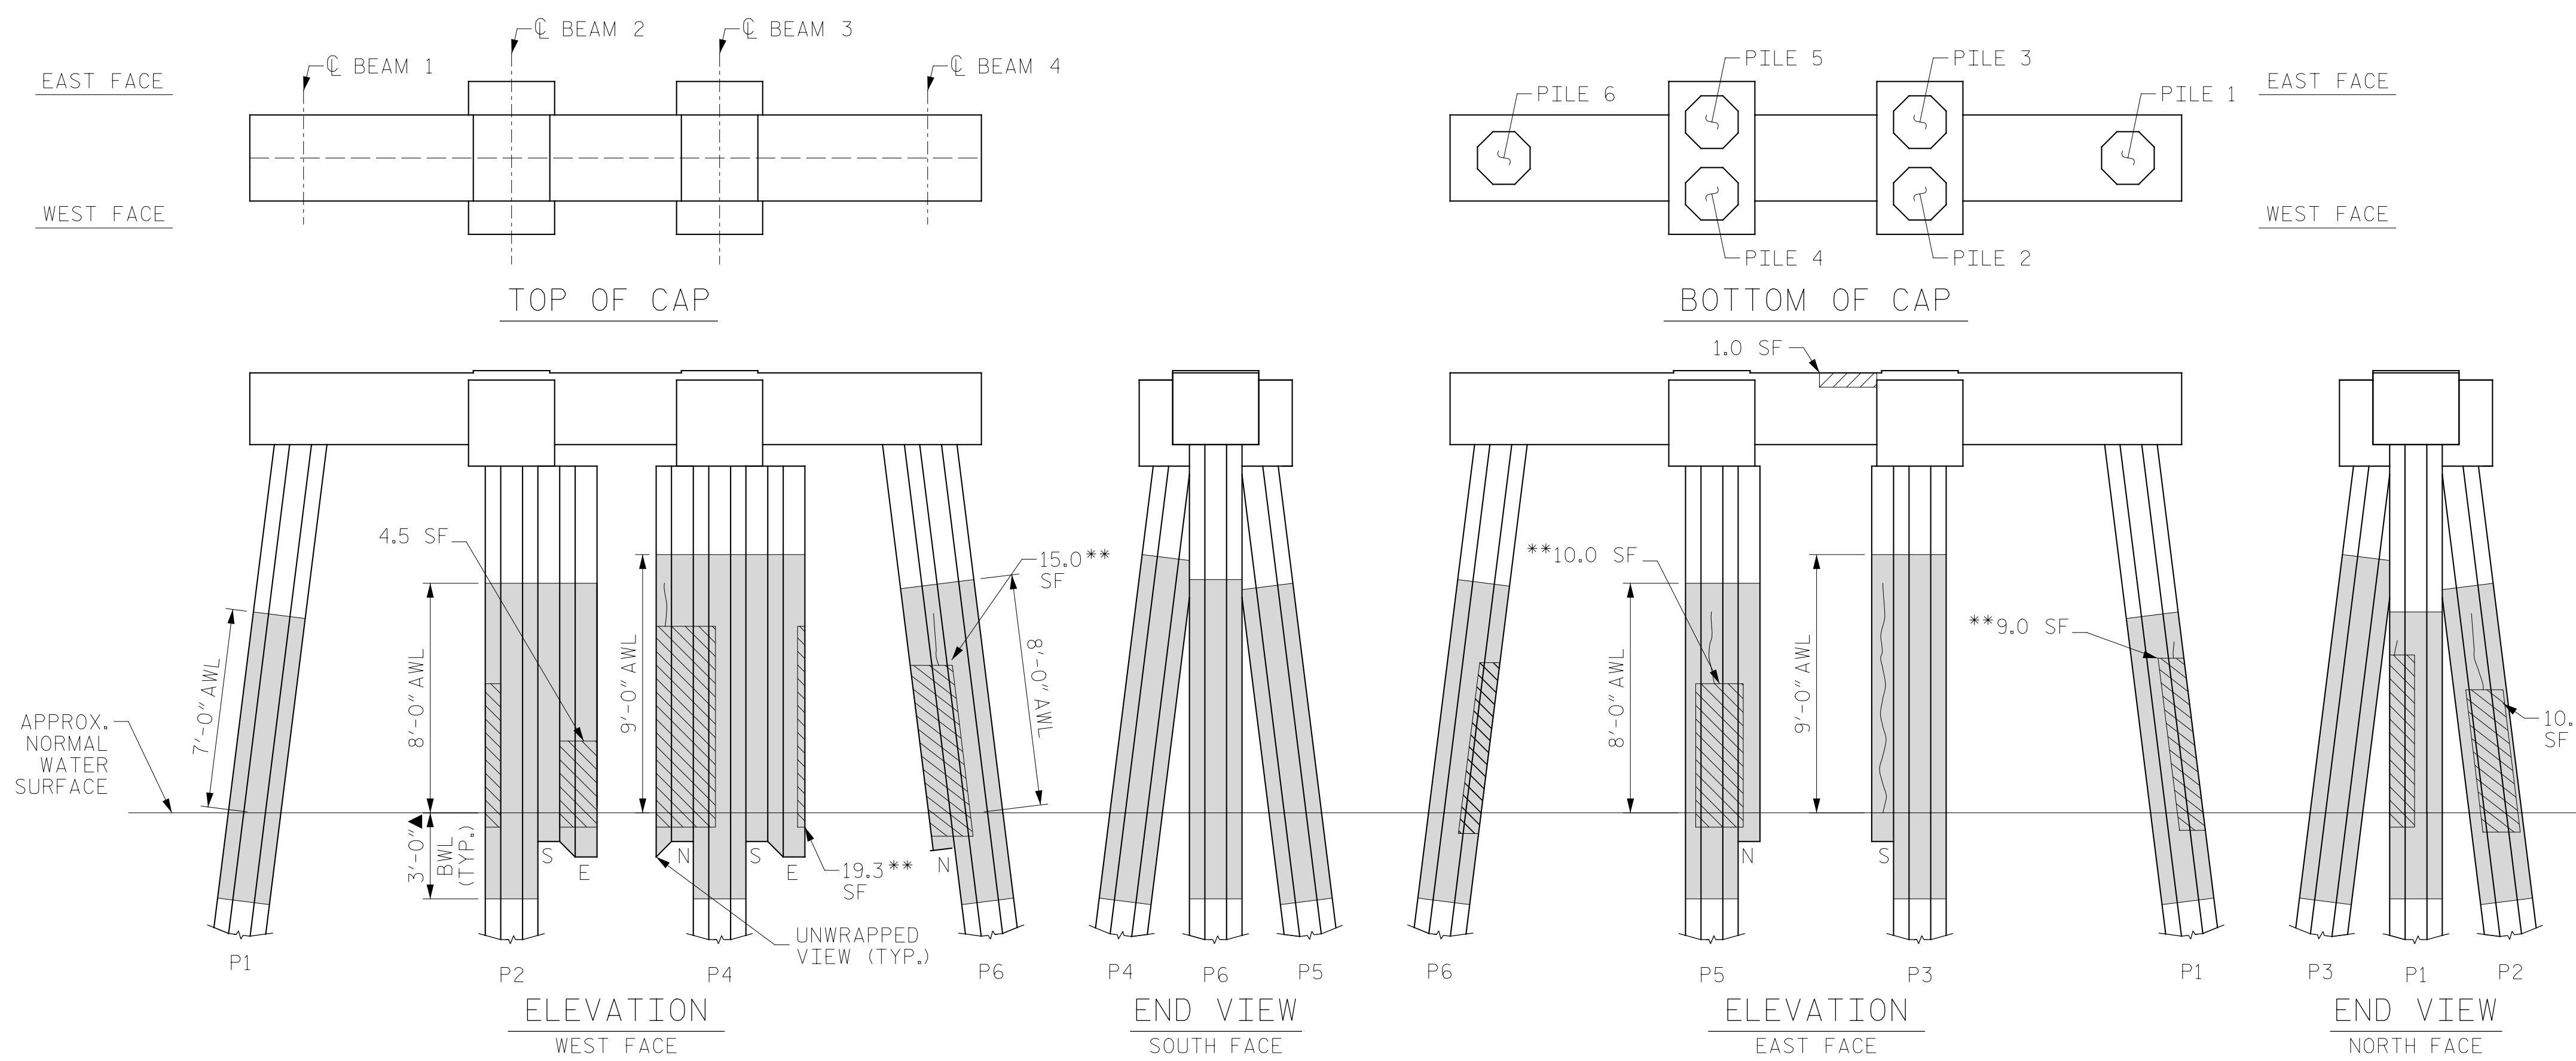
BENT 101

CAP REPAIRS			
SHOTCRETE REPAIRS	1.0 SF	0.5 CF	
EPOXY RESIN INJECTION	- LF		
PILE REPAIRS			
PILE CONCRETE RESTORATION	67.8 SF	27.2 CF	
FRP PROTECTIVE SYSTEM AWL	269.5 SF		
FRP PROTECTIVE SYSTEM BWL	99.0 SF

(AWL = ABOVE WATERLINE)
(BWL = BELOW WATERLINE)
(**QUANTITY INCLUDES ADJACENT REPAIRS)

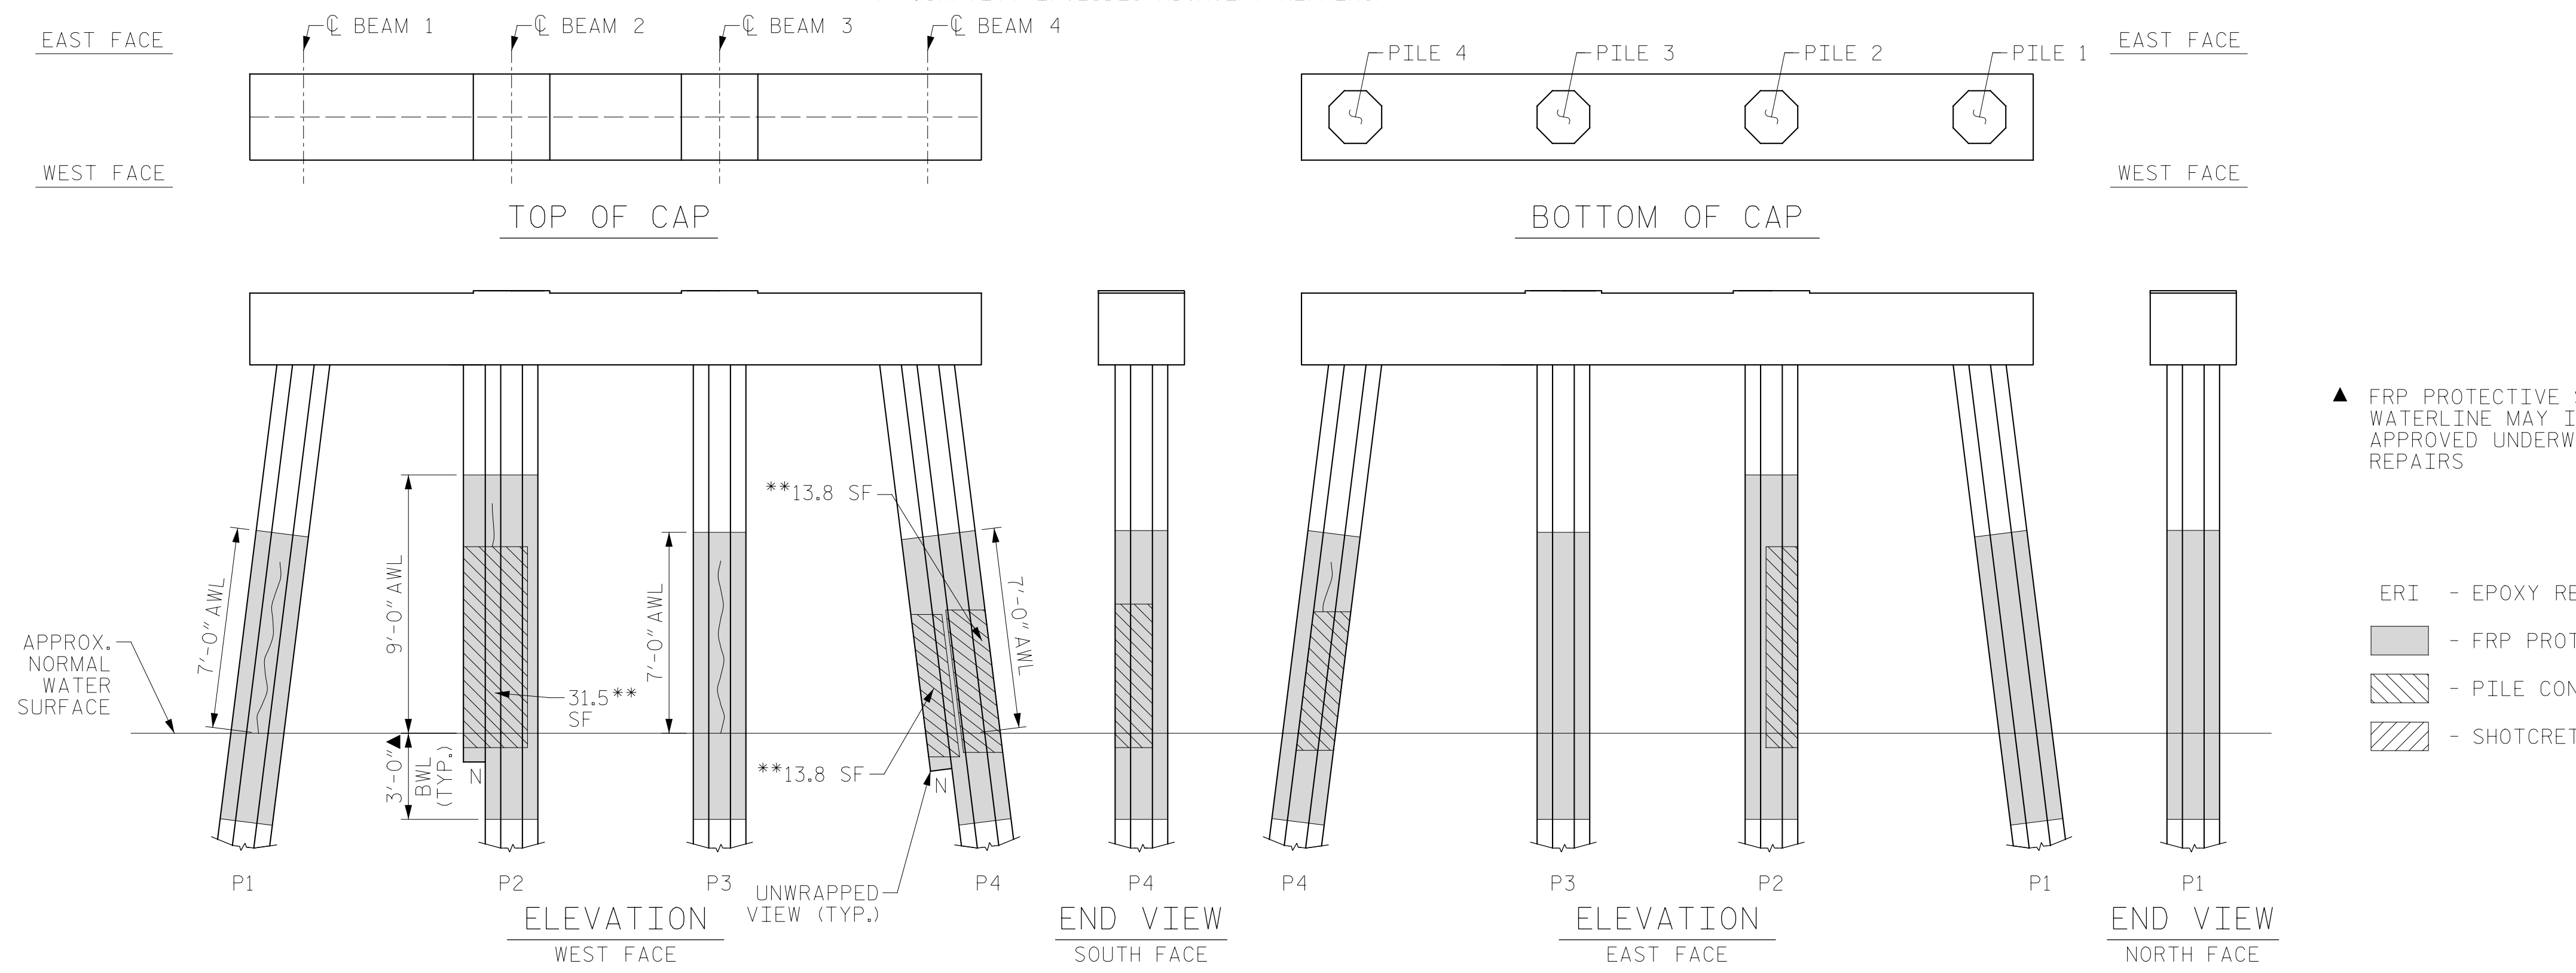
BENT 102

CAP REPAIRS			
SHOTCRETE REPAIRS	- SF	- CF	
EPOXY RESIN INJECTION	- LF		
PILE REPAIRS			
PILE CONCRETE RESTORATION	59.1 SF	23.0 CF	
FRP PROTECTIVE SYSTEM AWL	165.0 SF		
FRP PROTECTIVE SYSTEM BWL	66.0 SF

(AWL = ABOVE WATERLINE)
(BWL = BELOW WATERLINE)
(**QUANTITY INCLUDES ADJACENT REPAIRS)
