AS-BUILT REPAIR QUANTITY TABLE

PROJECT NO. HB-0017
DARE COUNTY
 BRIDGE NO. 270009

BENT 103 & BENT 104

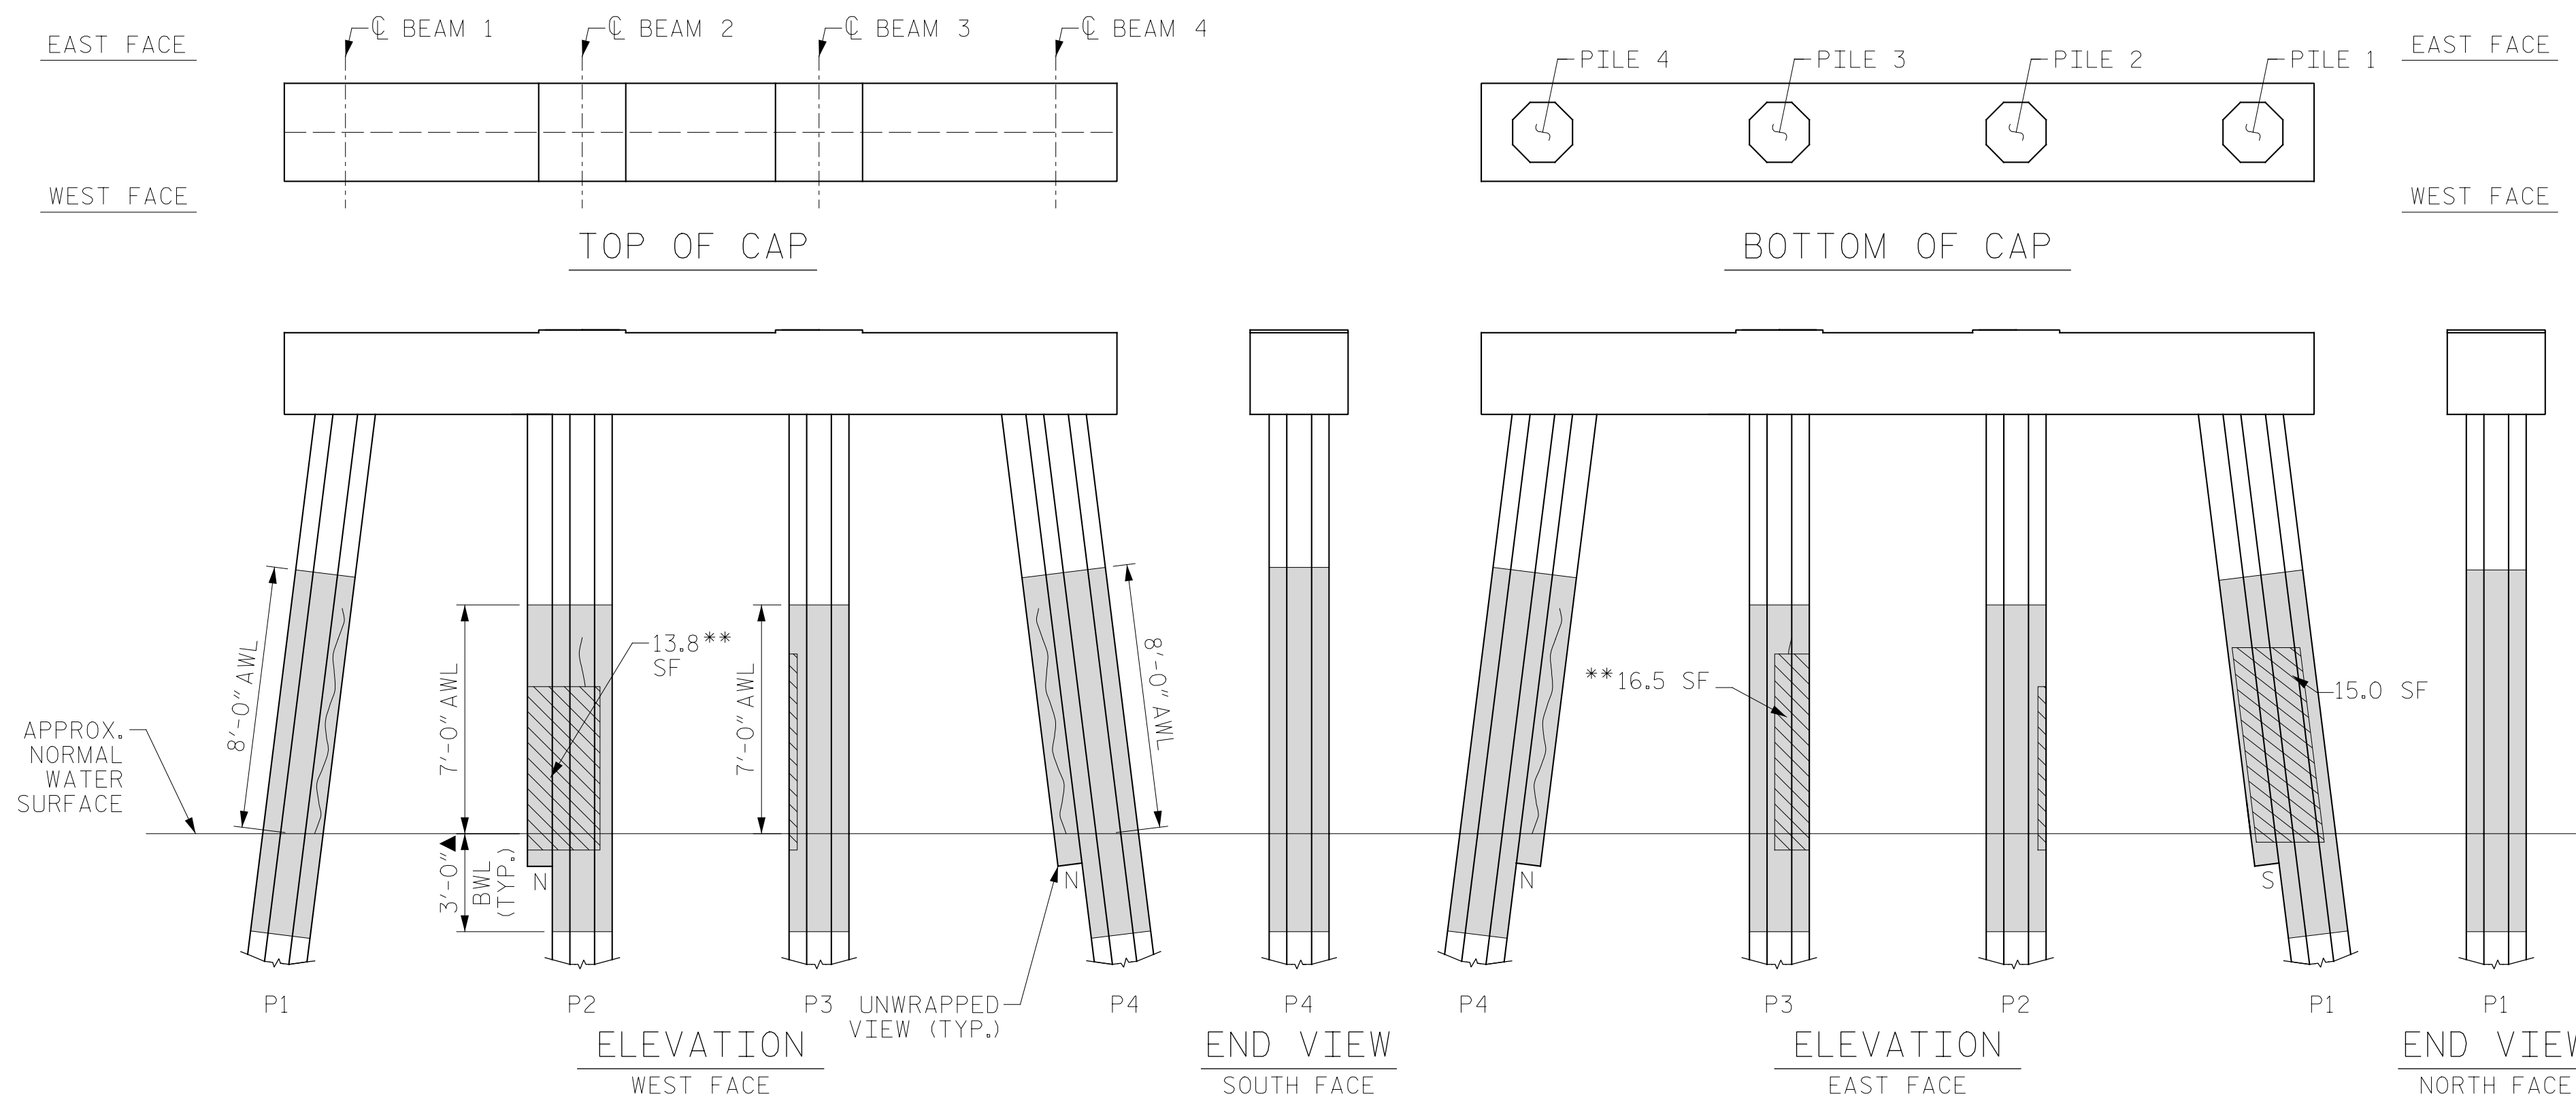
BENT 103

CAP REPAIRS			
SHOTCRETE REPAIRS	- SF	- CF	SF CF
EPOXY RESIN INJECTION	- LF		LF
PILE REPAIRS			
PILE CONCRETE RESTORATION	45.3 SF	17.7 CF	SF CF
FRP PROTECTIVE SYSTEM AWL	165.0 SF		
FRP PROTECTIVE SYSTEM BWL	66.0 SF

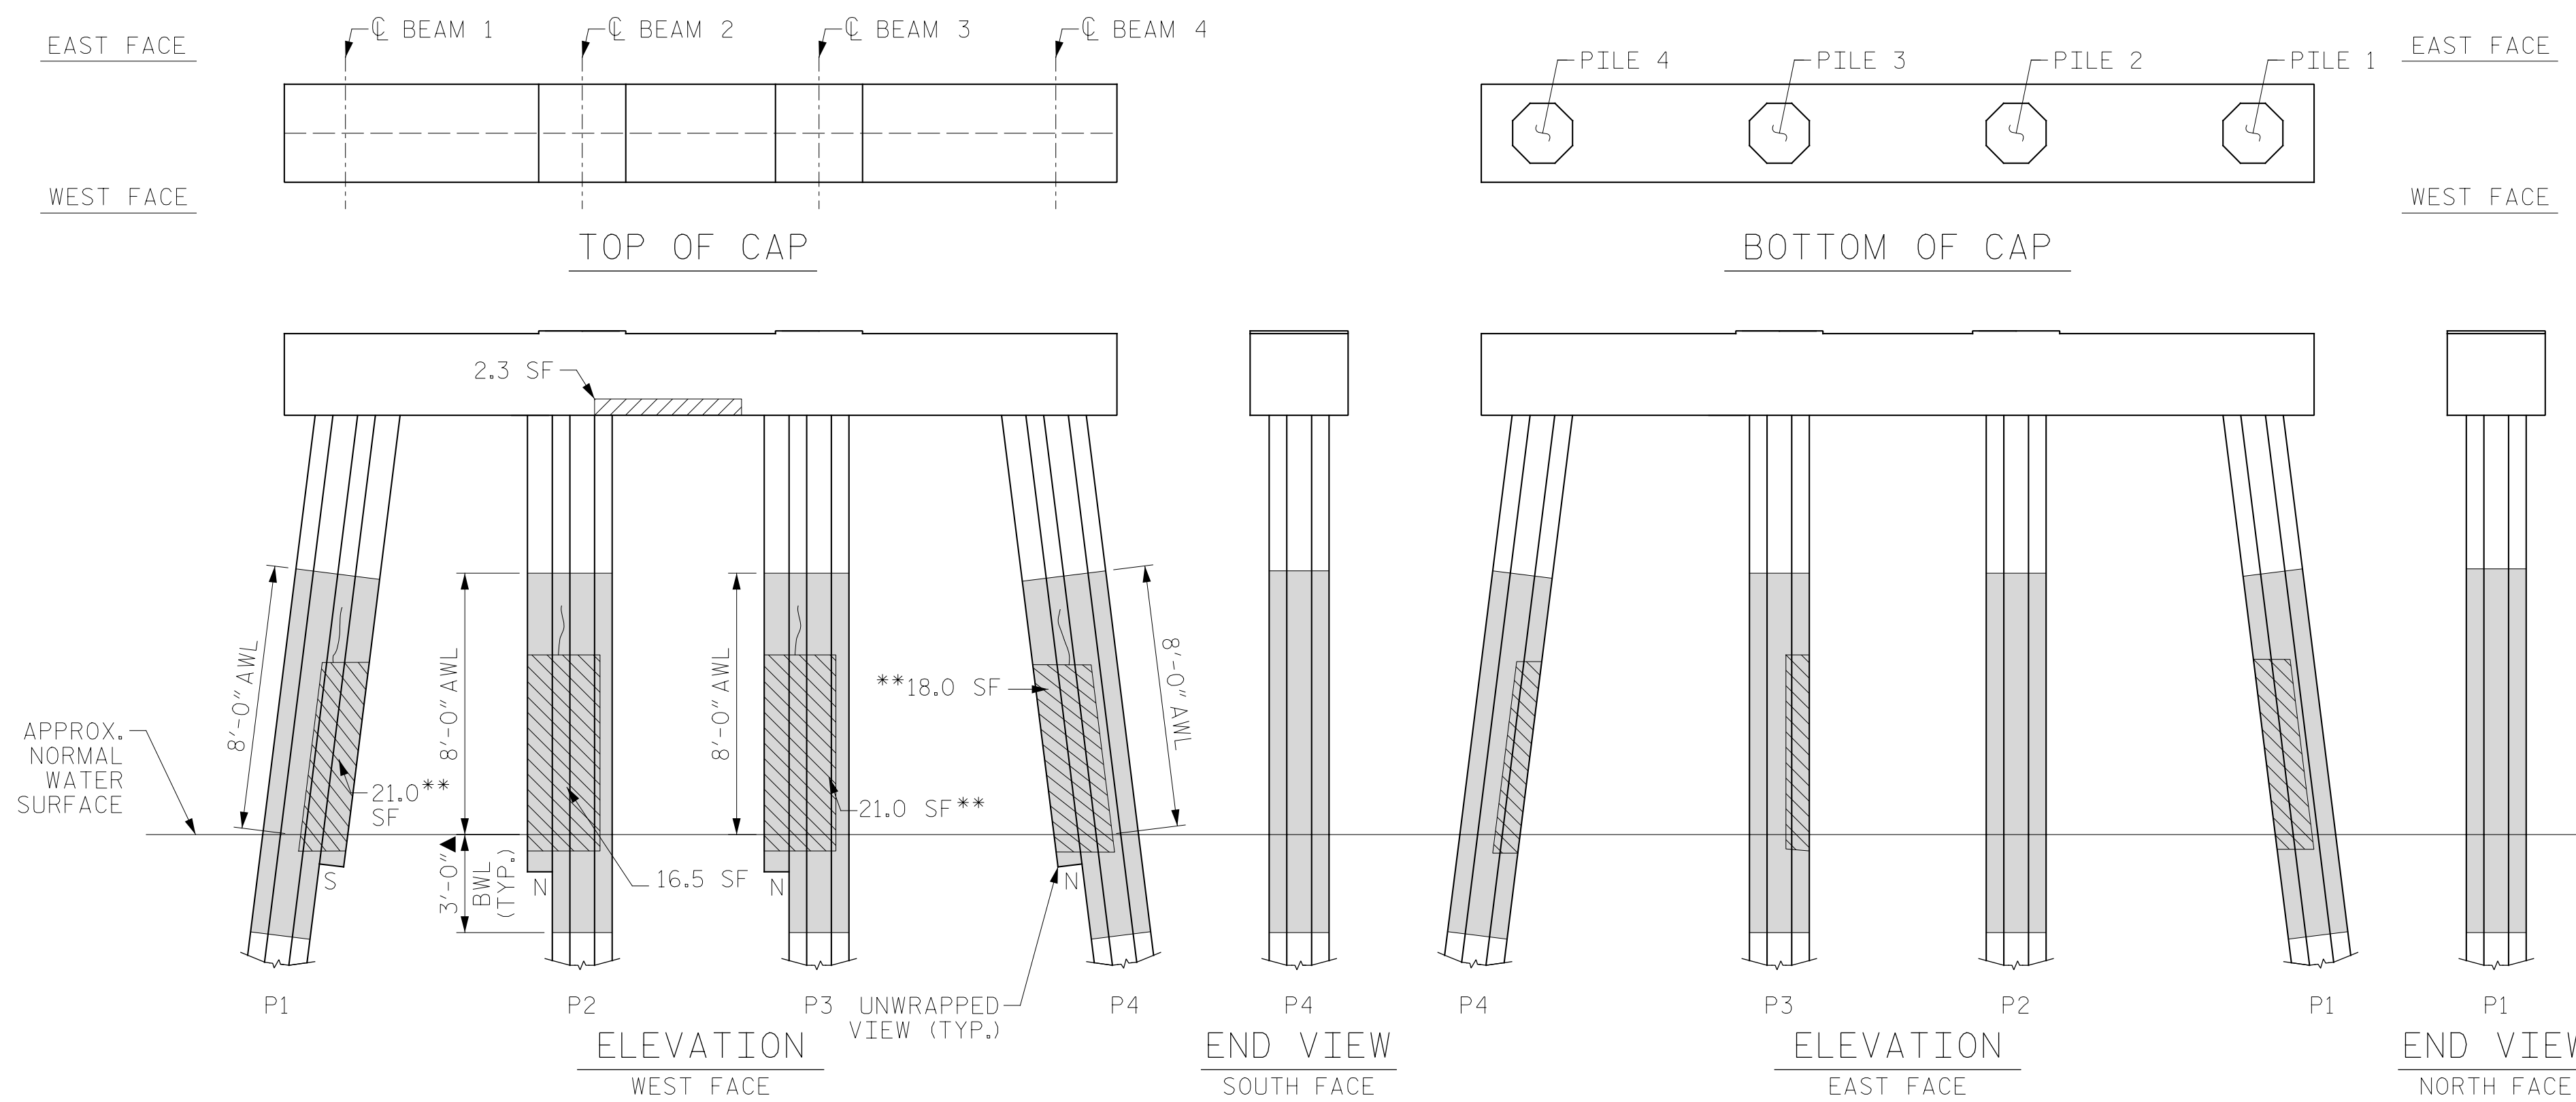
BENT 104

CAP REPAIRS			
SHOTCRETE REPAIRS	2.3 SF	1.2 CF	SF CF
EPOXY RESIN INJECTION	- LF		LF
PILE REPAIRS			
PILE CONCRETE RESTORATION	76.5 SF	29.3 CF	SF CF
FRP PROTECTIVE SYSTEM AWL	176.0 SF		
FRP PROTECTIVE SYSTEM BWL	66.0 SF
