AS-BUILT REPAIR QUANTITY TABLE

PROJECT NO. HB-0017  
DARE COUNTY  
BRIDGE NO. 270009

BENT 107 & BENT 108

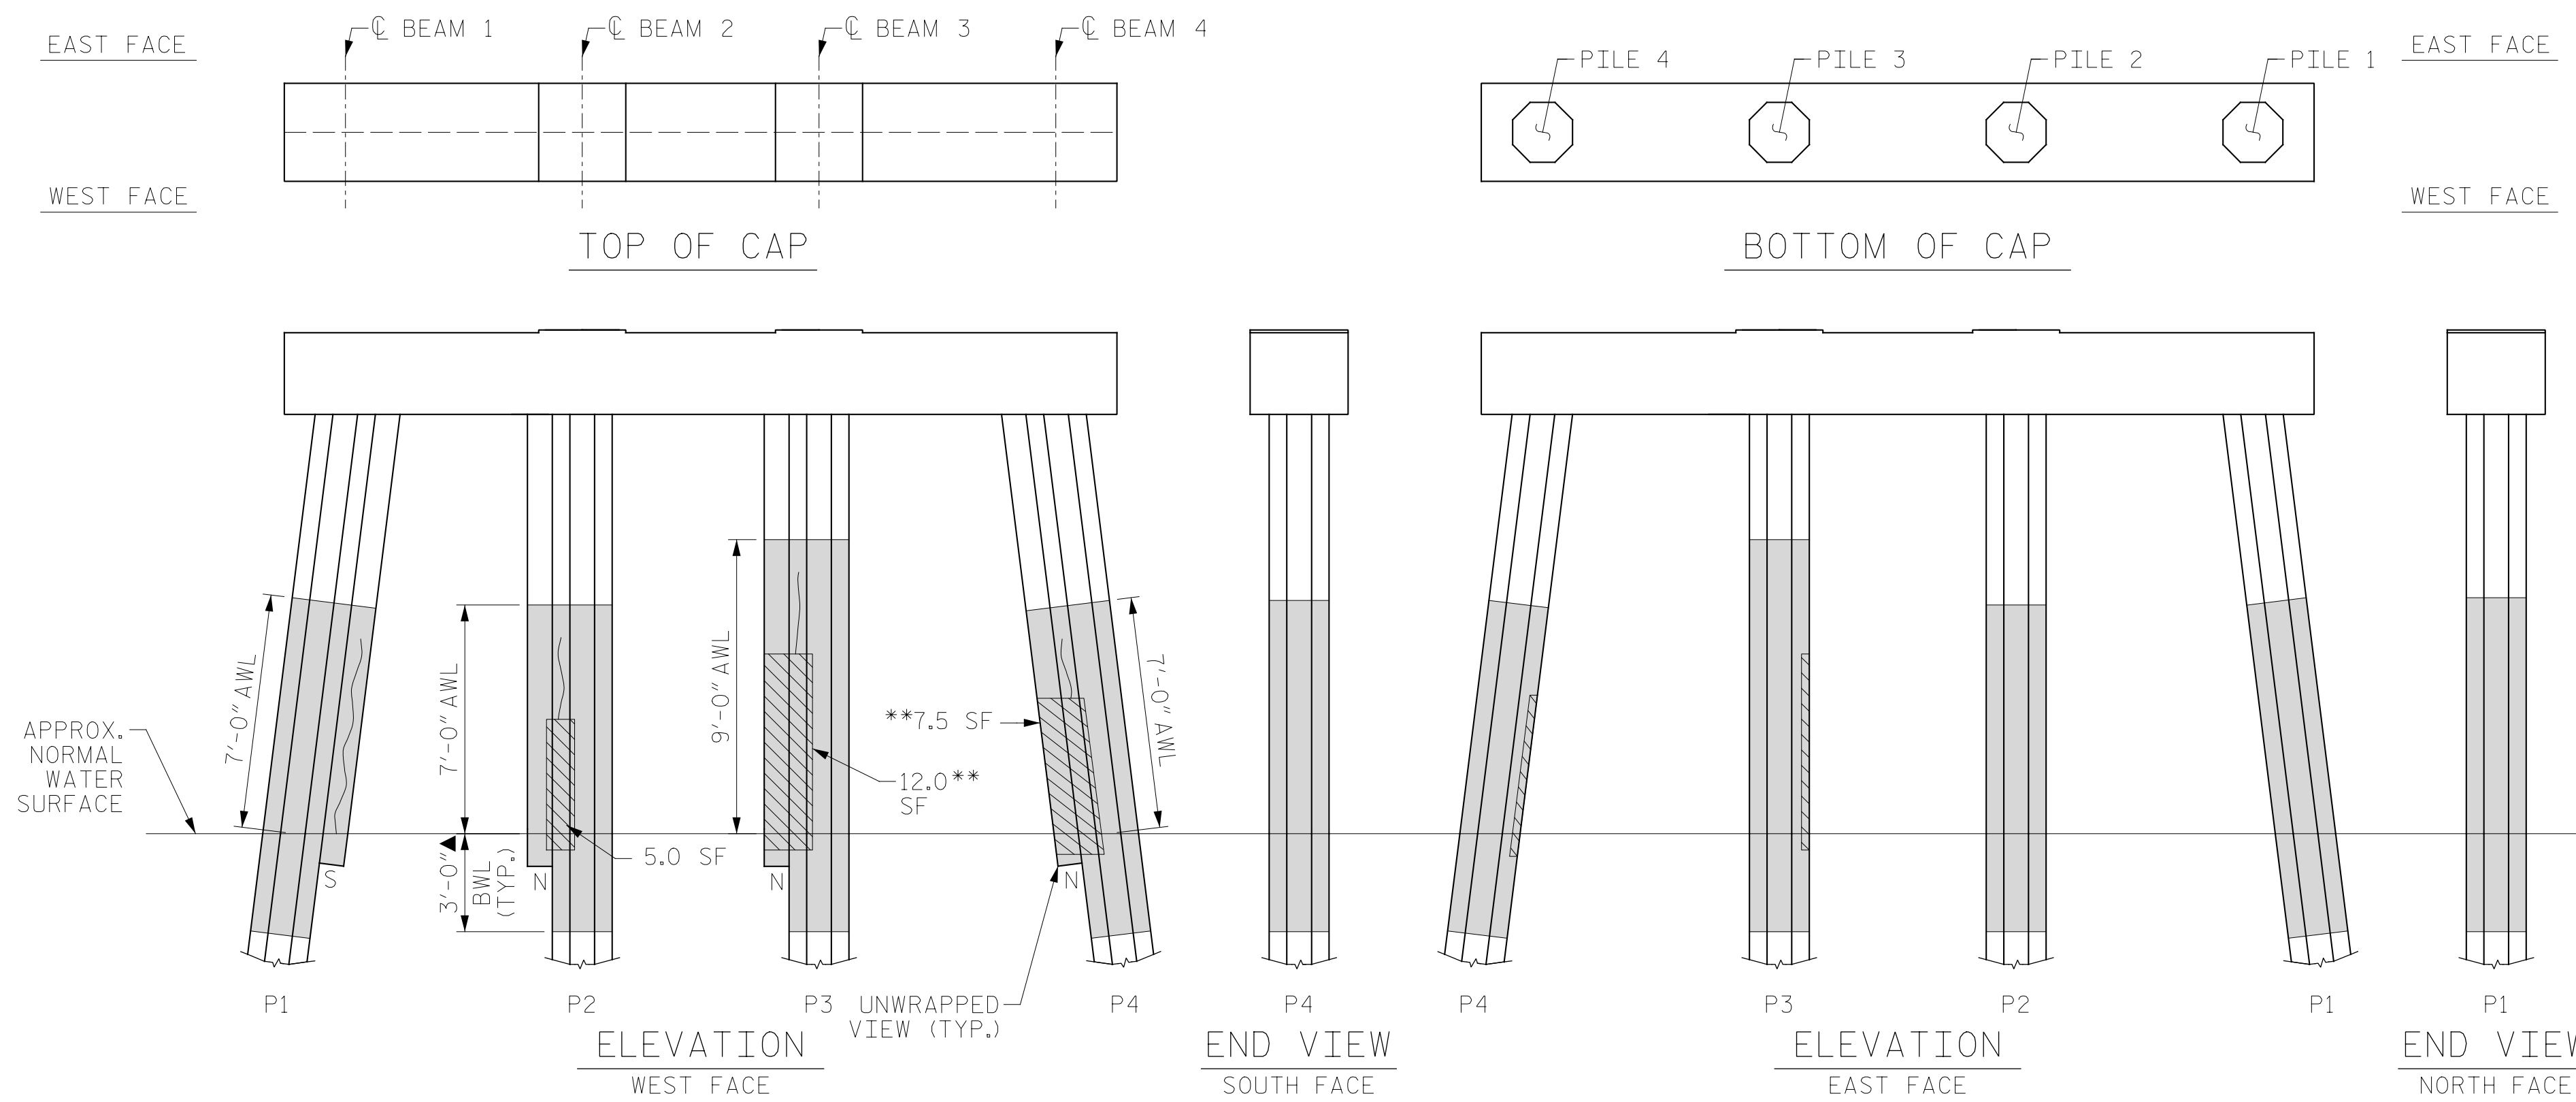
BENT 107

CAP REPAIRS			
SHOTCRETE REPAIRS	- SF	- CF	SF CF
EPOXY RESIN INJECTION	- LF		LF
PILE REPAIRS			
PILE CONCRETE RESTORATION	24.5 SF	10.2 CF	SF CF
FRP PROTECTIVE SYSTEM AWL	165.0 SF		
FRP PROTECTIVE SYSTEM BWL	66.0 SF

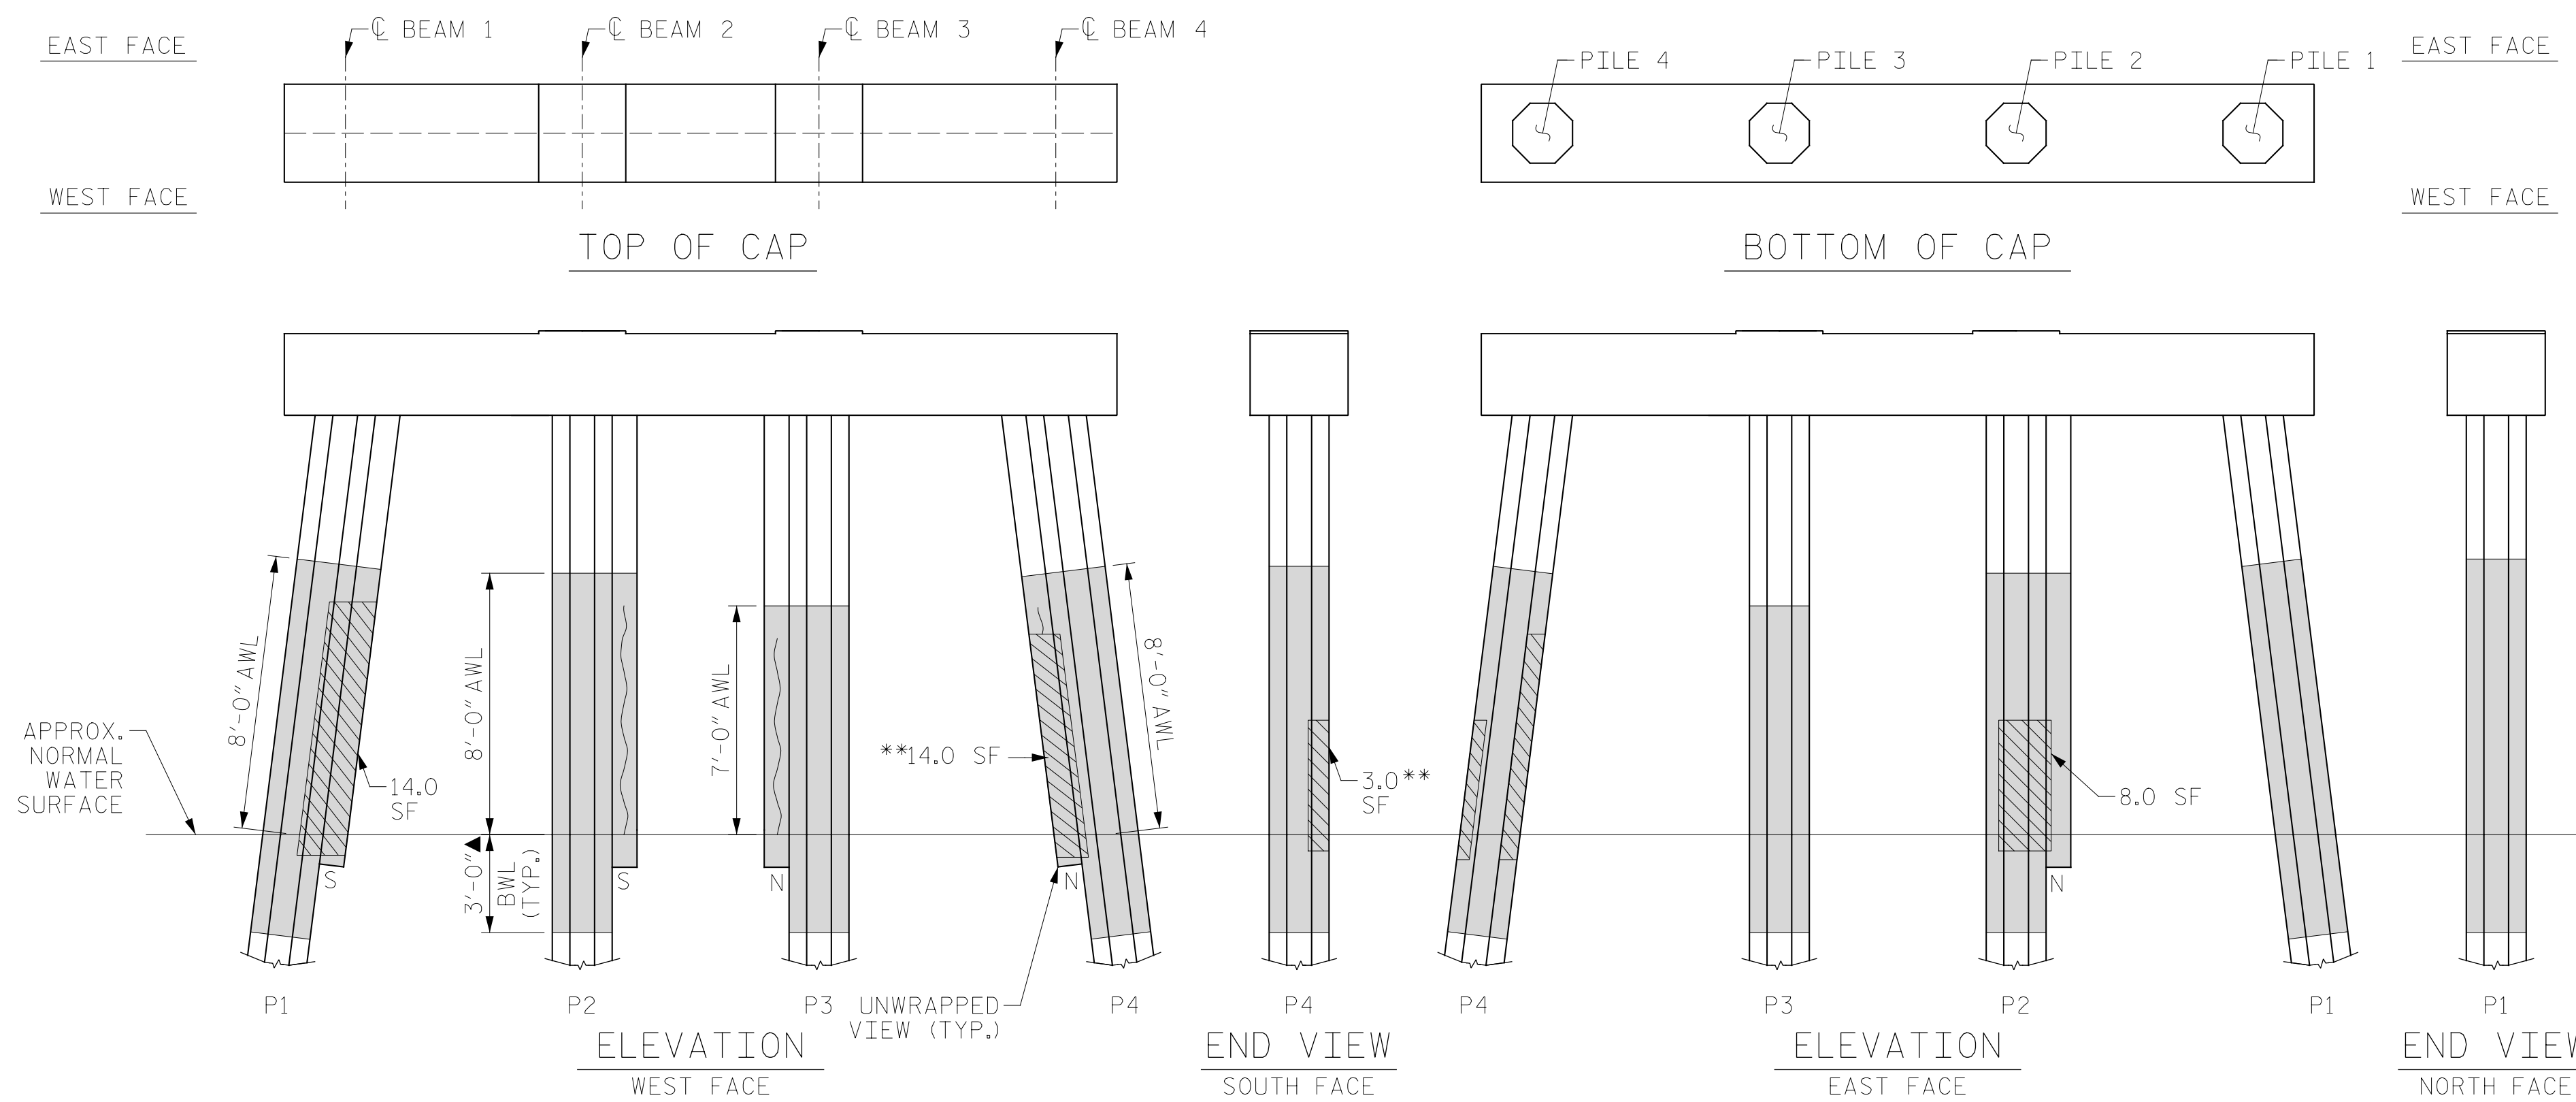
BENT 108

CAP REPAIRS			
SHOTCRETE REPAIRS	- SF	- CF	SF CF
EPOXY RESIN INJECTION	- LF		LF
PILE REPAIRS			
PILE CONCRETE RESTORATION	39.0 SF	15.7 CF	SF CF
FRP PROTECTIVE SYSTEM AWL	170.5 SF		
FRP PROTECTIVE SYSTEM BWL	66.0 SF
