AS-BUILT REPAIR QUANTITY TABLE

PROJECT NO. HB-0017  
DARE COUNTY  
BRIDGE NO. 270009

STATE OF NORTH CAROLINA  
DEPARTMENT OF TRANSPORTATION  
RALEIGH

BENT 109 & BENT 110

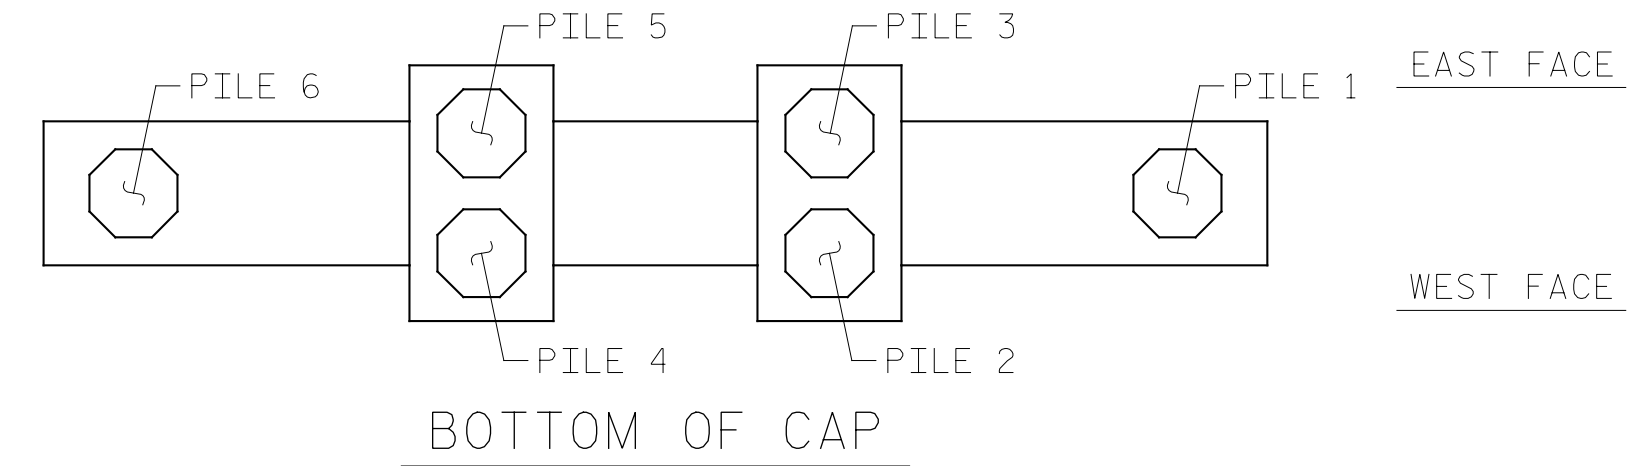
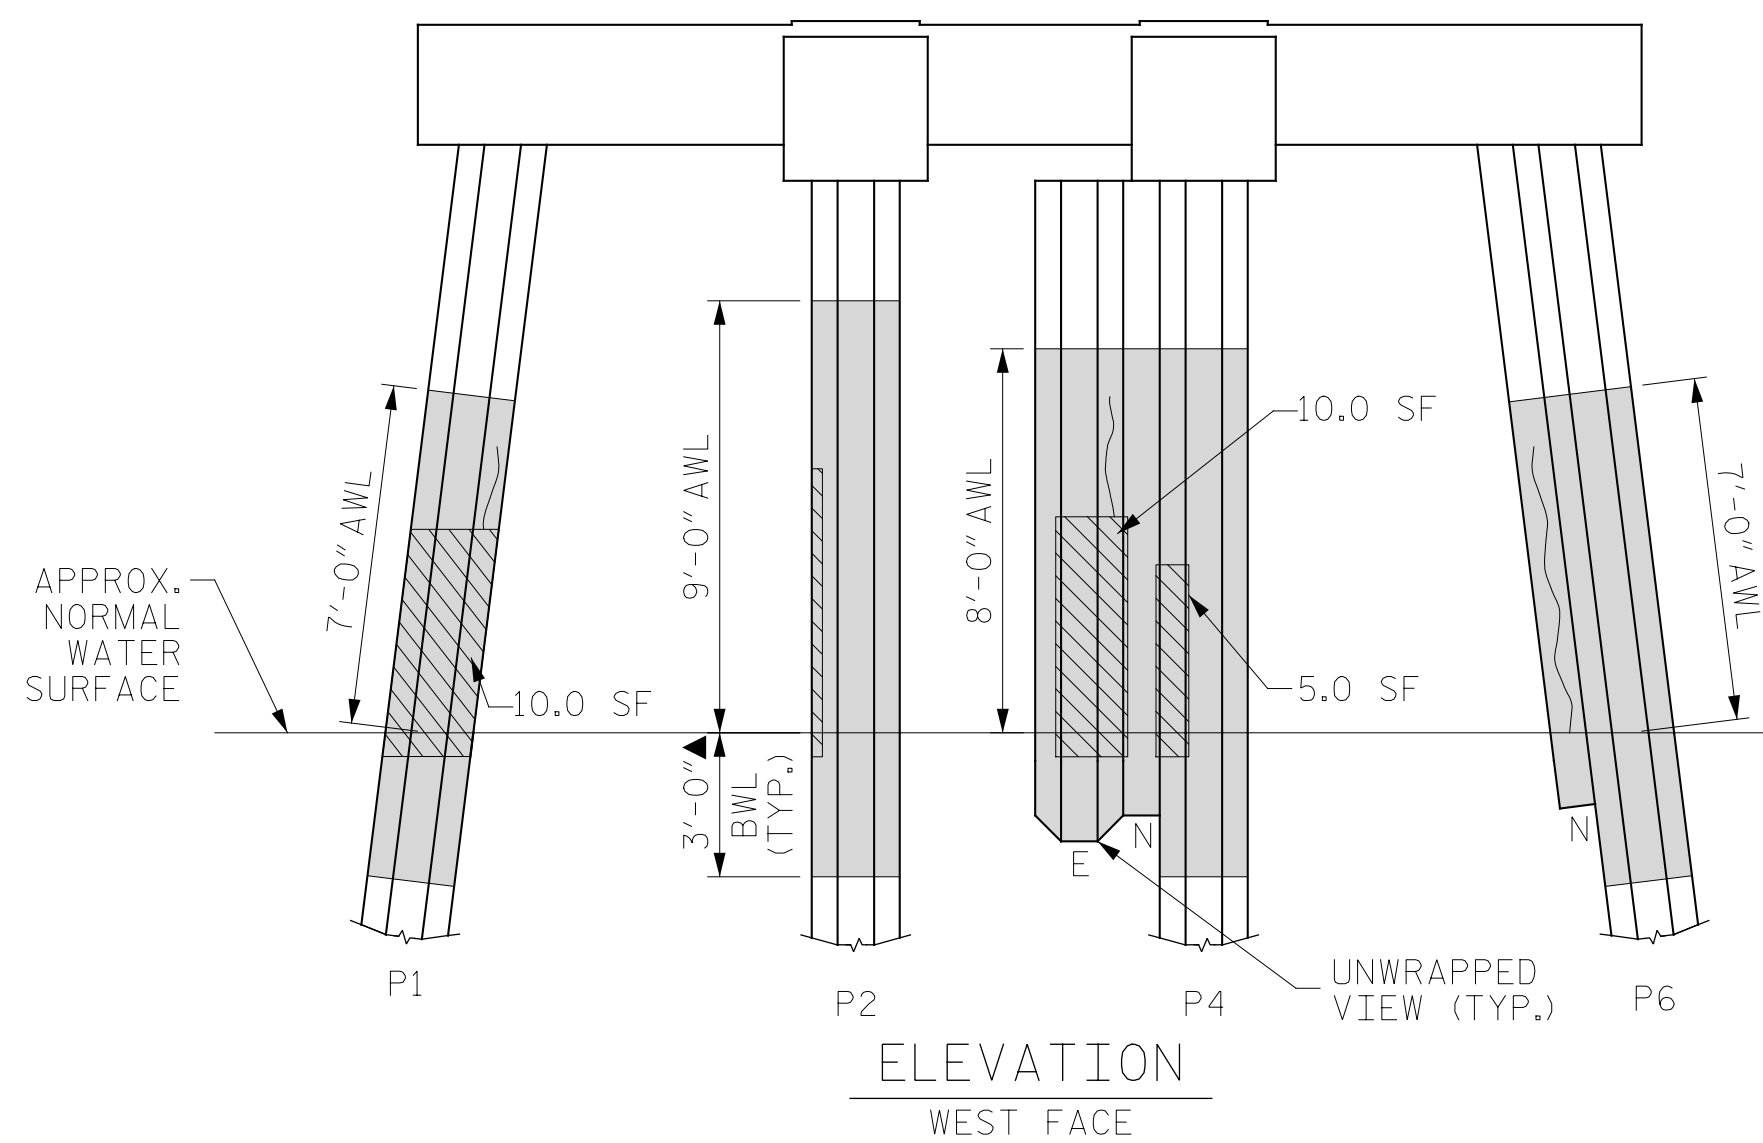
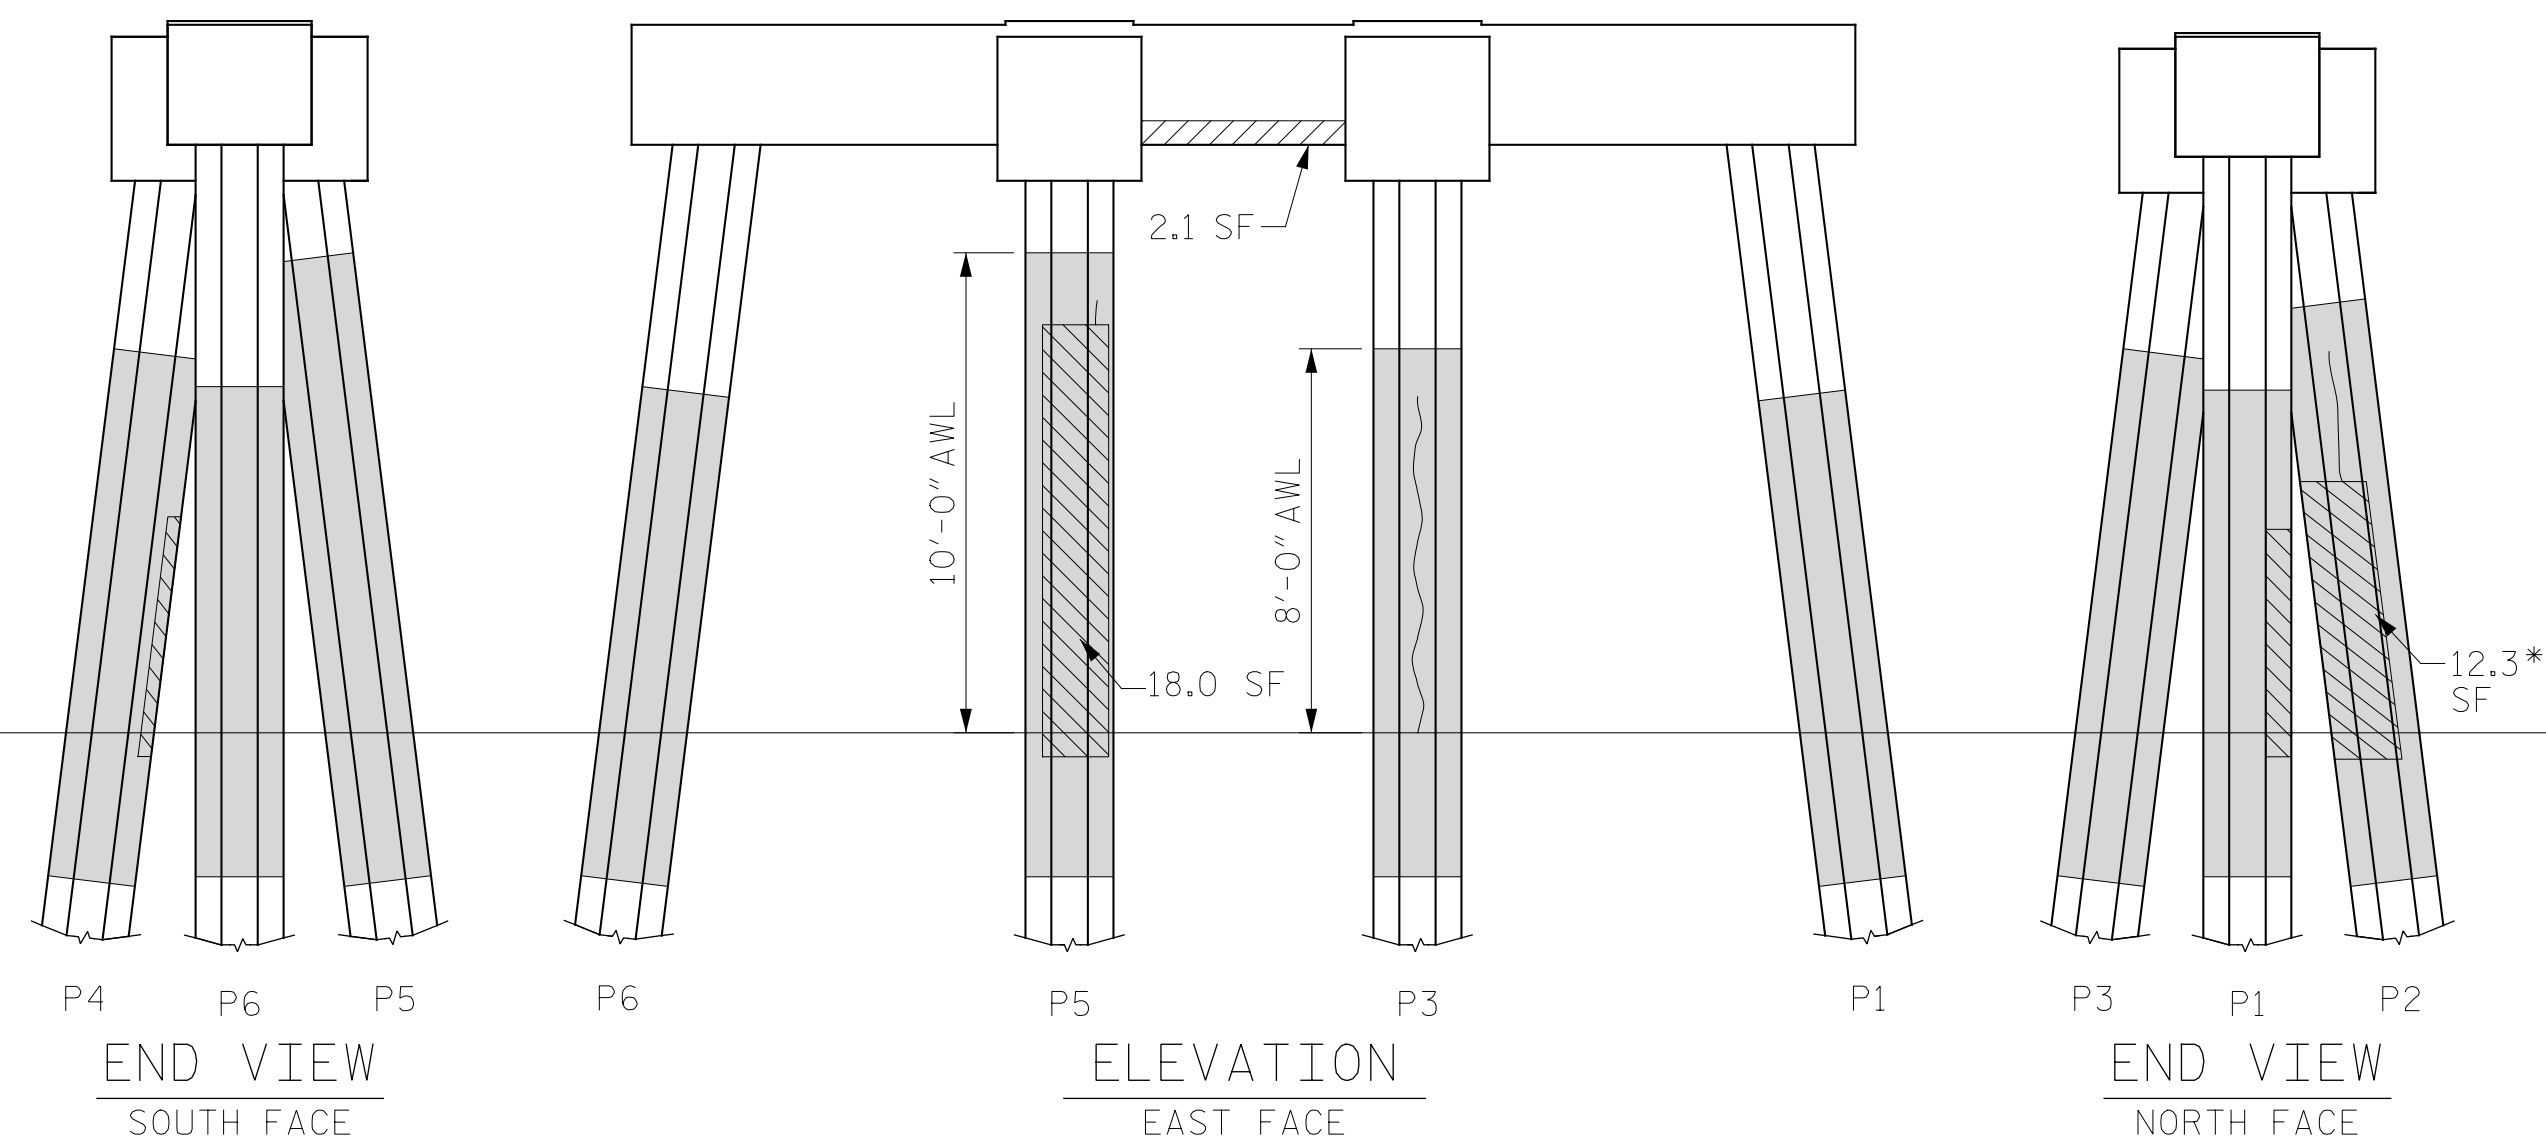
BENT 109

CAP REPAIRS			
SHOTCRETE REPAIRS	2.1 SF	1.1 CF	SF CF
EPOXY RESIN INJECTION	- LF		LF
PILE REPAIRS			
PILE CONCRETE RESTORATION	55.3 SF	22.2 CF	SF CF
FRP PROTECTIVE SYSTEM AWL	269.5 SF		
FRP PROTECTIVE SYSTEM BWL	99.0 SF

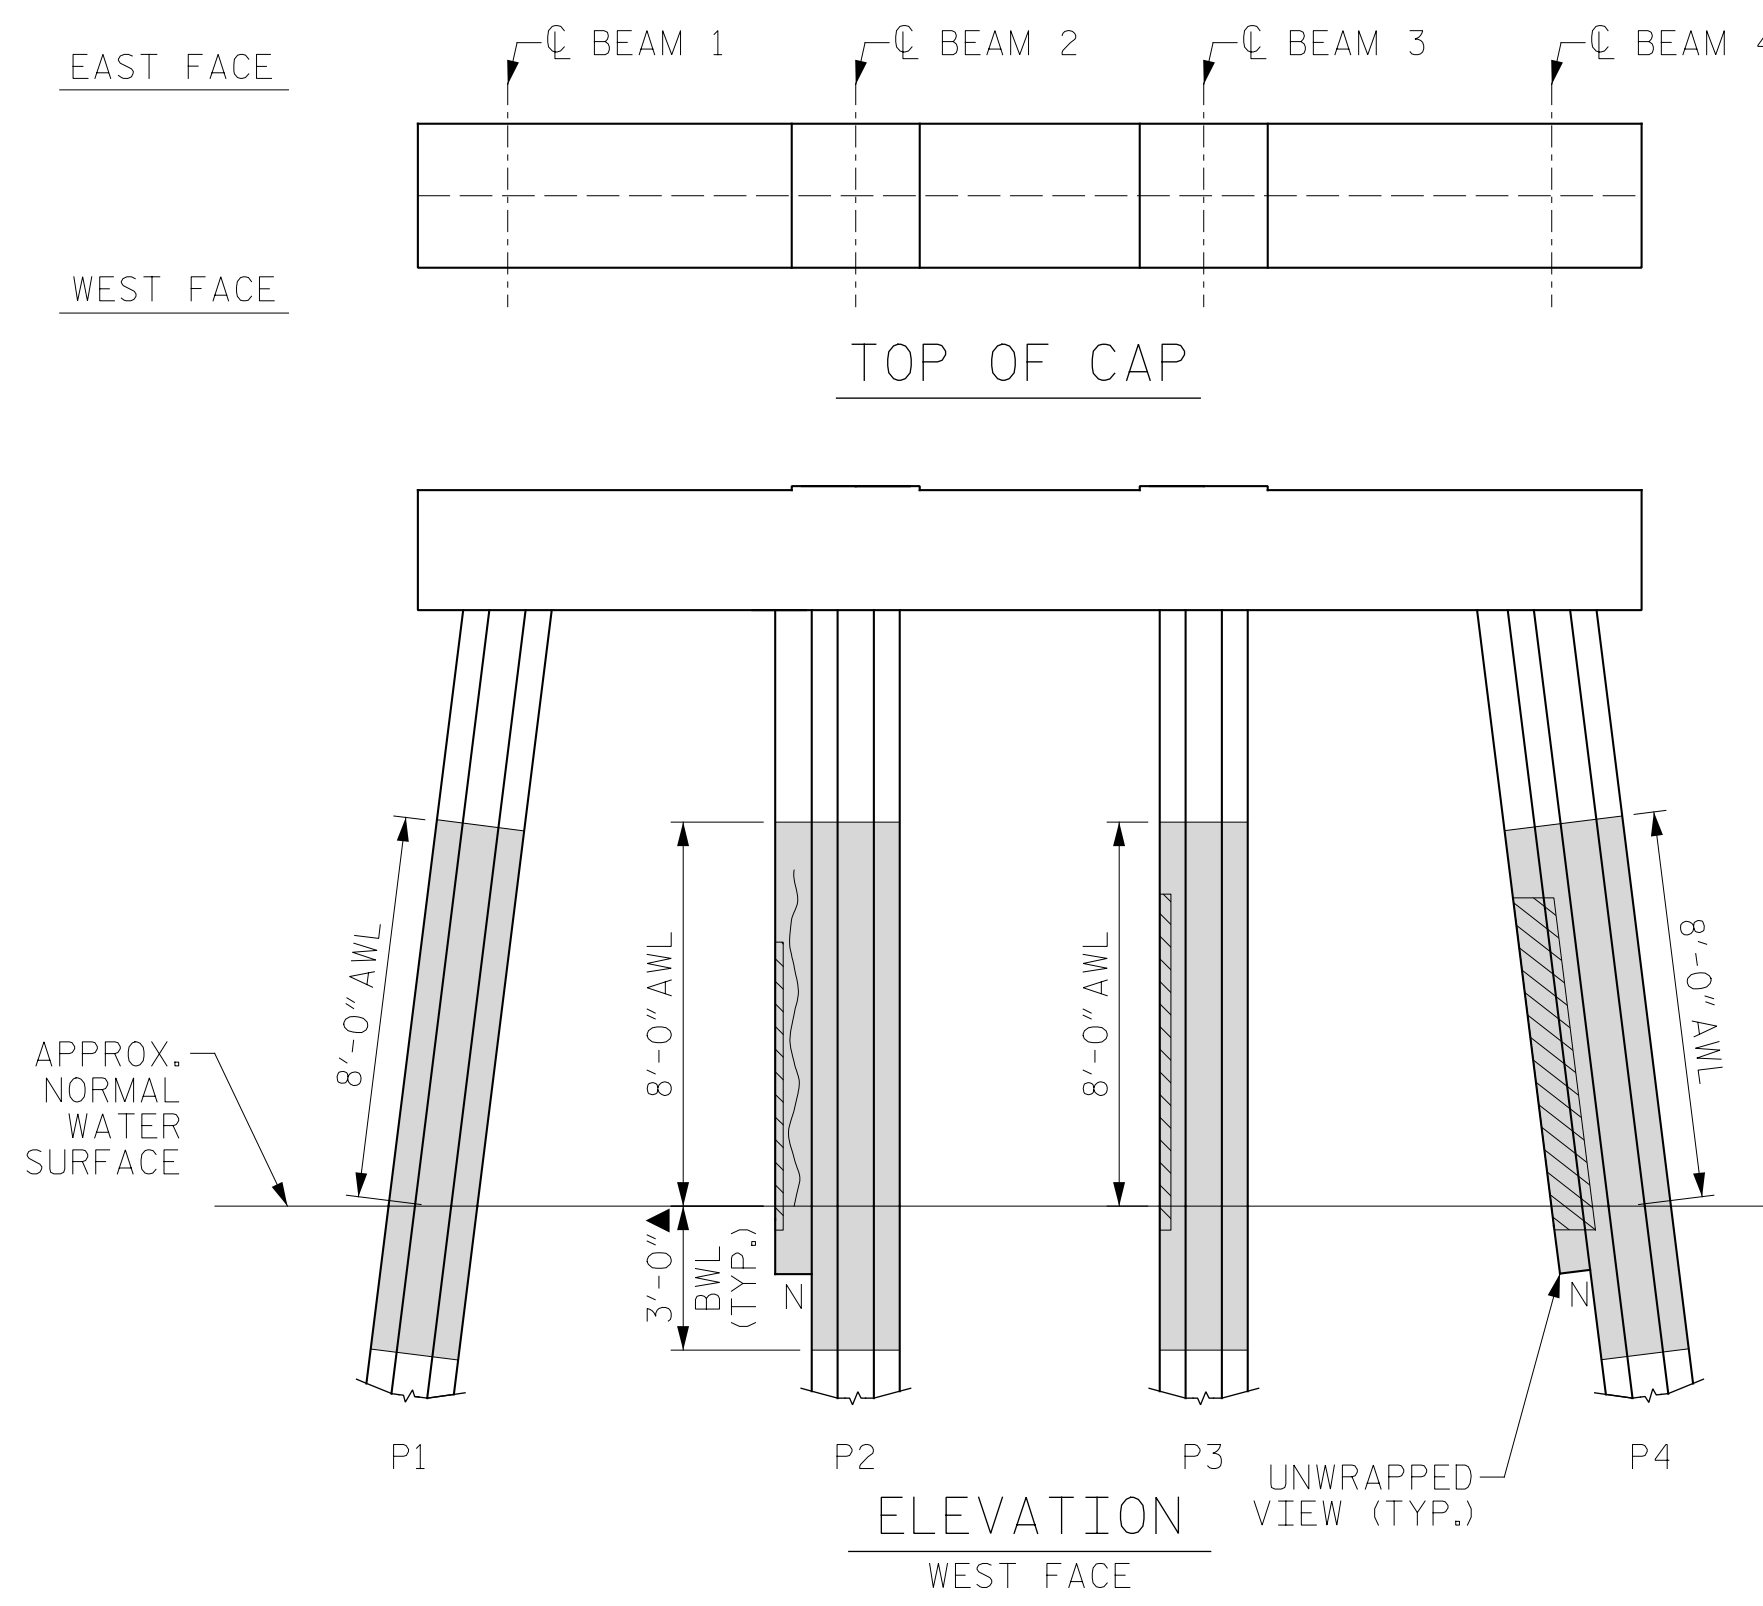
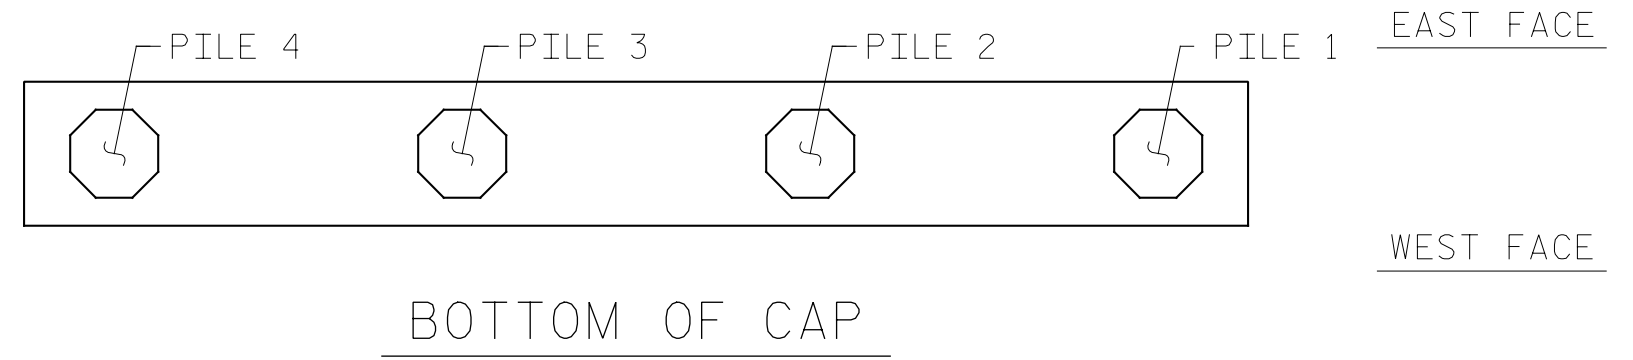
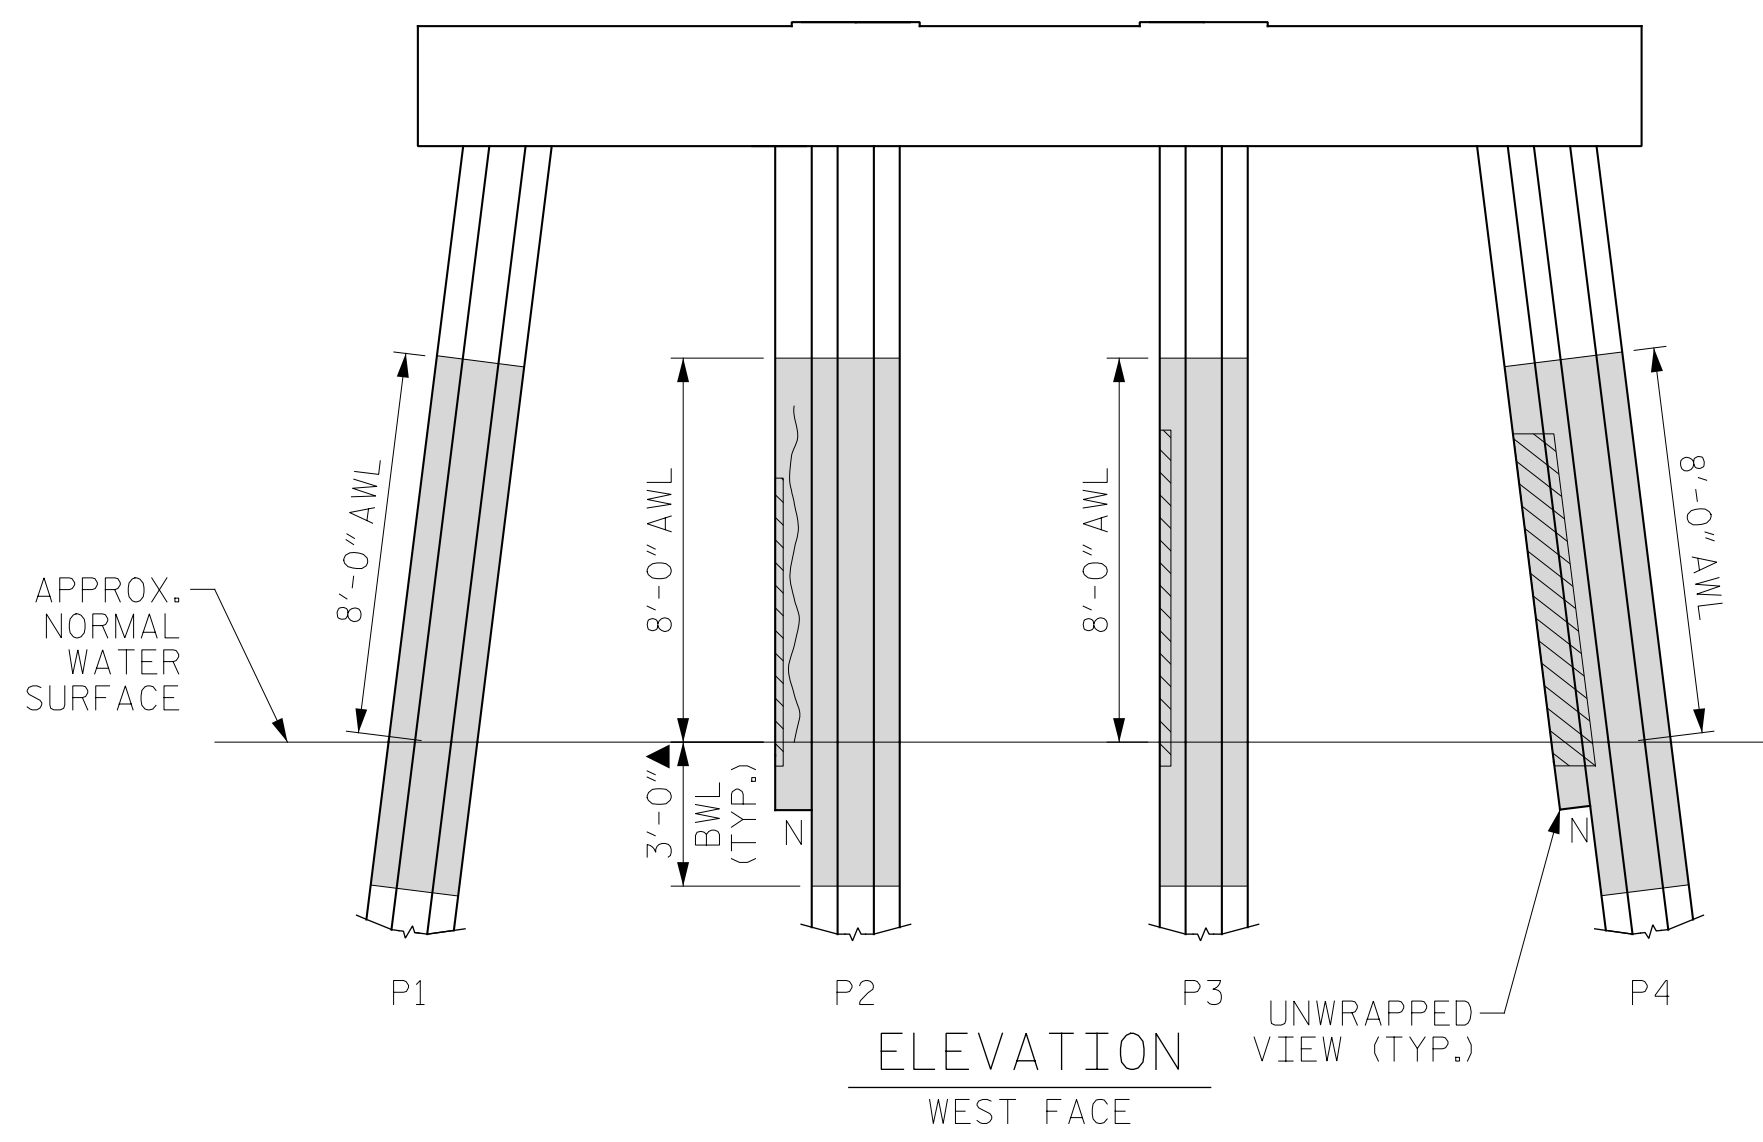
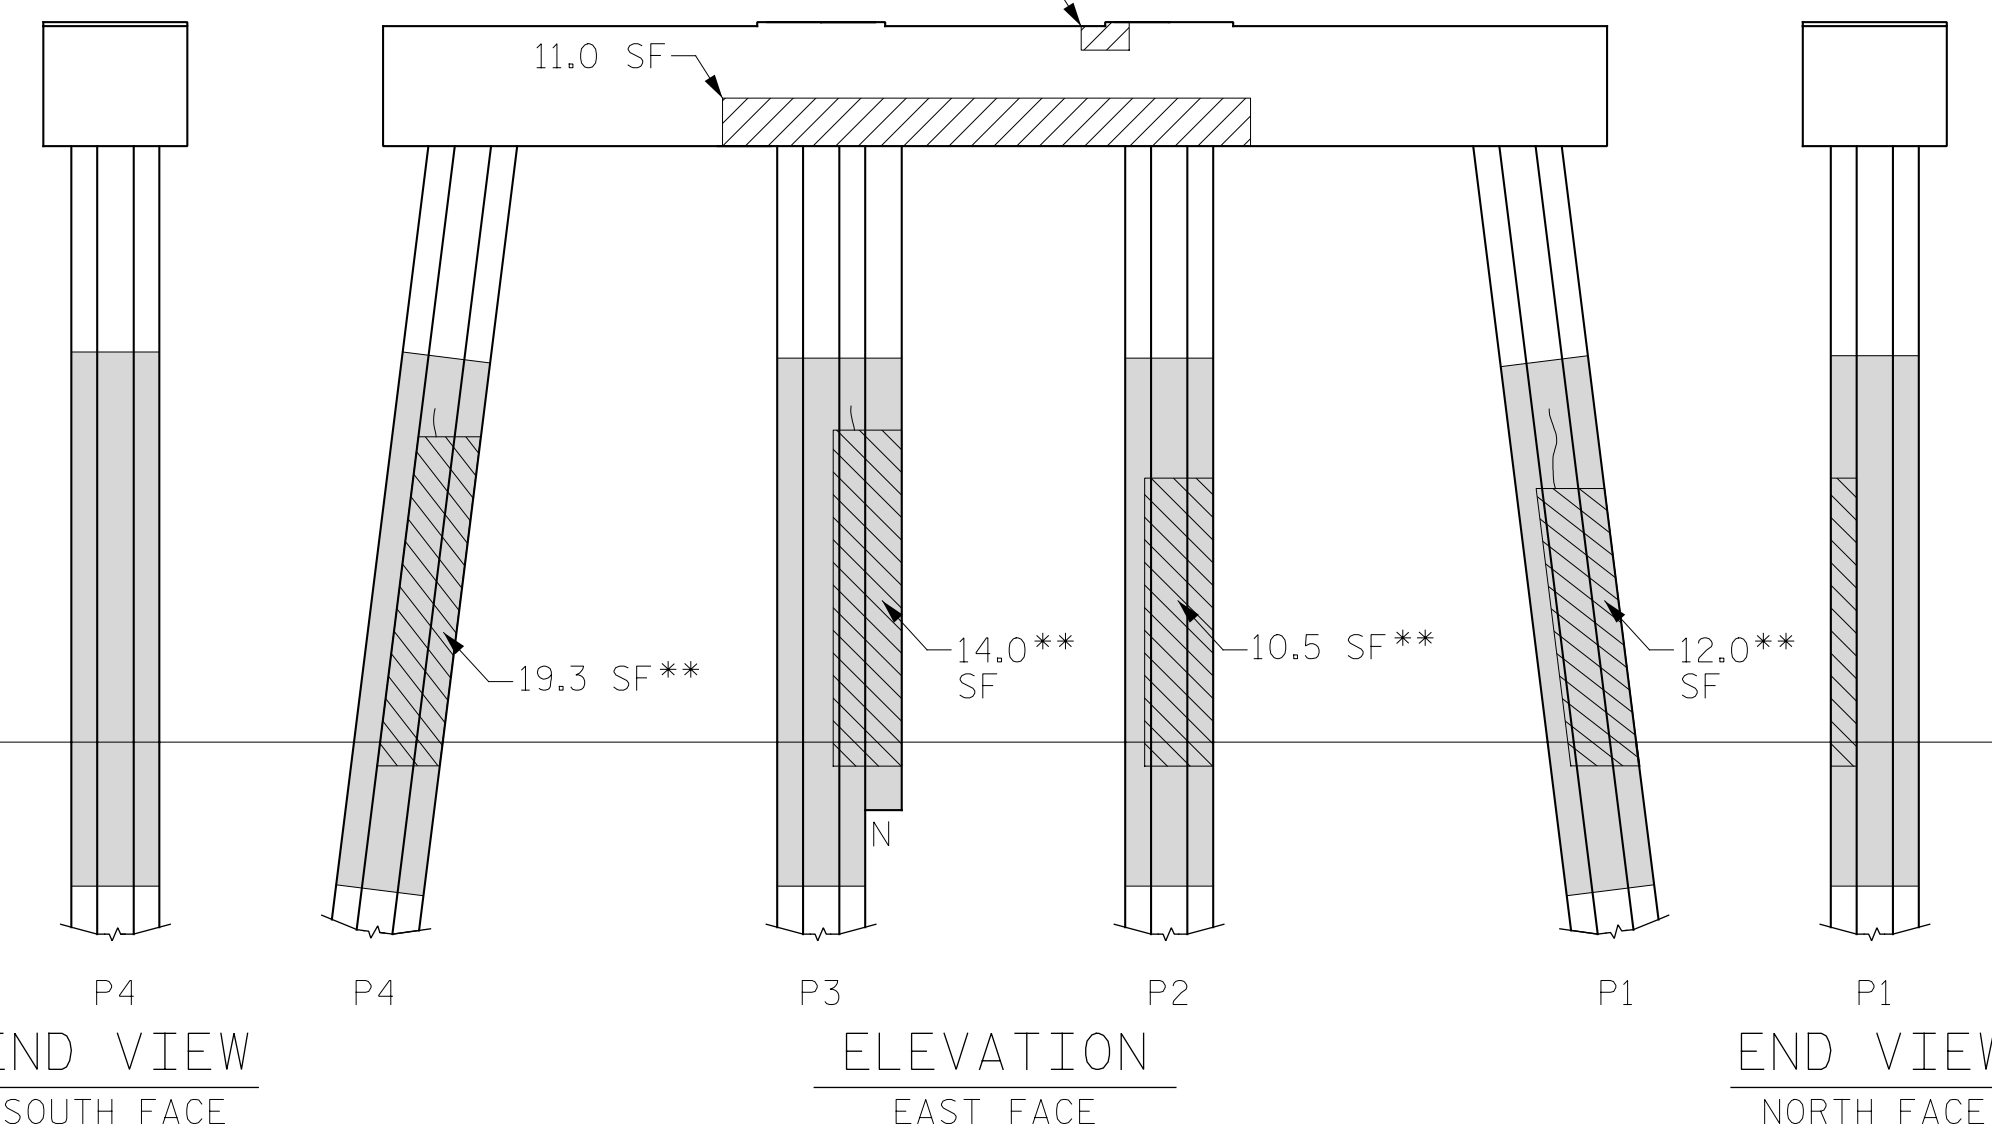
BENT 110

CAP REPAIRS			
SHOTCRETE REPAIRS	11.5 SF	5.8 CF	SF CF
EPOXY RESIN INJECTION	- LF		LF
PILE REPAIRS			
PILE CONCRETE RESTORATION	55.8 SF	22.2 CF	SF CF
FRP PROTECTIVE SYSTEM AWL	176.0 SF		
FRP PROTECTIVE SYSTEM BWL	66.0 SF
