AS-BUILT REPAIR QUANTITY TABLE

PROJECT NO. HB-0017
DARE COUNTY
BRIDGE NO. 270009

BENT 111 & BENT 112

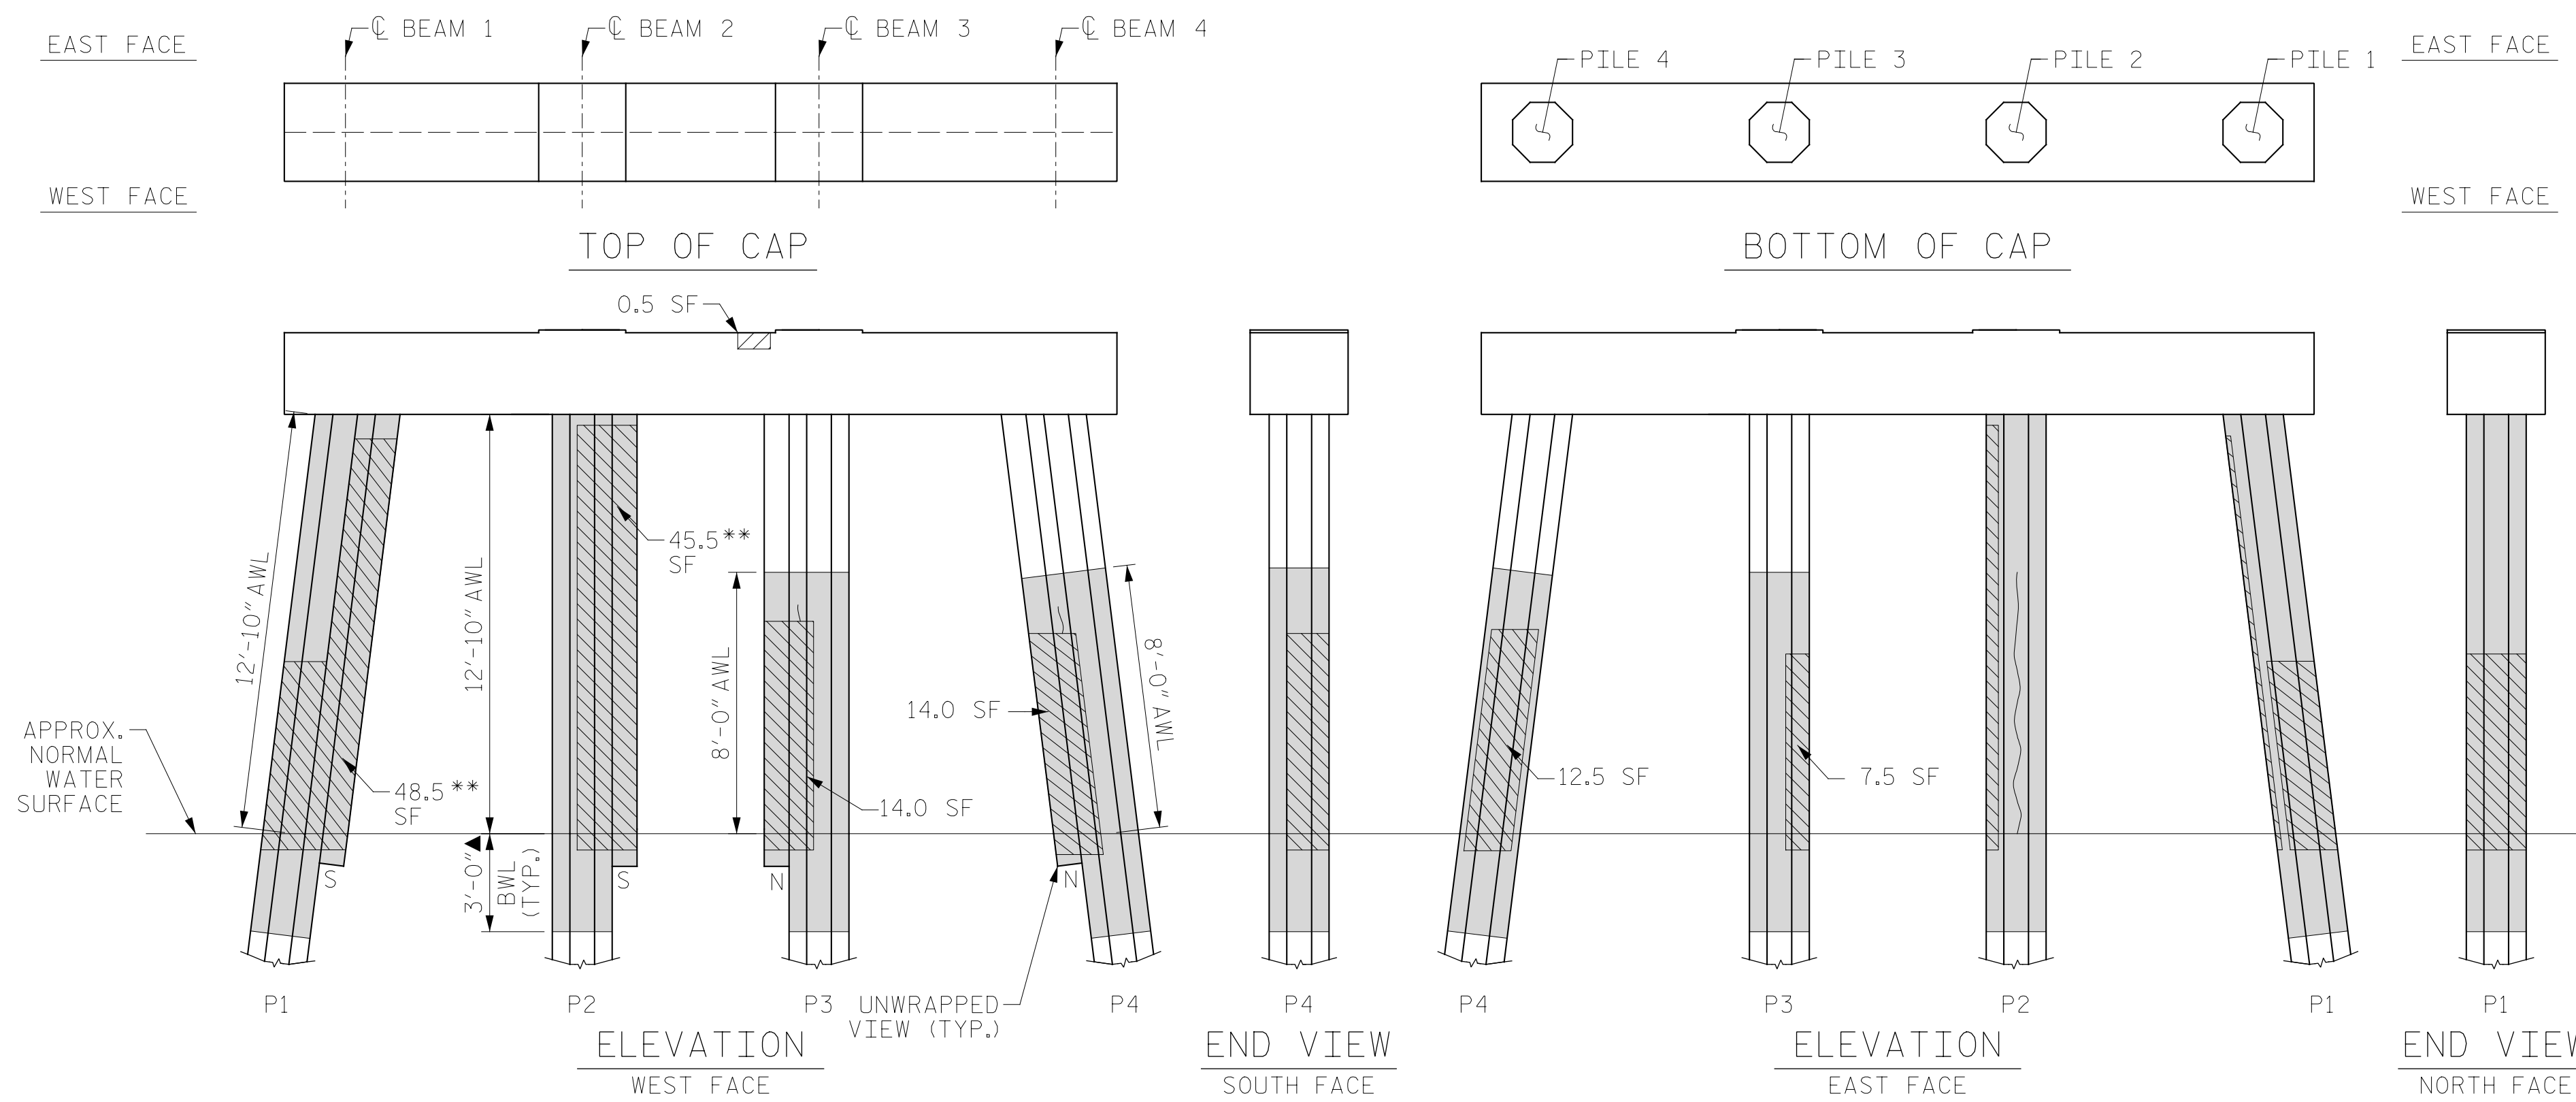
BENT 111

CAP REPAIRS			
SHOTCRETE REPAIRS	0.5 SF	0.3 CF	SF CF
EPOXY RESIN INJECTION	- LF		LF
PILE REPAIRS			
PILE CONCRETE RESTORATION	142.0 SF	54.6 CF	SF CF
FRP PROTECTIVE SYSTEM AWL	229.2 SF		
FRP PROTECTIVE SYSTEM BWL	66.0 SF

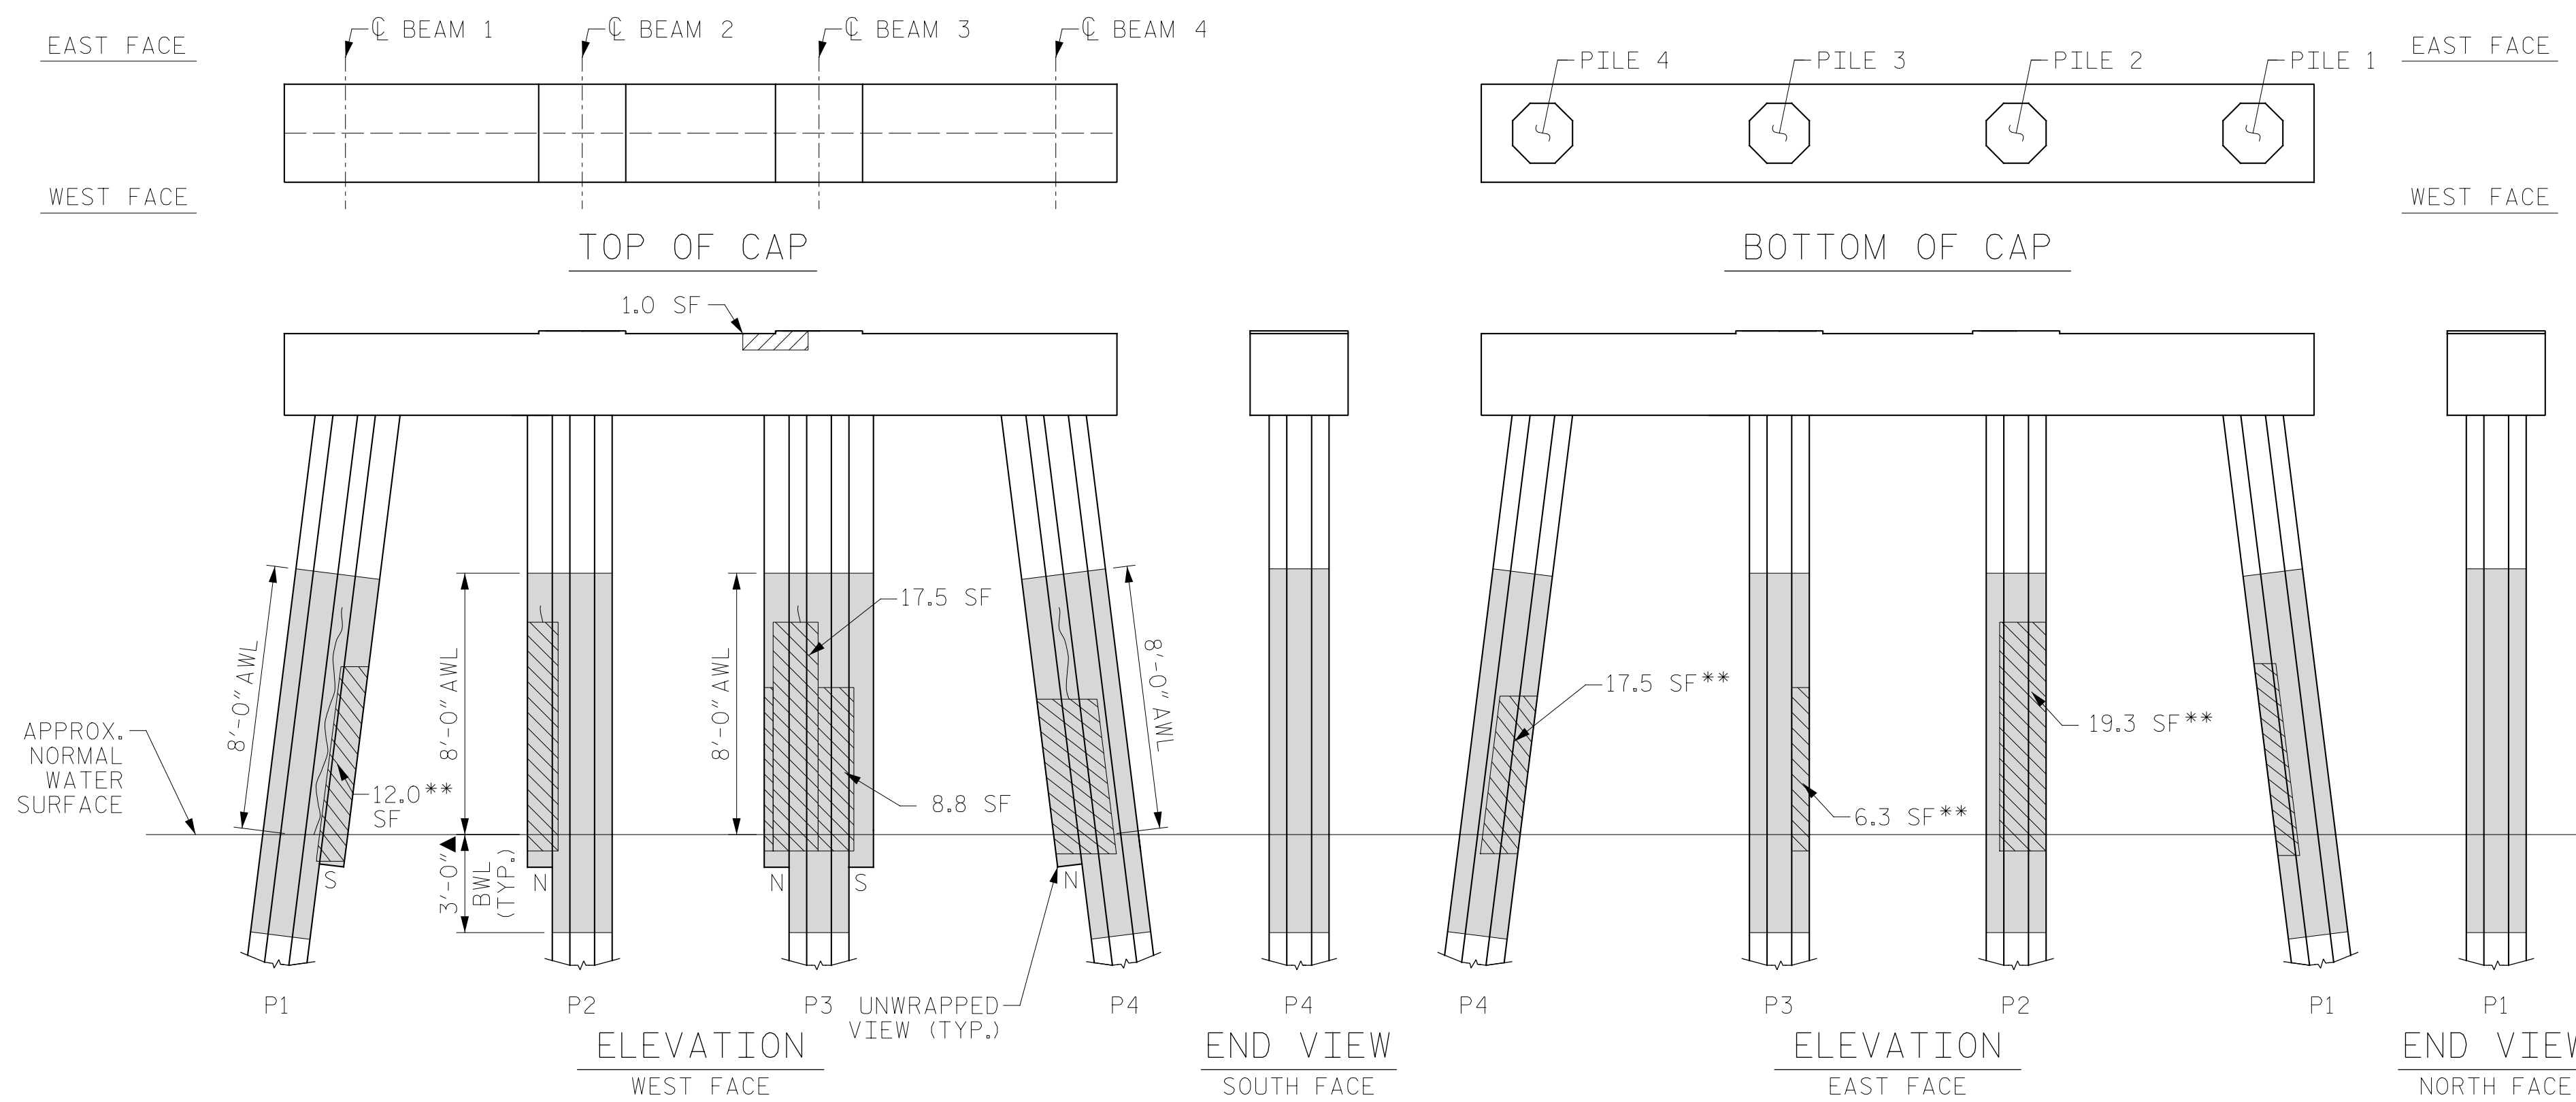
BENT 112

CAP REPAIRS			
SHOTCRETE REPAIRS	1.0 SF	0.5 CF	SF CF
EPOXY RESIN INJECTION	- LF		LF
PILE REPAIRS			
PILE CONCRETE RESTORATION	81.3 SF	31.8 CF	SF CF
FRP PROTECTIVE SYSTEM AWL	176.0 SF		
FRP PROTECTIVE SYSTEM BWL	66.0 SF
