AS-BUILT REPAIR QUANTITY TABLE

PROJECT NO. HB-0017
DARE COUNTY
BRIDGE NO. 270009

STATE OF NORTH CAROLINA
DEPARTMENT OF TRANSPORTATION
RALEIGH

BENT 113 & BENT 114

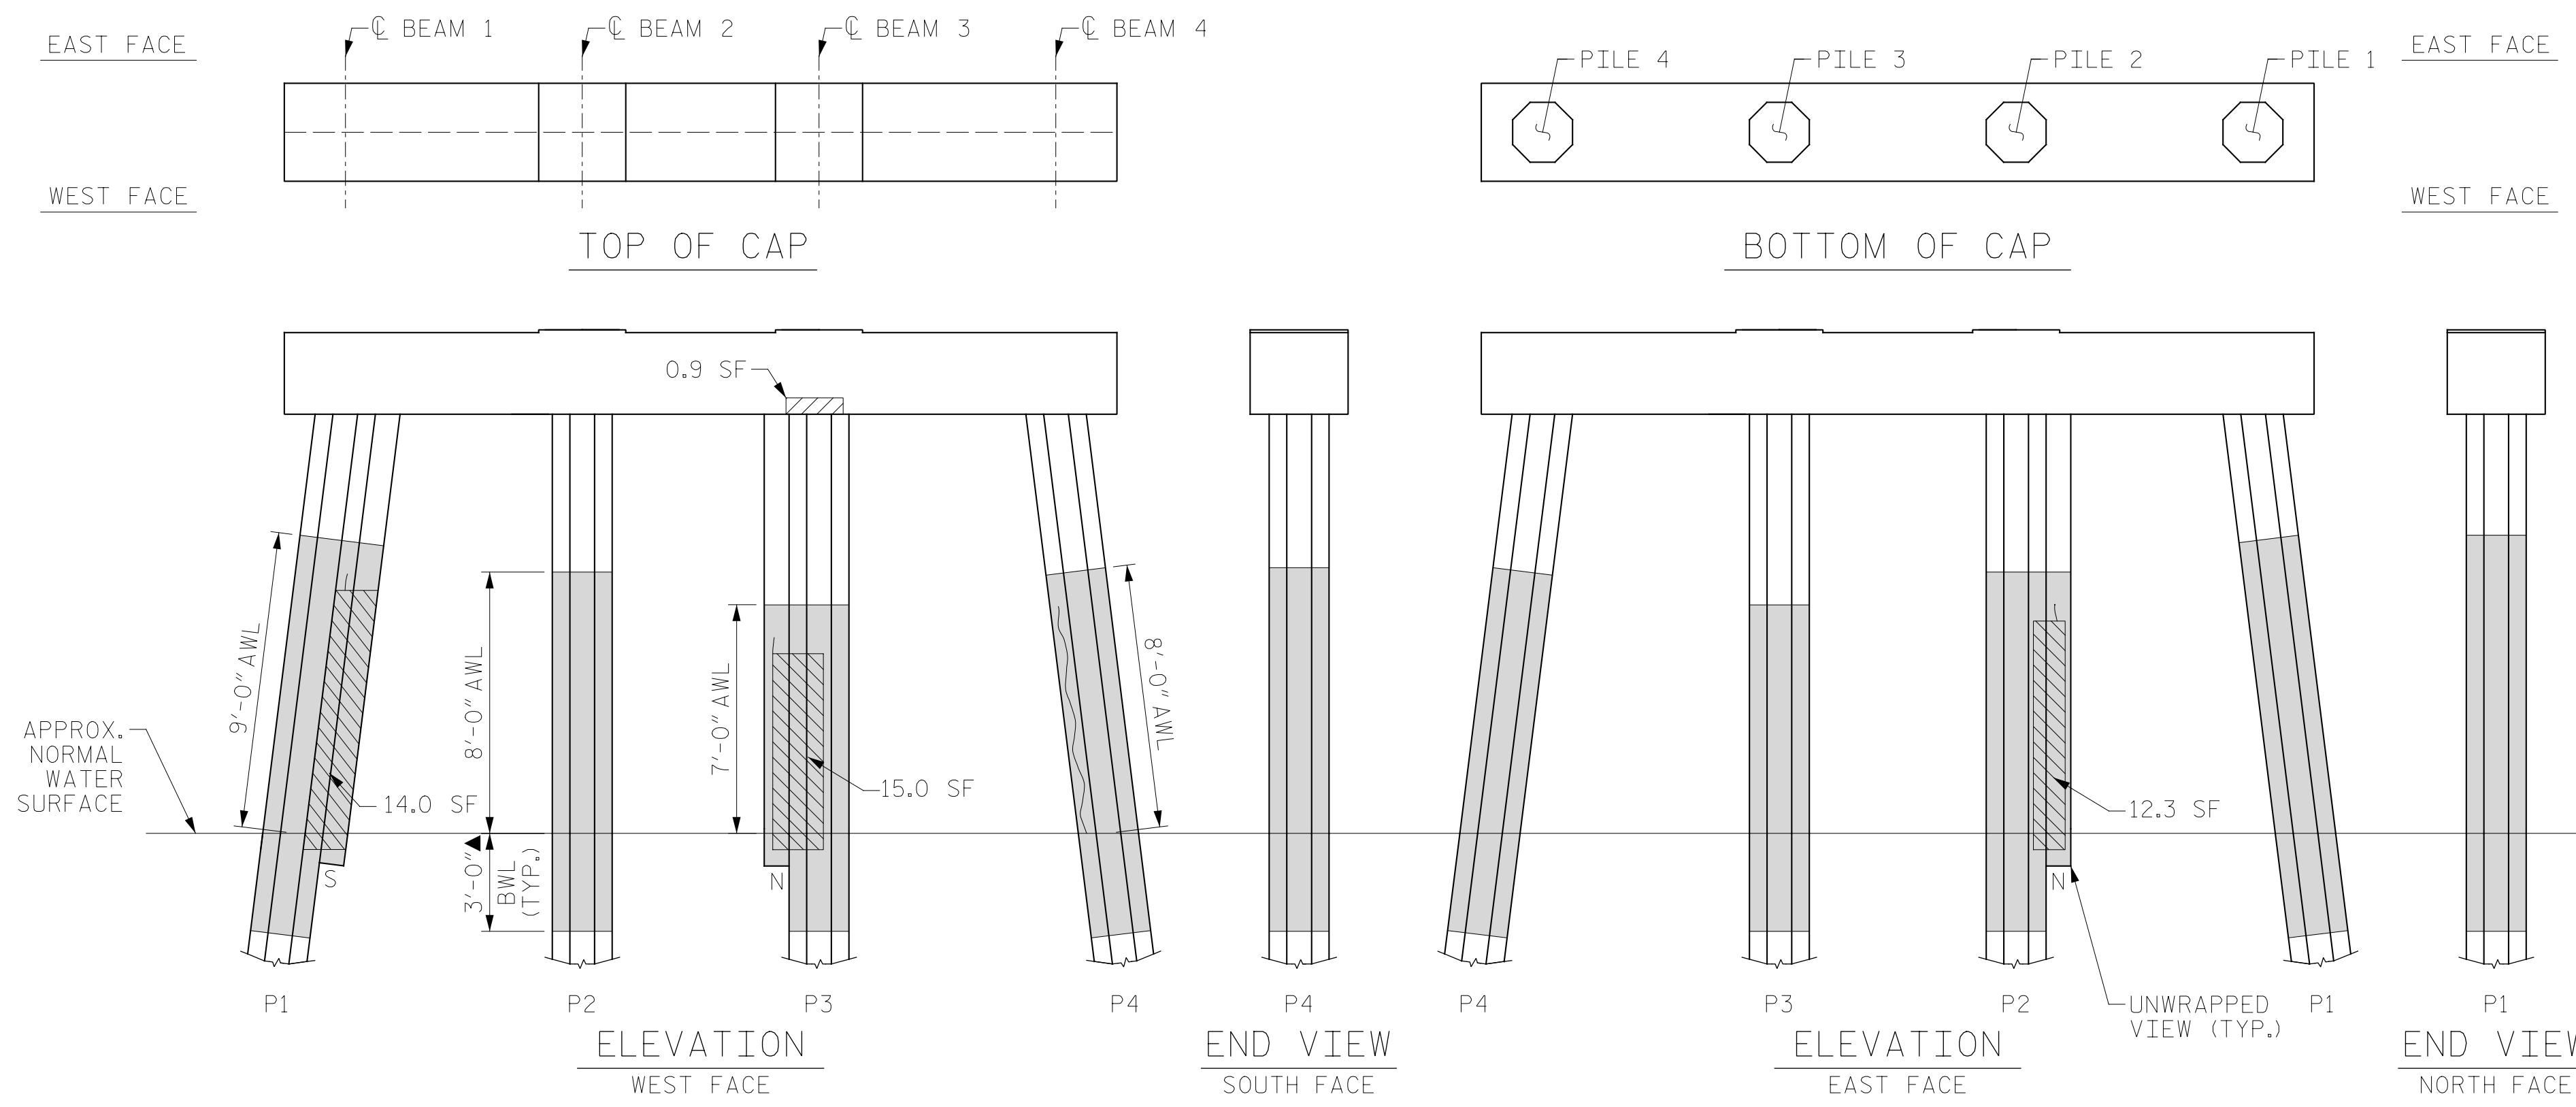
BENT 113

| CAP REPAIRS | | ESTIMATE | | ACTUAL | |
|---|---|---|---|---|---|
| SHOTCRETE REPAIRS | 0.9 SF | 0.5 CF | SF | CF | |
| PILE CONCRETE RESTORATION | 41.3 SF | 16.6 CF | SF | CF | |
| FRP PROTECTIVE SYSTEM AWL | 176.0 SF | | | | SF |
| FRP PROTECTIVE SYSTEM BWL | 66.0 SF | | | | SF |

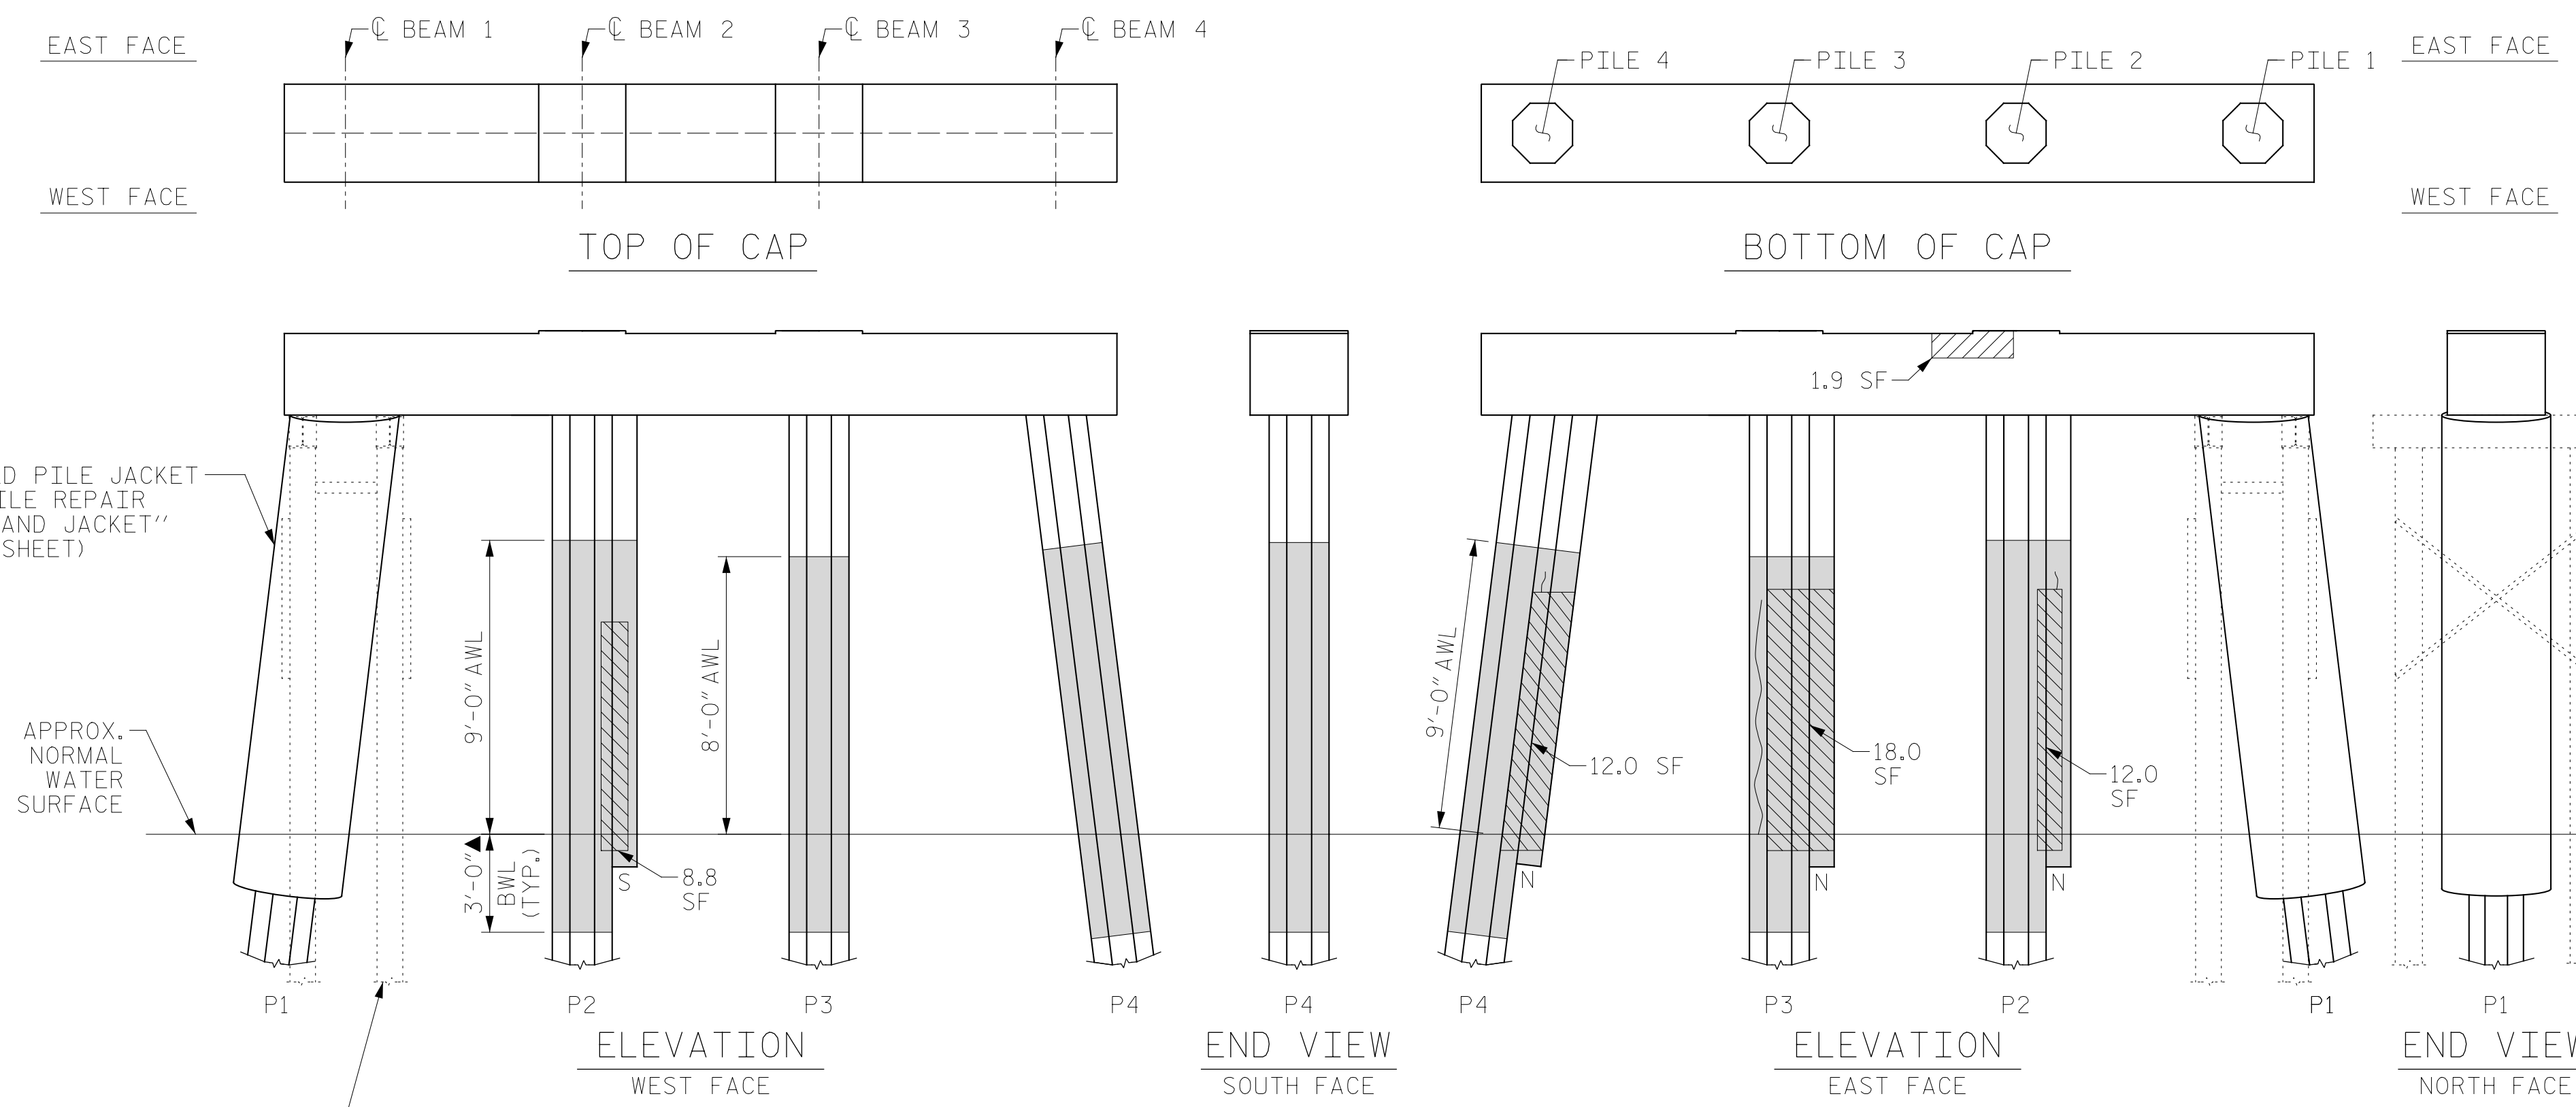
BENT 114

| CAP REPAIRS | | ESTIMATE | | ACTUAL | |
|---|---|---|---|---|---|
| SHOTCRETE REPAIRS | 1.9 SF | 1.0 CF | SF | CF | |
| PILE CONCRETE RESTORATION | 50.8 SF | 21.7 CF | SF | CF | |
| FRP PROTECTIVE SYSTEM AWL | 143.0 SF | | | | SF |
| FRP PROTECTIVE SYSTEM BWL | 49.5 SF | | | | SF |
| PILE SPLICE AND PRELOAD | 14 LF | | | | LF |
| FRP PROTECTIVE SYSTEM BWL | 15 LF | | | | LF |
