ELEVATION WEST FACE

AS-BUILT	REPAIR	QUANTITY	TABLE
	BENT	120

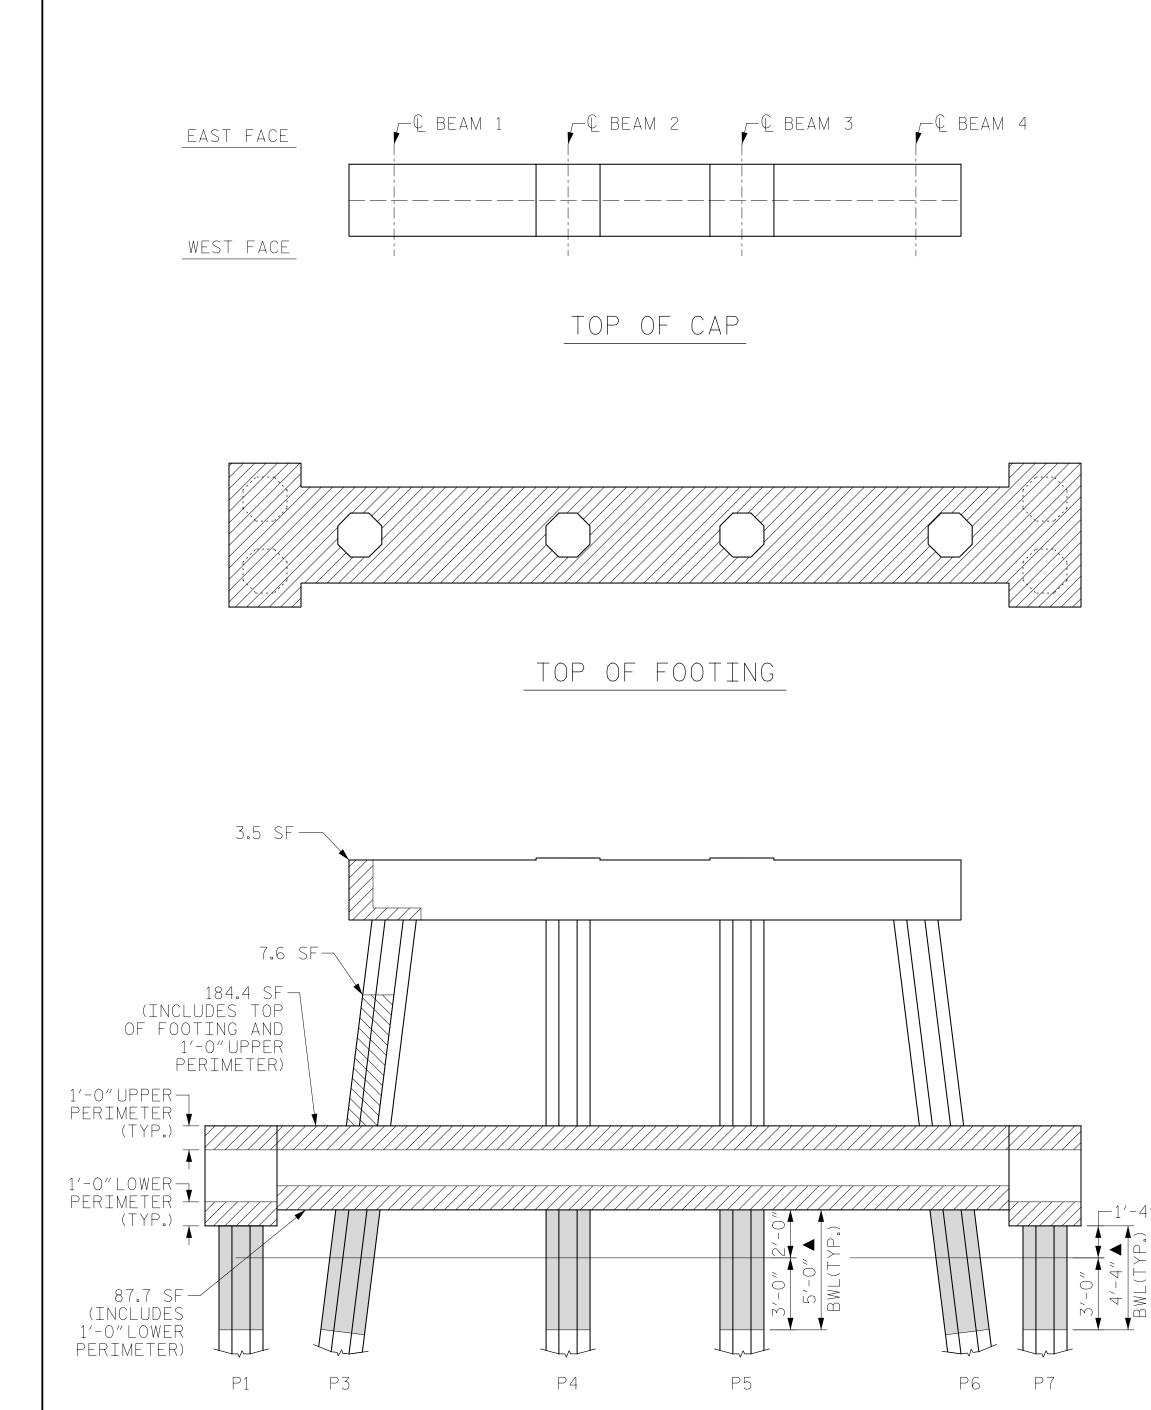
CAP/FOOTING REPAIRS	-		-	
SHOTCRETE REPAIRS	283.1 SF	141.6 CF	SF	CF
EPOXY RESIN INJECTION	- LF			LF
PILE REPAIRS	-			
PILE CONCRETE RESTORATION	7.6 SF	3.7 CF	SF	CF
FRP PROTECTIVE SYSTEM AWL	- SF			-
FRP PROTECTIVE SYSTEM BWL	205.2 SF

FOR CAP REPAIRS: VALUES IN CHART REPRESENT ESTIMATED REPAIR TOTALS AFTER REMOVAL OF UNSOUND CONCRETE, MIN. OF 1"BEHIND REBAR AND MIN. 2"CL TO SAWCUT. SEE REPAIR DETAILS.
