PROJECT NO	HB-0017
DARE	COUNTY
BRIDGE NO	270009

STATE OF NORTH CAROLINA DEPARTMENT OF TRANSPORTATION RALEIGH

SHEET NO REVISIONS S-193 NO. BY: DATE: BY: DATE: DOCUMENT NOT CONSIDERED FINAL UNLESS ALL SIGNATURES COMPLETED TOTAL SHEETS 355

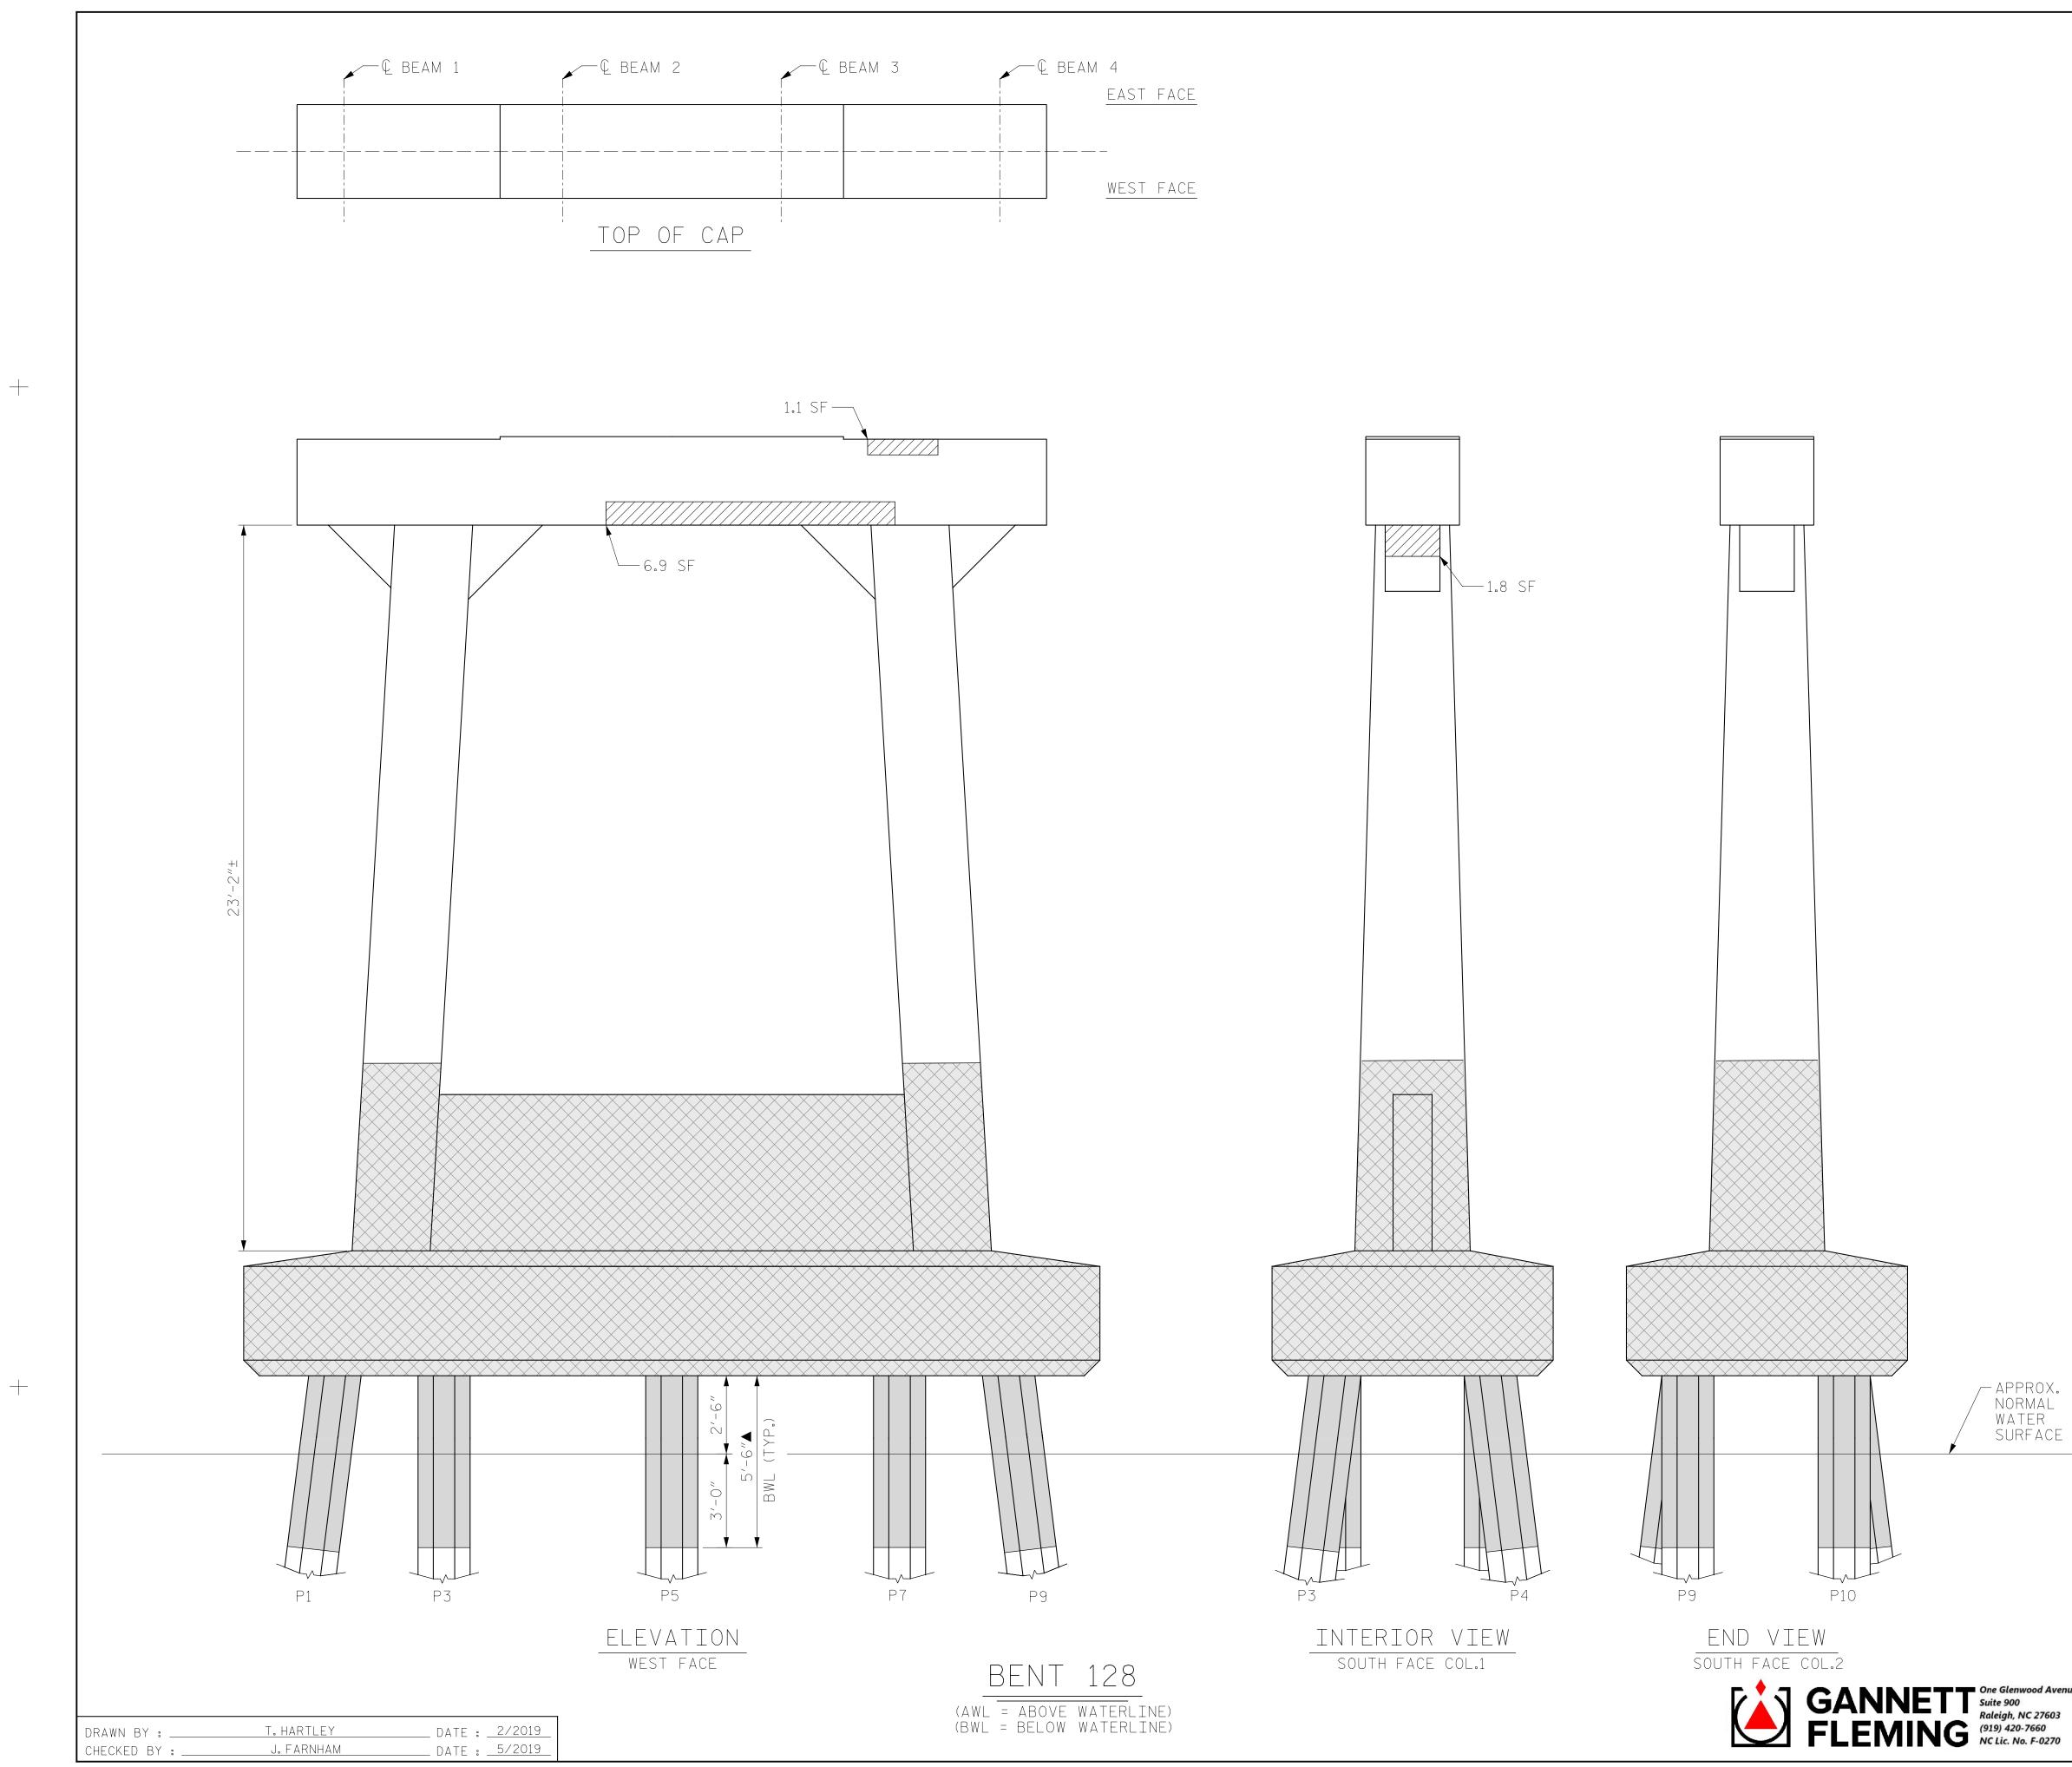
AS-BUILT REPAIR QUANTITY TABLE				
BENT 128				
CAP REPAIRS	ESTIMATE		ACTUAL	
SHOTCRETE REPAIRS	9.8 SF	4.9 CF	SF	CF
EPOXY RESIN INJECTION	- LF			LF
COLUMN REPAIRS	ESTIMATE		ACTUAL	
SHOTCRETE REPAIRS	44.3 SF	22.2 CF	SF	CF
EPOXY RESIN INJECTION	- LF		LF	
PILE REPAIRS	ESTIMATE		ACTUAL	
FRP PROTECTIVE SYSTEM AWL	- SF		SF	
FRP PROTECTIVE SYSTEM BWL	302.5 SF		SF

FOR CAP REPAIRS: VALUES IN CHART REPRESENT ESTIMATED REPAIR TOTALS AFTER REMOVAL OF UNSOUND CONCRETE, MIN. OF 1"BEHIND REBAR AND MIN. 2"CL TO SAWCUT. SEE REPAIR DETAILS.

▲ FRP PROTECTIVE SYSTEM BELOW WATERLINE MAY INCLUDE APPROVED UNDERWATER MORTAR REPAIRS

REPAIR LOCATIONS AND ESTIMATE OF QUANTITIES ARE GIVEN WITH THE BEST INFORMATION AVAILABLE. IF ADDITIONAL REPAIRS NOT SHOWN ON THE DRAWINGS ARE DEEMED NECESSARY BY THE ENGINEER THE CONTRACTOR SHALL NOTE ON THE DRAWINGS THE APPROXIMATE LOCATION AND DESCRIPTION OF THE REPAIRS AND ADJUST THE ACTUAL QUANTITIES ENTERED INTO THE REPAIR QUANTITY TABLE.
