HB-0017 DARE COUNTY 270009

STATE OF NORTH CAROLINA

BENT 129

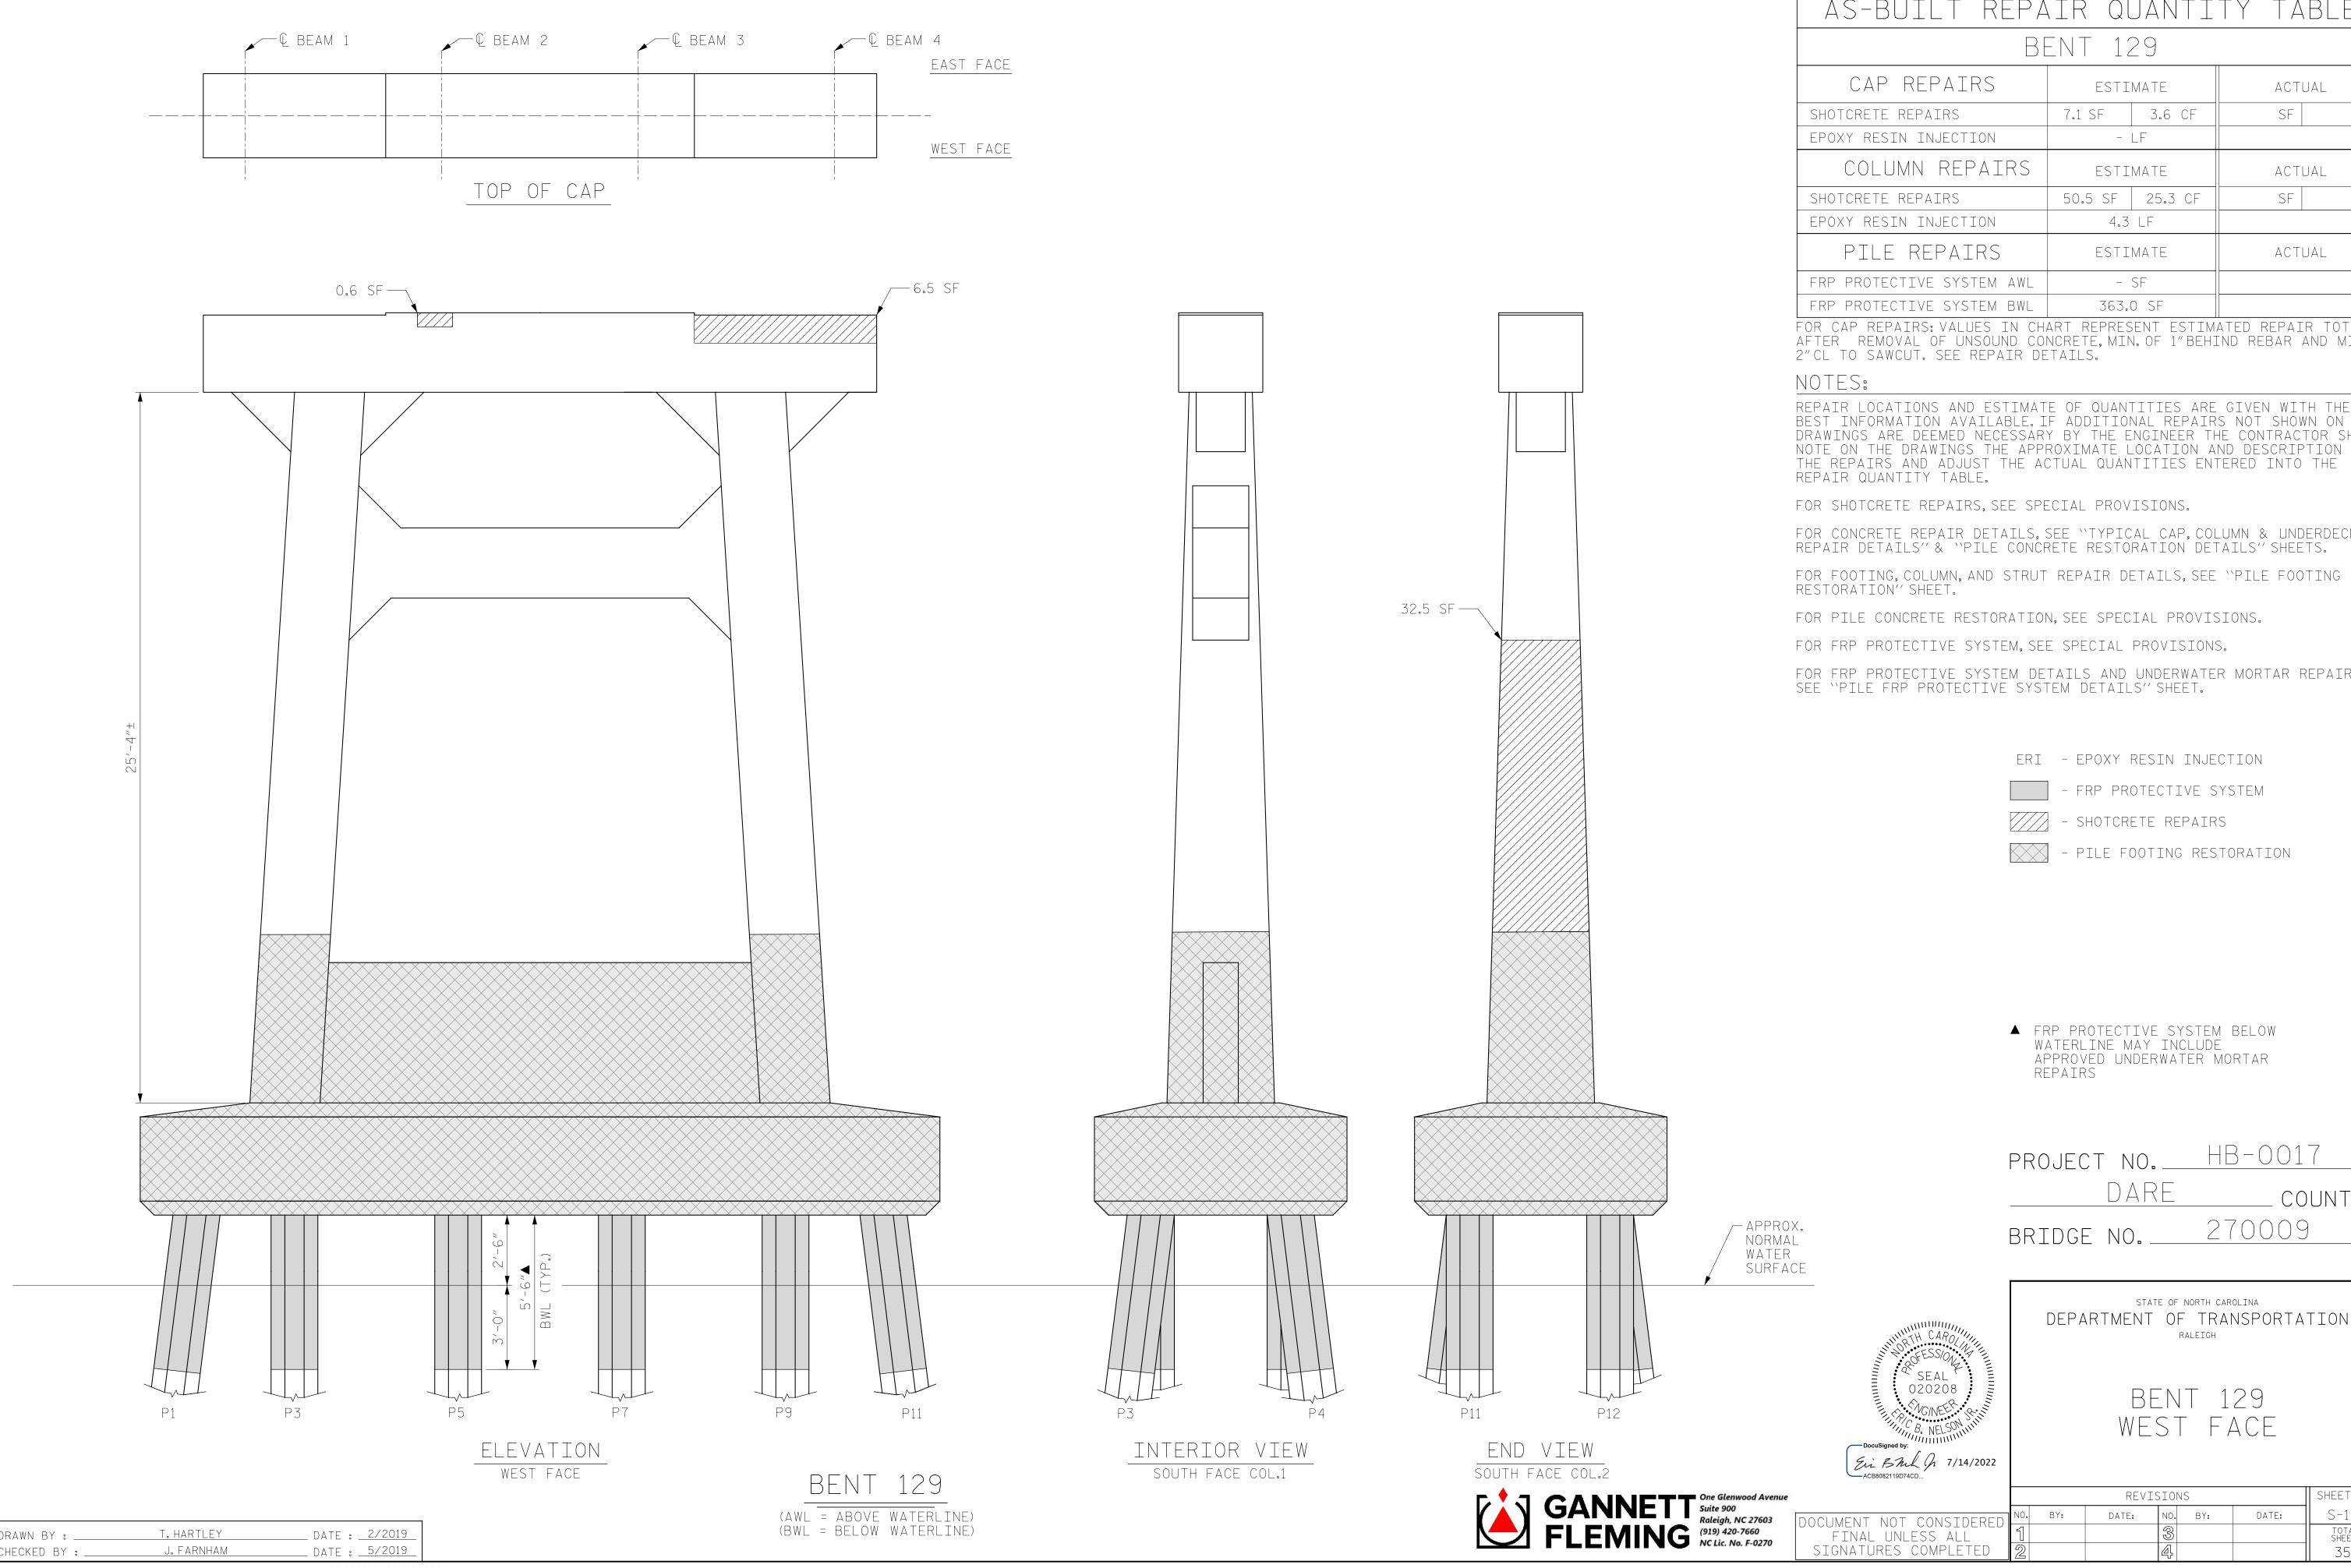
B	$\equiv$ NT 13	29		
CAP REPAIRS	ESTIMATE		ACTUAL	
SHOTCRETE REPAIRS	7.1 SF	3.6 CF	SF	Cf
EPOXY RESIN INJECTION	- LF			LF
COLUMN REPAIRS	ESTIMATE		ACTUAL	
SHOTCRETE REPAIRS	50.5 SF	25.3 CF	SF	CF
EPOXY RESIN INJECTION	4.3 LF		LF	
PILE REPAIRS	ESTIMATE		ACTUAL	
FRP PROTECTIVE SYSTEM AWL	- SF		SF	
ERP PROTECTIVE CYCTEM RWI	363 A SE		2

- FOR CONCRETE REPAIR DETAILS, SEE "TYPICAL CAP, COLUMN & UNDERDECK REPAIR DETAILS" & "PILE CONCRETE RESTORATION DETAILS" SHEETS.
- FOR FOOTING, COLUMN, AND STRUT REPAIR DETAILS, SEE "PILE FOOTING
- FOR PILE CONCRETE RESTORATION, SEE SPECIAL PROVISIONS.
- FOR FRP PROTECTIVE SYSTEM, SEE SPECIAL PROVISIONS.
- FOR FRP PROTECTIVE SYSTEM DETAILS AND UNDERWATER MORTAR REPAIRS, SEE "PILE FRP PROTECTIVE SYSTEM DETAILS" SHEET.
