AS-BUILT REPAIR QUANTITY TABLE

PROJECT NO. DARE COUNTY 270009 BRIDGE NO.\_

STATE OF NORTH CAROLINA DEPARTMENT OF TRANSPORTATION RALEIGH

> BENT 141 WEST FACE

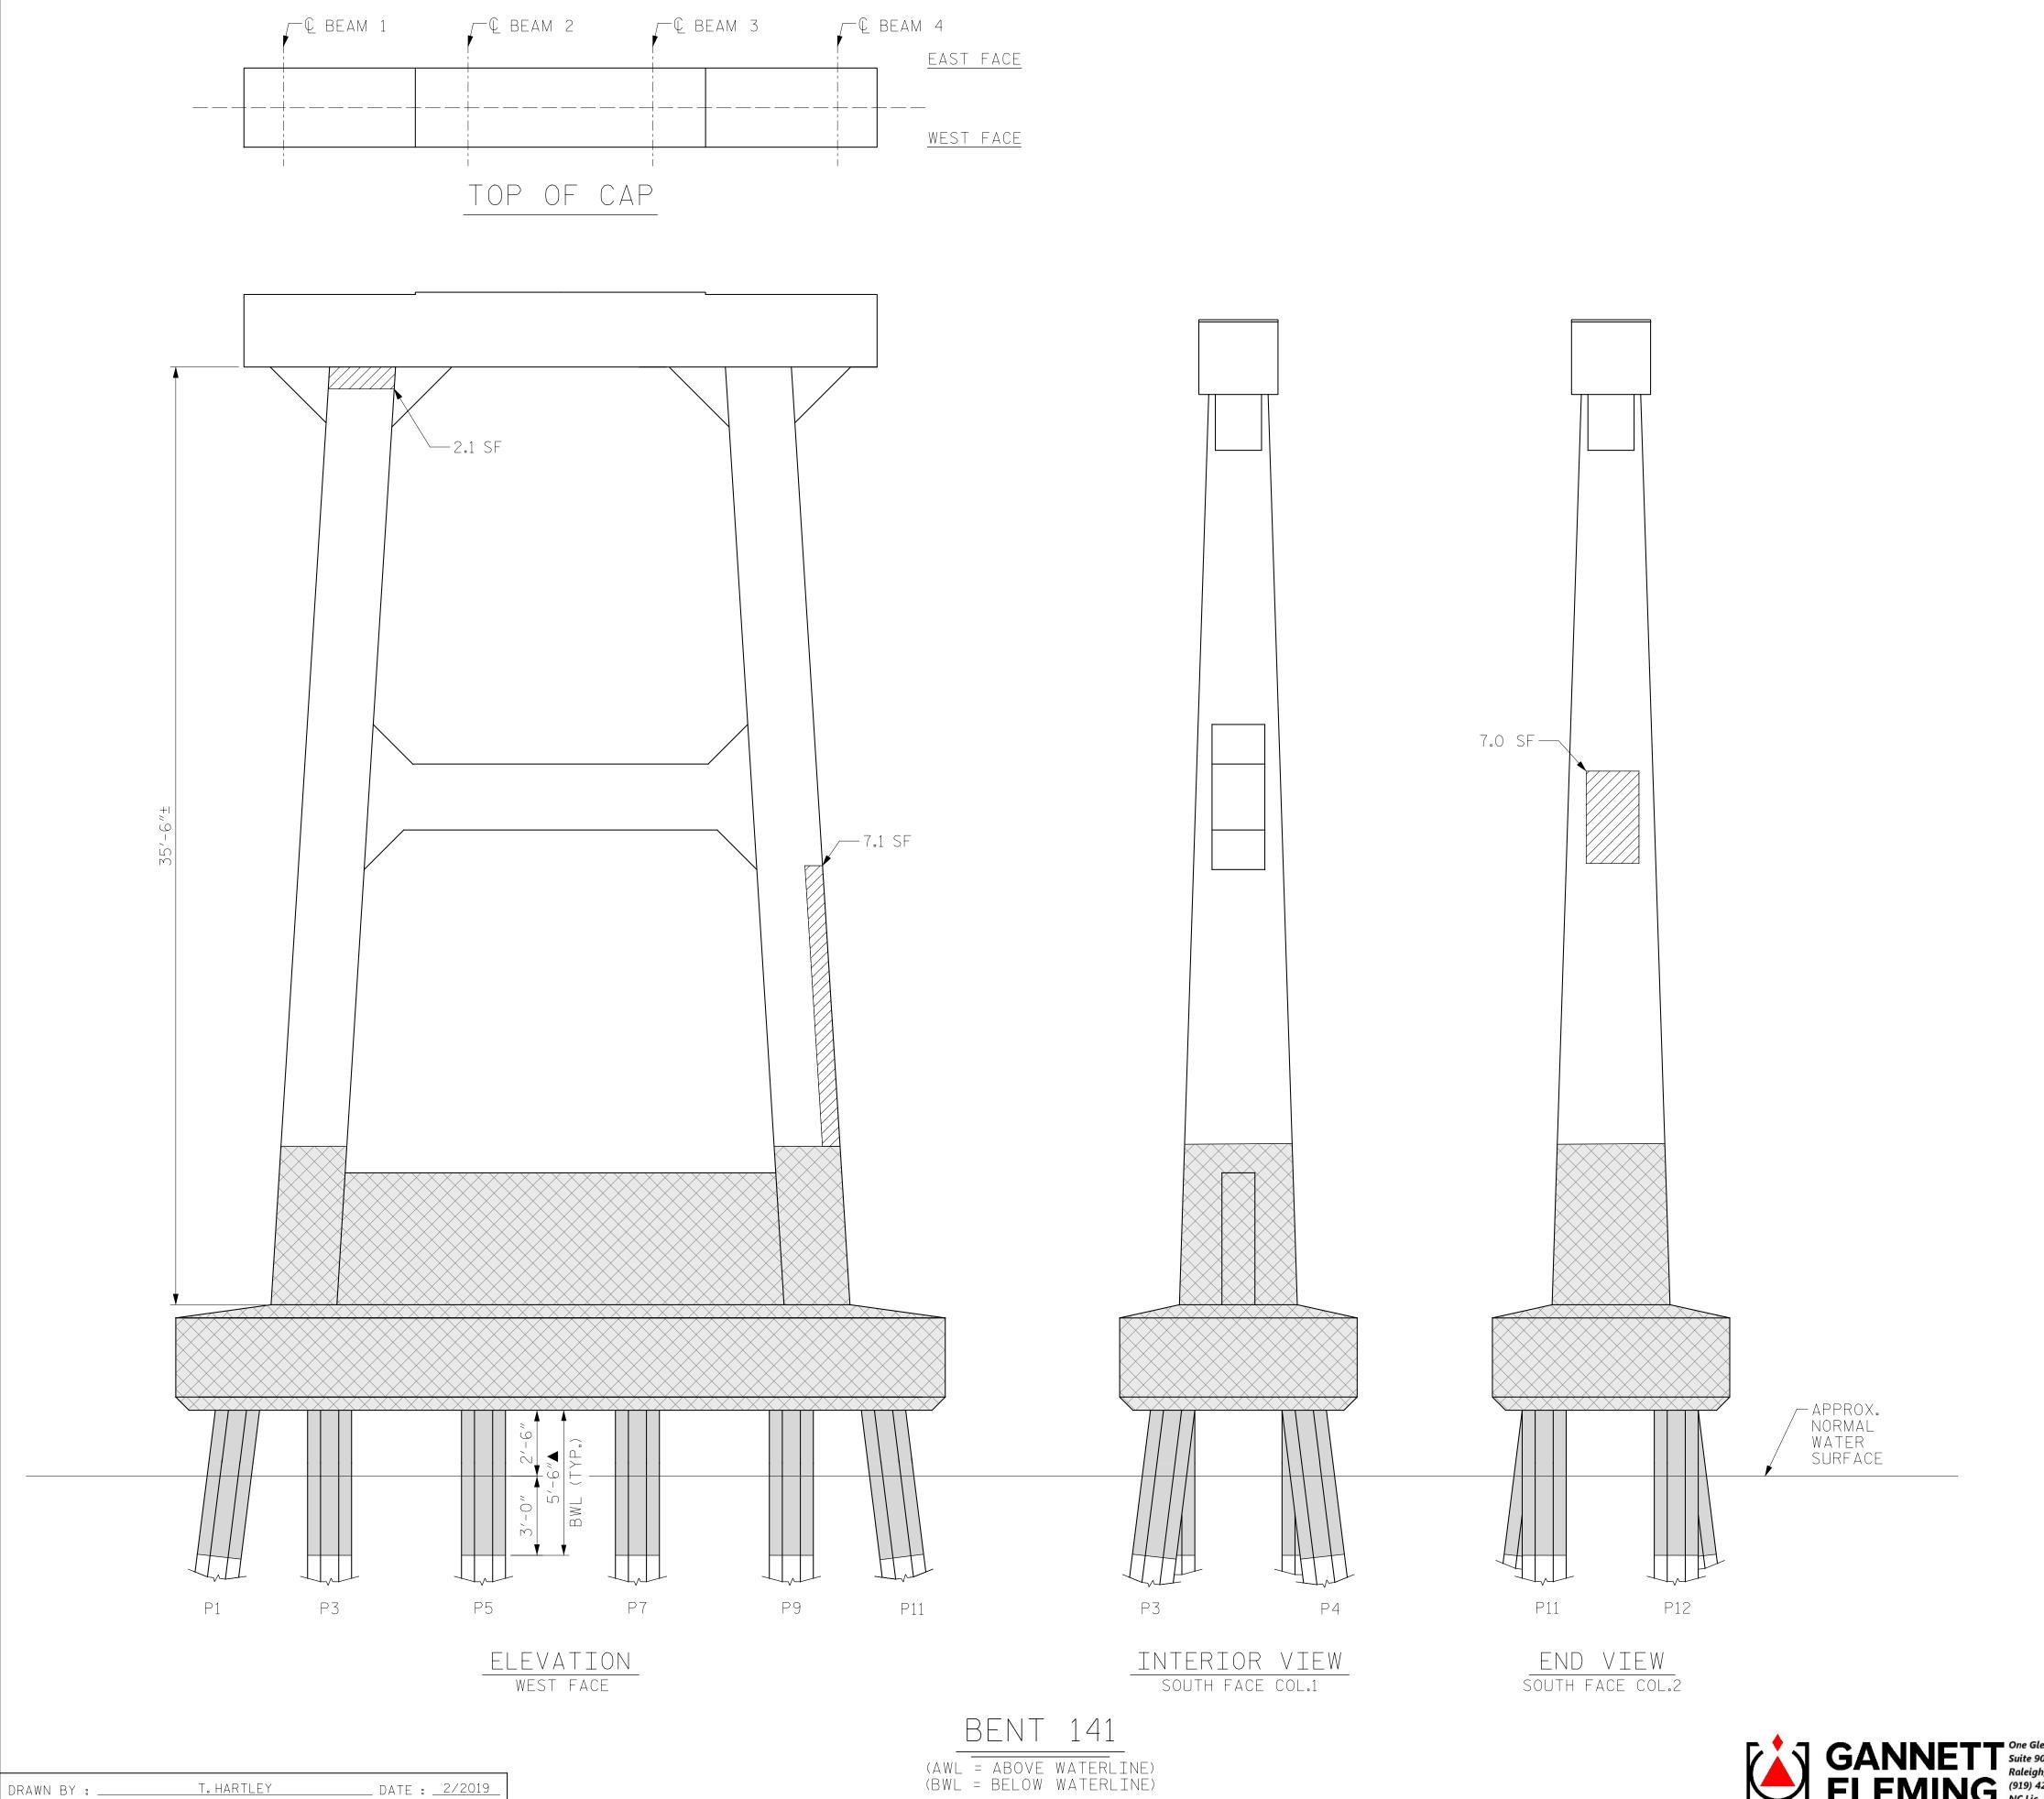
BENT 141				
	CAP REPAIRS	ESTIMATE		ACTUAL	
	SHOTCRETE REPAIRS	1.5 SF	0.8 CF	SF	CF
	EPOXY RESIN INJECTION	- LF ESTIMATE		LF	
	COLUMN REPAIRS			ACTUAL	
	SHOTCRETE REPAIRS	60.2 SF	30.1 CF	SF	CF
	EPOXY RESIN INJECTION	- LF ESTIMATE			LF
	PILE REPAIRS			ACTUAL	
	FRP PROTECTIVE SYSTEM AWL	- SF		SF	
	FRP PROTECTIVE SYSTEM BWL	363.0 SF		SF
