AS-BUILT REPAIR QUANTITY TABLE

PROJECT NO. HB-001/
DARE COUNTY
BRIDGE NO. 270009

BENT 143 WEST FACE

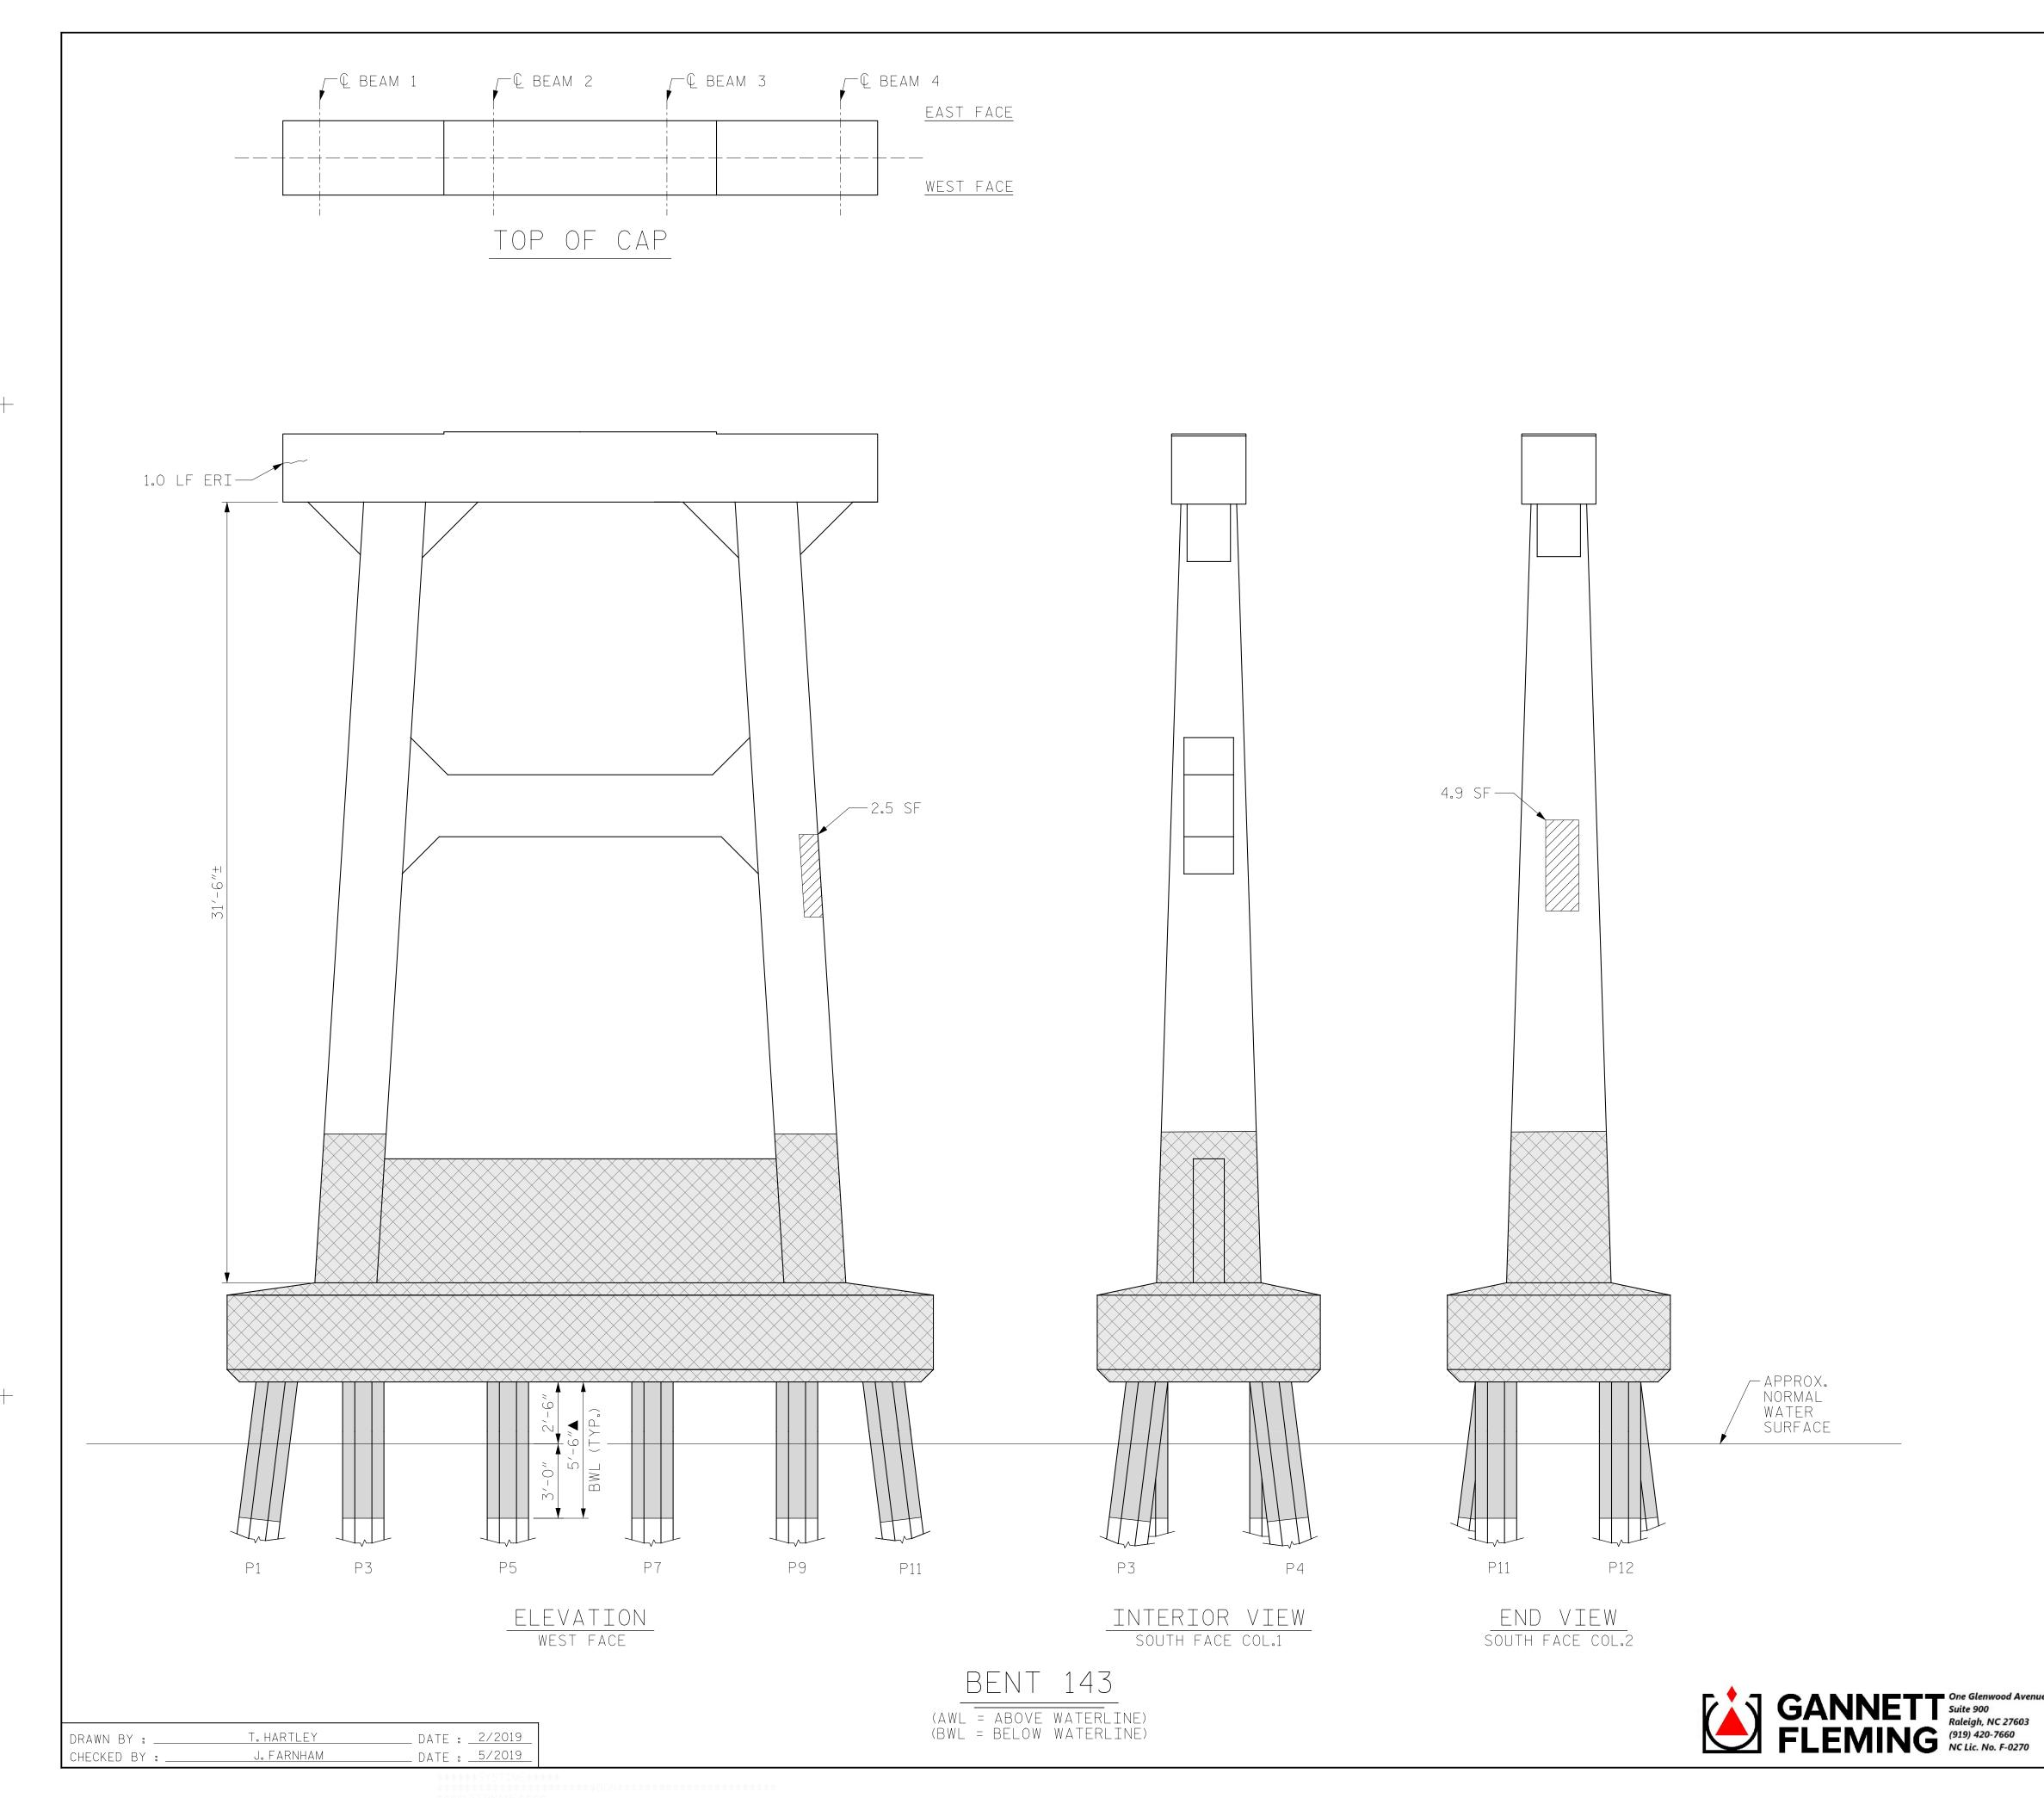
BENT 143									
CAP REPAIRS	ESTIMATE		ACTUAL						
SHOTCRETE REPAIRS	- SF	- CF	SF	CF					
EPOXY RESIN INJECTION	4.0 LF			LF					
COLUMN REPAIRS	ESTIMATE		ACTUAL						
SHOTCRETE REPAIRS	8.9 SF	4.5 CF	SF	CF					
EPOXY RESIN INJECTION	- LF			LF					
PILE REPAIRS	ESTIMATE		ACTUAL						
FRP PROTECTIVE SYSTEM AWL	- SF		SF						
FRP PROTECTIVE SYSTEM BWL	363.0 SF			SF

♠ FRP PROTECTIVE SYSTEM BELOW WATERLINE MAY INCLUDE APPROVED UNDERWATER MORTAR REPAIRS
