AS-BUILT REPA	AIR QUANTITY TABLE									
BENT 161										
CAP REPAIRS										
SHOTCRETE REPAIRS	9.8 SF	4.9 CF	SF	CF						
EPOXY RESIN INJECTION	_	LF		LF						
PILE REPAIRS										
PILE CONCRETE RESTORATION	70.0 SF	27.6 CF	SF	CF						
FRP PROTECTIVE SYSTEM AWL	201.	3 SF								
FRP PROTECTIVE SYSTEM BWL	73.2	2 SF								
BENT 162										
CAP REPAIRS										
SHOTCRETE REPAIRS	1.5 SF	0.8 CF	SF	CF						
EPOXY RESIN INJECTION	_	LF		LF						
PILE REPAIRS										
PILE CONCRETE RESTORATION	70.0 SF	27.5 CF	SF	CF						
FRP PROTECTIVE SYSTEM AWL	213.	5 SF								
FRP PROTECTIVE SYSTEM BWL	73.2	2 SF								
EAR CAR REPAIRS VALUES IN CHART REPRESENT ESTIMATER REPAIR TATALS

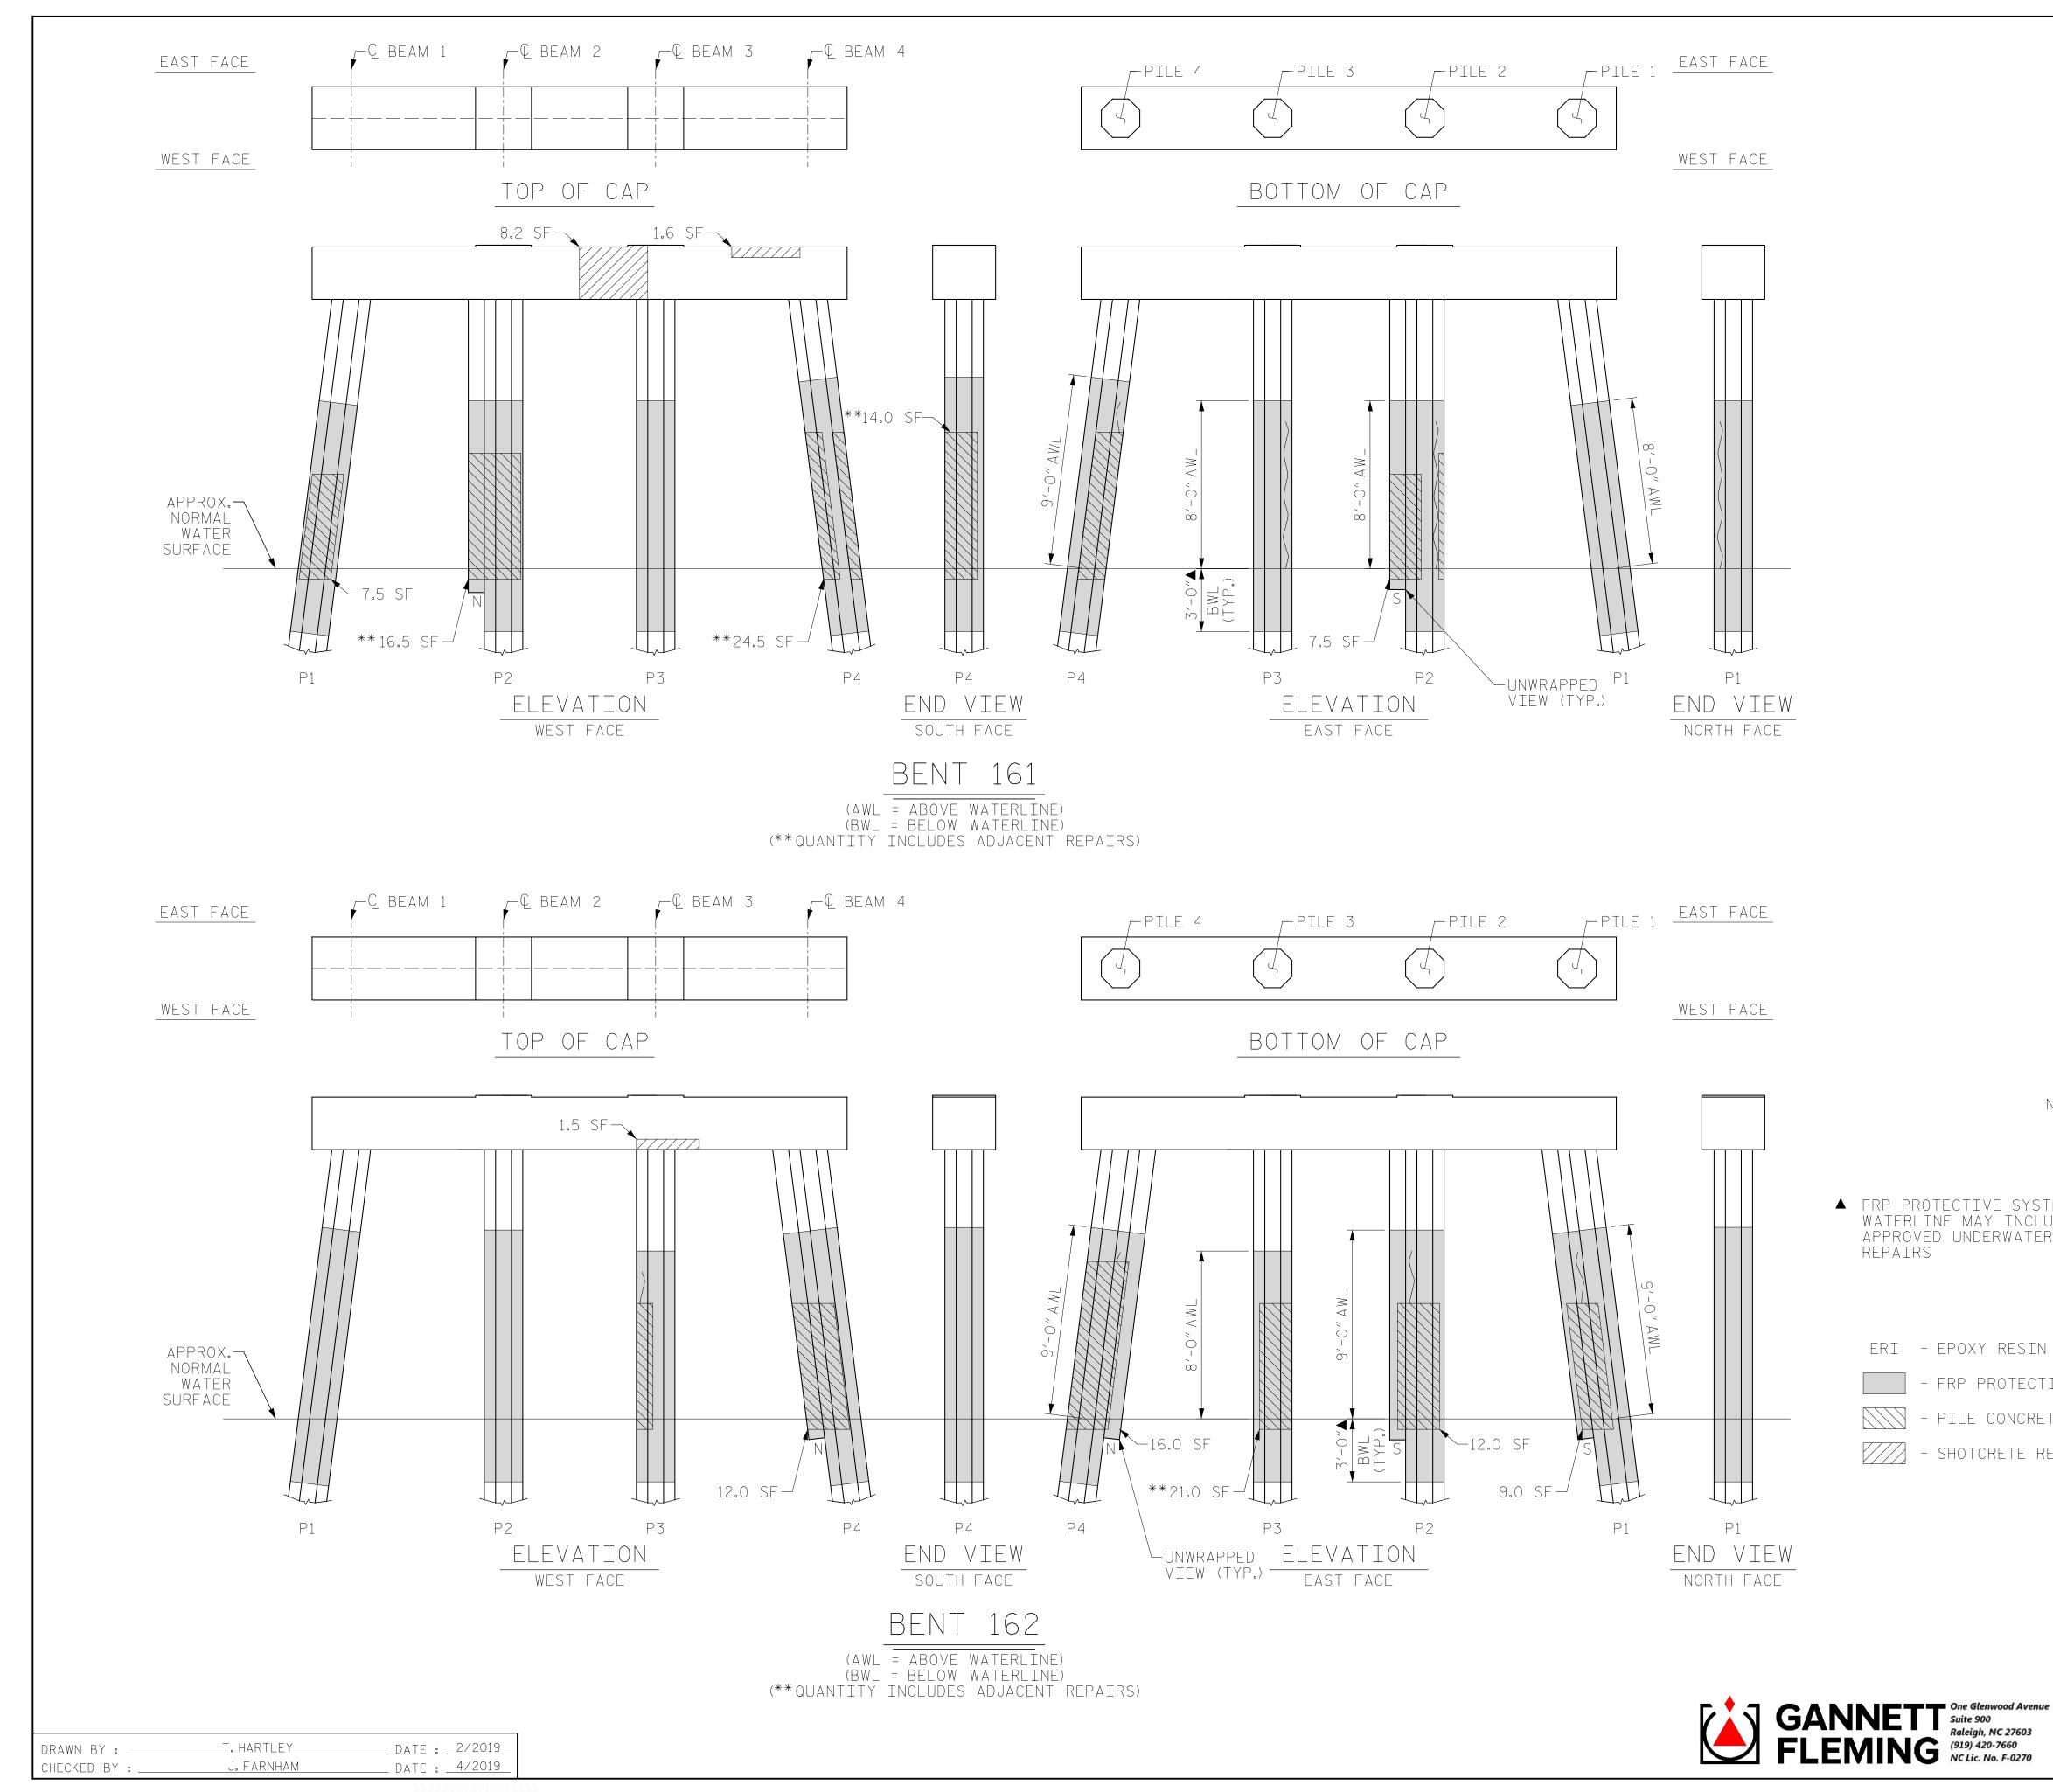
ESTIMATED PILE CRACK QTY. TABLE								E	
E			NW	W	SW	S	SE	E	NE	N
NE SE BENT		PILE 1	3	1	_	3	_	7	7	5
	BENT	PILE 2	-	-	-	-	_	4	7	_
	161	PILE 3	6	1	3	3	12	4	7	7
NW SW		PILE 4	_	5	1	-	_	_	2	-
W		PILE 1	5	6	4	_	3	_	6	6
TEM BELOW UDE	BENT	PILE 2	7	-	4	_	3	2	7	3
R MORTAR	162	PILE 3	2	3	2	6	_	_	_	1
		PILE 4	1	-	3	3	2	_	1	2
NOTE: FOR INFORMATION ON PILE CONDITION ONLY.										
		PROJEC) T (NO.		- [3-(17	
N INJECTION	ľ		_					0		
rive system								ΛΤΥ		
ete restoration BRIDGE NO. 27					70($\bigcirc \bigcirc$	9			
REPAIRS]									
STATE OF NORTH CAROLINA							$\cap \mathbb{N}$			
	DEPARTMENT OF TRANSPORTATION Raleigh									
	FESS/ON THE									
	SEAL 20208									
	VGINEER &	REN	T	16	1 2	, F	RFN	NΤ	16	52
DEPARTMENT OF TRANSPORTATION RALEIGH BENT 161 & BENT 162 BENT 162										
DocuSigned by: F_{11} F_{12} $F_{14}/2022$										
ACB8082119D74CD										
le		NO, BY:		REVISIONS DATE: NO. BY: DAT				ATE:		EET NO. S-250

FOR CAP REPAIRS: VALUES IN CHART REPRESENT ESTIMATED REPAIR TOTALS AFTER REMOVAL OF UNSOUND CONCRETE, MIN. OF 1"BEHIND REBAR AND MIN. 2" CL. TO SAWCUT. SEE REPAIR DETAILS. NOTES:

FOR CONCRETE REPAIR DETAILS, SEE ``TYPICAL CAP, COLUMN & UNDERDECK REPAIR DETAILS'' & ``PILE CONCRETE RESTORATION DETAILS'' SHEETS. FOR PILE CONCRETE RESTORATION, SEE SPECIAL PROVISIONS.

FOR FRP PROTECTIVE SYSTEM DETAILS AND UNDERWATER MORTAR REPAIRS, SEE ``PILE FRP PROTECTIVE SYSTEM DETAILS'' SHEET.
