AS-BUILT REPAIR QUANTITY TABLE

PROJECT NO. HB-0017
DARE COUNTY
 BRIDGE NO. 270009

BENT 163 & BENT 164

REVISIONS						SHEET NO.
NO.	BY:	DATE:	NO.	BY:	DATE:	S-251
1			3			TOTAL SHEETS
2			4			355

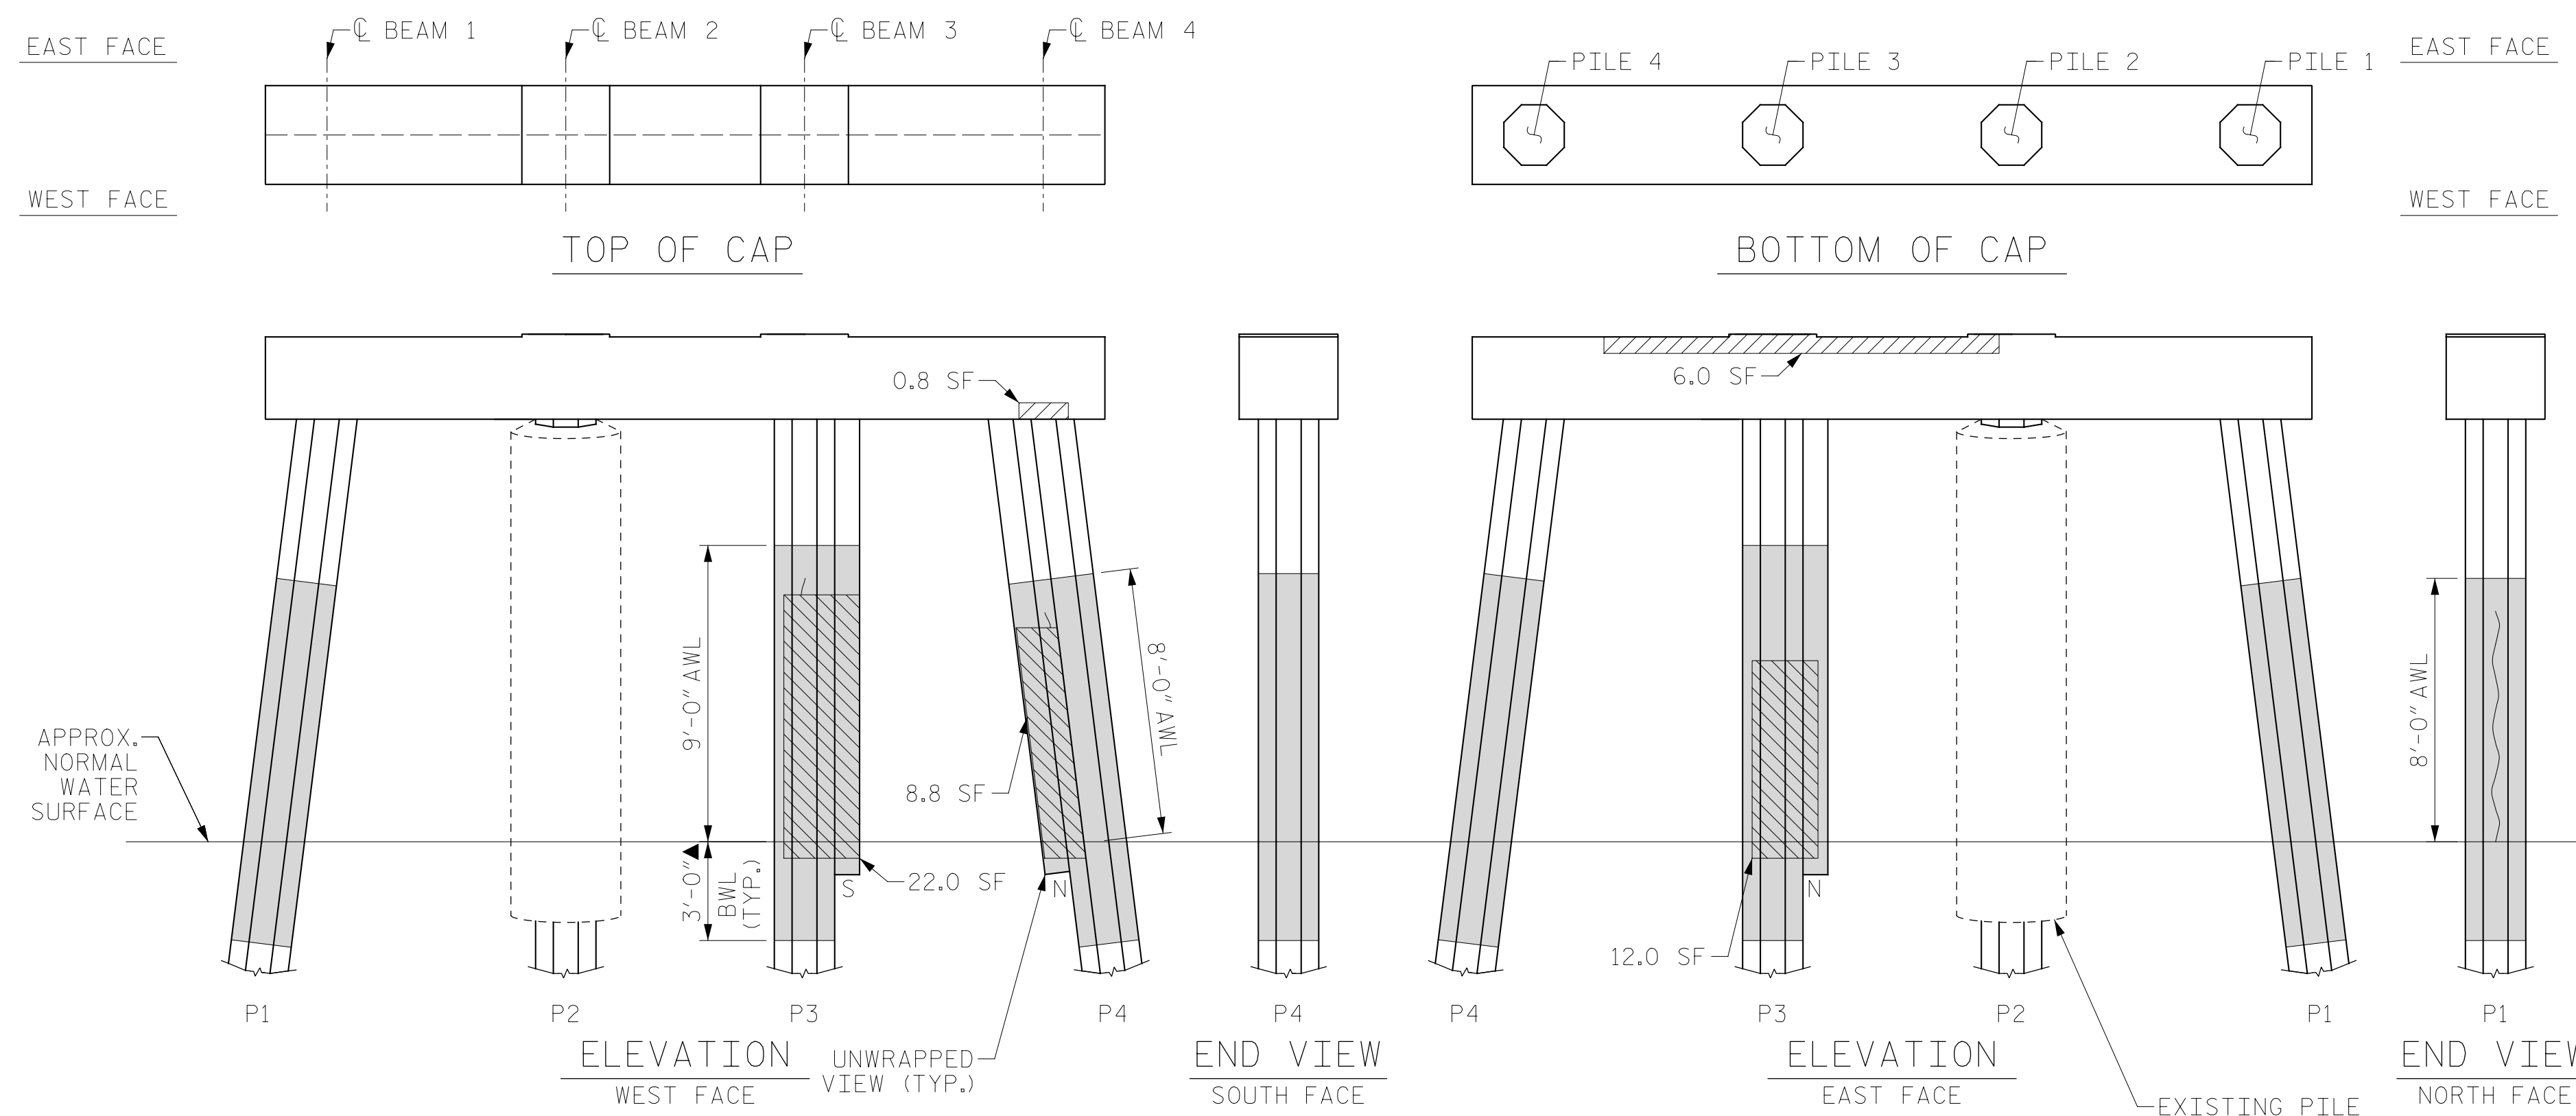
CAP REPAIRS			
SHOTCRETE REPAIRS	6.8 SF	3.4 CF	SF CF
EPOXY RESIN INJECTION	- LF		LF
PILE REPAIRS			
PILE CONCRETE RESTORATION	42.8 SF	17.1 CF	SF CF
FRP PROTECTIVE SYSTEM AWL	152.5 SF		
FRP PROTECTIVE SYSTEM BWL	54.9 SF

NW	W	SW	S	SE	E	NE	N
BENT 163	PILE 1	6	4	6	-	4	-	2	7
	PILE 2	-	-	-	-	-	-	-	-
	PILE 3	-	1	-	-	3	-	2	5
	PILE 4	1	4	4	6	-	-	-	-
BENT 164	PILE 1	-	-	-	-	-	3	3	-
	PILE 2	18	-	-	-	5	-	-	3
	PILE 3	5	-	7	-	4	7	5	-
	PILE 4	6	-	12	-	-	-	2	-

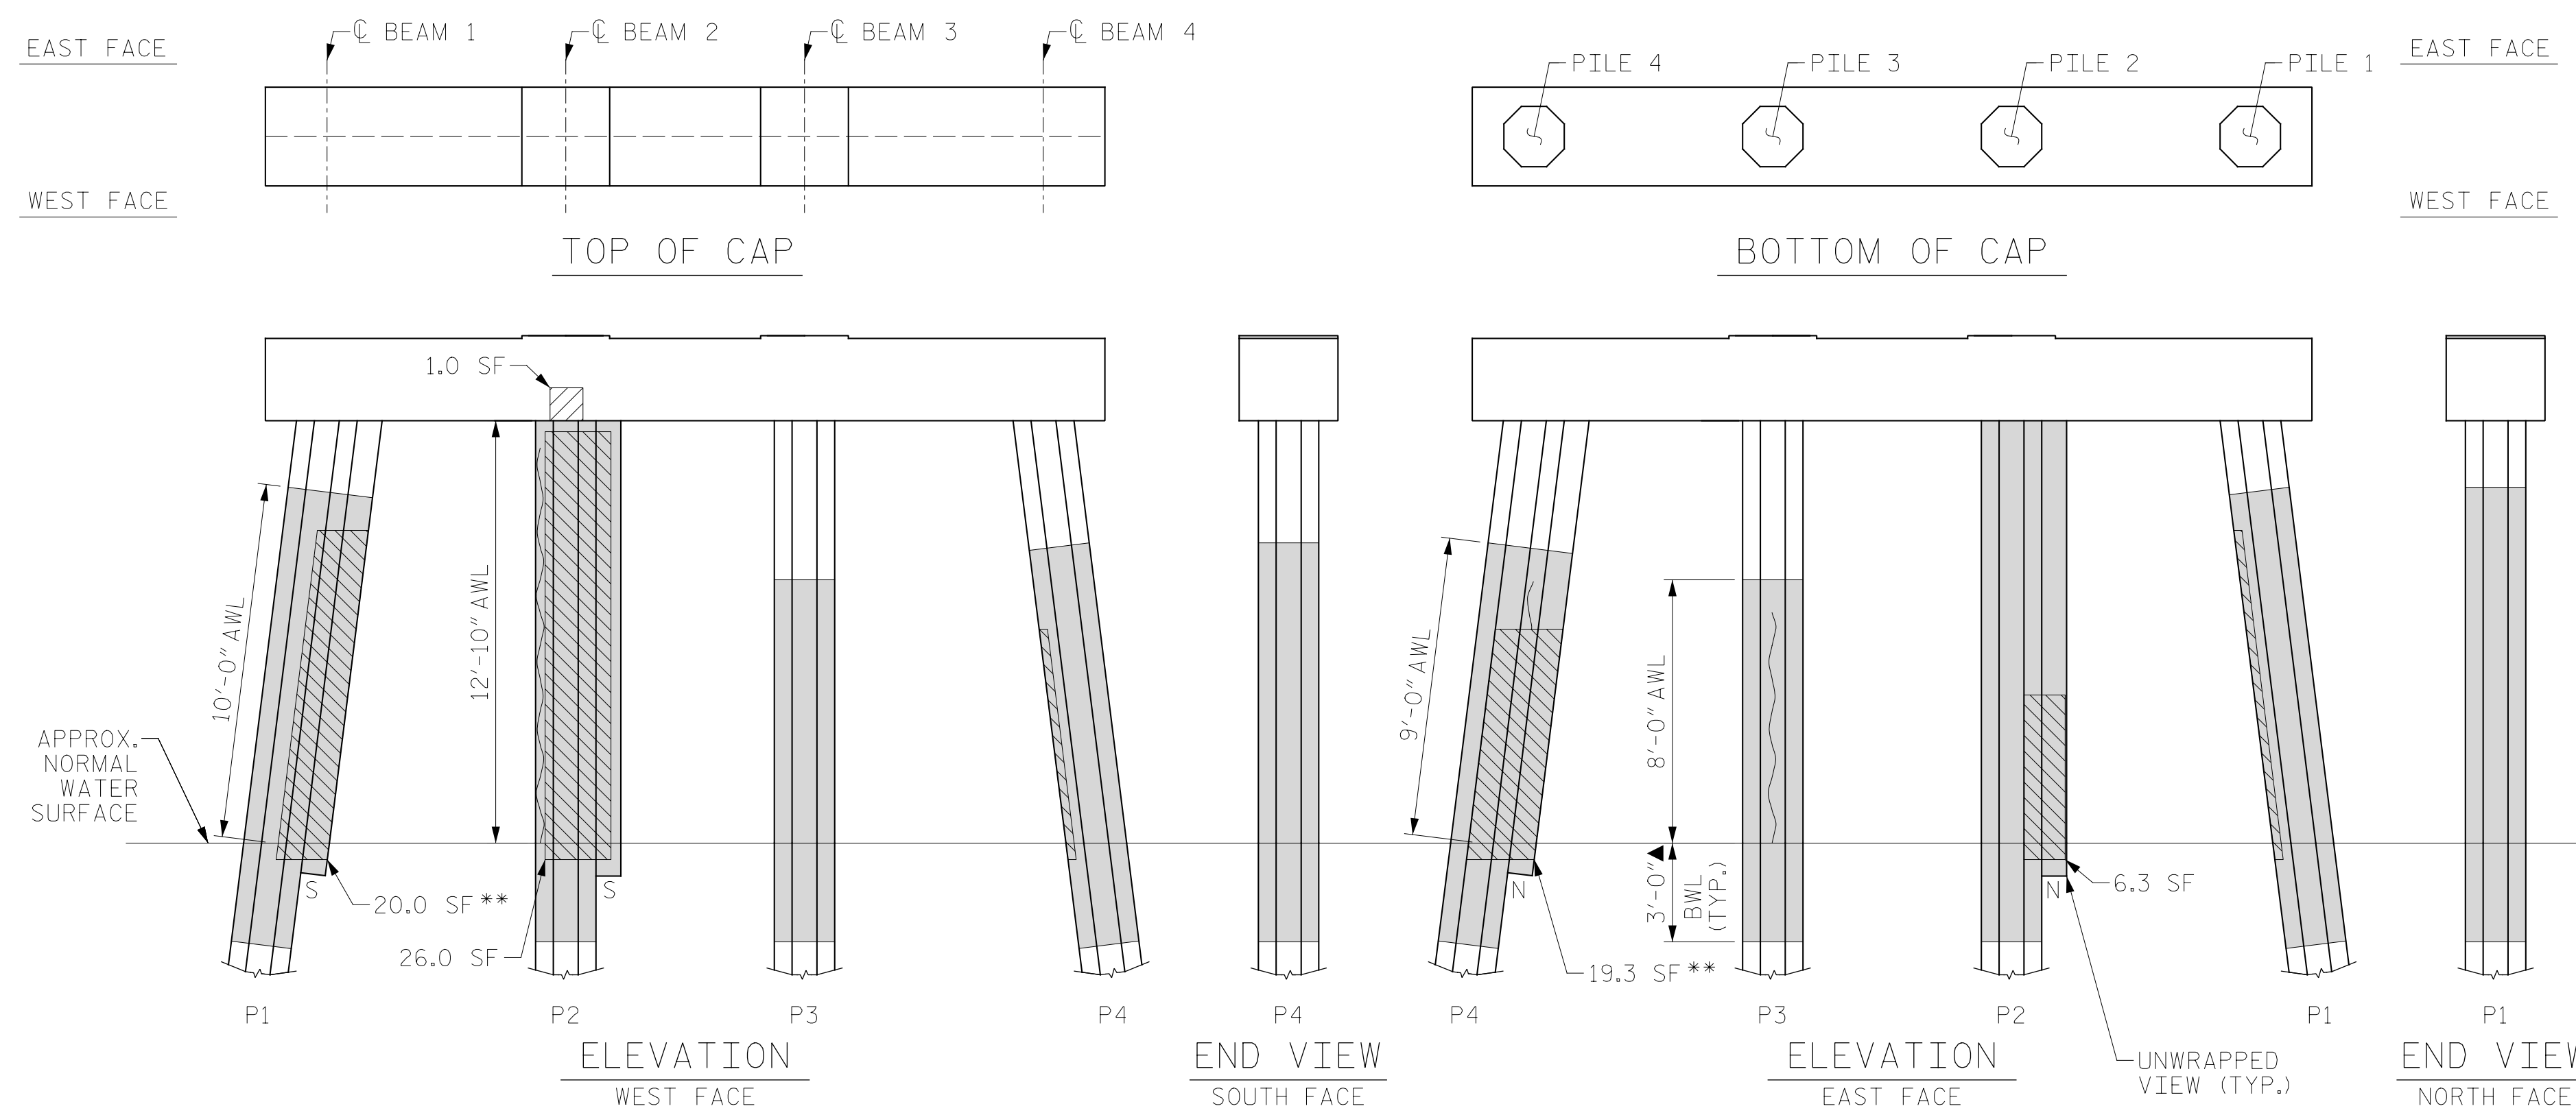
BENT 164

CAP REPAIRS			
SHOTCRETE REPAIRS	1.0 SF	0.5 CF	SF CF
EPOXY RESIN INJECTION	- LF		LF
PILE REPAIRS			
PILE CONCRETE RESTORATION	71.6 SF	30.0 CF	SF CF
FRP PROTECTIVE SYSTEM AWL	243.0 SF		
FRP PROTECTIVE SYSTEM BWL	73.2 SF
