AS-BUILT REPAIR QUANTITY TABLE

PROJECT NO. HB-0017  
DARE COUNTY  
 BRIDGE NO. 270009

BENT 165 & BENT 166

REVISIONS						SHEET NO. S-252
NO.	BY:	DATE:	NO.	BY:	DATE:	
1			3			TOTAL SHEETS 355
2			4

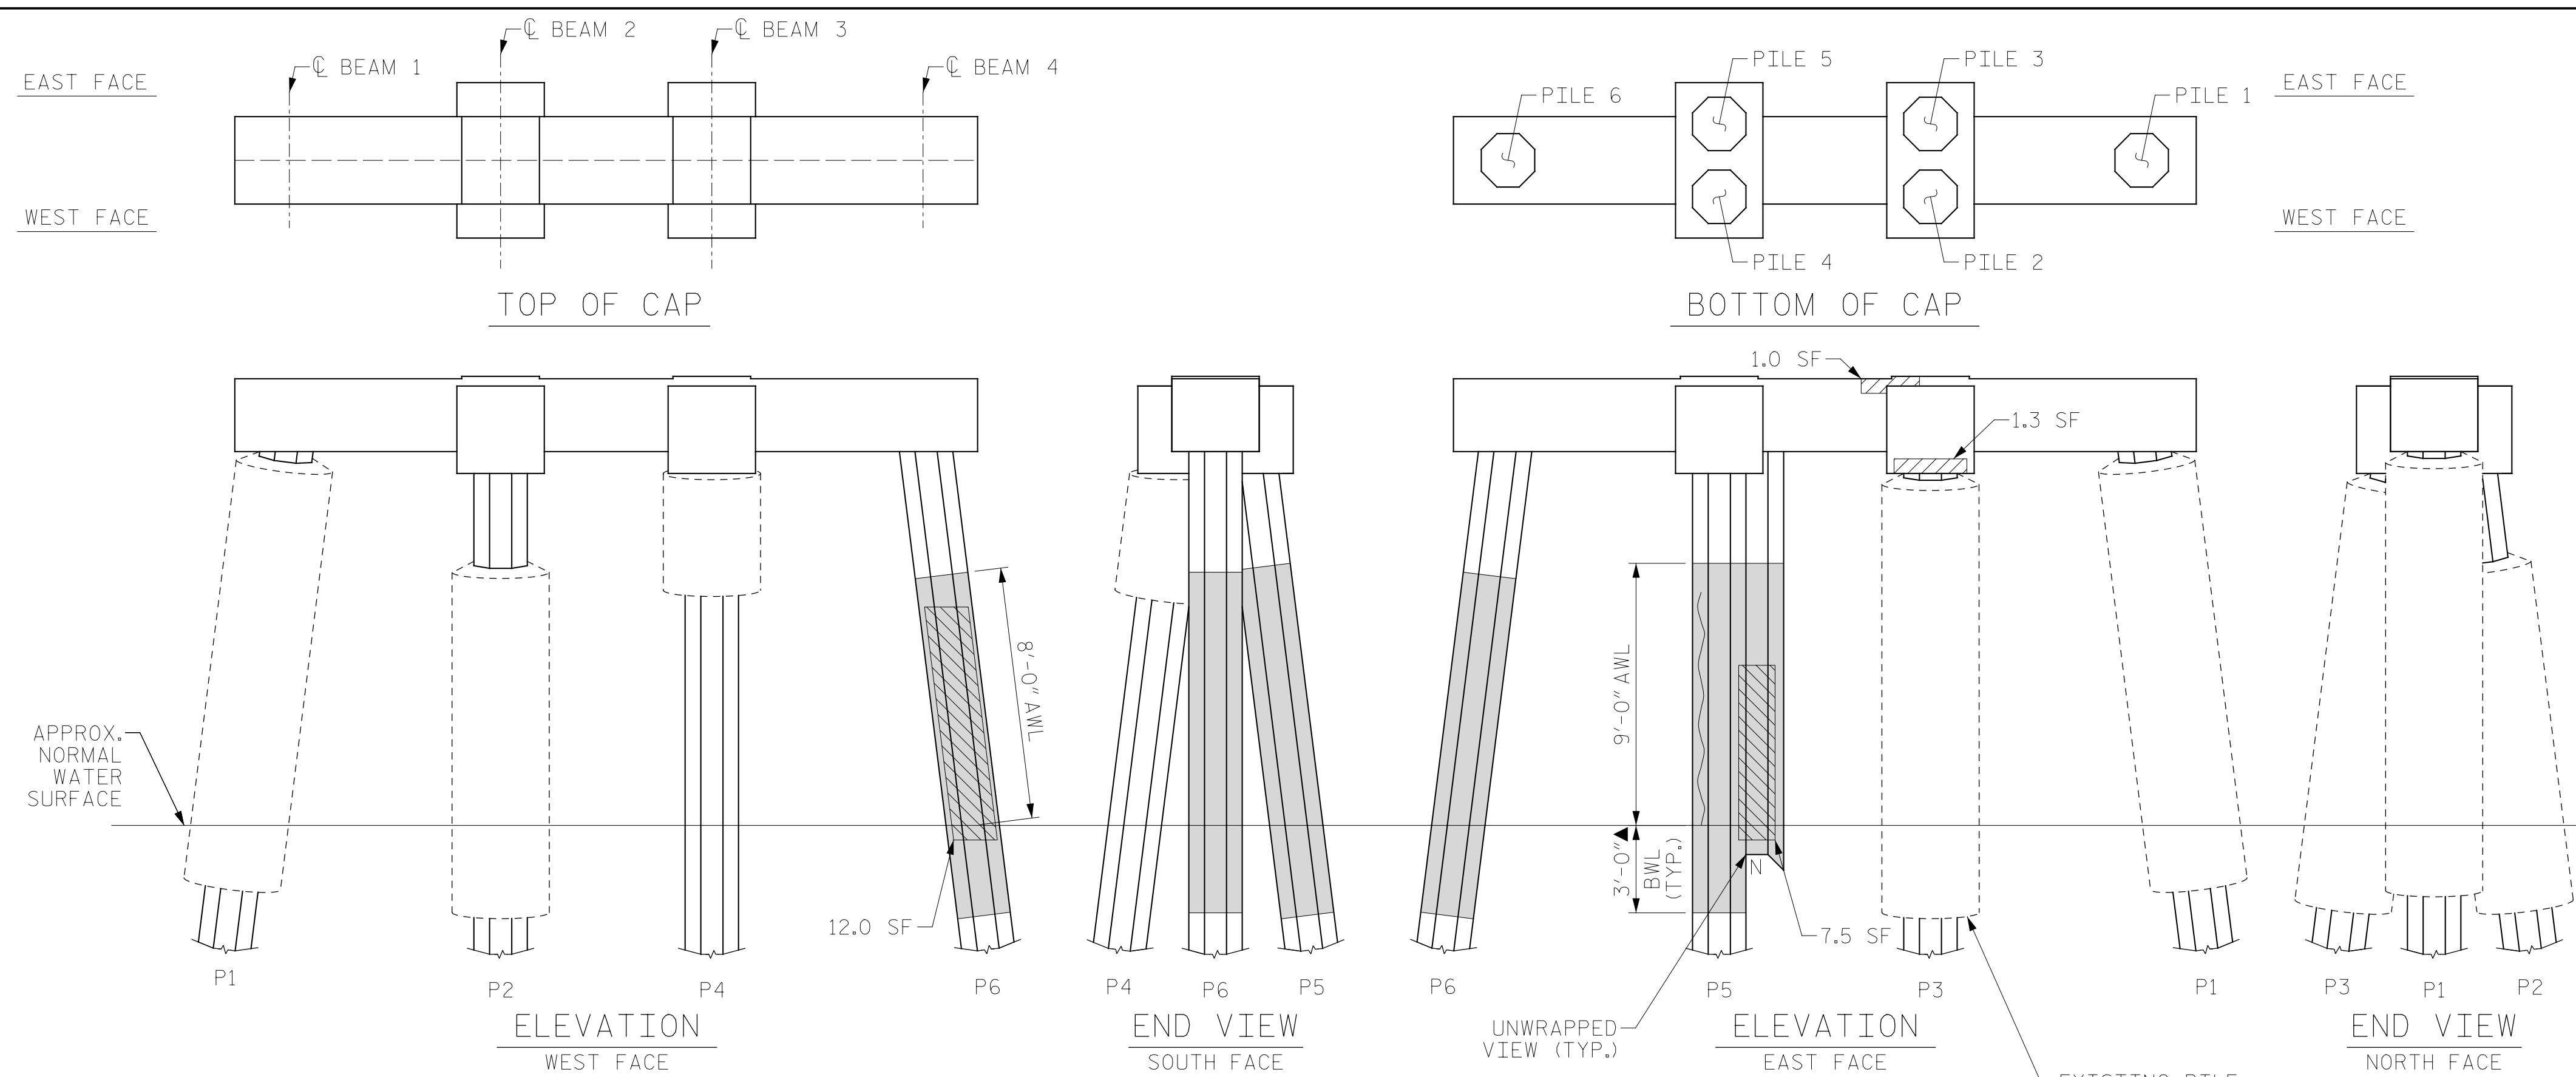
CAP REPAIRS			
SHOTCRETE REPAIRS	2.3 SF	1.2 CF	SF CF
EPOXY RESIN INJECTION	- LF		LF
PILE REPAIRS			
PILE CONCRETE RESTORATION	19.5 SF	8.5 CF	SF CF
FRP PROTECTIVE SYSTEM AWL	103.7 SF		
FRP PROTECTIVE SYSTEM BWL	36.6 SF

DIRECTION							
		NW	W	SW	S	SE	E	NE	N
BENT 165	PILE 1	-	-	-	-	-	-	-	-
	PILE 2	-	-	-	-	-	-	-	-
	PILE 3	-	-	-	-	-	-	-	-
	PILE 4	-	-	-	-	-	-	-	-
BENT 166	PILE 1	4	6	2	-	2	-	6	-
	PILE 2	-	6	8	7	-	7	7	-
	PILE 3	-	-	8	-	3	2	-	-
	PILE 4	-	-	6	2	4	-	4	6

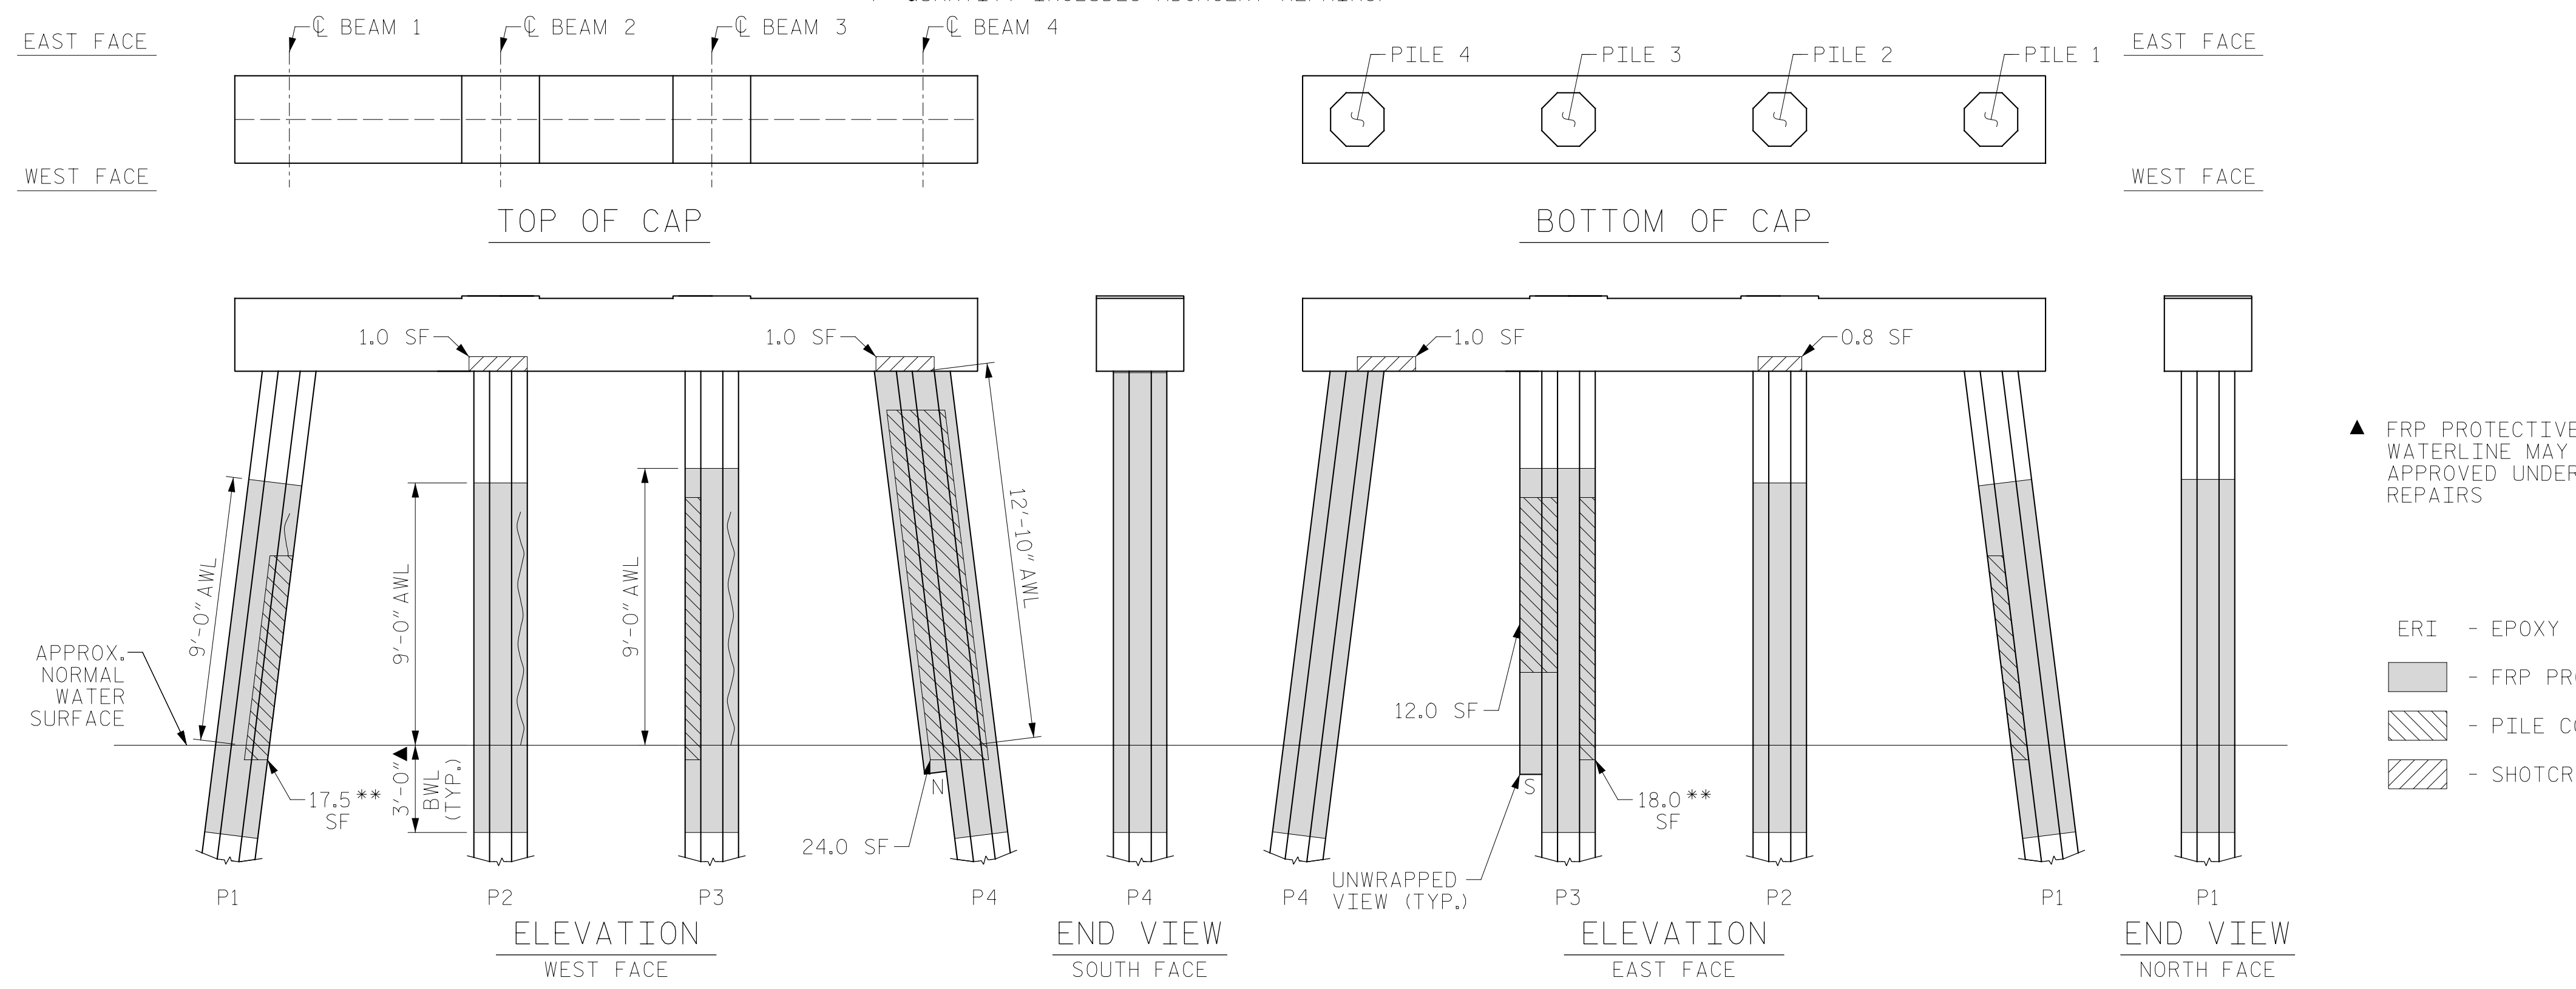
BENT 166

CAP REPAIRS			
SHOTCRETE REPAIRS	3.8 SF	1.9 CF	SF CF
EPOXY RESIN INJECTION	- LF		LF
PILE REPAIRS			
PILE CONCRETE RESTORATION	71.5 SF	28.1 CF	SF CF
FRP PROTECTIVE SYSTEM AWL	243.0 SF		
FRP PROTECTIVE SYSTEM BWL	73.2 SF
