AS-BUILT REPAIR QUANTITY TABLE

PROJECT NO. HB-0017
DARE COUNTY
 BRIDGE NO. 270009

BENT 167 & BENT 168

REVISIONS						SHEET NO.
NO.	BY:	DATE:	NO.	BY:	DATE:	S-253
1			3			TOTAL SHEETS
2			4			355

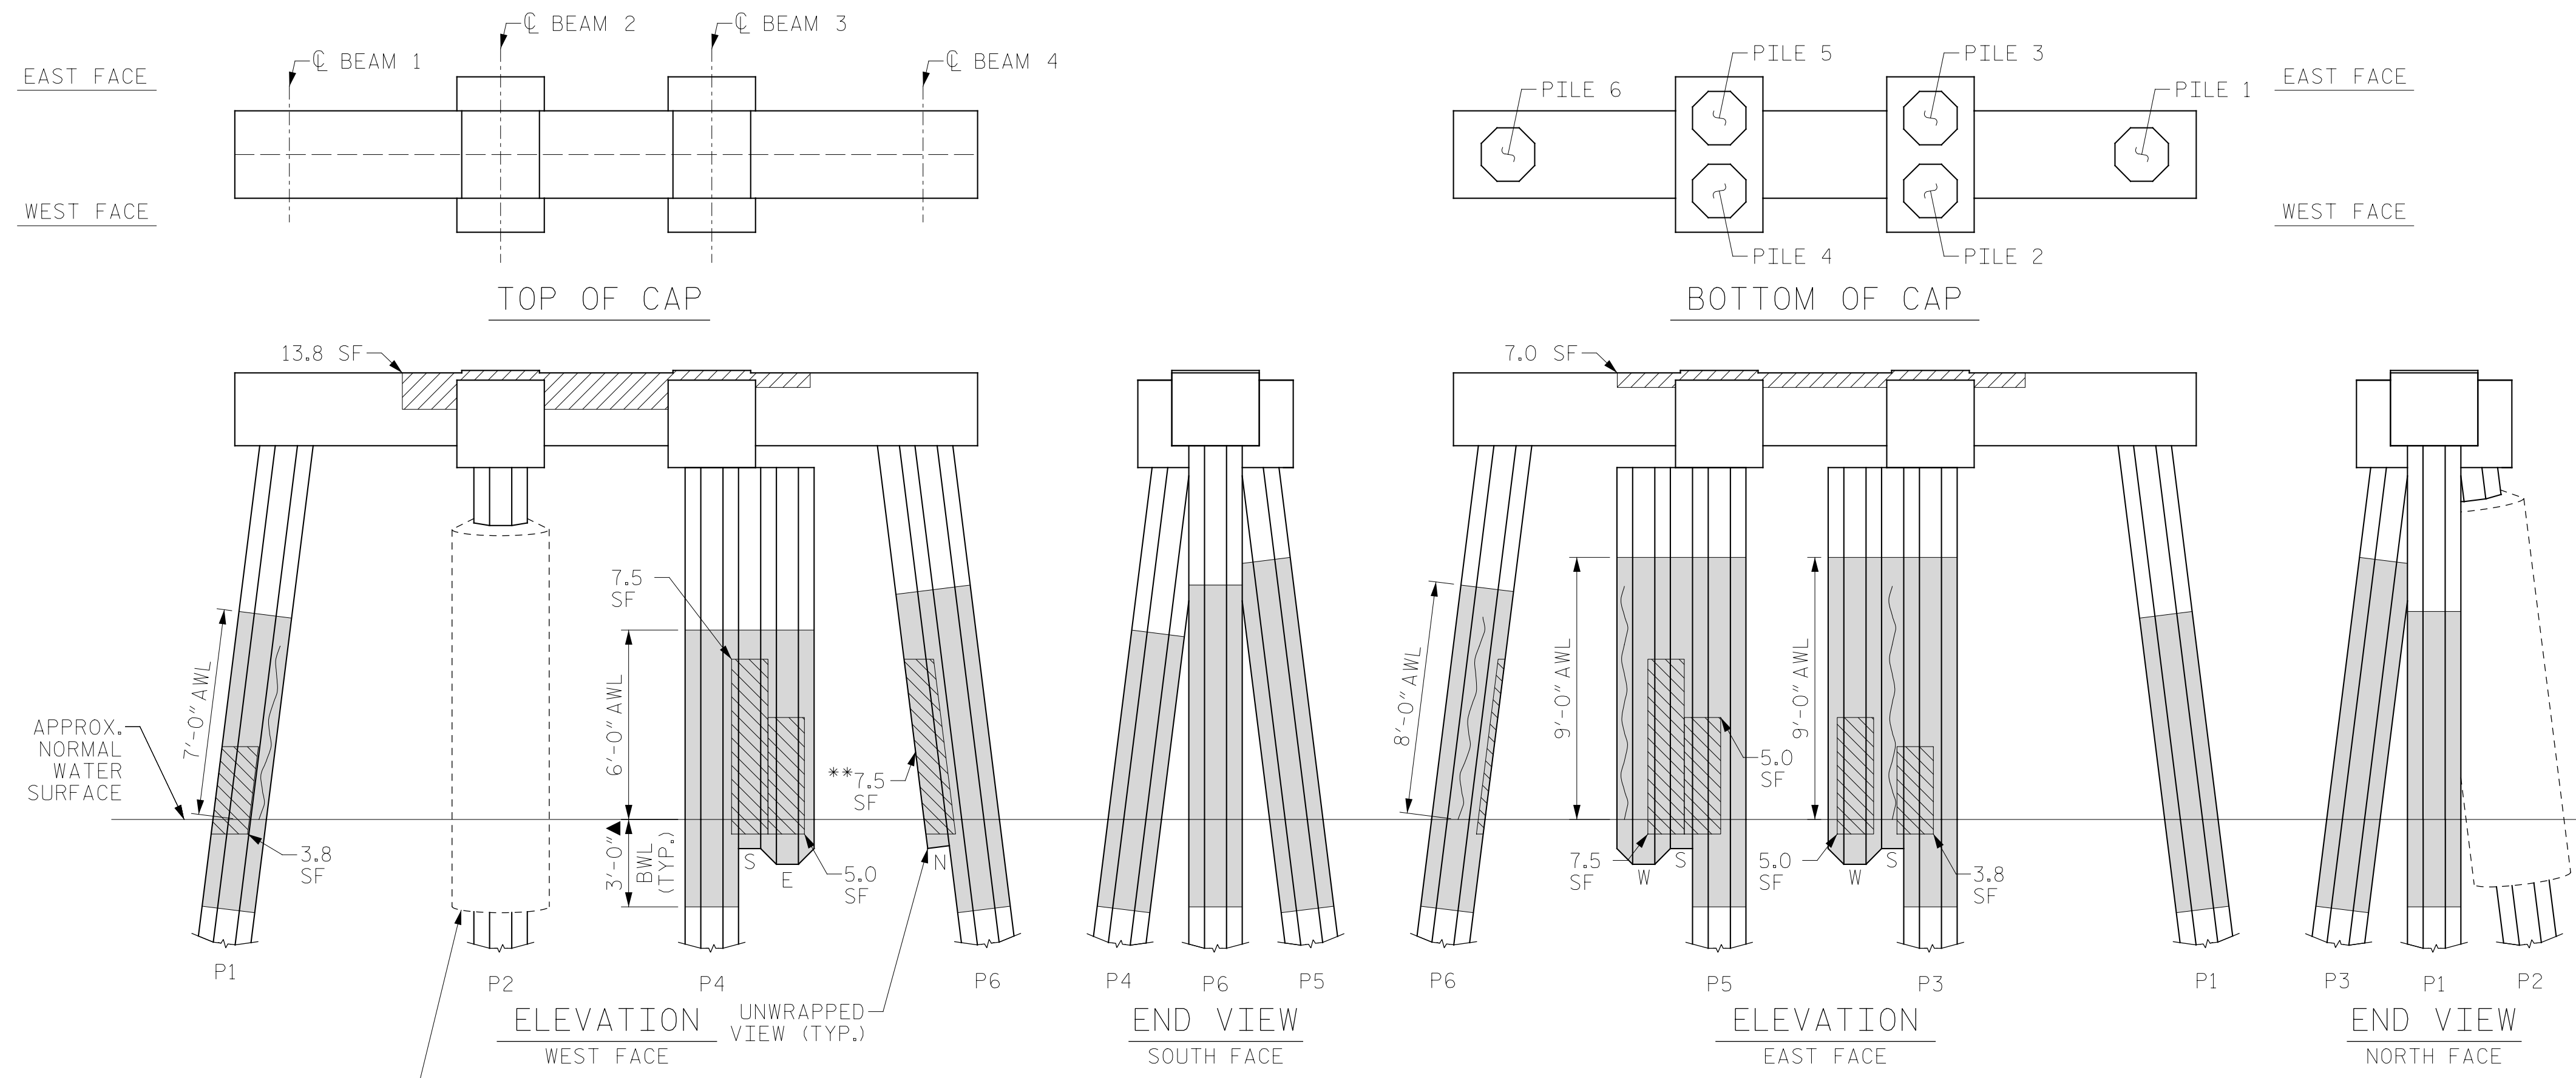
BENT 167

CAP REPAIRS			
SHOTCRETE REPAIRS	20.8 SF	10.4 CF	
EPOXY RESIN INJECTION	- LF		
PILE REPAIRS			
PILE CONCRETE RESTORATION	45.0 SF	19.1 CF	
FRP PROTECTIVE SYSTEM AWL	237.9 SF		
FRP PROTECTIVE SYSTEM BWL	91.5 SF

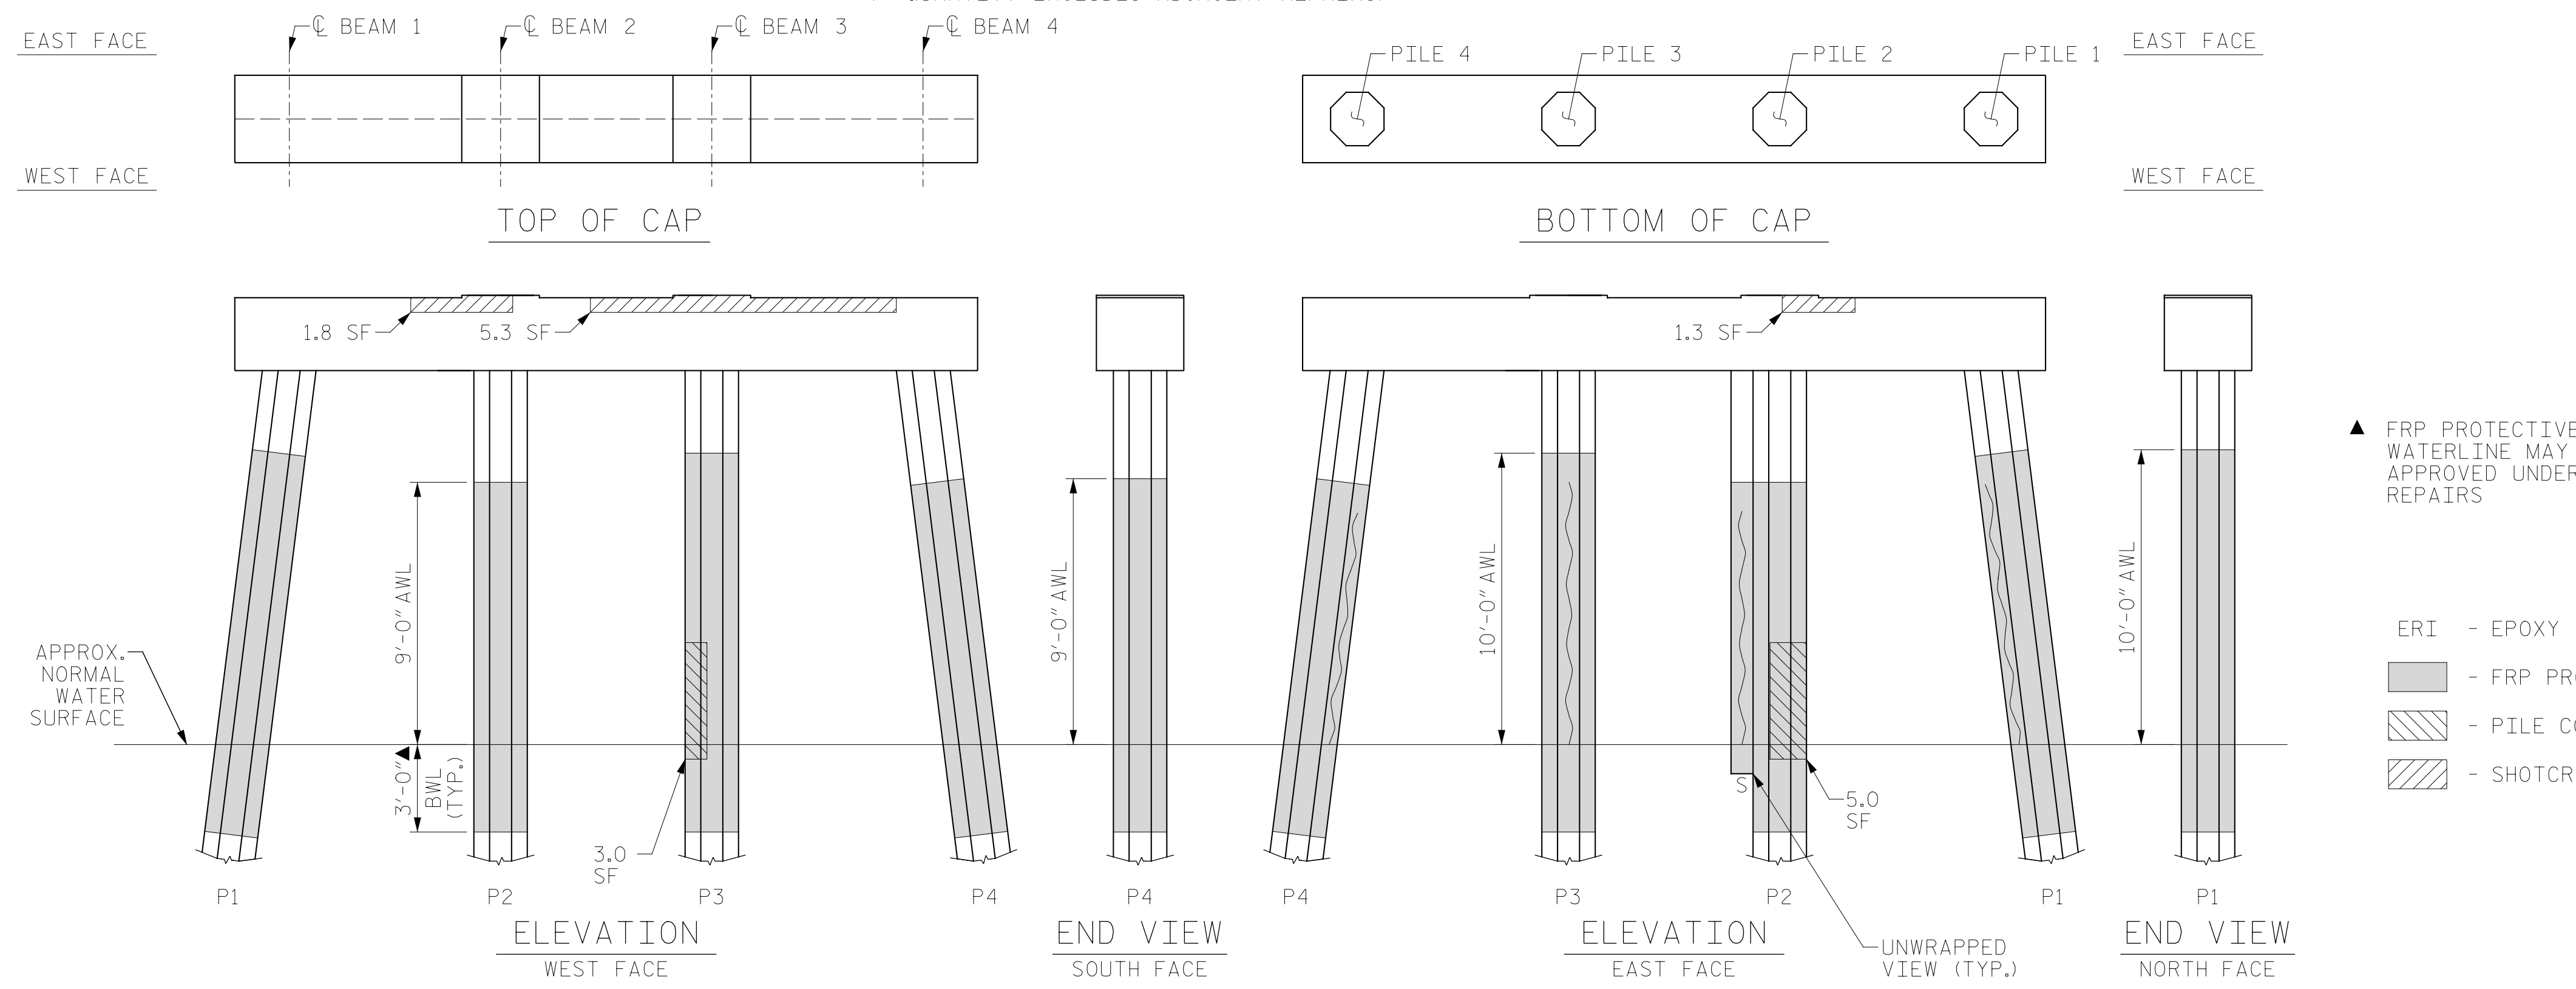
BENT 168

CAP REPAIRS			
SHOTCRETE REPAIRS	8.4 SF	4.2 CF	
EPOXY RESIN INJECTION	- LF		
PILE REPAIRS			
PILE CONCRETE RESTORATION	8.0 SF	3.7 CF	
FRP PROTECTIVE SYSTEM AWL	231.8 SF		
FRP PROTECTIVE SYSTEM BWL	73.2 SF
