AS-BUILT REPAIR QUANTITY TABLE

PROJECT NO. HB-0017
DARE COUNTY
 BRIDGE NO. 270009

STATE OF NORTH CAROLINA
 DEPARTMENT OF TRANSPORTATION
 RALEIGH
 BENT 169 & BENT 170

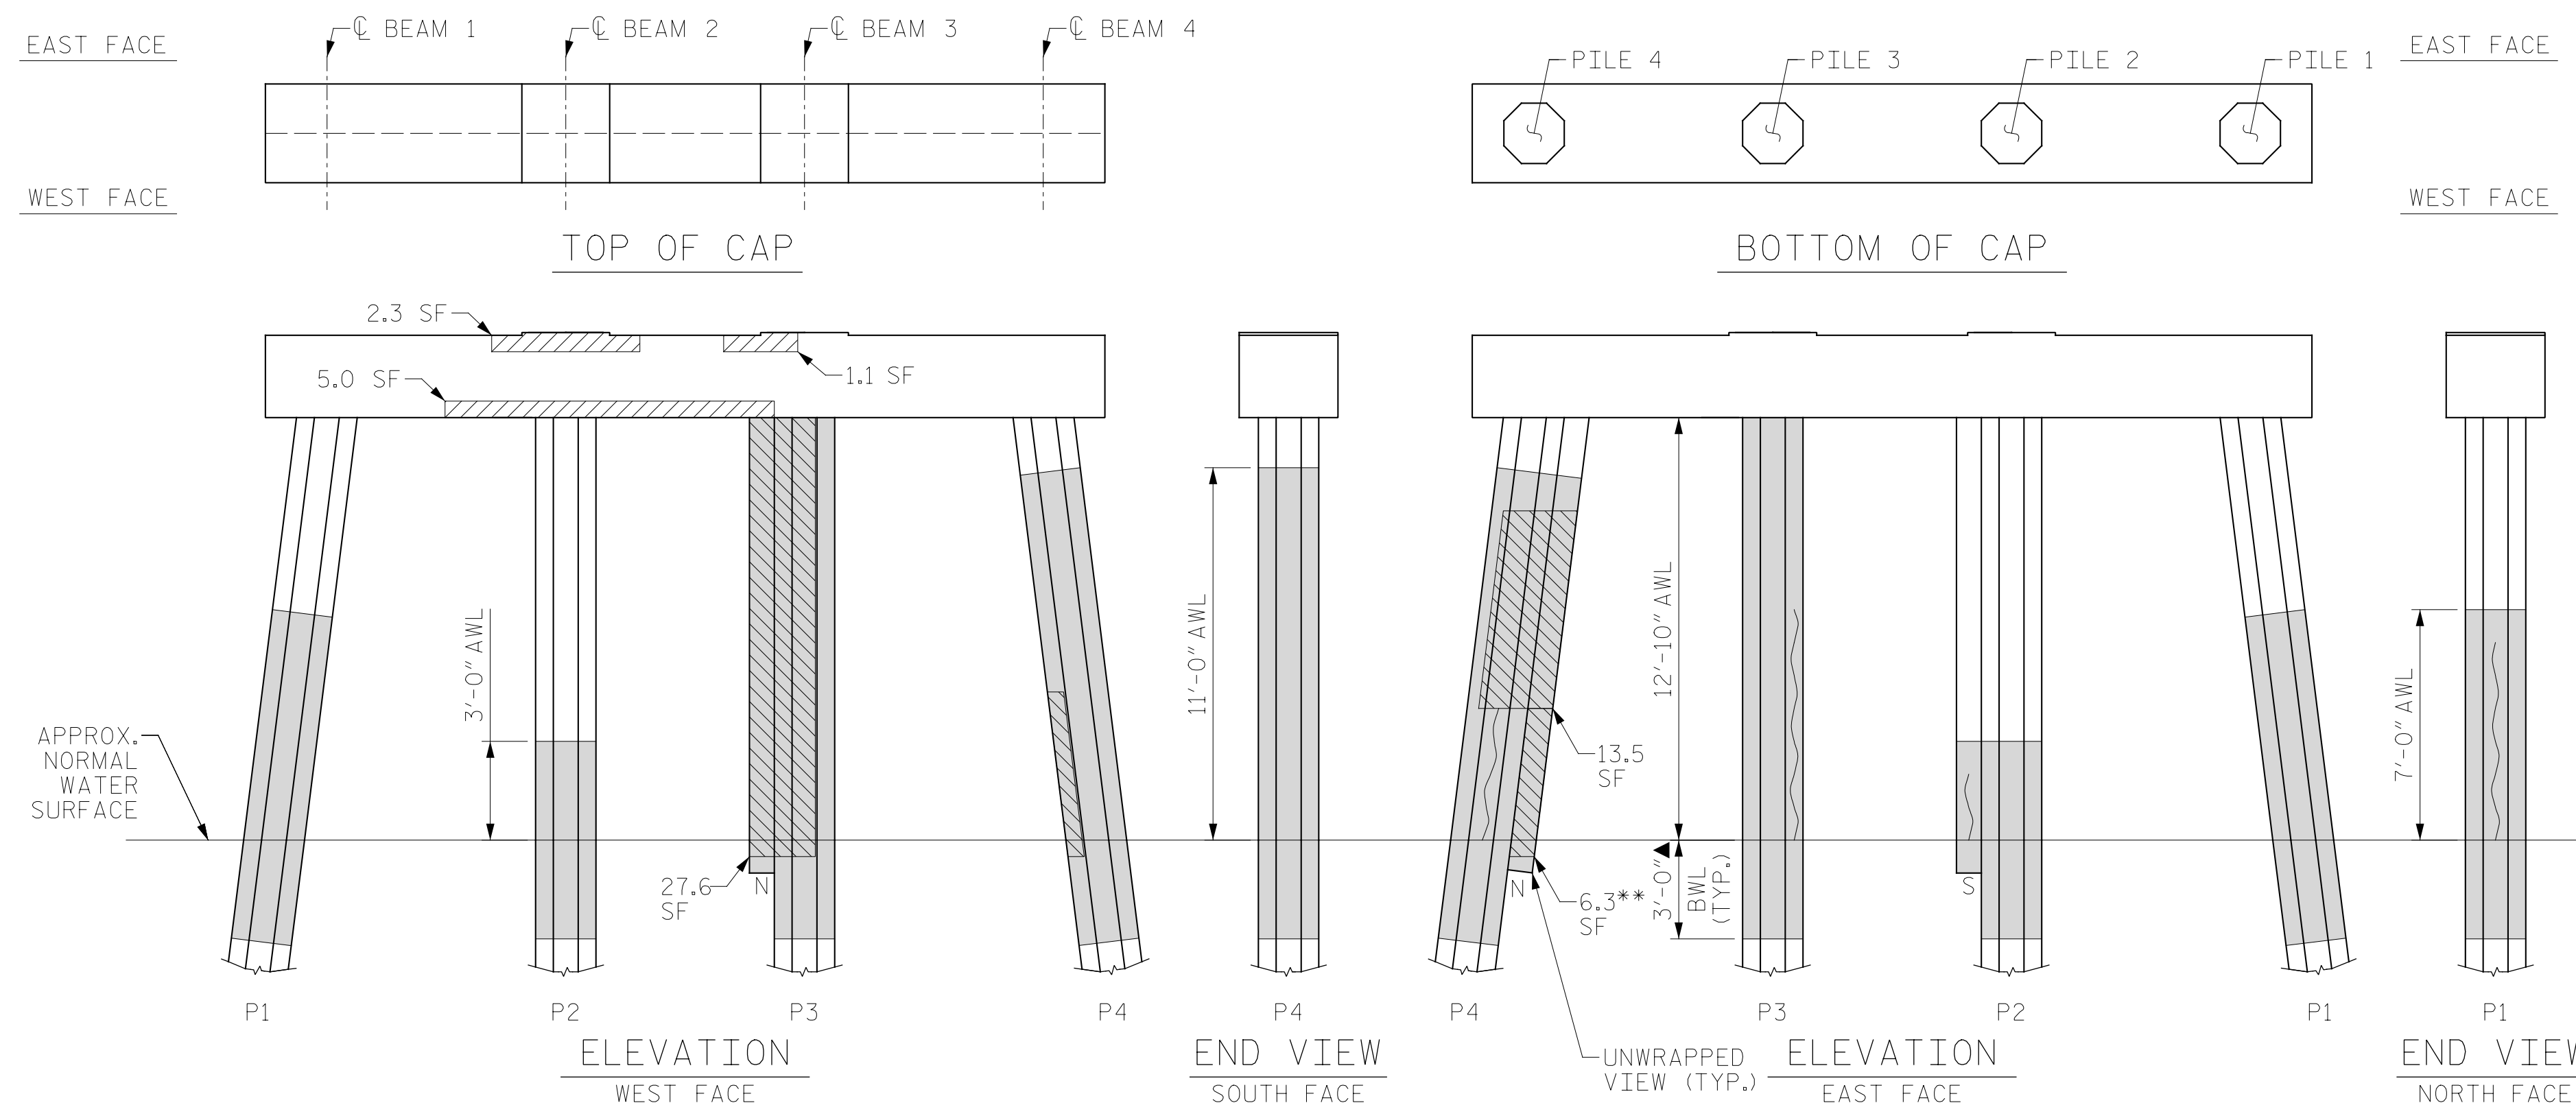
BENT 169

CAP REPAIRS			
SHOTCRETE REPAIRS	8.4 SF	4.2 CF	SF CF
EPOXY RESIN INJECTION	- LF		LF
PILE REPAIRS			
PILE CONCRETE RESTORATION	47.4 SF	19.6 CF	SF CF
FRP PROTECTIVE SYSTEM AWL	206.4 SF		
FRP PROTECTIVE SYSTEM BWL	73.2 SF

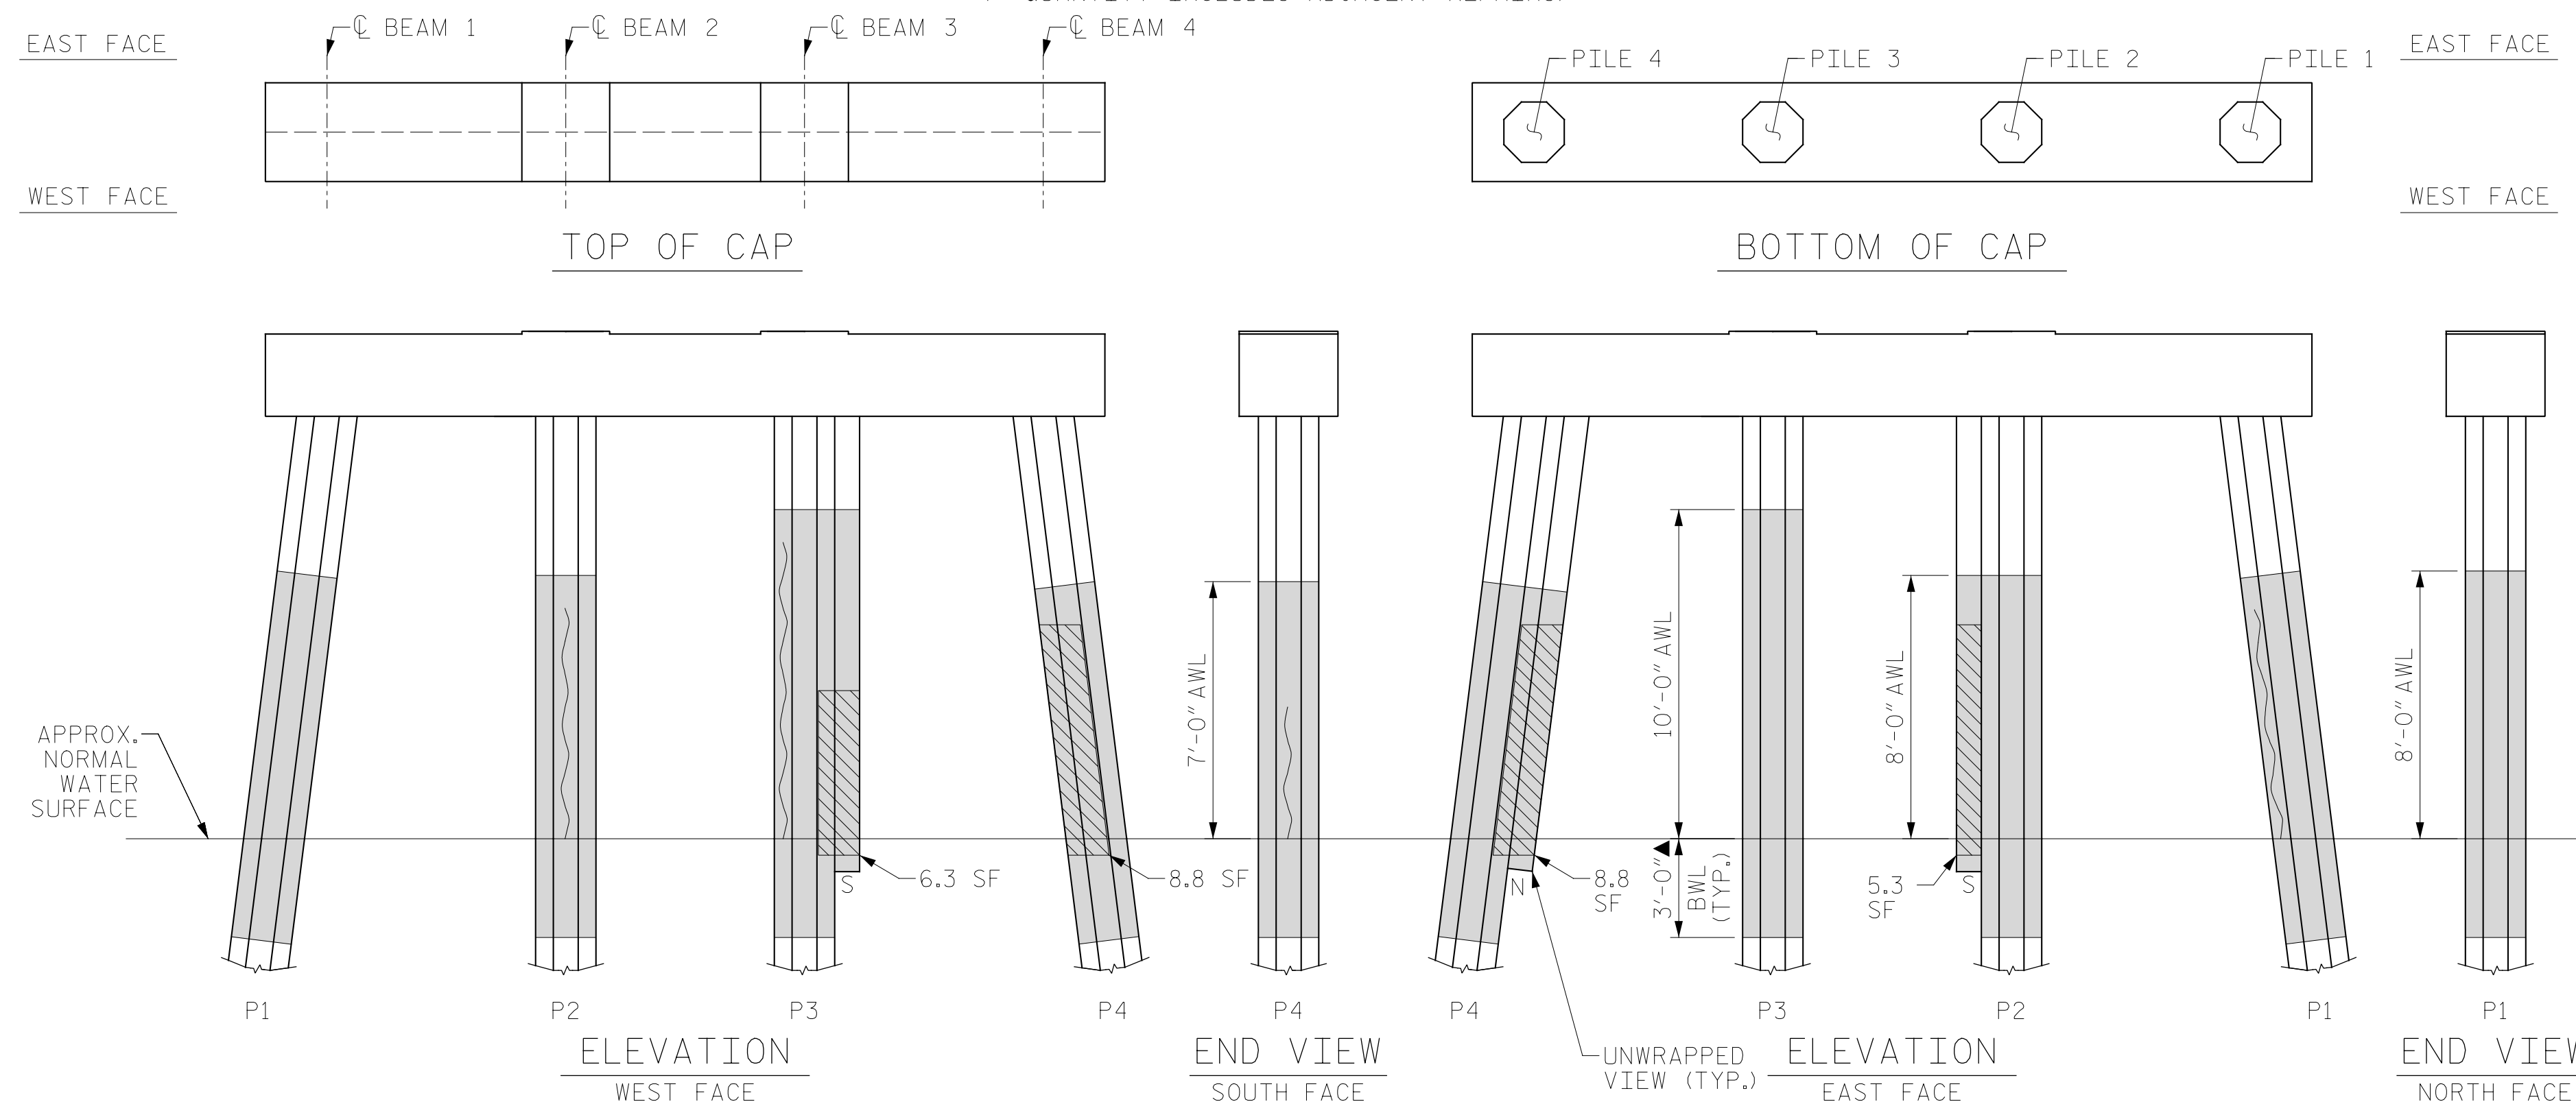
BENT 170

CAP REPAIRS			
SHOTCRETE REPAIRS	- SF	- CF	SF CF
EPOXY RESIN INJECTION	- LF		LF
PILE REPAIRS			
PILE CONCRETE RESTORATION	29.2 SF	12.7 CF	SF CF
FRP PROTECTIVE SYSTEM AWL	201.3 SF		
FRP PROTECTIVE SYSTEM BWL	73.2 SF
