AS-BUILT REPAIR QUANTITY TABLE

PROJECT NO. HB-0017  
DARE COUNTY  
 BRIDGE NO. 270009

BENT 171 & BENT 172

REVISIONS						SHEET NO.
NO.	BY:	DATE:	NO.	BY:	DATE:	S-255
1			3			TOTAL SHEETS
2			4			355

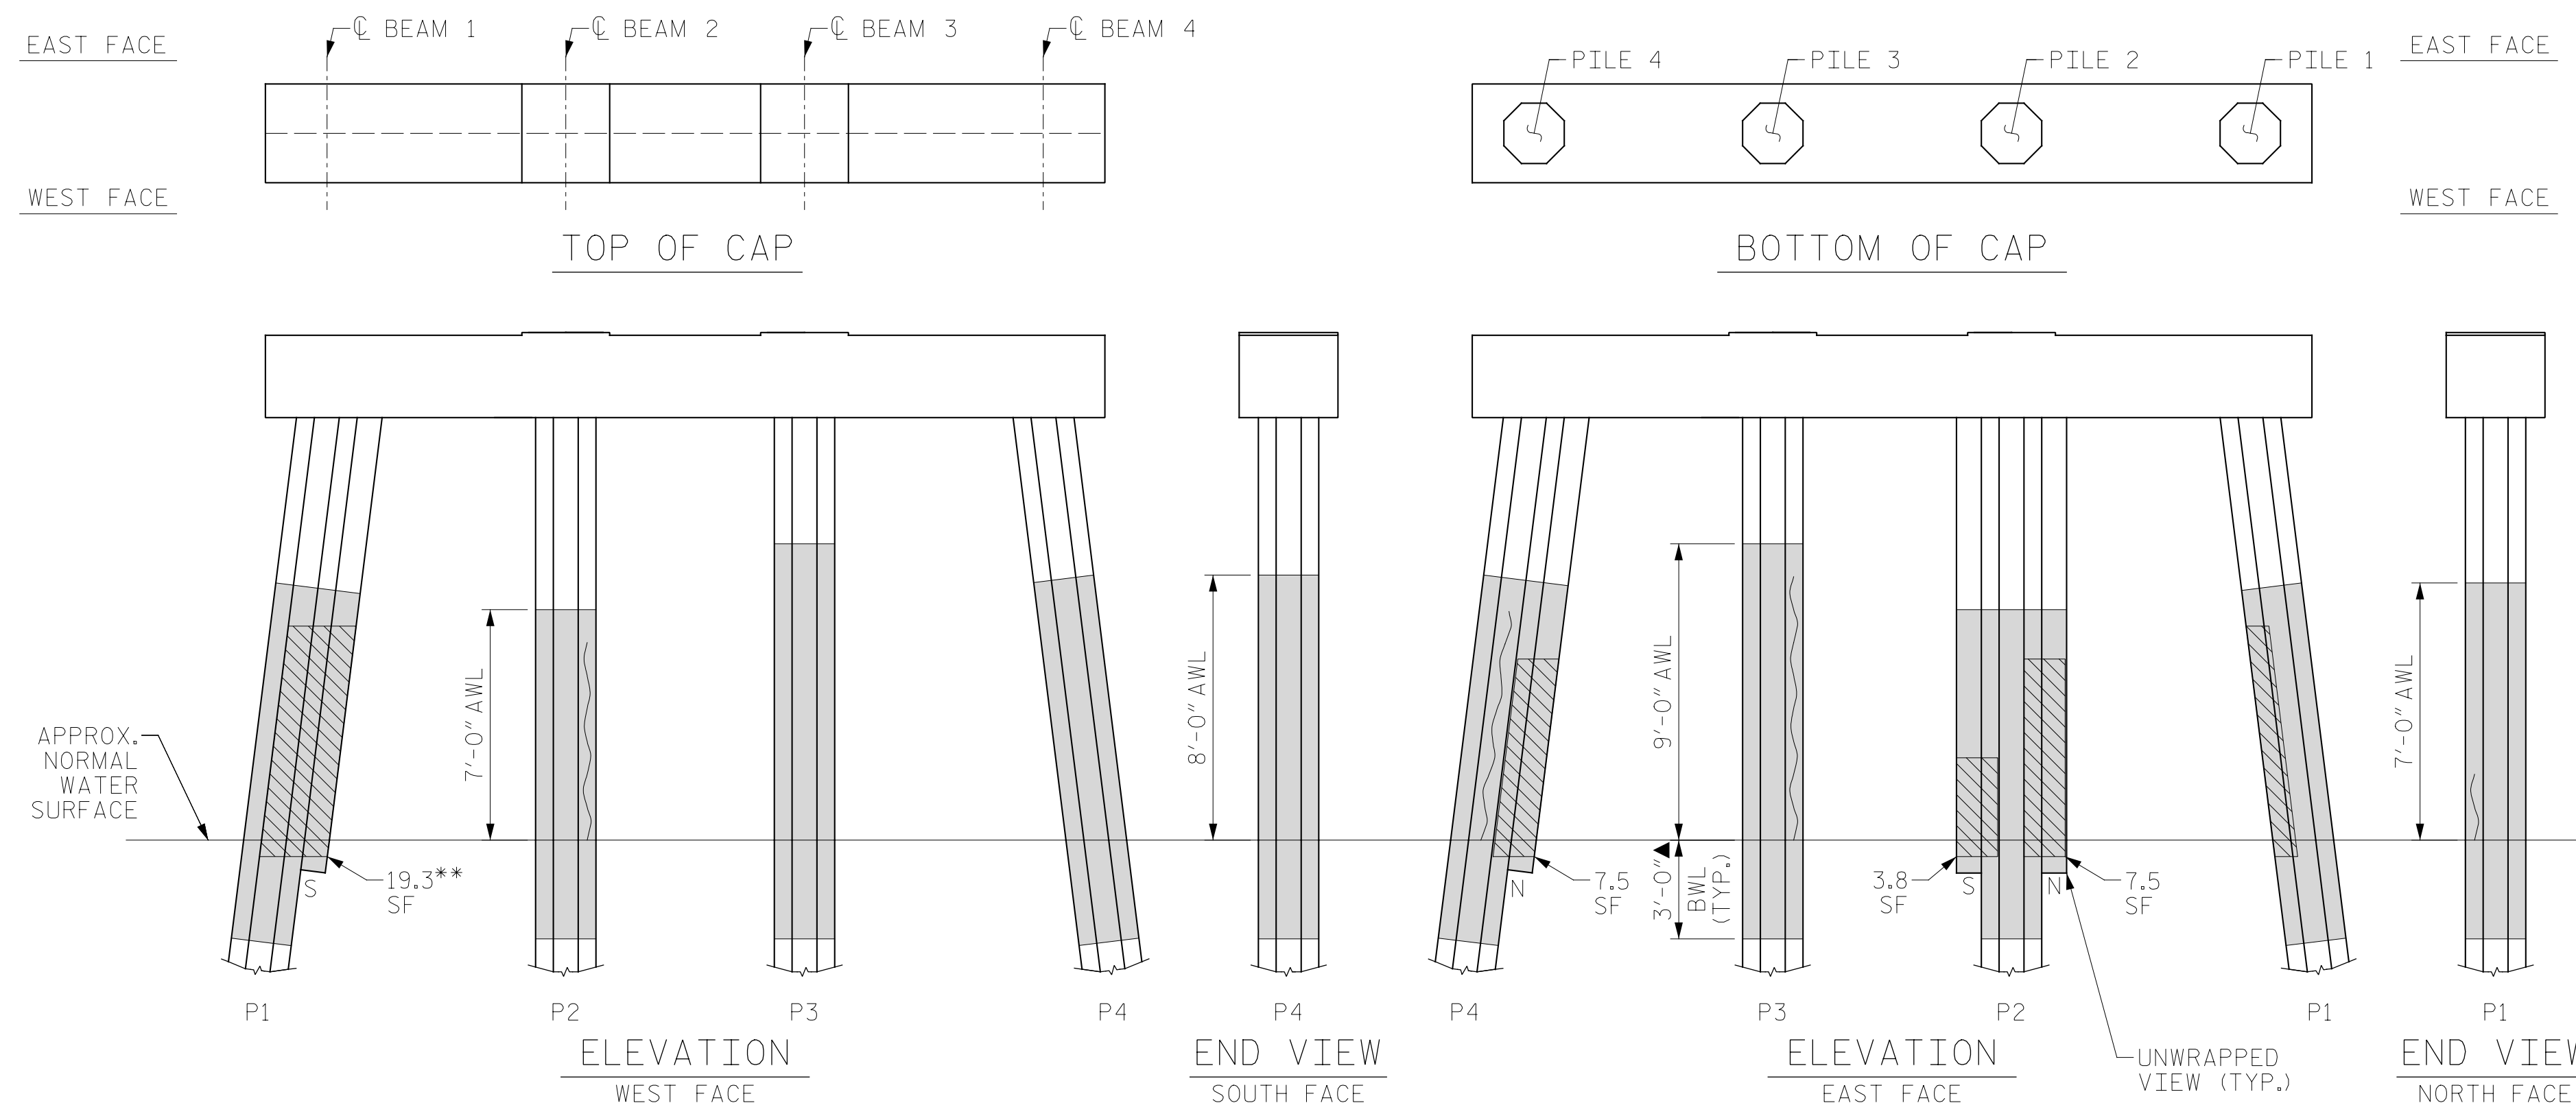
BENT 171

CAP REPAIRS			
SHOTCRETE REPAIRS	- SF	- CF	SF CF
EPOXY RESIN INJECTION	- LF		LF
PILE REPAIRS			
PILE CONCRETE RESTORATION	38.1 SF	15.5 CF	SF CF
FRP PROTECTIVE SYSTEM AWL	189.1 SF		
FRP PROTECTIVE SYSTEM BWL	73.2 SF

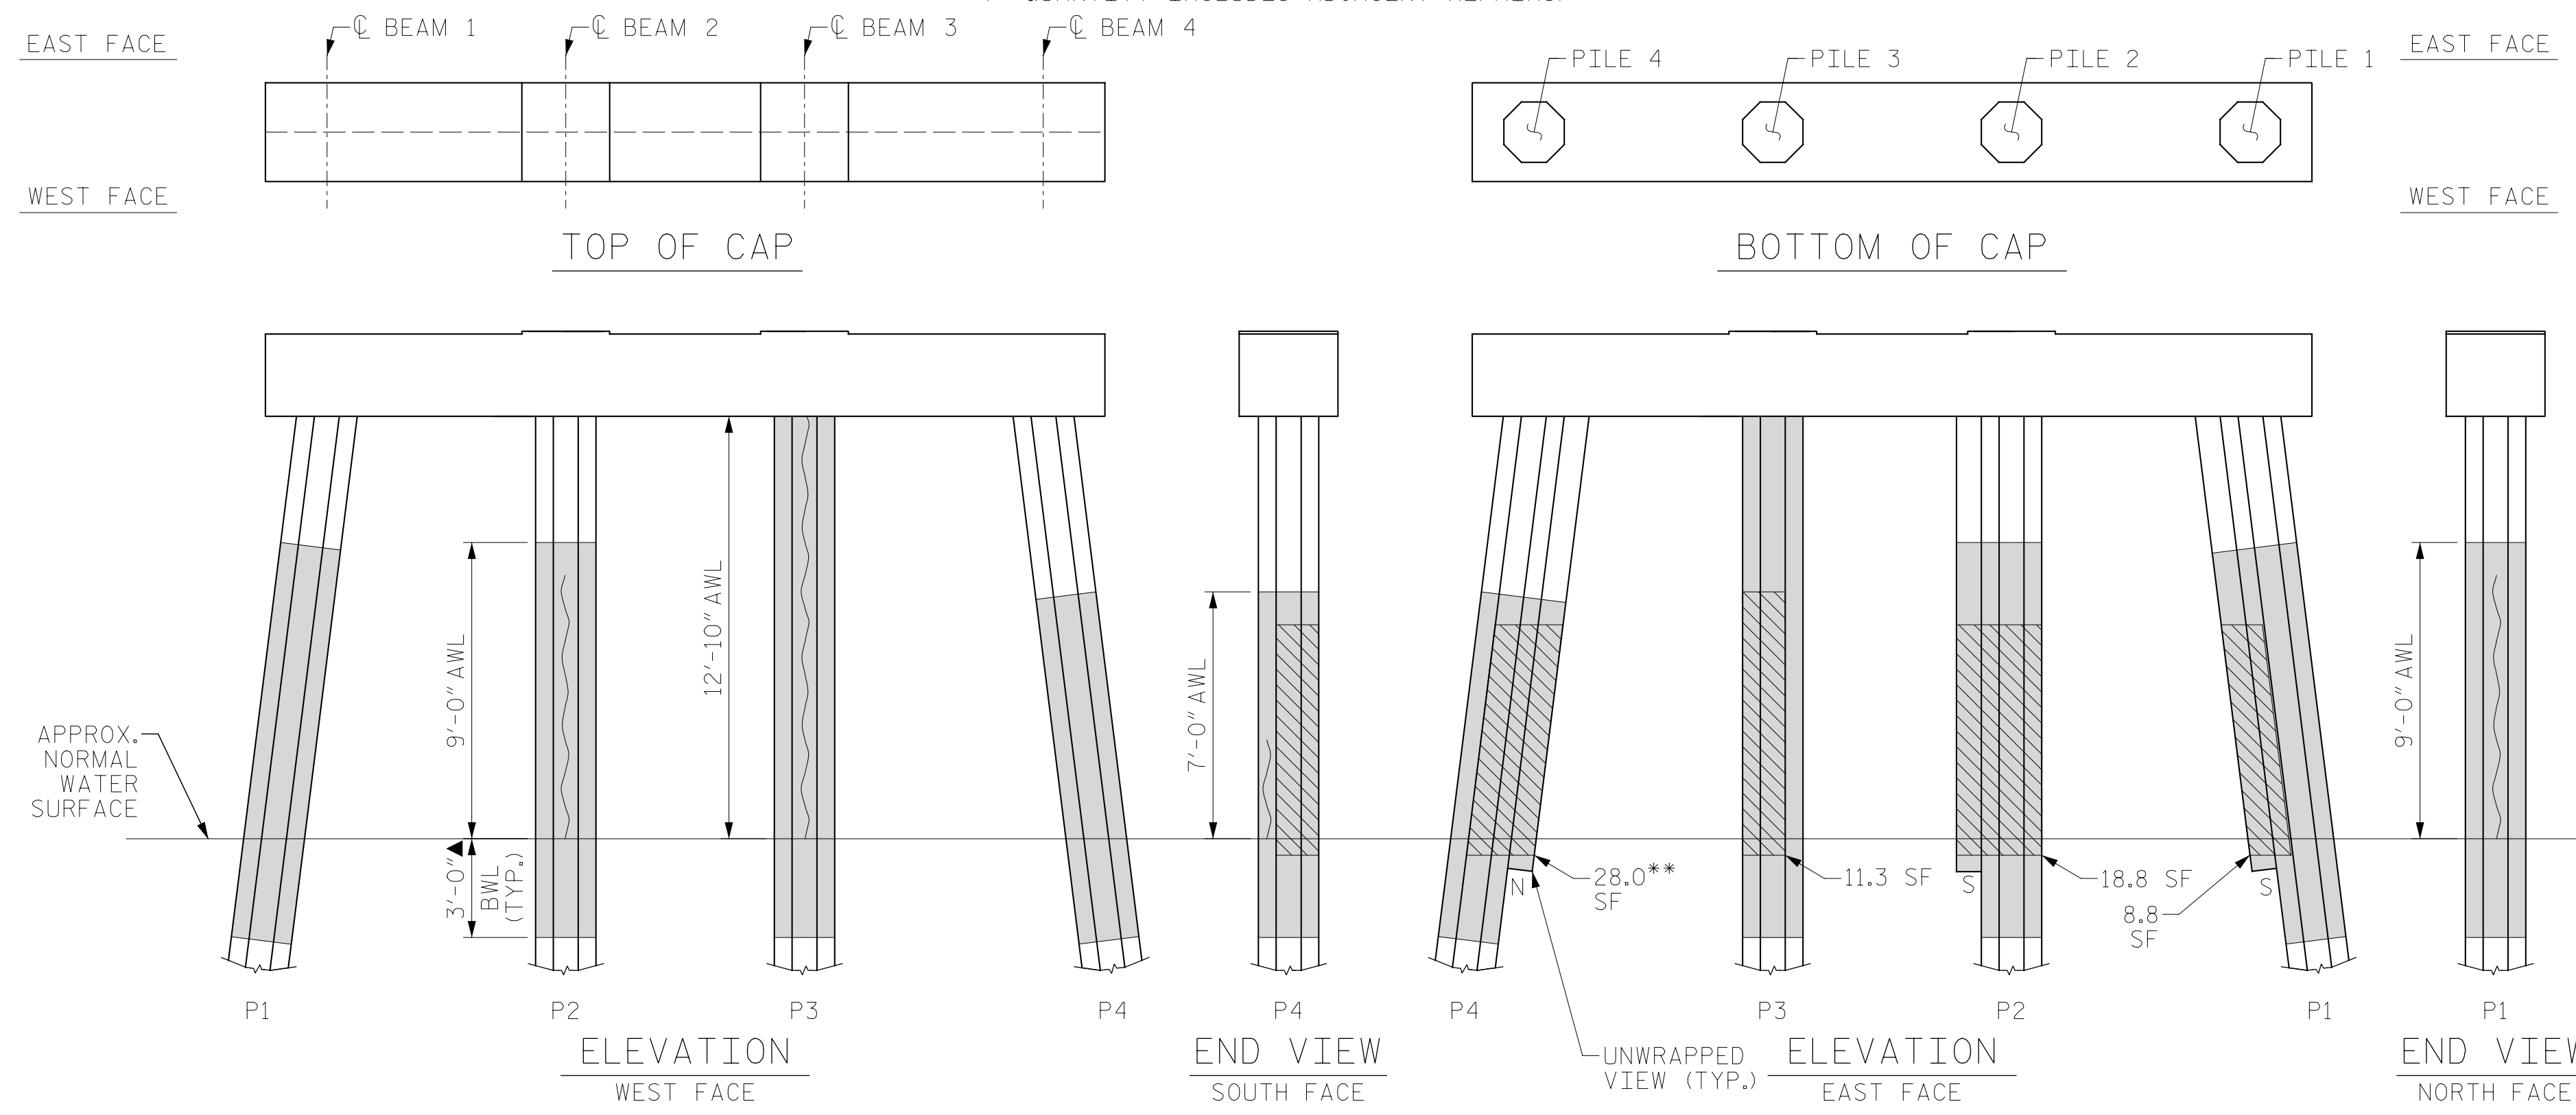
BENT 172

CAP REPAIRS			
SHOTCRETE REPAIRS	- SF	- CF	SF CF
EPOXY RESIN INJECTION	- LF		LF
PILE REPAIRS			
PILE CONCRETE RESTORATION	66.9 SF	26.1 CF	SF CF
FRP PROTECTIVE SYSTEM AWL	230.8 SF		
FRP PROTECTIVE SYSTEM BWL	73.2 SF
