270009 BRIDGE NO.

STATE OF NORTH CAROLINA DEPARTMENT OF TRANSPORTATION RALEIGH

S-256

BENT 173 & BENT 174

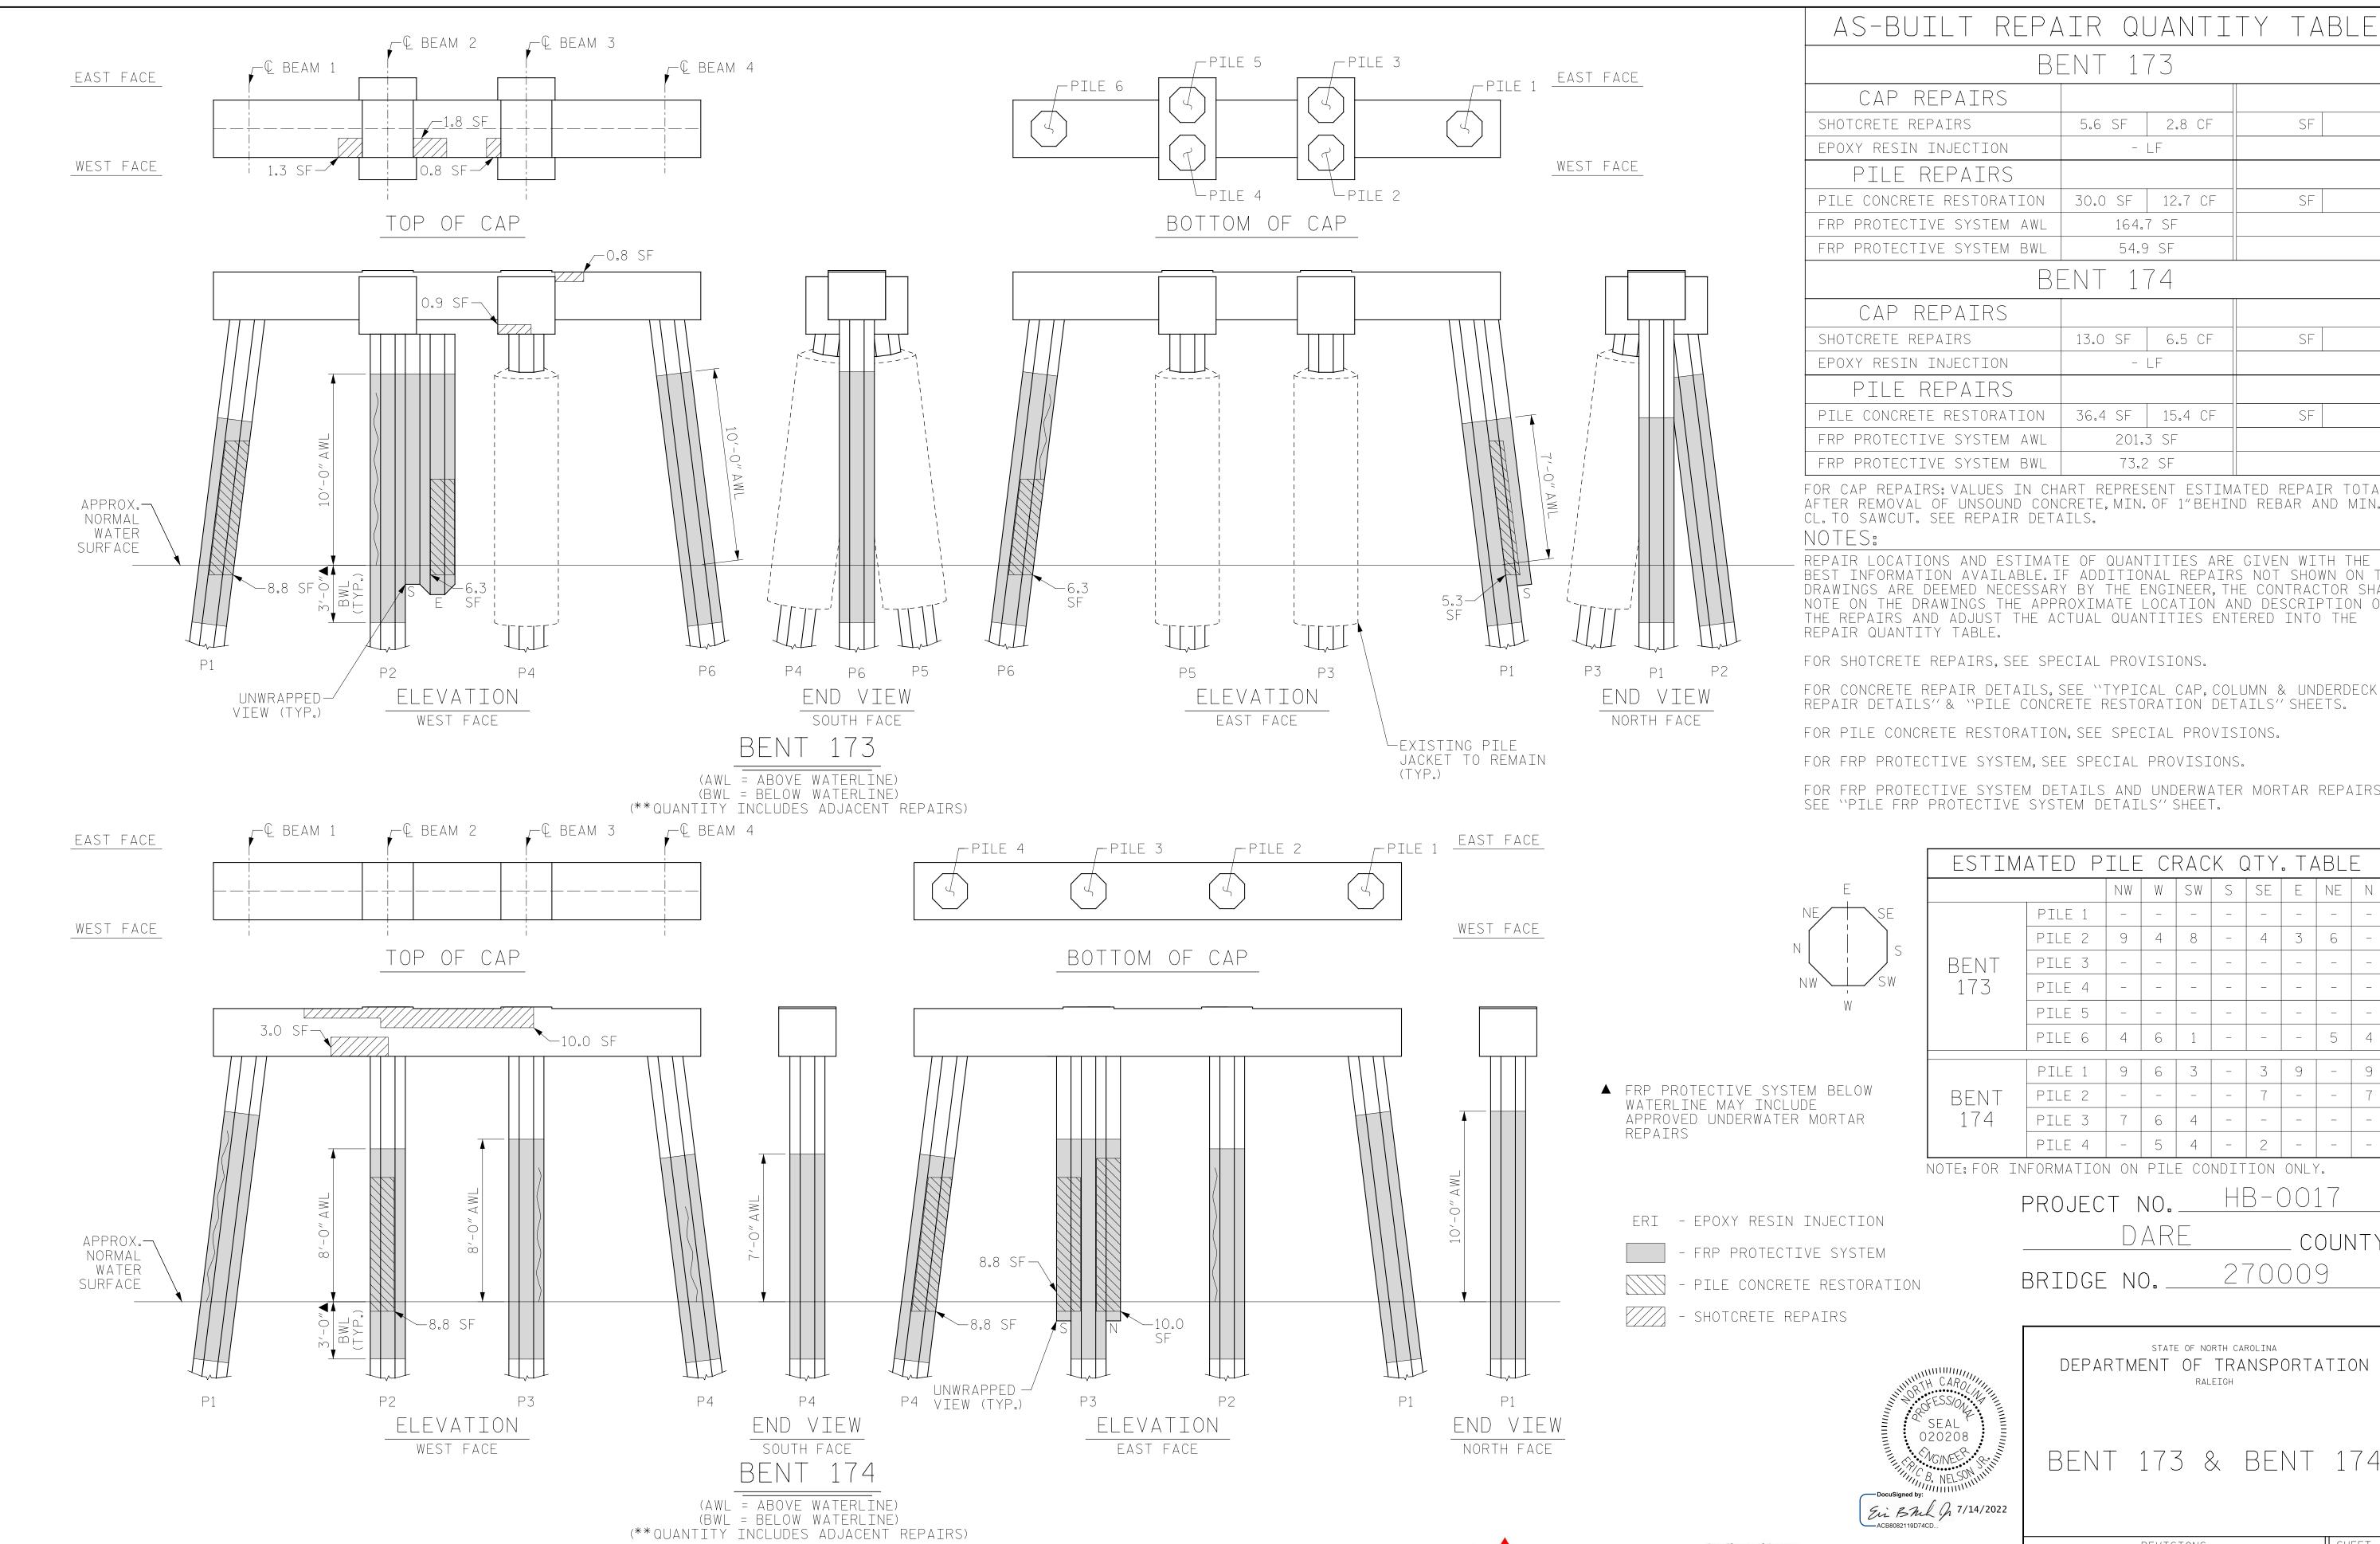
AS-BUILT REPAIR QUANTITY TABLE BENT 173 5.6 SF | 2.8 CF SF - LF PILE CONCRETE RESTORATION | 30.0 SF | 12.7 CF SF FRP PROTECTIVE SYSTEM AWL 164.7 SF FRP PROTECTIVE SYSTEM BWL 54.9 SF BENT 174 SF 13.0 SF | 6.5 CF

ESTIMATED PILE CRACK QTY. TABLE									
		NW	W	SW	S	SE	E	NE	N
BENT 173	PILE 1	_	_	_	_	_	_	_	_
	PILE 2	9	4	8	_	4	3	6	_
	PILE 3	_	_	_	_	_	_	_	_
	PILE 4	_	_	_	_	_	_	_	_
	PILE 5	_	_		_		_	-	_
	PILE 6	4	6	1	_	_	_	5	4
BENT 174	PILE 1	9	6	3	_	3	9	_	9
	PILE 2	_	_	_	_	7	_	_	7
	PILE 3	7	6	4	_	_	_	_	_
	PILE 4	_	5	4	-	2	-	_	-
NOTE: FOR INFORMATION ON PILE CONDITION ONLY.

FRP PROTECTIVE SYSTEM BWL 73.2 SF FOR CAP REPAIRS: VALUES IN CHART REPRESENT ESTIMATED REPAIR TOTALS AFTER REMOVAL OF UNSOUND CONCRETE, MIN. OF 1"BEHIND REBAR AND MIN. 2 CL. TO SAWCUT. SEE REPAIR DETAILS.

FOR CONCRETE REPAIR DETAILS, SEE "TYPICAL CAP, COLUMN & UNDERDECK REPAIR DETAILS" & "PILE CONCRETE RESTORATION DETAILS" SHEETS.

FOR FRP PROTECTIVE SYSTEM DETAILS AND UNDERWATER MORTAR REPAIRS, SEE "PILE FRP PROTECTIVE SYSTEM DETAILS" SHEET.
