AS-BUILT REPAIR QUANTITY TABLE BENT 175 32.4 SF | 16.2 CF SF - LF PILE CONCRETE RESTORATION | 28.0 SF | 10.7 CF SF 91.5 SF 36.6 SF BENT 176 SF 11.5 SF | 5.8 CF - LF

STATE OF NORTH CAROLINA DEPARTMENT OF TRANSPORTATION RALEIGH

BENT 175 & BENT 176

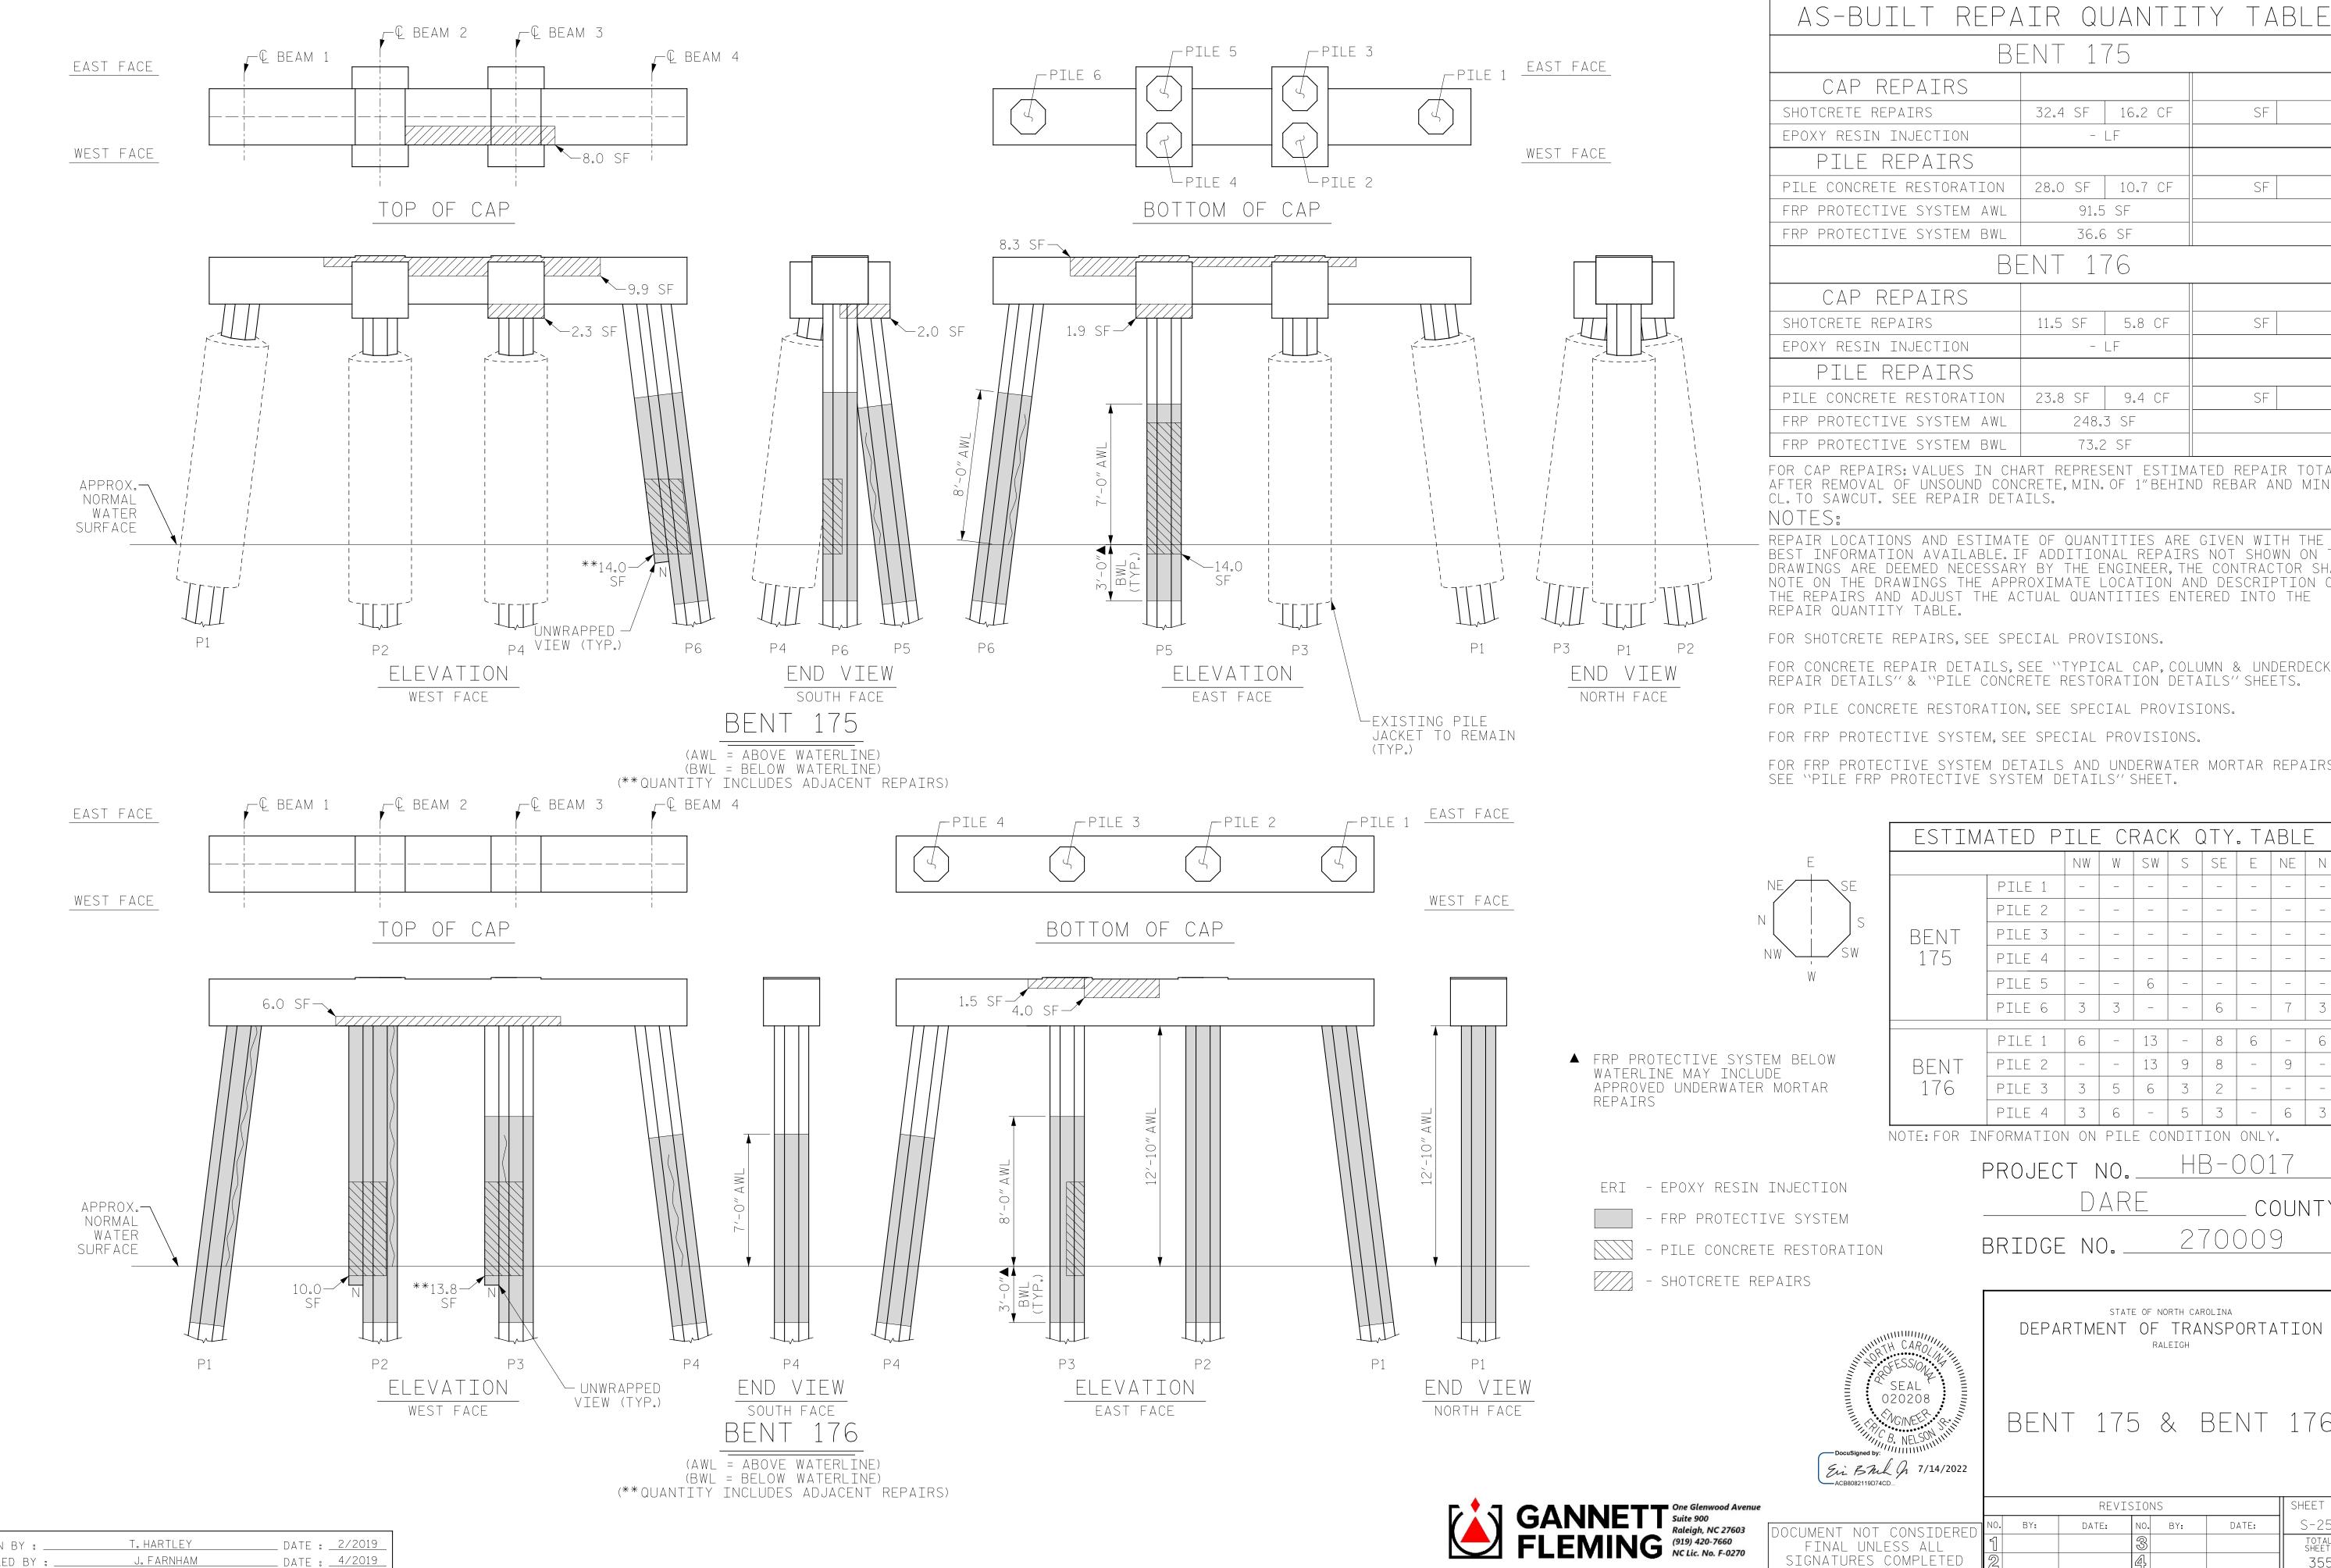
ESTIMATED PILE CRACK QTY. TABLE										
		NW	W	SW	S	SE	E	NE	Z	
BENT 175	PILE 1	_	_	_	_	_	_	_		
	PILE 2	_	_	_	_	_	_	_	_	
	PILE 3	_	_	_	_	_	_	_	_	
	PILE 4	_	_	_	_	_	-	_	-	
	PILE 5	-	-	6	-	-	=	-	_	
	PILE 6	3	3	_	_	6	-	7	3	
BENT 176	PILE 1	6	_	13	_	8	6	_	6	
	PILE 2	_	_	13	9	8	-	9	_	
	PILE 3	3	5	6	3	2	_	_	_	
	PILE 4	3	6	-	5	3	-	6	3	
NOTE: FOR INFORMATION ON PILE CONDITION ONLY.

FOR CONCRETE REPAIR DETAILS, SEE "TYPICAL CAP, COLUMN & UNDERDECK REPAIR DETAILS" & "PILE CONCRETE RESTORATION DETAILS" SHEETS.

FOR FRP PROTECTIVE SYSTEM DETAILS AND UNDERWATER MORTAR REPAIRS, SEE "PILE FRP PROTECTIVE SYSTEM DETAILS" SHEET.
