AS-BUILT REPAIR QUANTITY TABLE

PROJECT NO. HB-0017
DARE COUNTY
BRIDGE NO. 270009

STATE OF NORTH CAROLINA
DEPARTMENT OF TRANSPORTATION
RALEIGH

BENT 179 & BENT 180

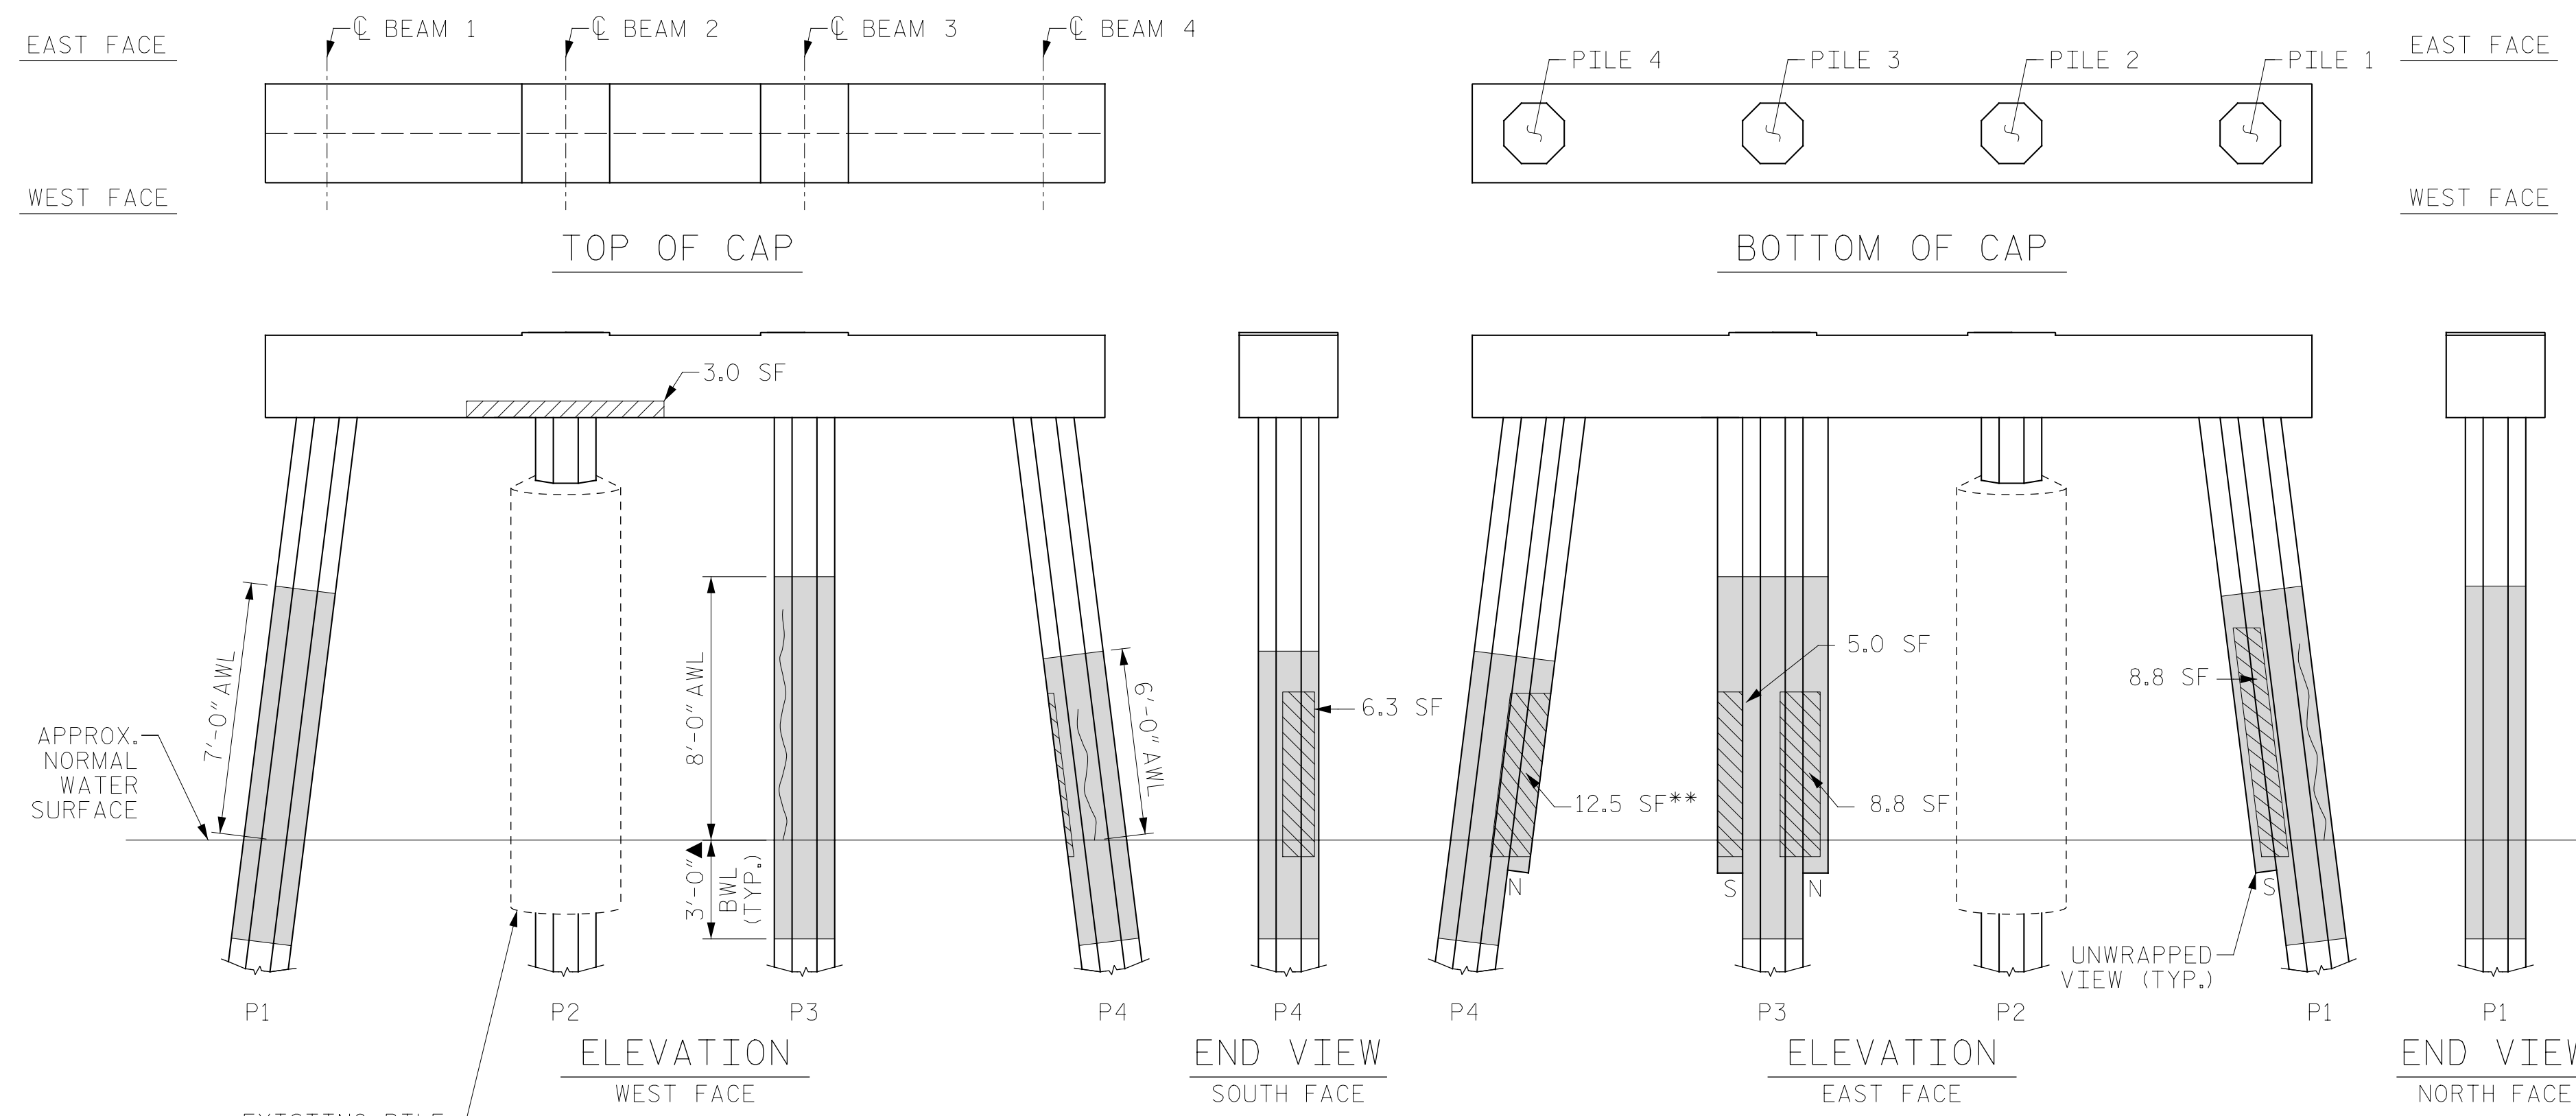
BENT 179

CAP REPAIRS			
SHOTCRETE REPAIRS	3.0 SF	1.5 CF	SF CF
EPOXY RESIN INJECTION	- LF		LF
PILE REPAIRS			
PILE CONCRETE RESTORATION	35.6 SF	16.0 CF	SF CF
FRP PROTECTIVE SYSTEM AWL	128.1 SF		
FRP PROTECTIVE SYSTEM BWL	54.9 SF

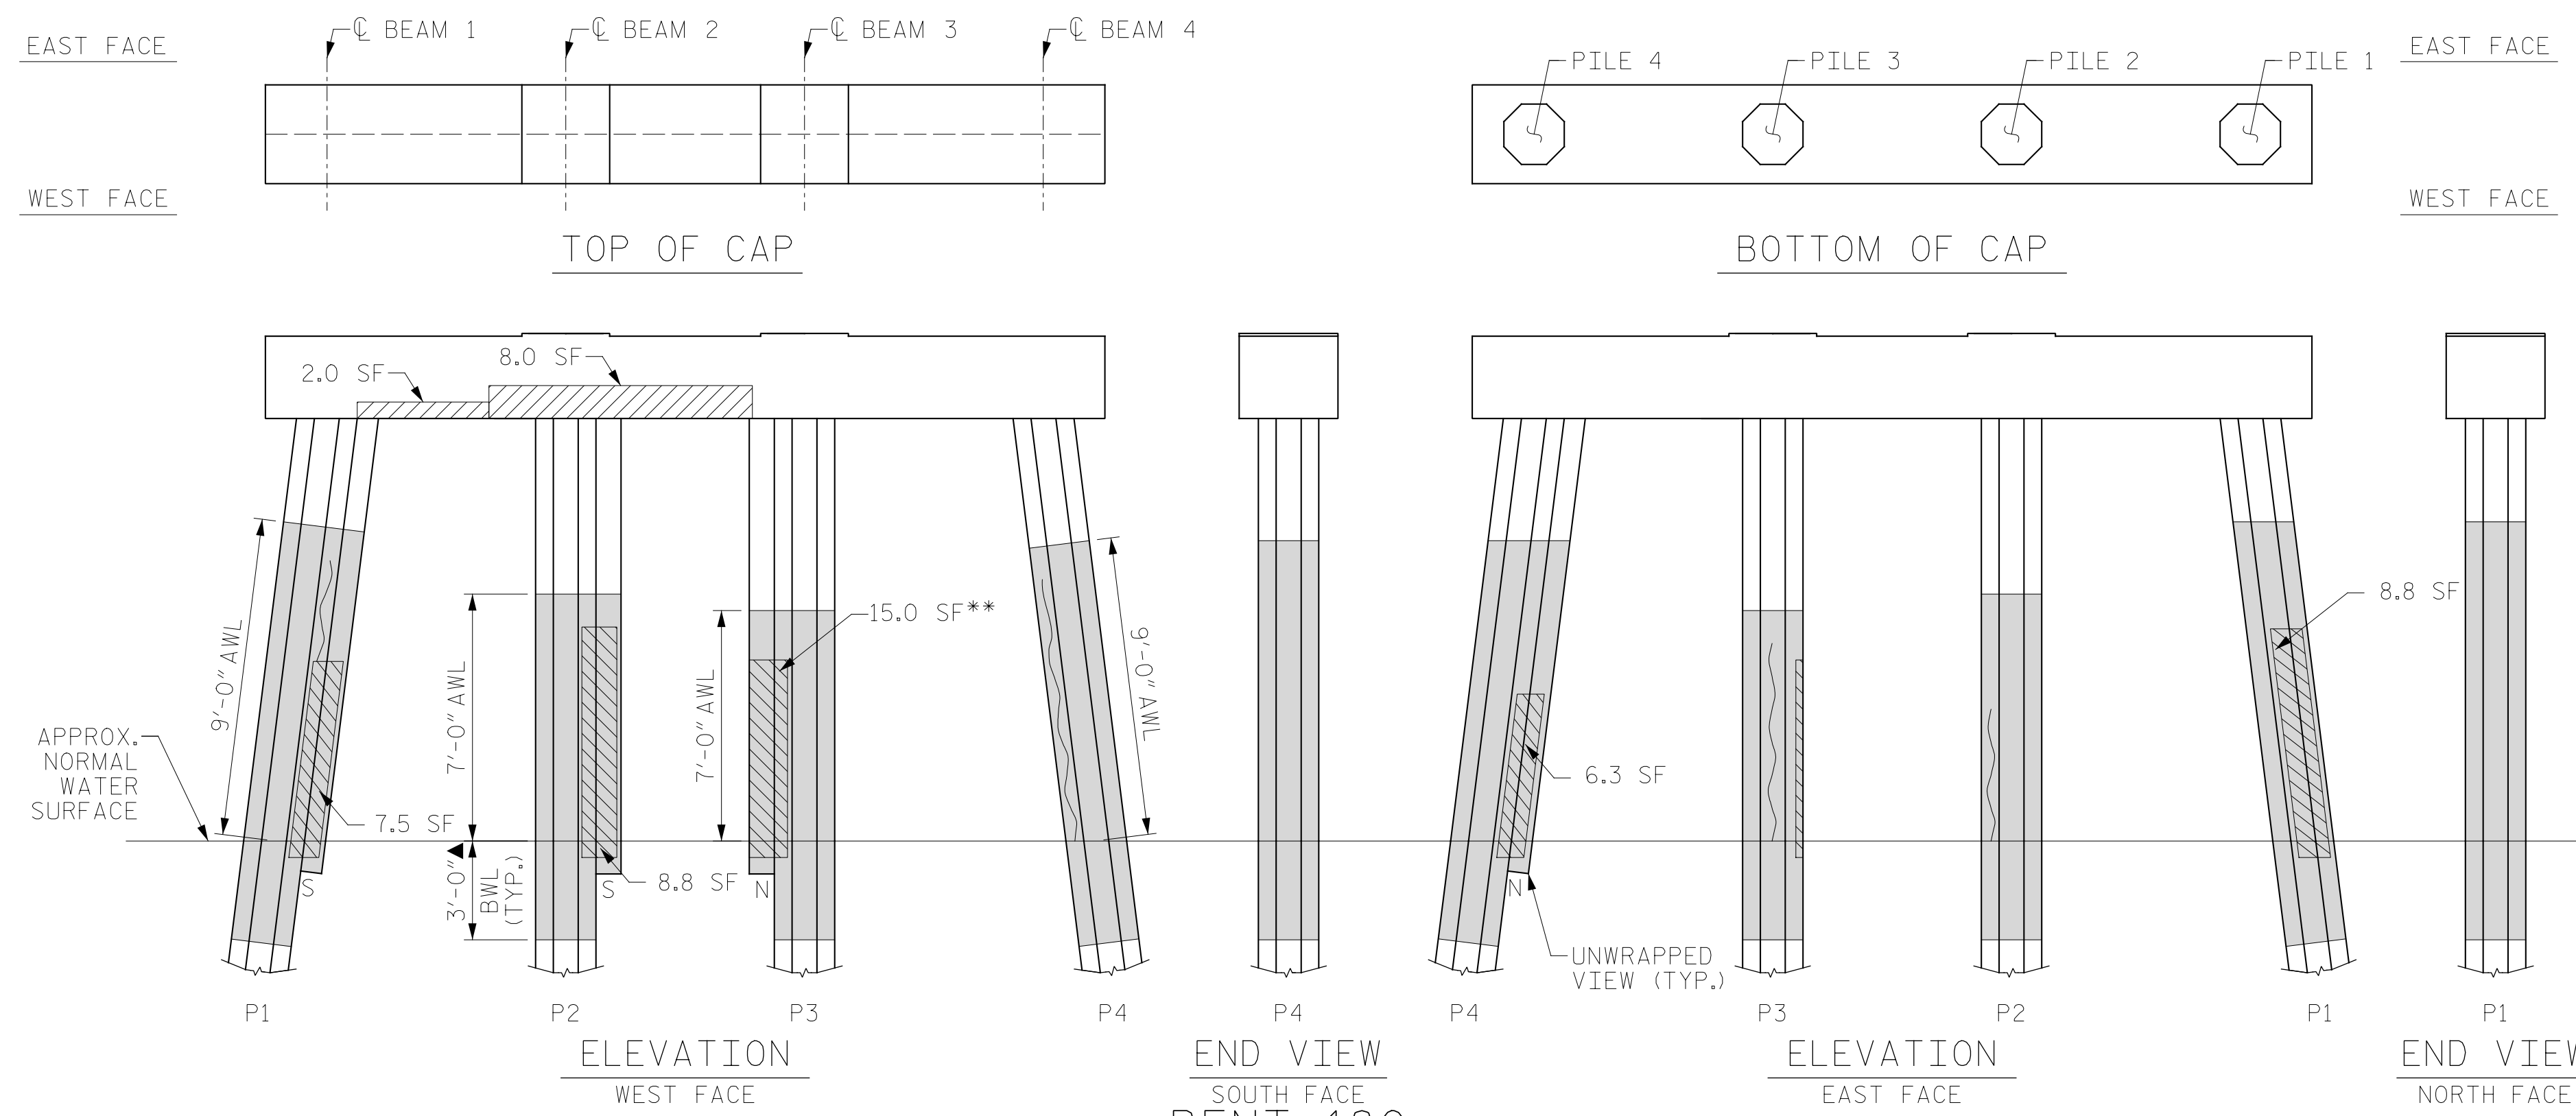
BENT 180

CAP REPAIRS			
SHOTCRETE REPAIRS	10.0 SF	5.0 CF	SF CF
EPOXY RESIN INJECTION	- LF		LF
PILE REPAIRS			
PILE CONCRETE RESTORATION	43.3 SF	18.0 CF	SF CF
FRP PROTECTIVE SYSTEM AWL	195.2 SF		
FRP PROTECTIVE SYSTEM BWL	73.2 SF
