AS-BUILT REPAIR QUANTITY TABLE

PROJECT NO. HB-0017  
DARE COUNTY  
BRIDGE NO. 270009

BENT 181 & BENT 182

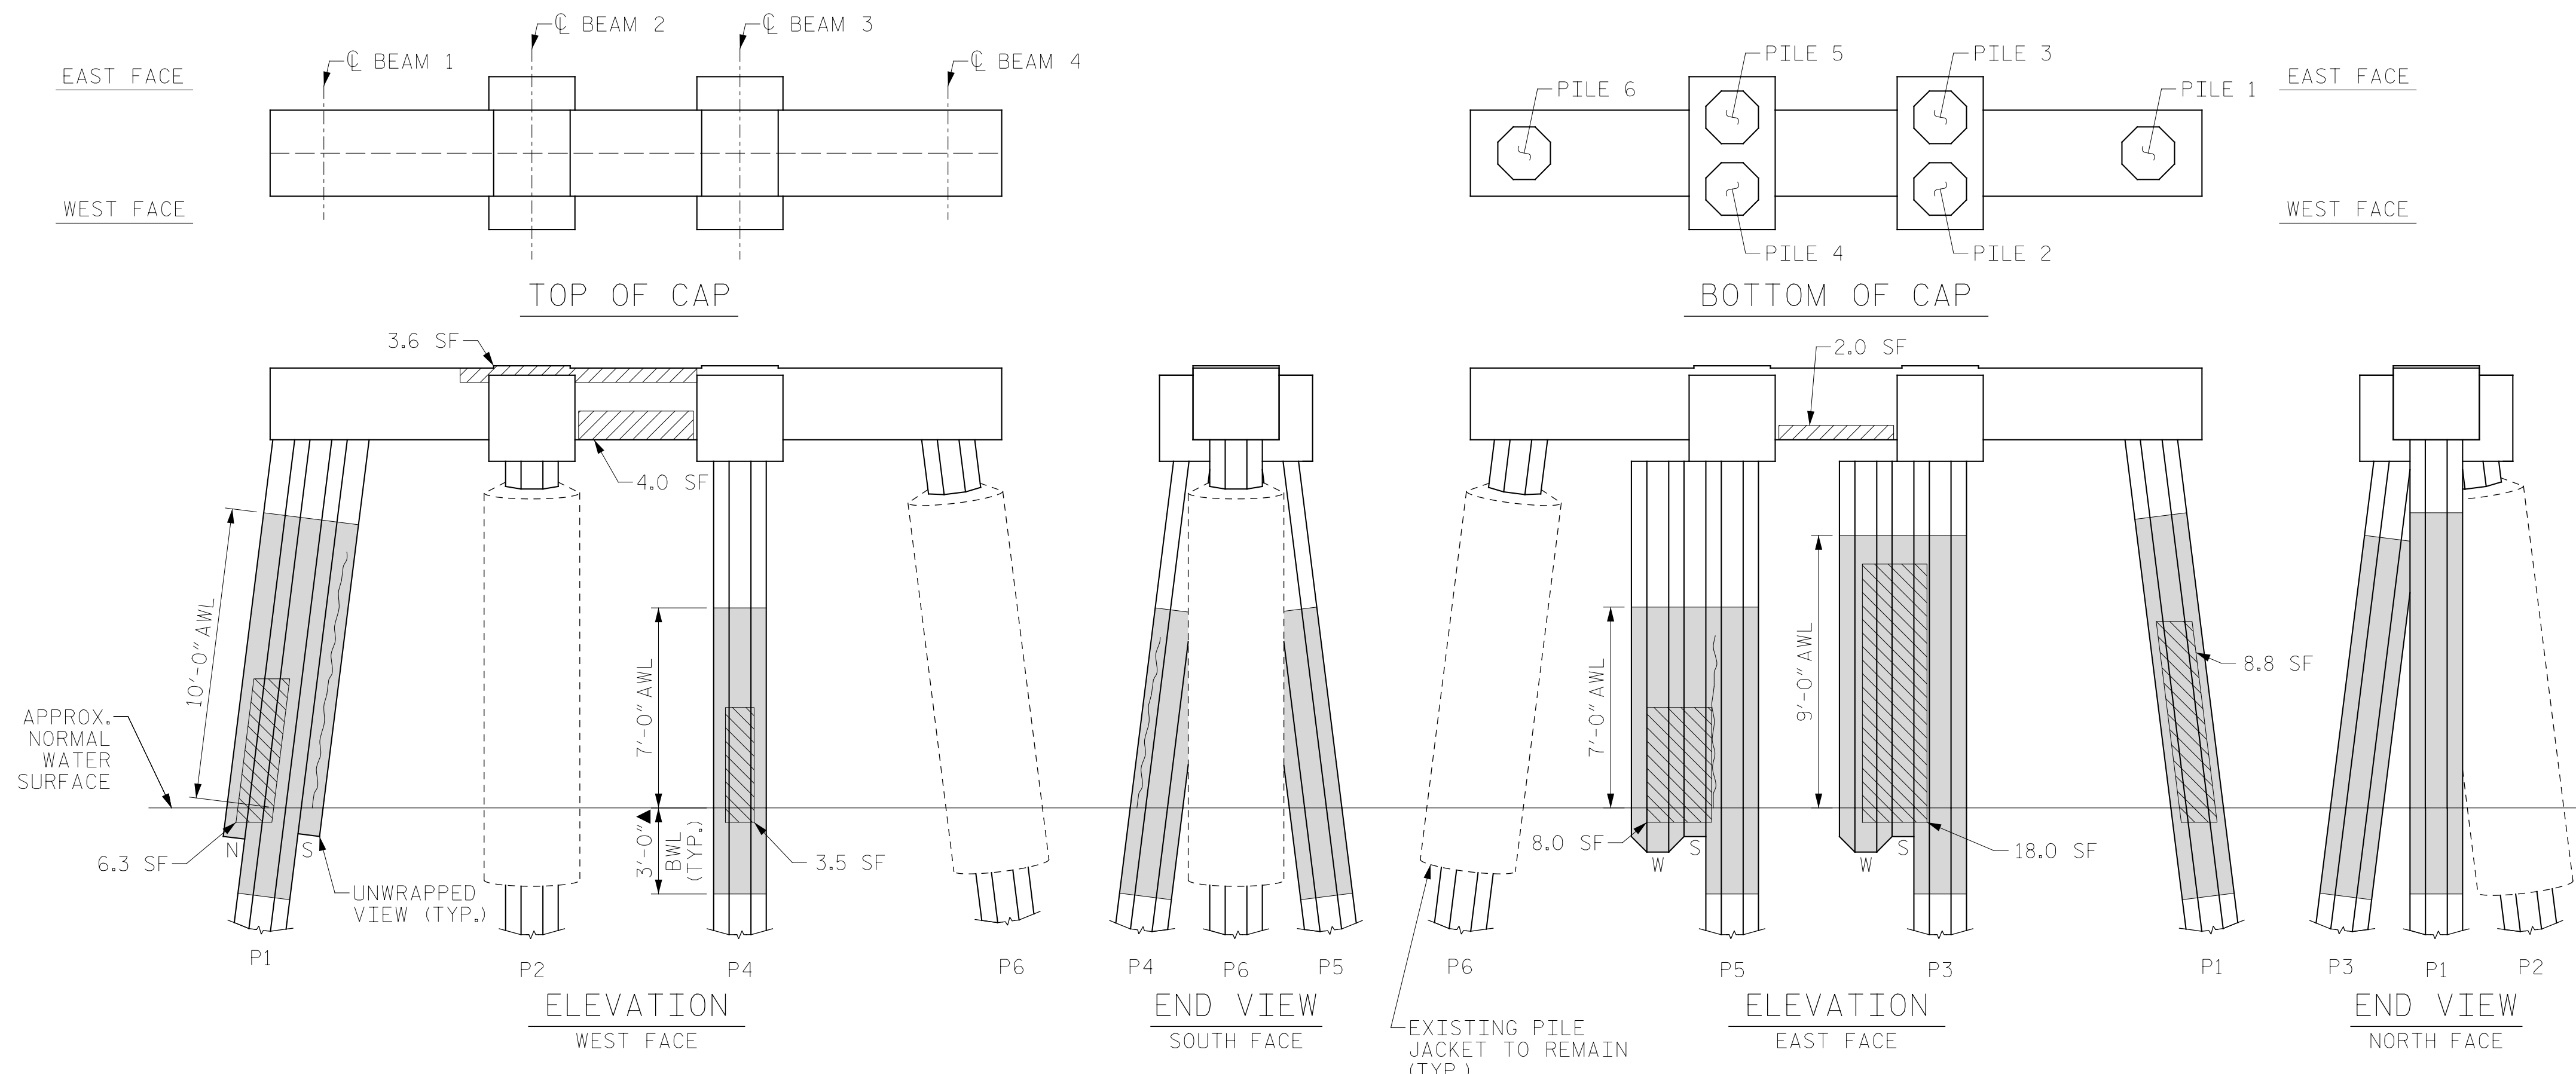
BENT 181

CAP REPAIRS			
SHOTCRETE REPAIRS	9.6 SF	4.8 CF	
EPOXY RESIN INJECTION	- LF		
PILE REPAIRS			
PILE CONCRETE RESTORATION	44.5 SF	18.2 CF	
FRP PROTECTIVE SYSTEM AWL	201.3 SF		
FRP PROTECTIVE SYSTEM BWL	73.2 SF

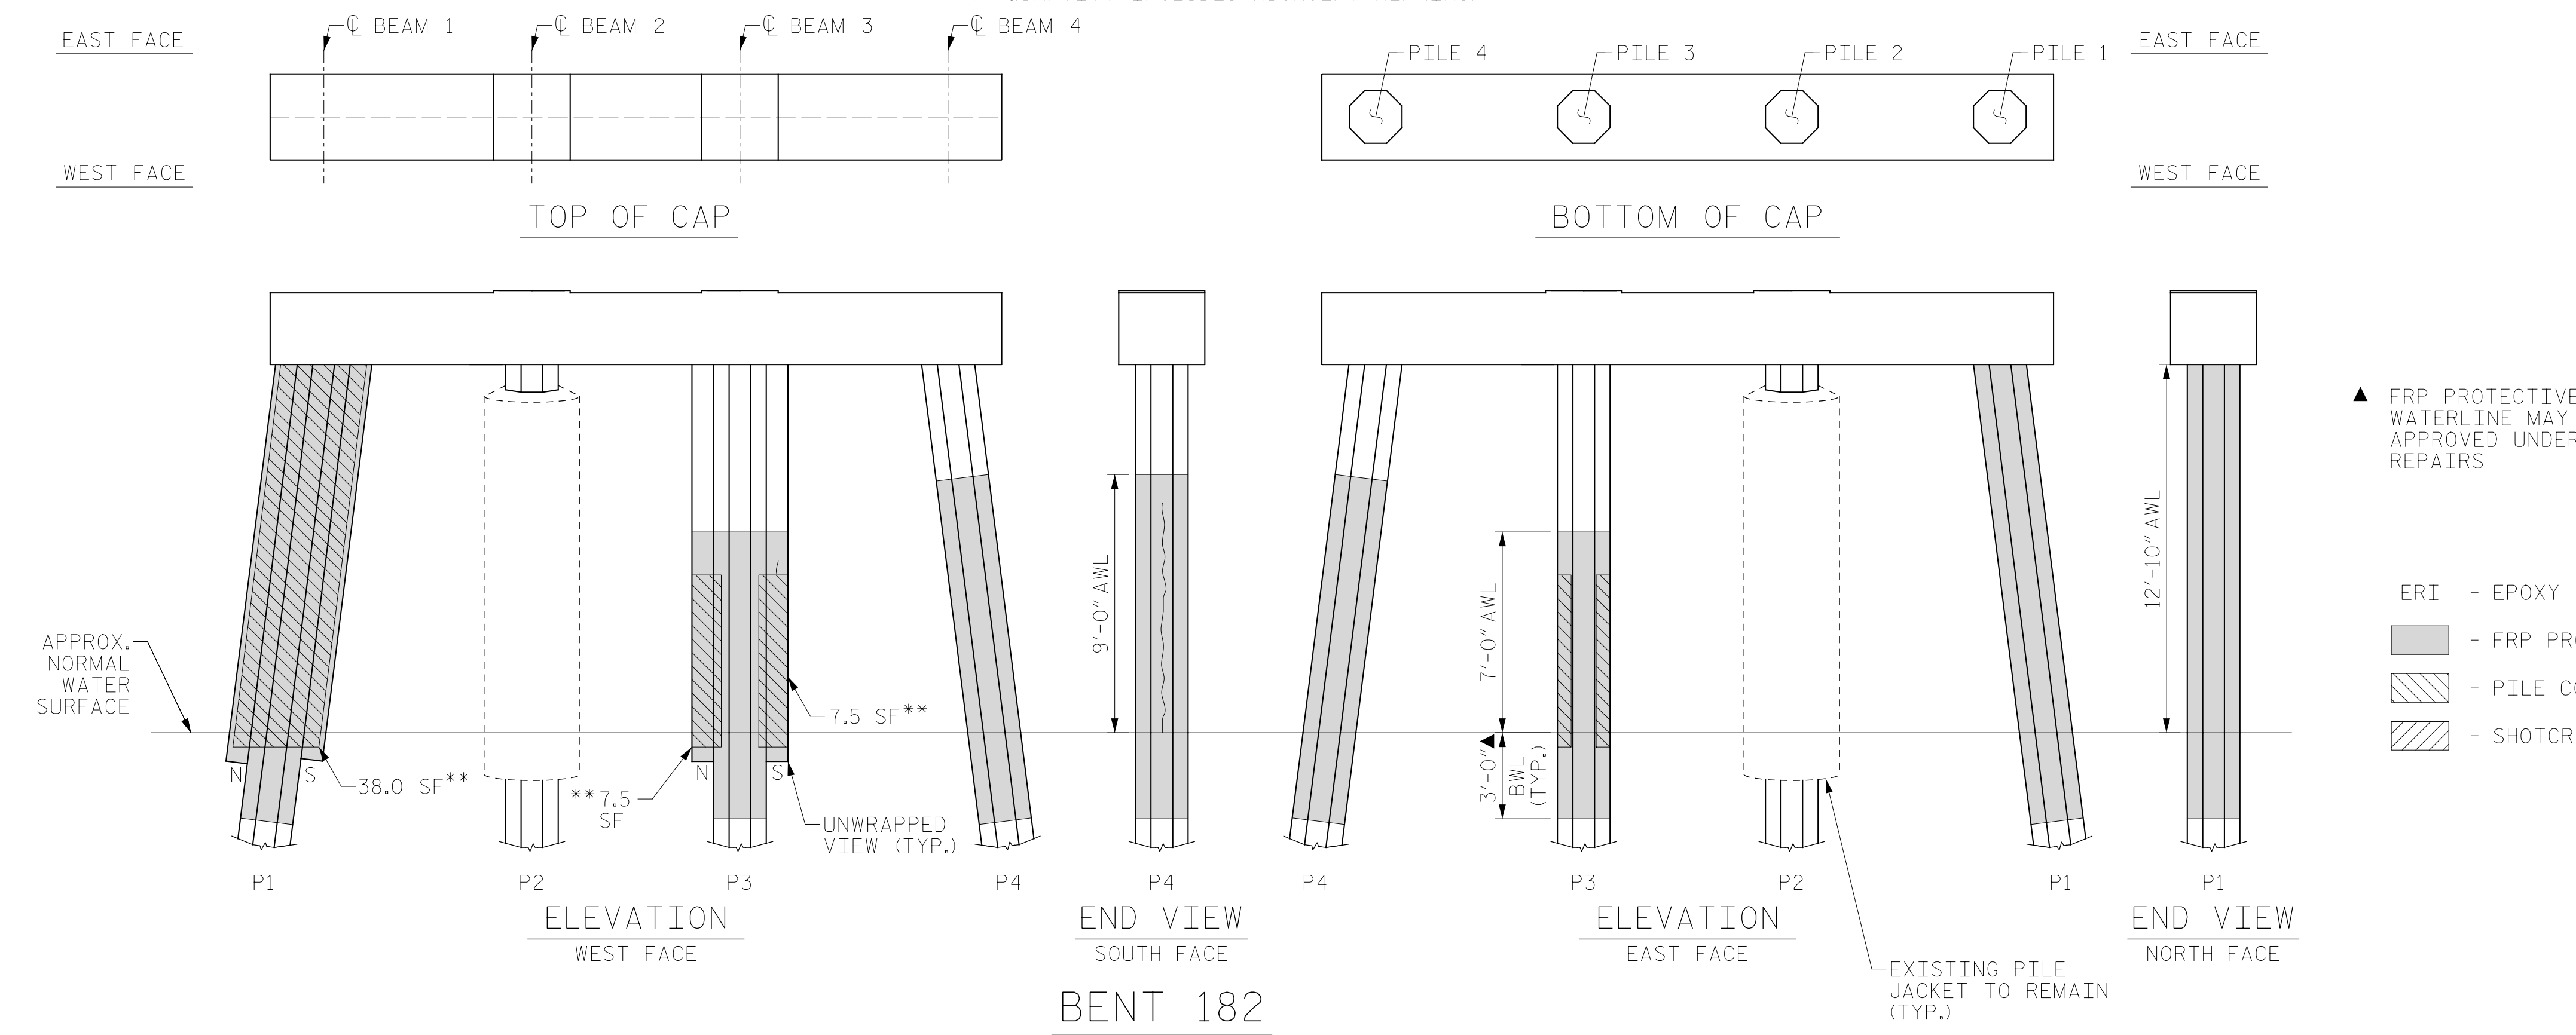
BENT 182

CAP REPAIRS			
SHOTCRETE REPAIRS	- SF	- CF	
EPOXY RESIN INJECTION	- LF		
PILE REPAIRS			
PILE CONCRETE RESTORATION	50.5 SF	20.4 CF	
FRP PROTECTIVE SYSTEM AWL	175.7 SF		
FRP PROTECTIVE SYSTEM BWL	54.9 SF
