PROJECT NO. HB-0017
DARE COUNTY
 BRIDGE NO. 270009

BENT 183 & BENT 184

REVISIONS						SHEET NO.
NO.	BY:	DATE:	NO.	BY:	DATE:	S-261
1			3			TOTAL SHEETS
2			4			355

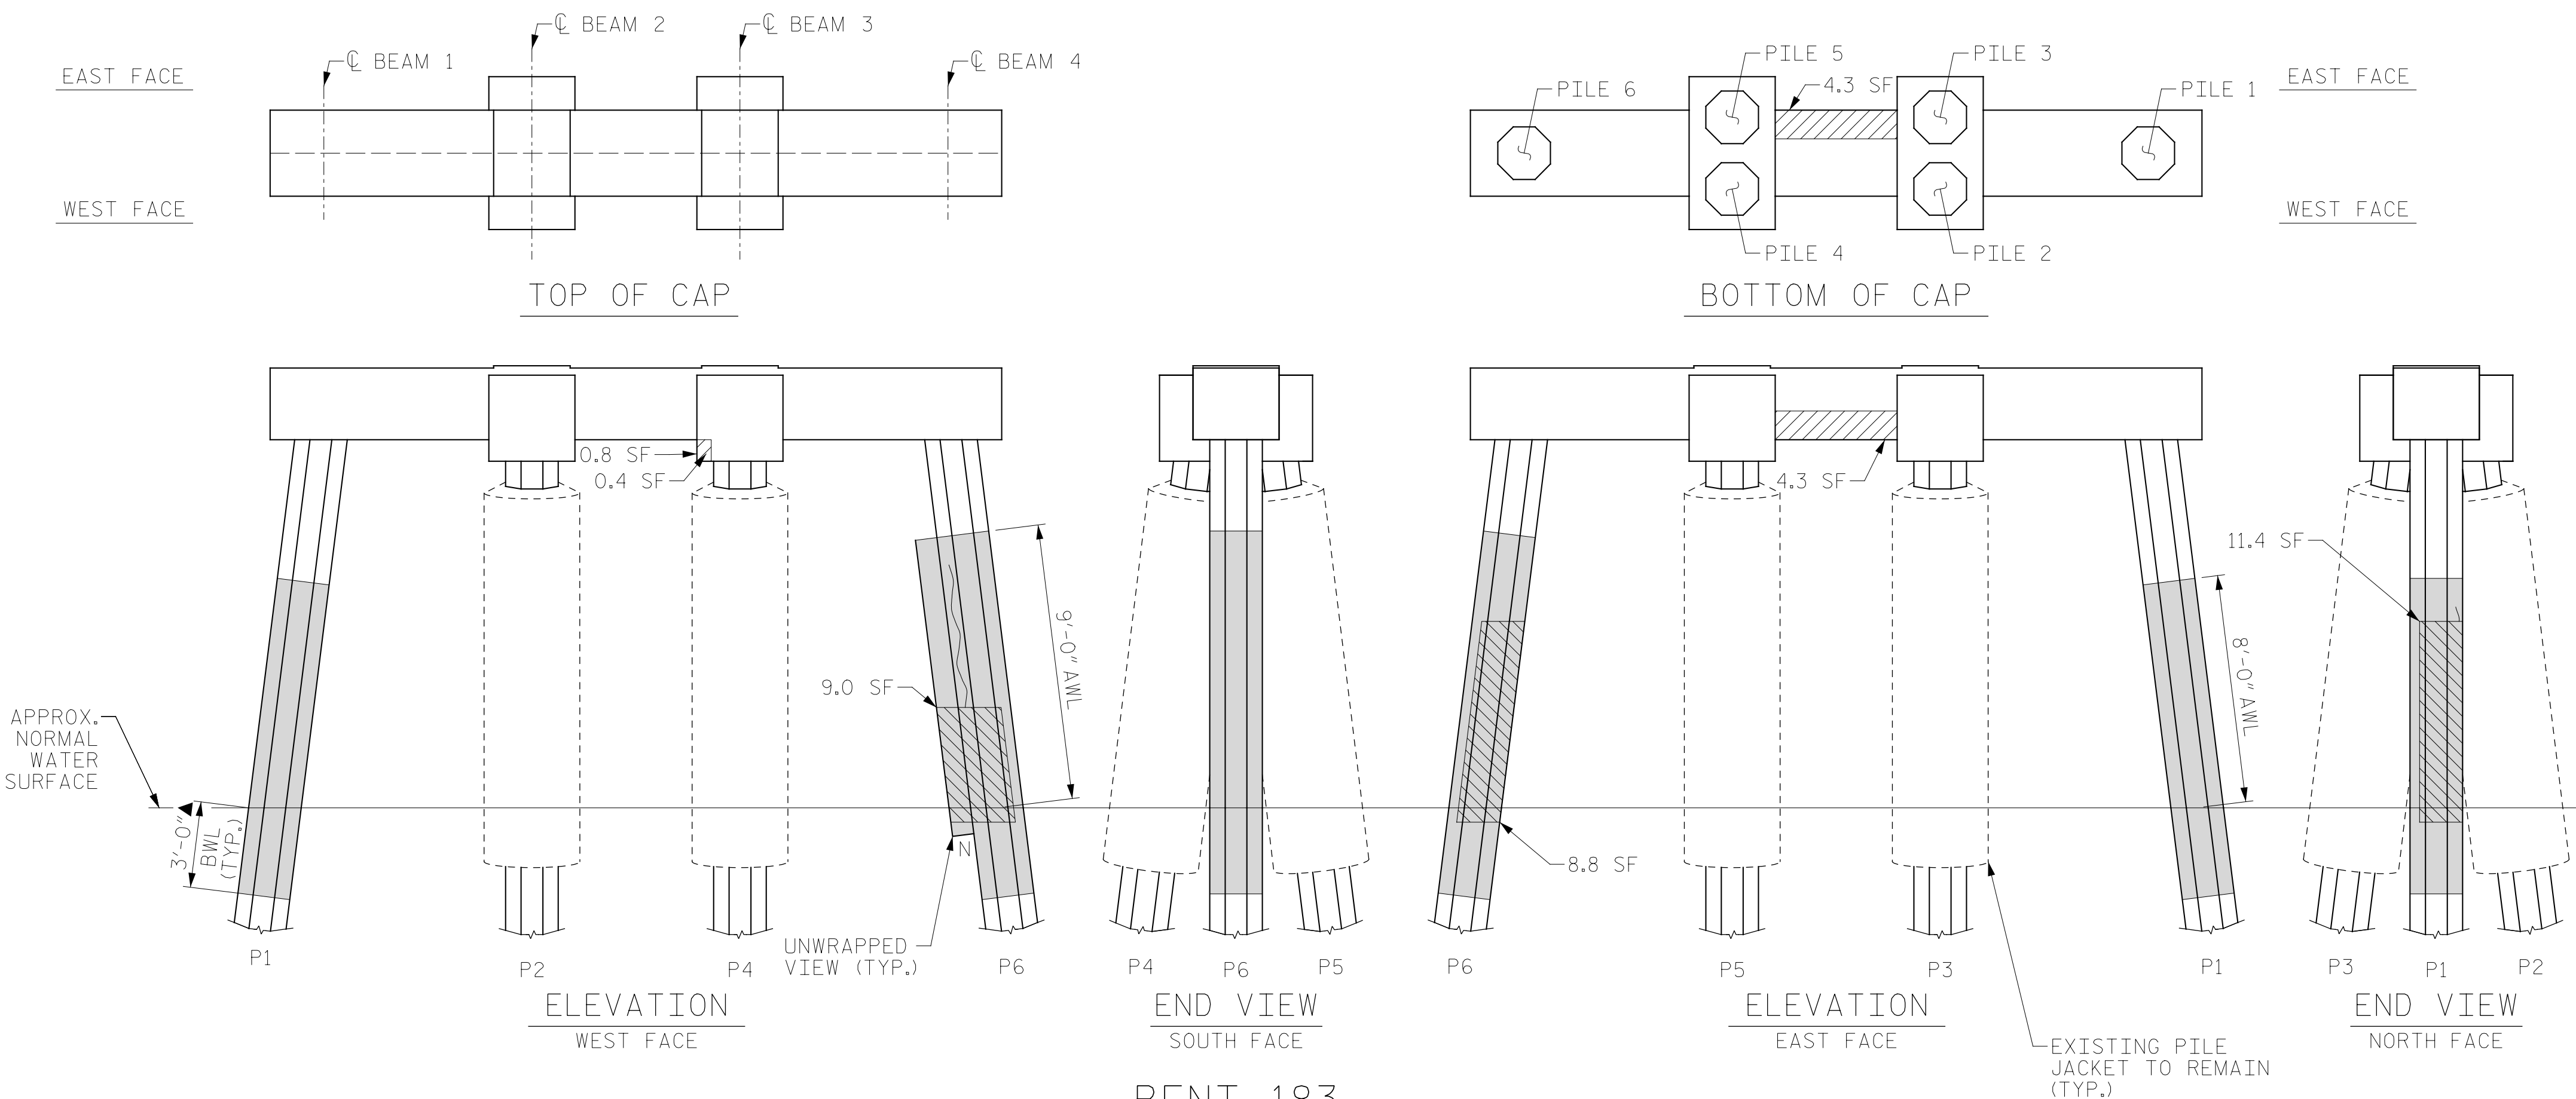
CAP REPAIRS			
SHOTCRETE REPAIRS	9.8 SF	4.9 CF	SF CF
EPOXY RESIN INJECTION	- LF		LF
PILE REPAIRS			
PILE CONCRETE RESTORATION	29.2 SF	12.0 CF	SF CF
FRP PROTECTIVE SYSTEM AWL	103.7 SF		
FRP PROTECTIVE SYSTEM BWL	36.6 SF

NW	W	SW	S	SE	E	NE	N
BENT 183	PILE 1	6	3	-	3	-	-	1	1
	PILE 2	-	-	-	-	-	-	-	-
	PILE 3	-	-	-	-	-	-	-	-
	PILE 4	-	-	-	-	-	-	-	-
	PILE 5	-	-	-	-	-	-	-	-
	PILE 6	5	3	-	5	2	-	-	4
BENT 184	PILE 1	6	-	-	-	-	-	6	-
	PILE 2	-	-	-	8	-	6	-	-
	PILE 3	-	-	4	-	5	-	-	-
	PILE 4	-	6	5	-	-	7	-	8

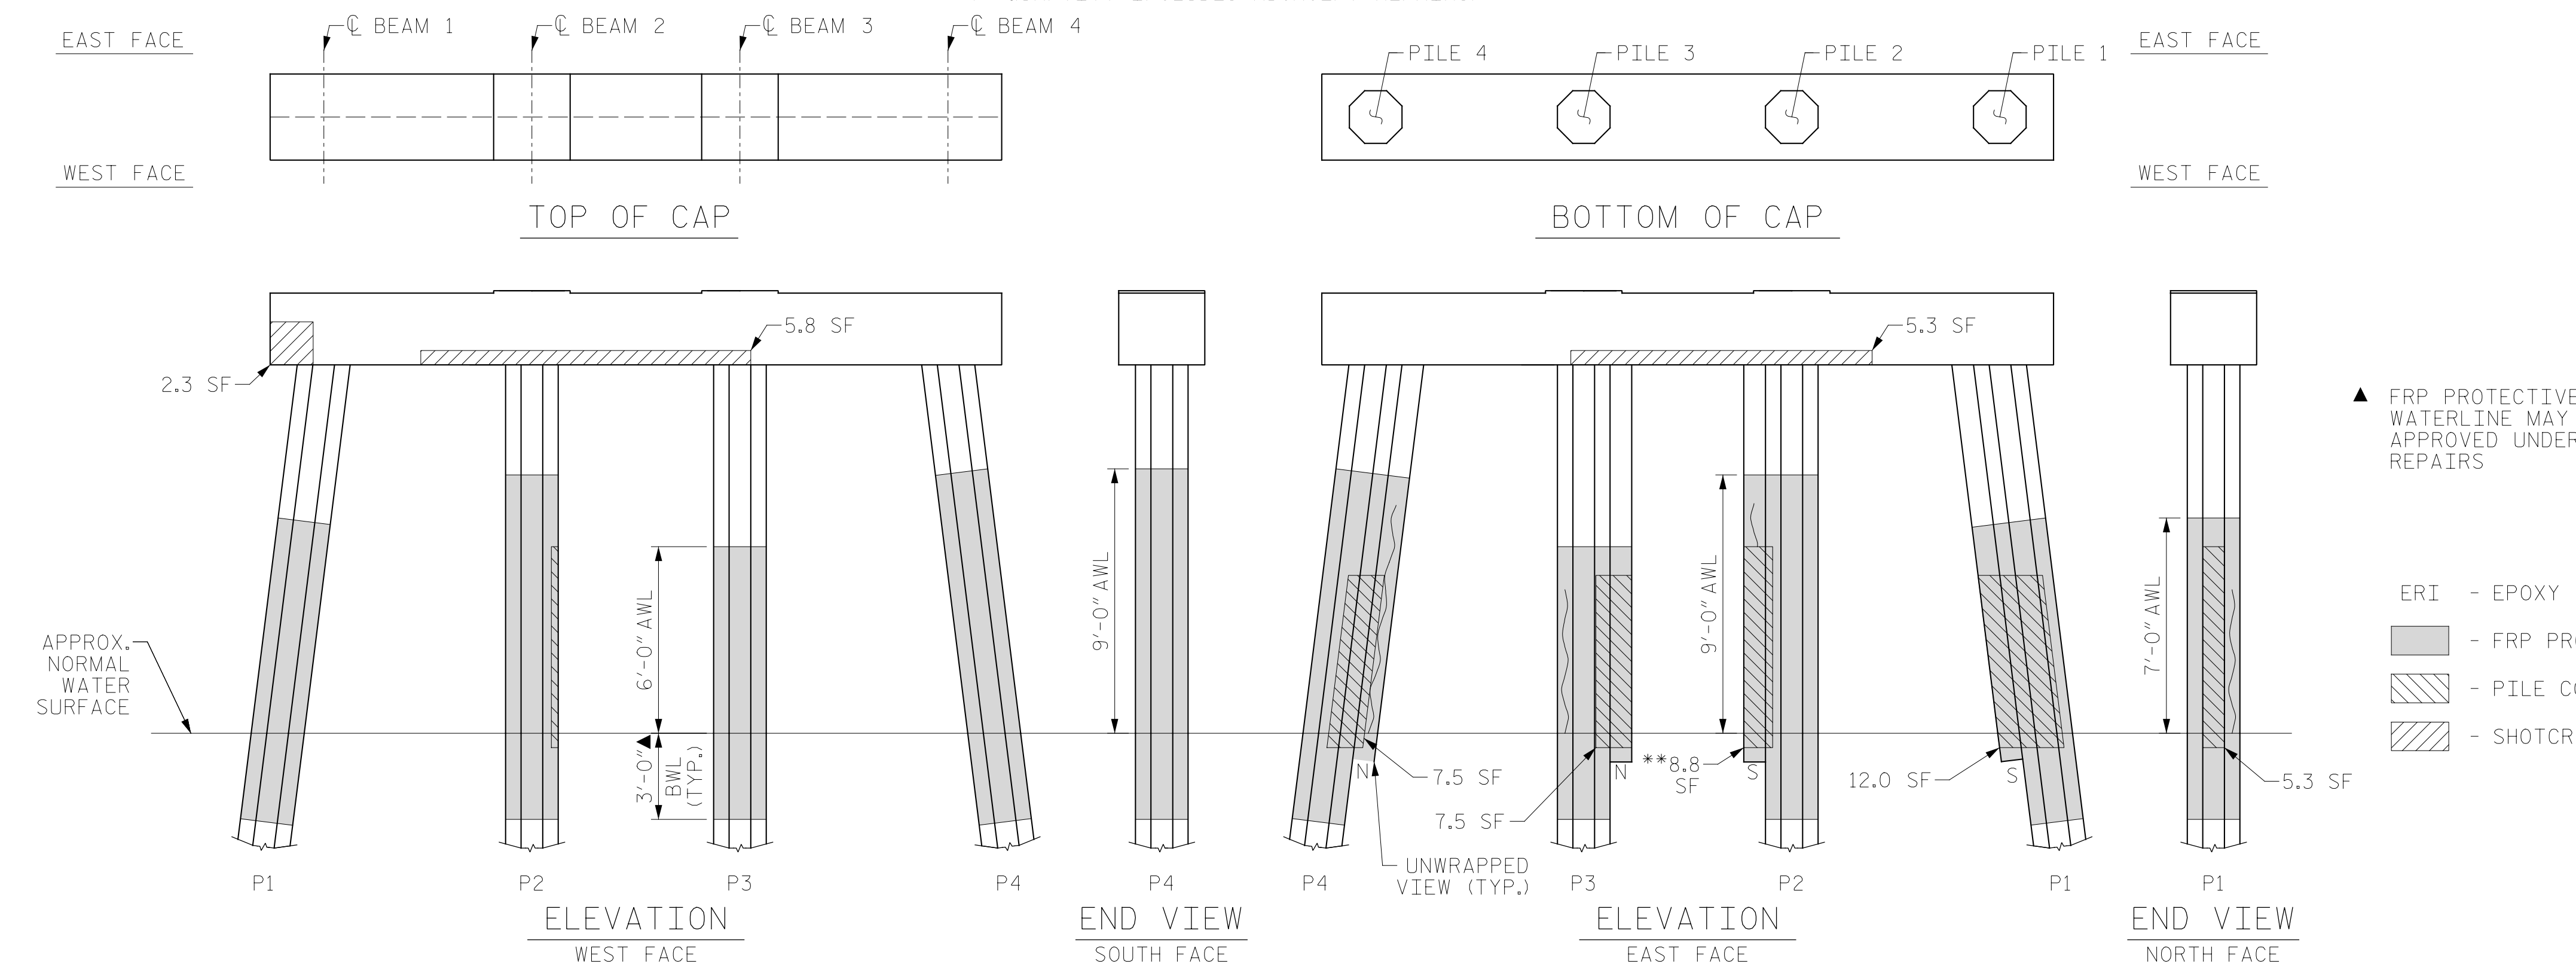
BENT 184

CAP REPAIRS			
SHOTCRETE REPAIRS	13.4 SF	6.7 CF	SF CF
EPOXY RESIN INJECTION	- LF		LF
PILE REPAIRS			
PILE CONCRETE RESTORATION	41.1 SF	17.5 CF	SF CF
FRP PROTECTIVE SYSTEM AWL	189.1 SF		
FRP PROTECTIVE SYSTEM BWL	73.2 SF
