AS-BUILT REPAIR QUANTITY TABLE

PROJECT NO. HB-0017
DARE COUNTY
BRIDGE NO. 270009

BENT 191 & BENT 192

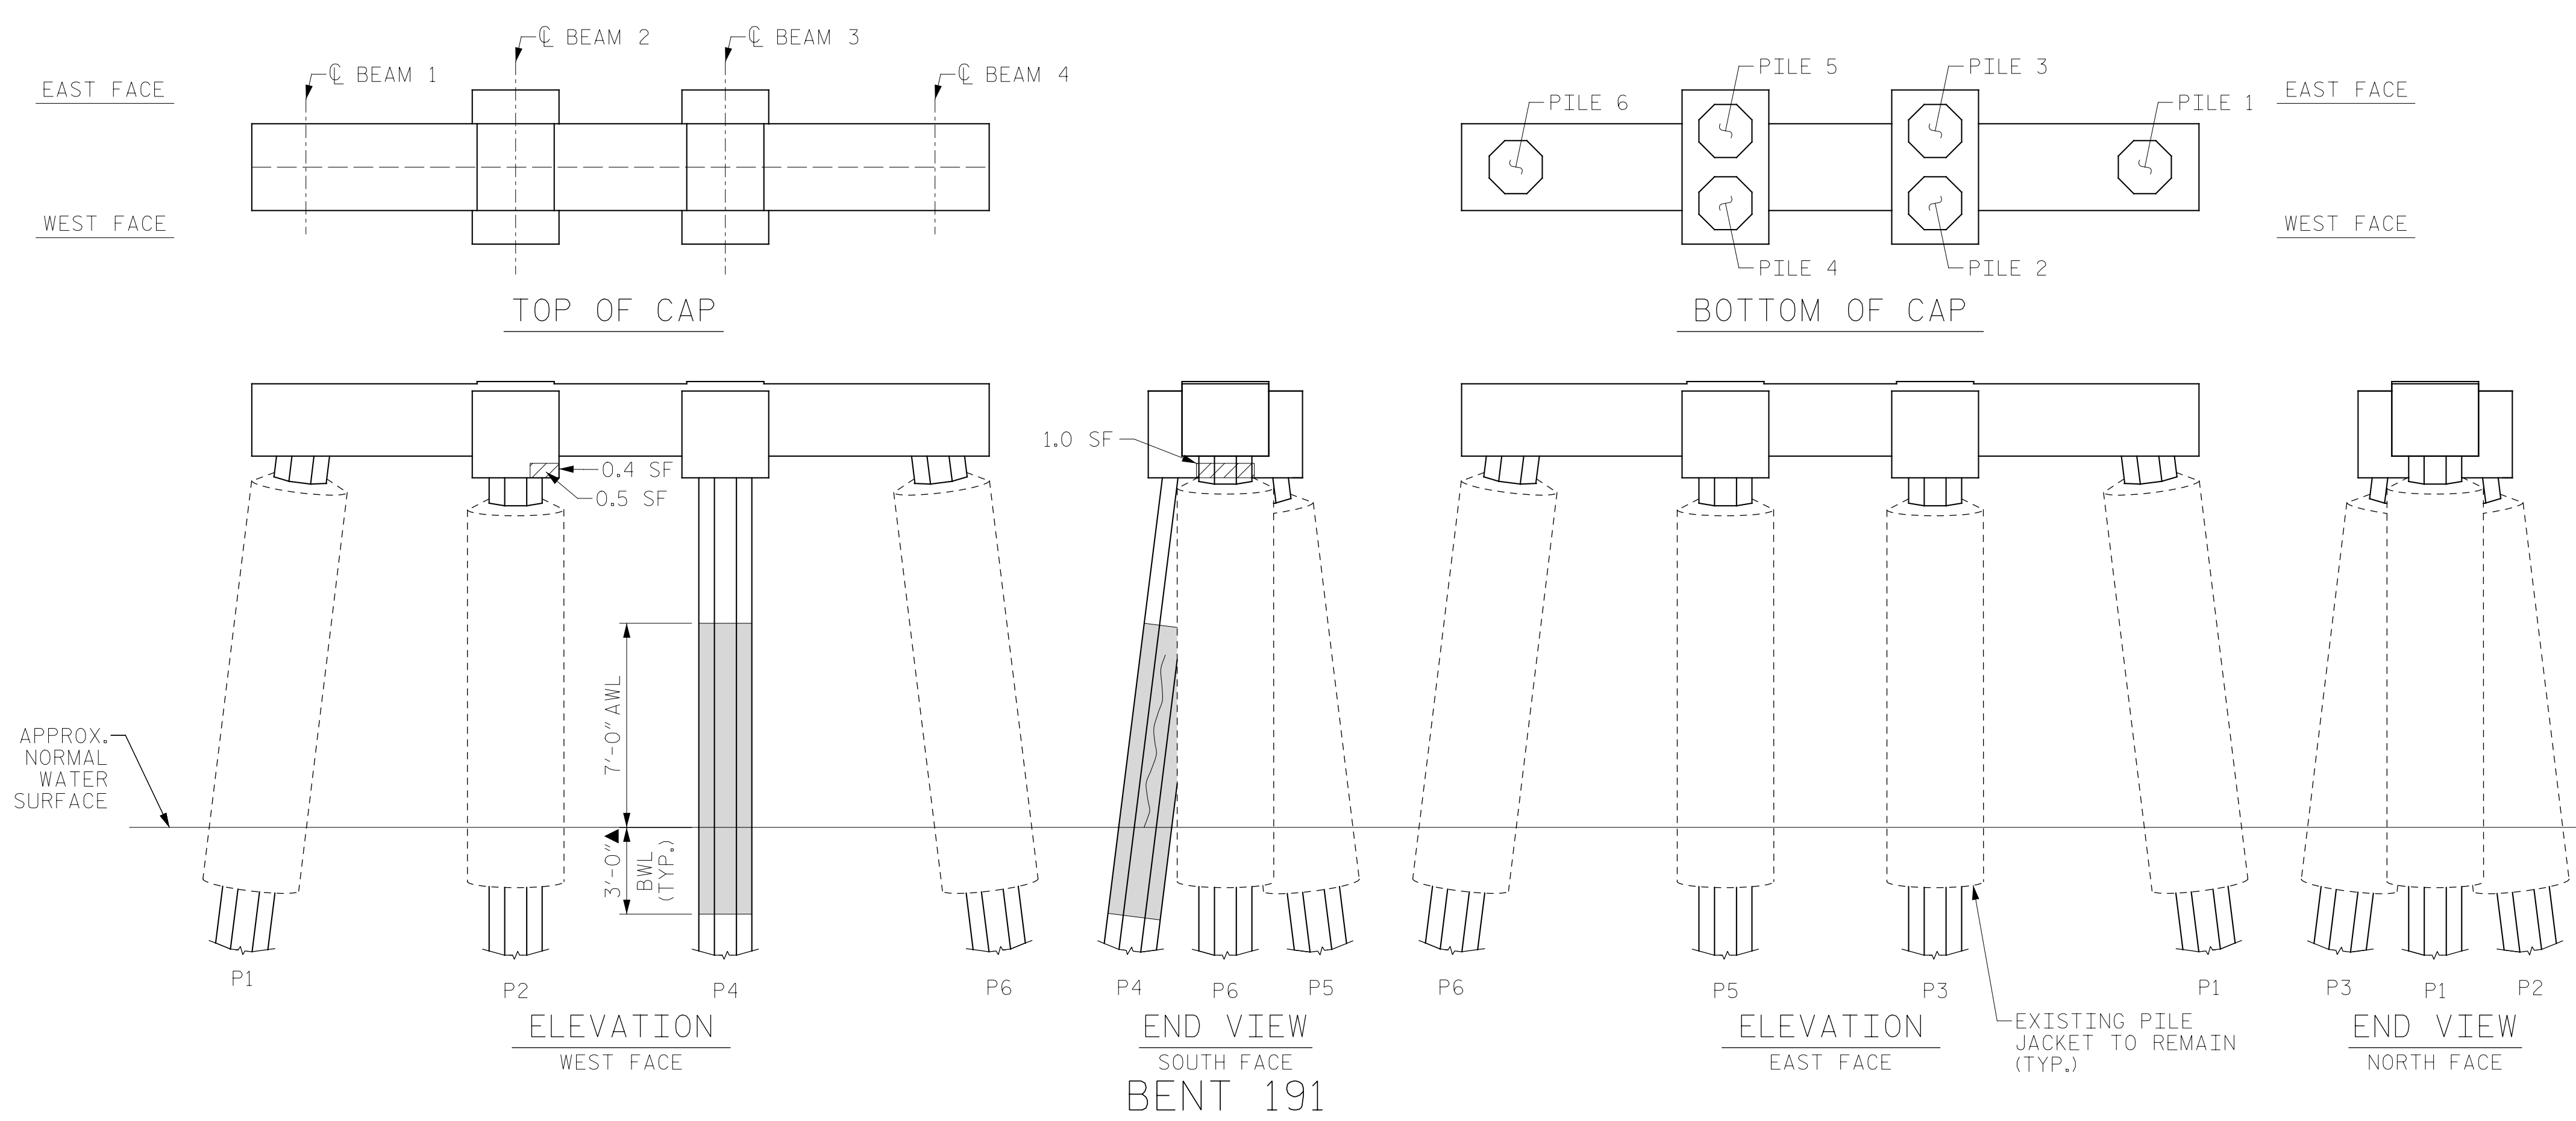
BENT 191

CAP REPAIRS			
SHOTCRETE REPAIRS	1.9 SF	1.0 CF	SF CF
EPOXY RESIN INJECTION	- LF		LF
PILE REPAIRS			
PILE CONCRETE RESTORATION	- SF	- CF	SF CF
FRP PROTECTIVE SYSTEM AWL	42.7 SF		
FRP PROTECTIVE SYSTEM BWL	18.3 SF

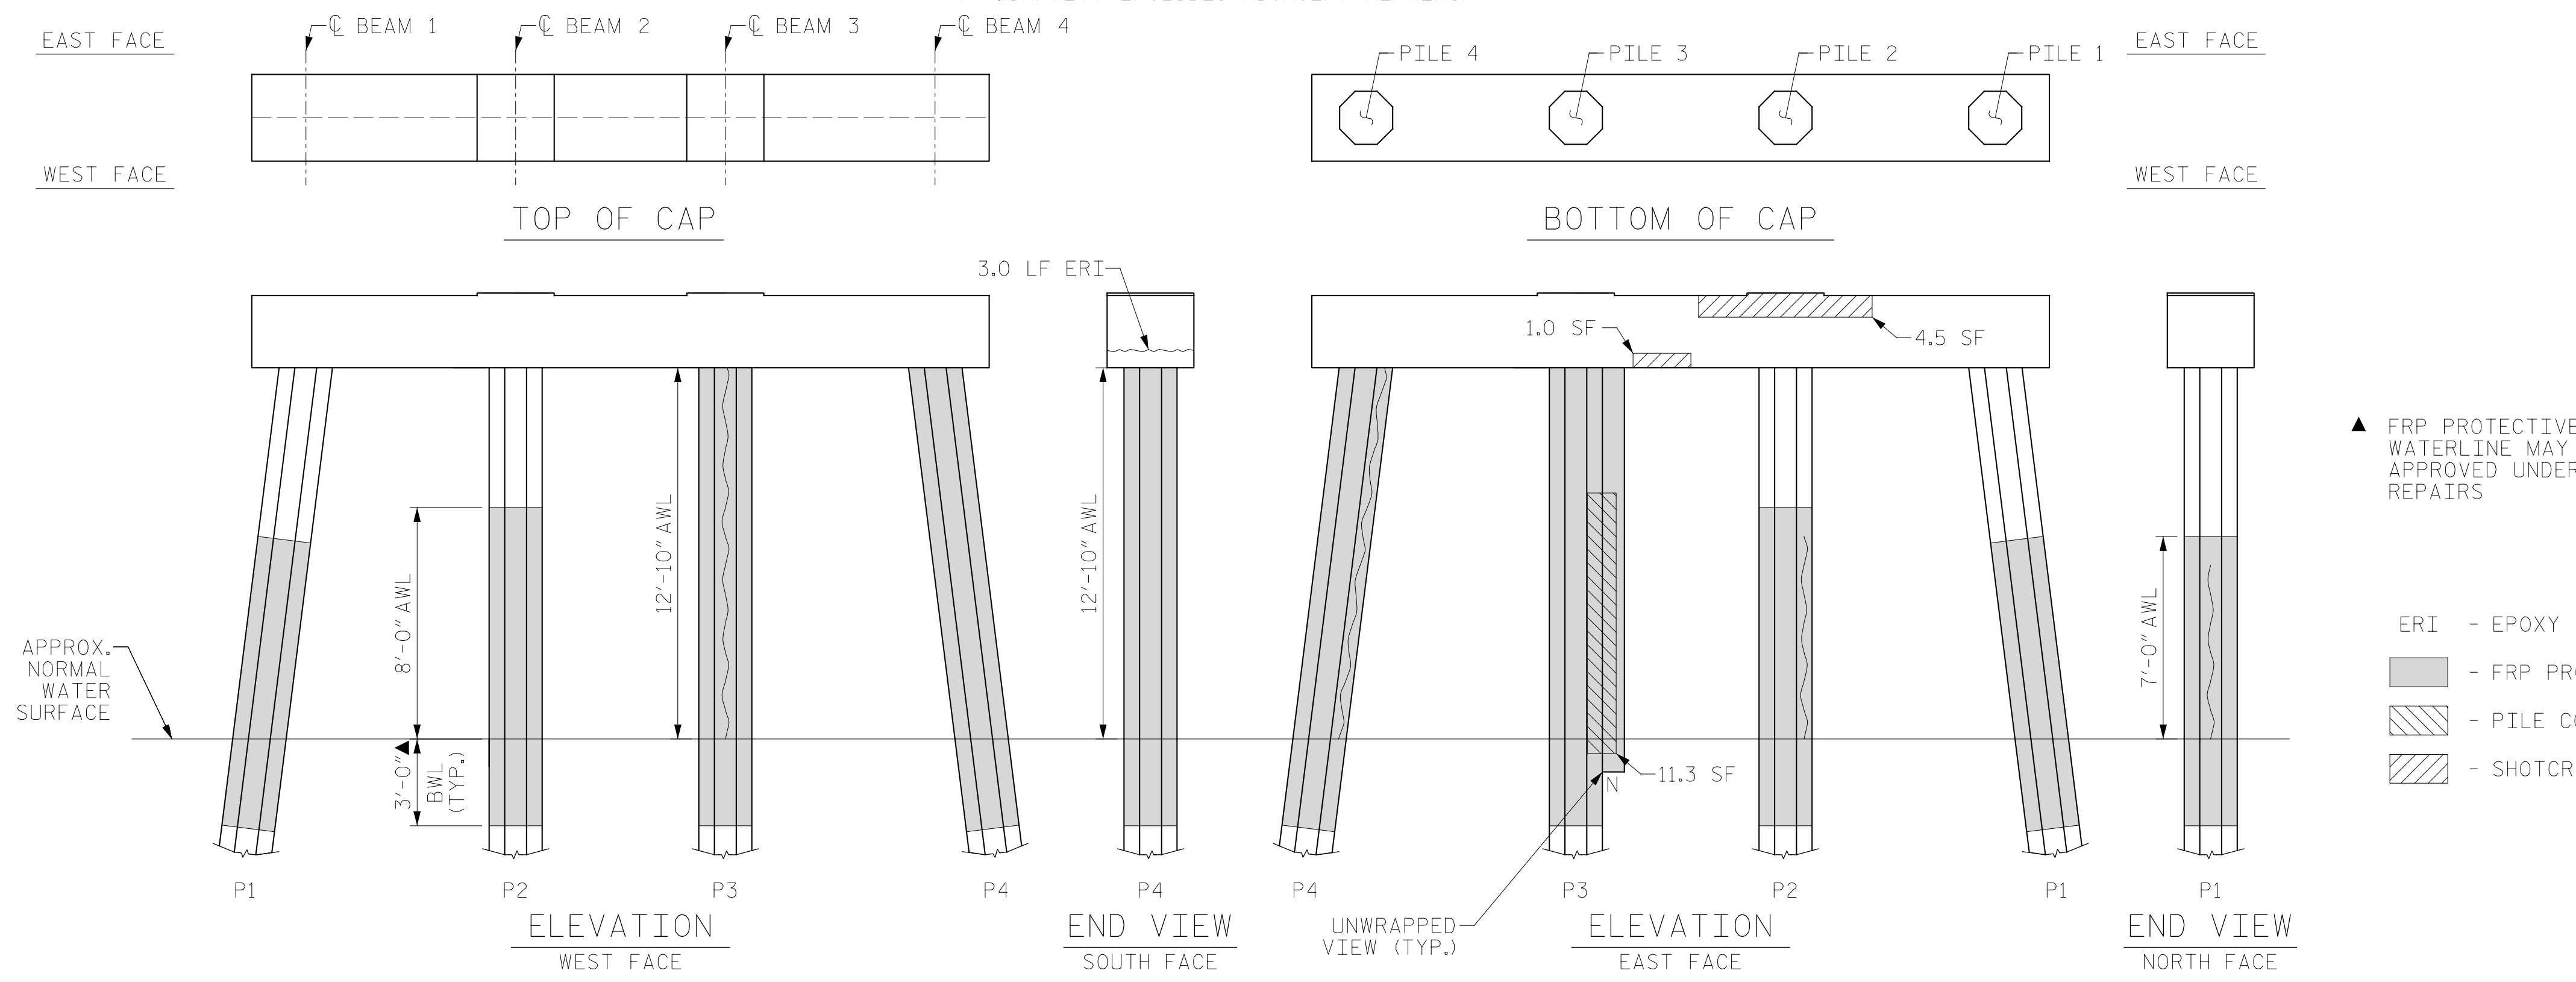
BENT 192

CAP REPAIRS			
SHOTCRETE REPAIRS	5.5 SF	2.8 CF	SF CF
EPOXY RESIN INJECTION	3.0 LF		LF
PILE REPAIRS			
PILE CONCRETE RESTORATION	11.3 SF	4.8 CF	SF CF
FRP PROTECTIVE SYSTEM AWL	248.1 SF		
FRP PROTECTIVE SYSTEM BWL	73.2 SF
