AS-BUILT REPAIR QUANTITY TABLE

STATE OF NORTH CAROLINA DEPARTMENT OF TRANSPORTATION

BENT 193 & BENT 194

SHEET NO S-266 DATE: TOTAL SHEETS 355

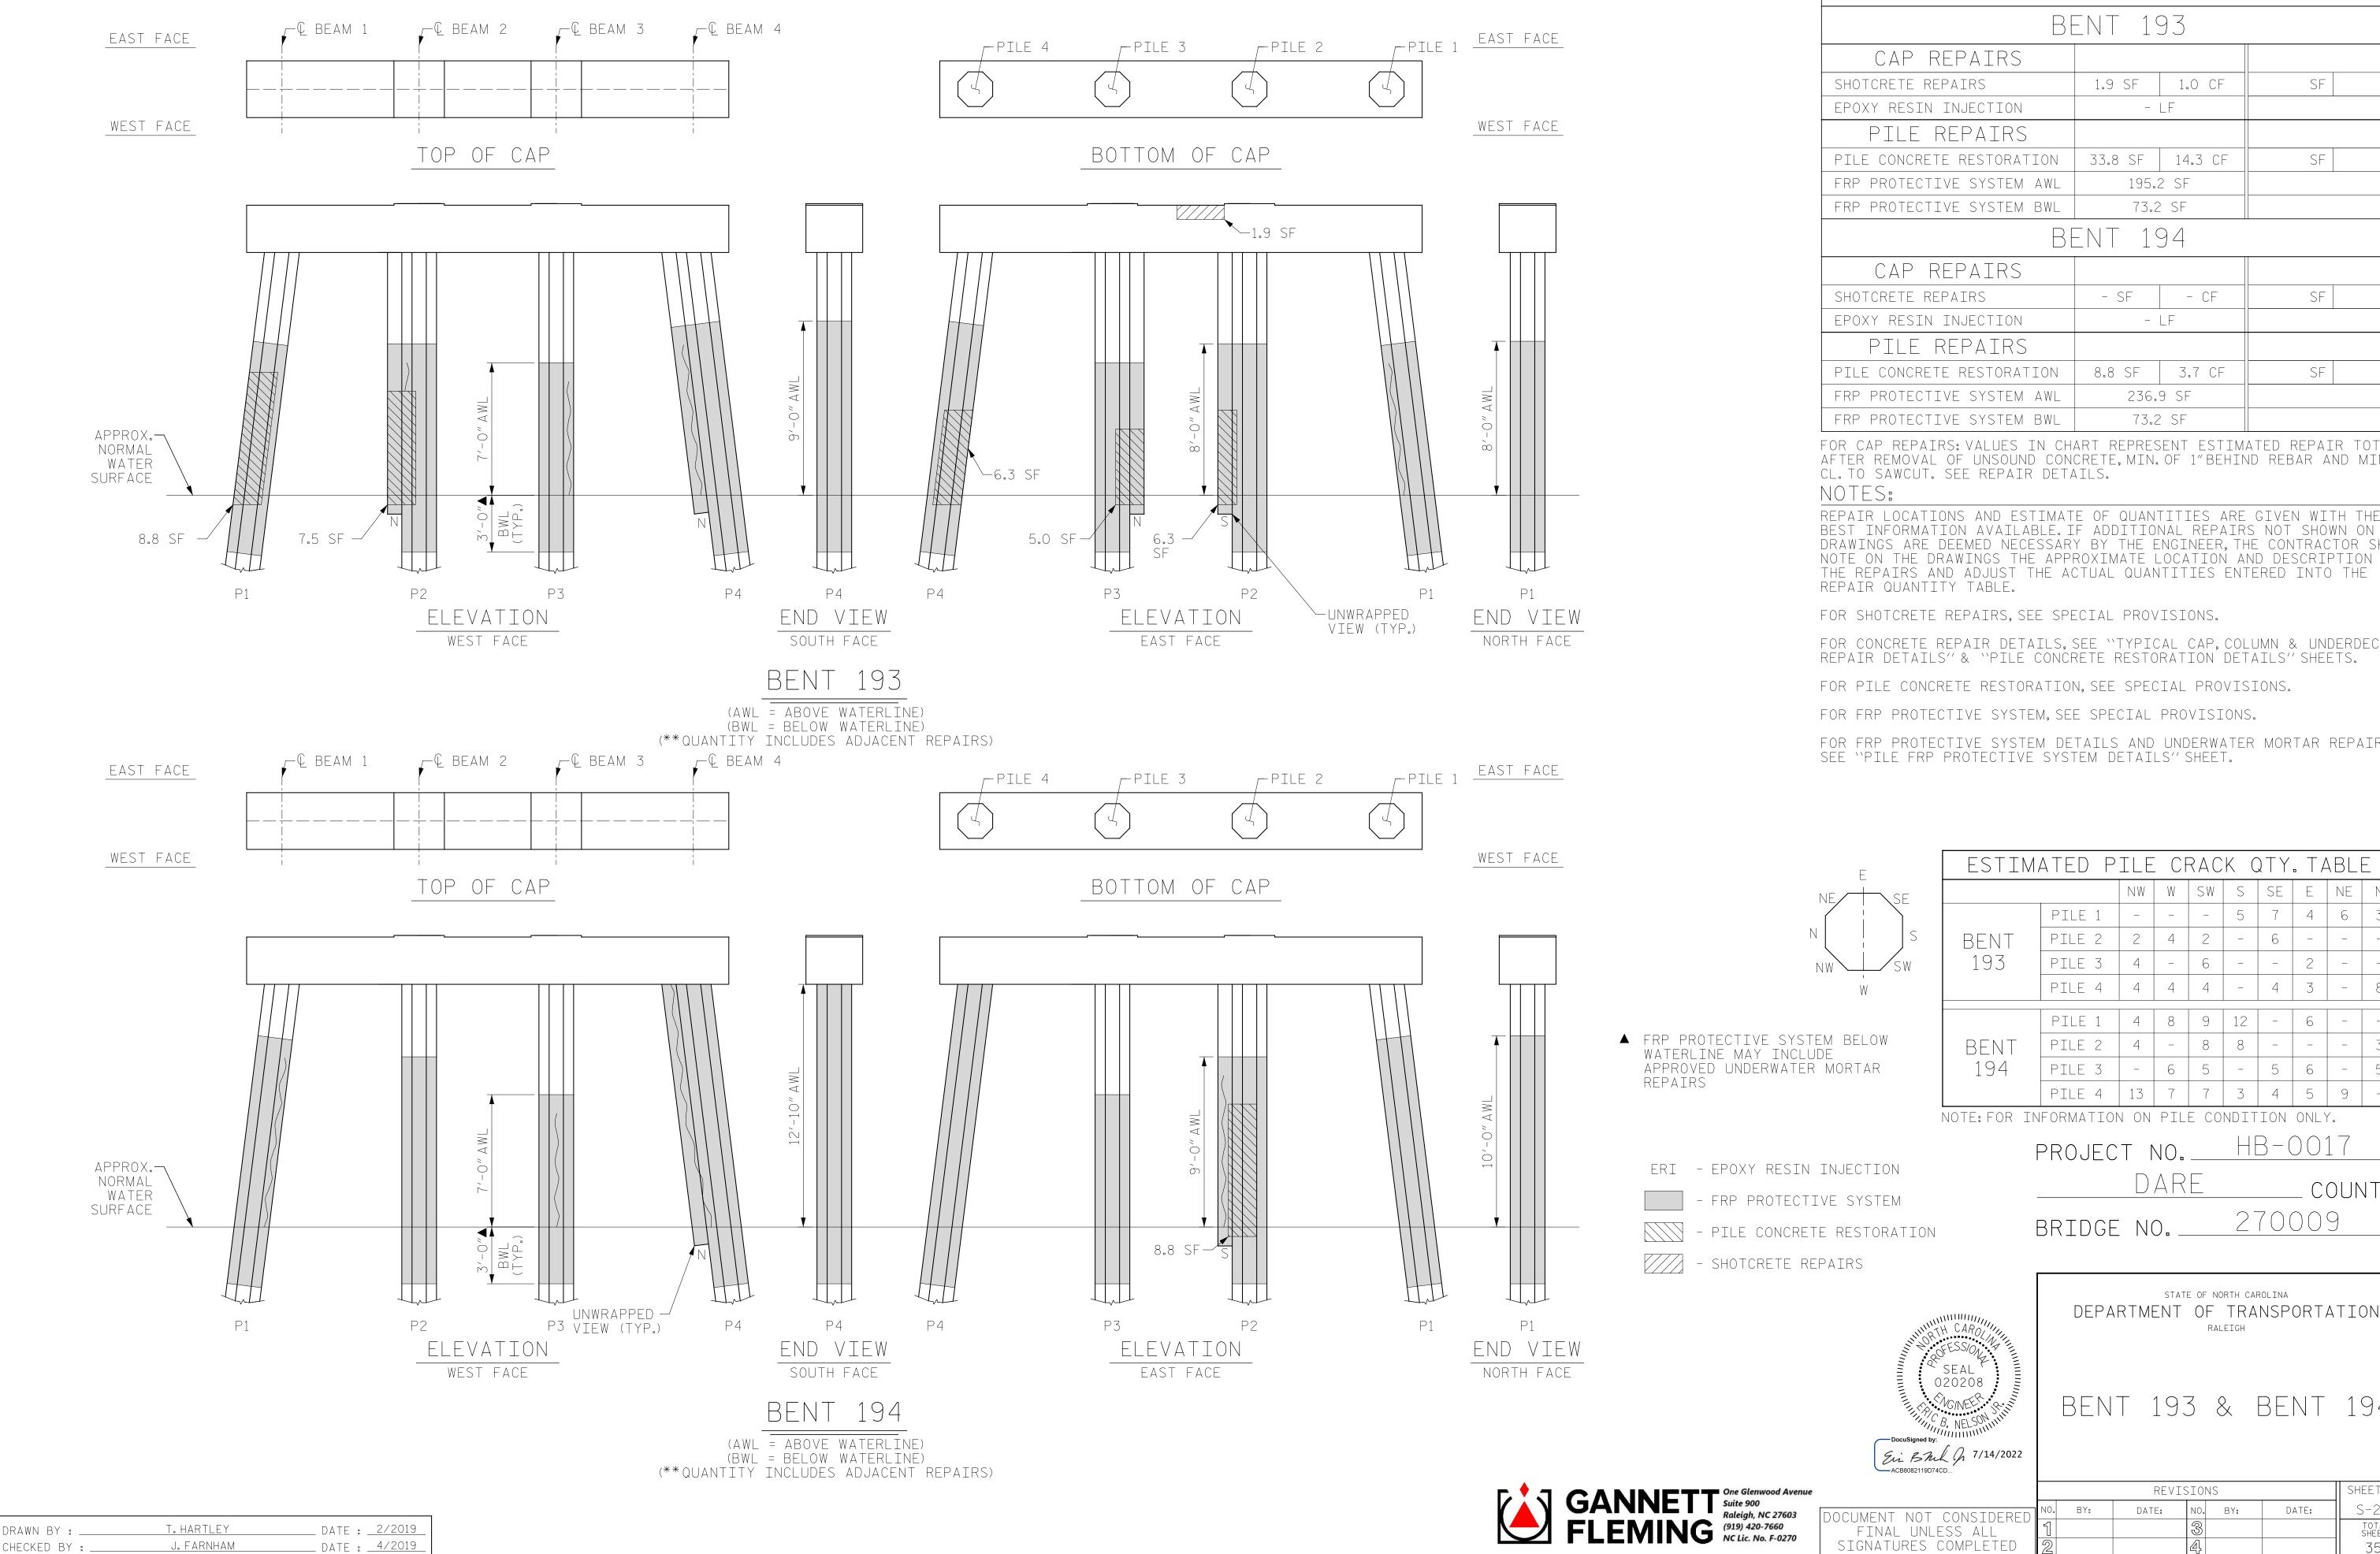
B	\equiv NT 19	93		
CAP REPAIRS				
SHOTCRETE REPAIRS	1.9 SF	1.0 CF	SF	CF
EPOXY RESIN INJECTION	_	LF		LF
PILE REPAIRS				
PILE CONCRETE RESTORATION	33.8 SF	14.3 CF	SF	CF
FRP PROTECTIVE SYSTEM AWL	195.2 SF			
FRP PROTECTIVE SYSTEM BWL	73.2 SF

CAP REPAIRS					
SHOTCRETE REPAIRS	- SF	- CF	SF	CF	
EPOXY RESIN INJECTION	_	LF		LF	
PILE REPAIRS					
PILE CONCRETE RESTORATION	8.8 SF	3.7 CF	SF	CF	
FRP PROTECTIVE SYSTEM AWL	236.9 SF				
FRP PROTECTIVE SYSTEM BWL	73.2 SF

ESTIMATED PILE CRACK QTT. TABLE									
		NW	W	SW	S	SE	E	NE	Ν
BENT 193	PILE 1	_	_	_	5	7	4	6	3
	PILE 2	2	4	2	_	6	_	_	_
	PILE 3	4	_	6	_	_	2	_	_
	PILE 4	4	4	4	_	4	3	I	8
BENT 194	PILE 1	4	8	9	12	_	6	-	_
	PILE 2	4	_	8	8	_	_	_	3
	PILE 3	_	6	5	_	5	6	_	5
	PILE 4	13	7	7	3	4	5	9	_
OTE: FOR THEORMATTON ON PTIE CONDITTON ONLY
