AS-BUILT REPAIR QUANTITY TABLE

PROJECT NO. HB-0017
DARE COUNTY
BRIDGE NO. 270009

STATE OF NORTH CAROLINA
DEPARTMENT OF TRANSPORTATION
RALEIGH

BENT 197 & BENT 198

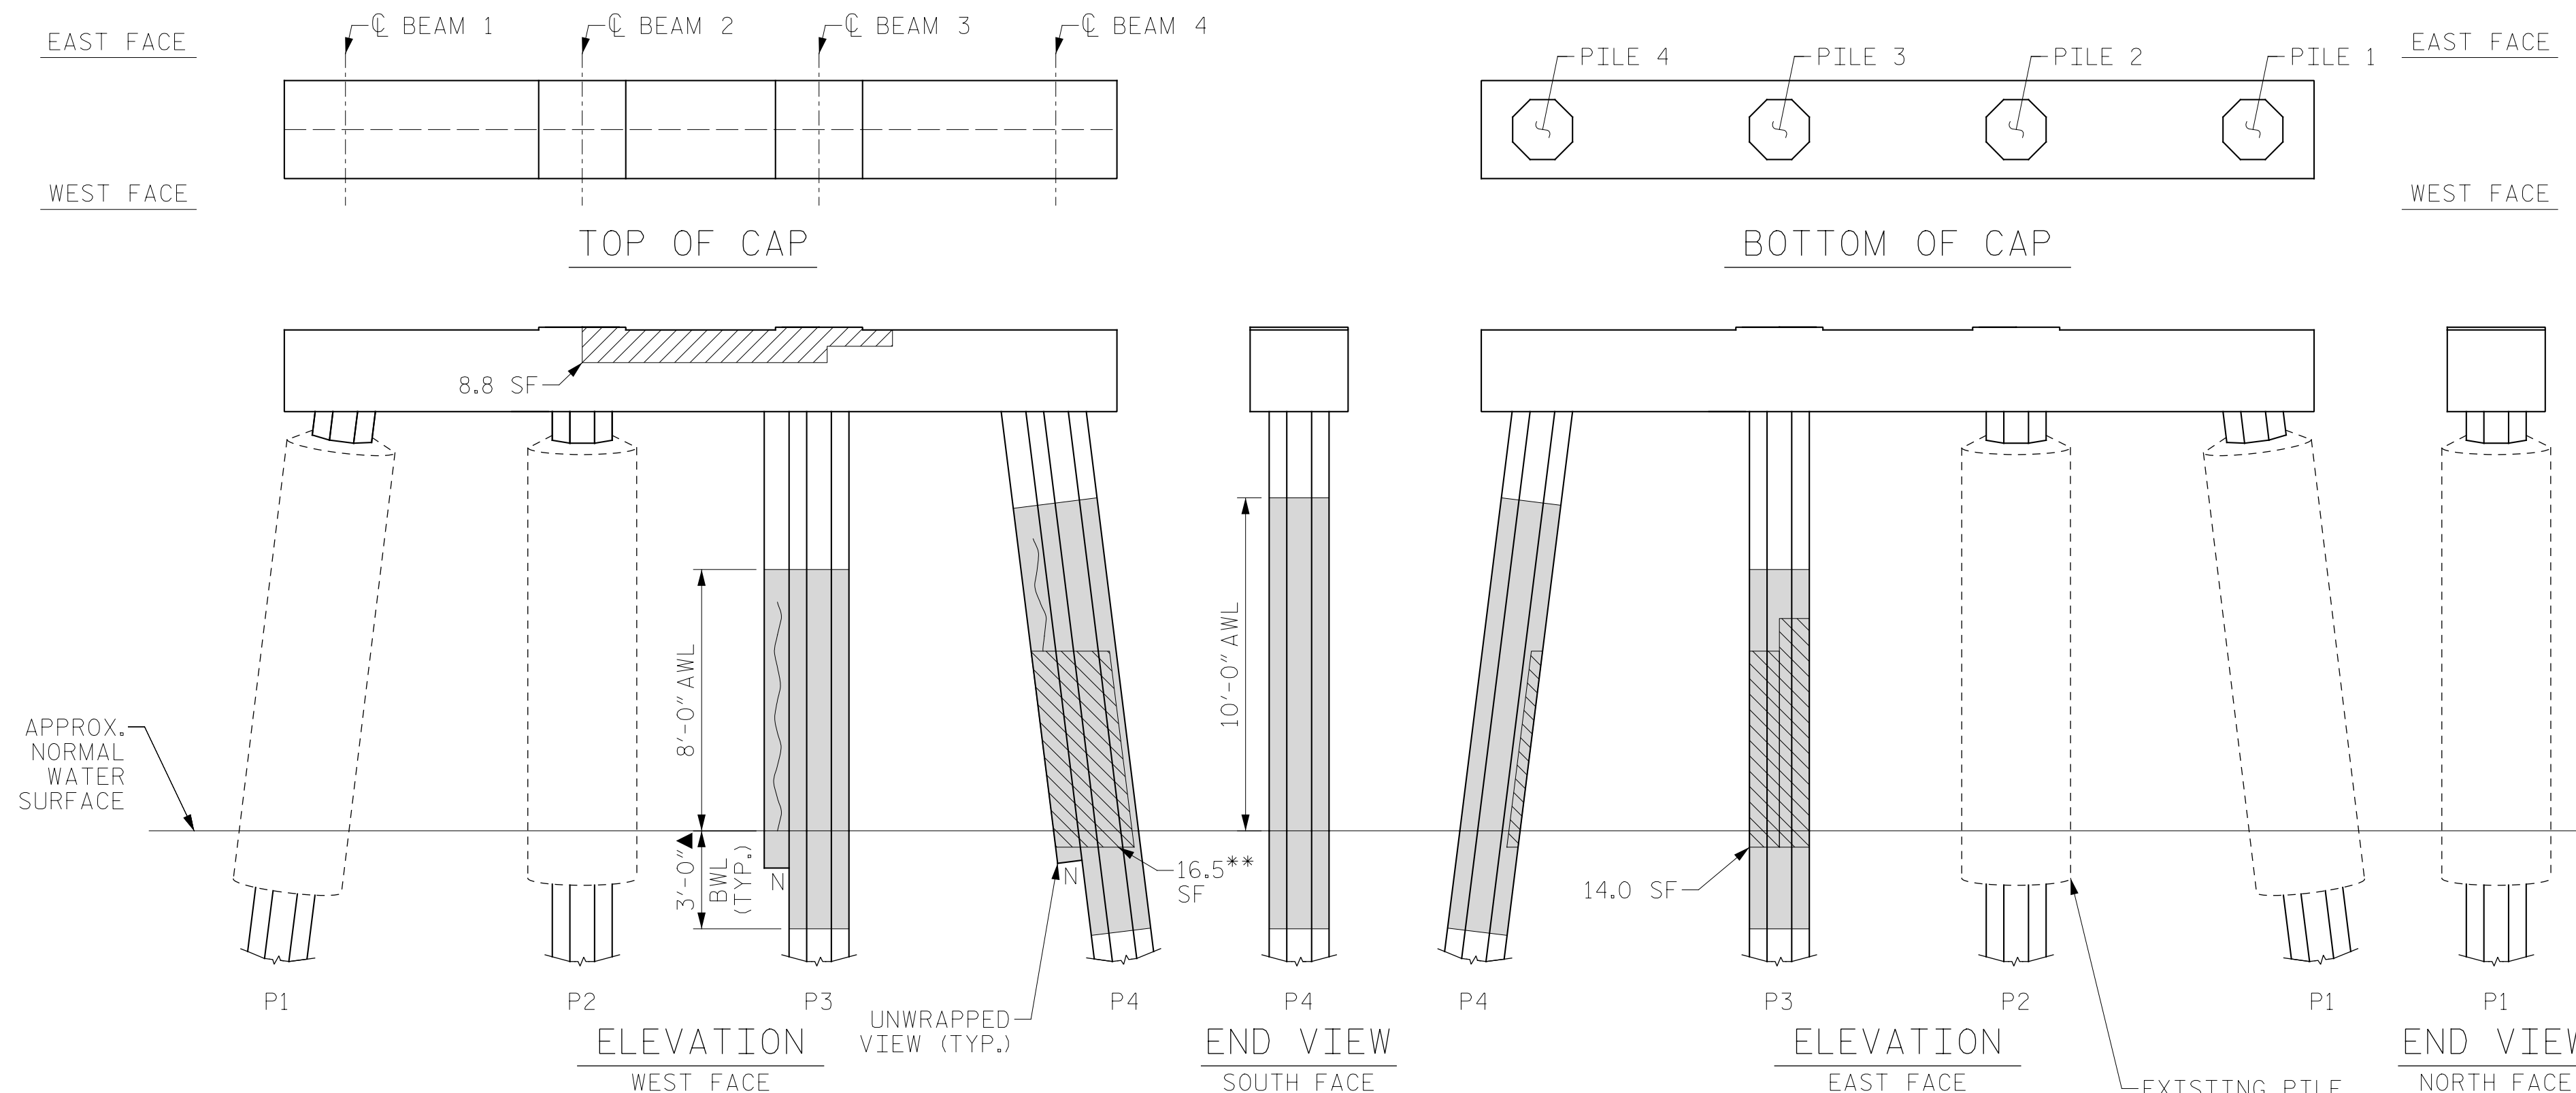
BENT 197

CAP REPAIRS			
SHOTCRETE REPAIRS	8.8 SF	4.4 CF	SF CF
EPOXY RESIN INJECTION	- LF		LF
PILE REPAIRS			
PILE CONCRETE RESTORATION	30.5 SF	12.1 CF	SF CF
FRP PROTECTIVE SYSTEM AWL	109.8 SF		
FRP PROTECTIVE SYSTEM BWL	36.6 SF

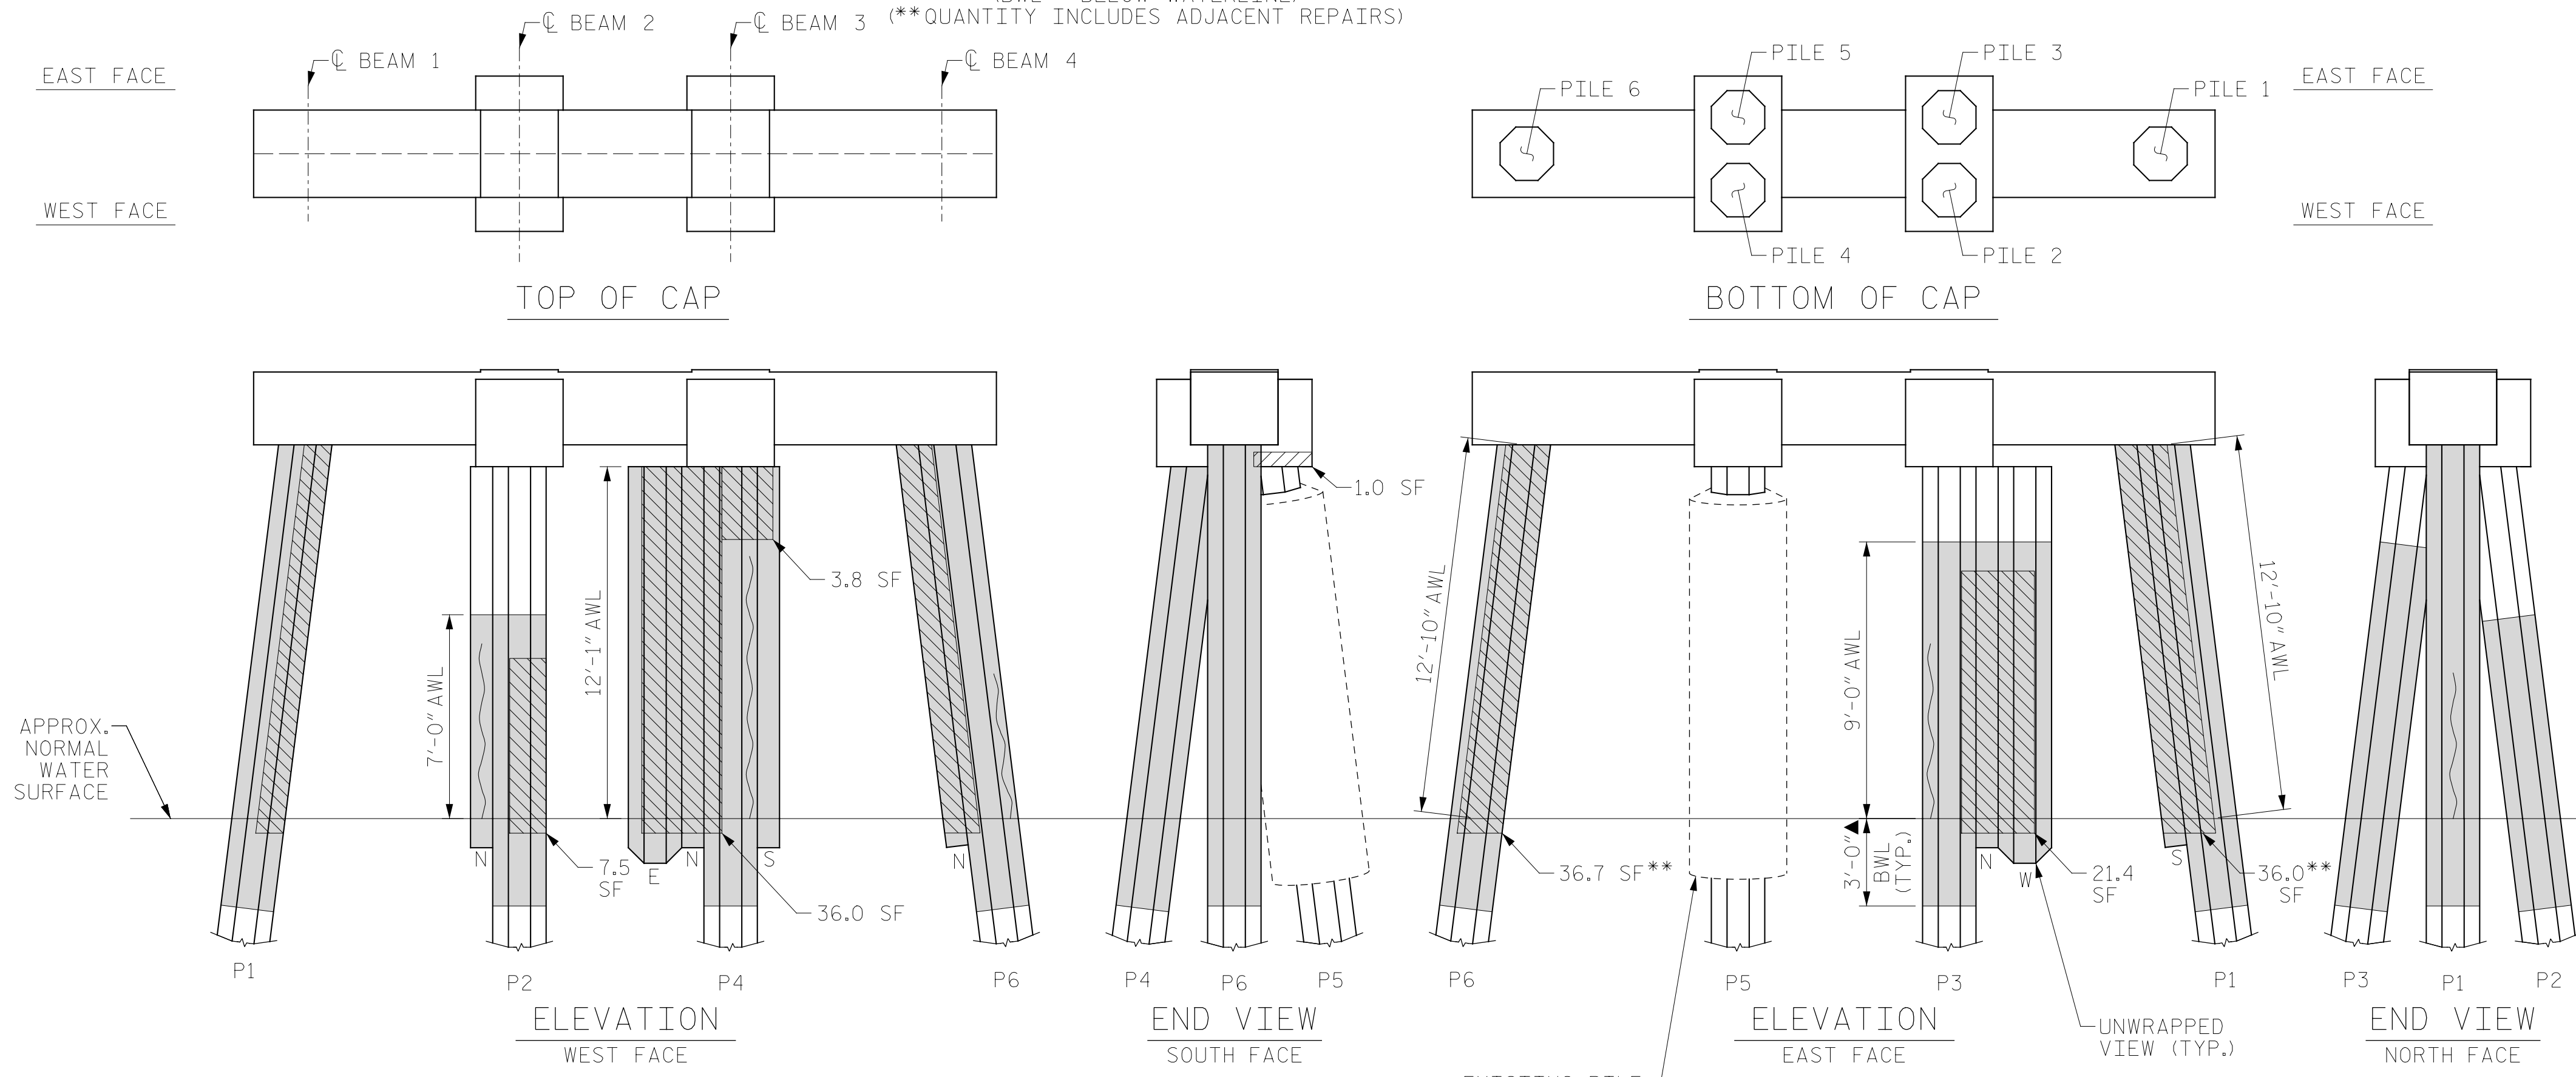
BENT 198

CAP REPAIRS			
SHOTCRETE REPAIRS	1.0 SF	0.5 CF	SF CF
EPOXY RESIN INJECTION	- LF		LF
PILE REPAIRS			
PILE CONCRETE RESTORATION	141.3 SF	56.5 CF	SF CF
FRP PROTECTIVE SYSTEM AWL	327.9 SF		
FRP PROTECTIVE SYSTEM BWL	91.5 SF
