AS-BUILT REPAIR QUANTITY TABLE

PROJECT NO. HB-0017  
DARE COUNTY  
BRIDGE NO. 270009

BENT 199 & BENT 200

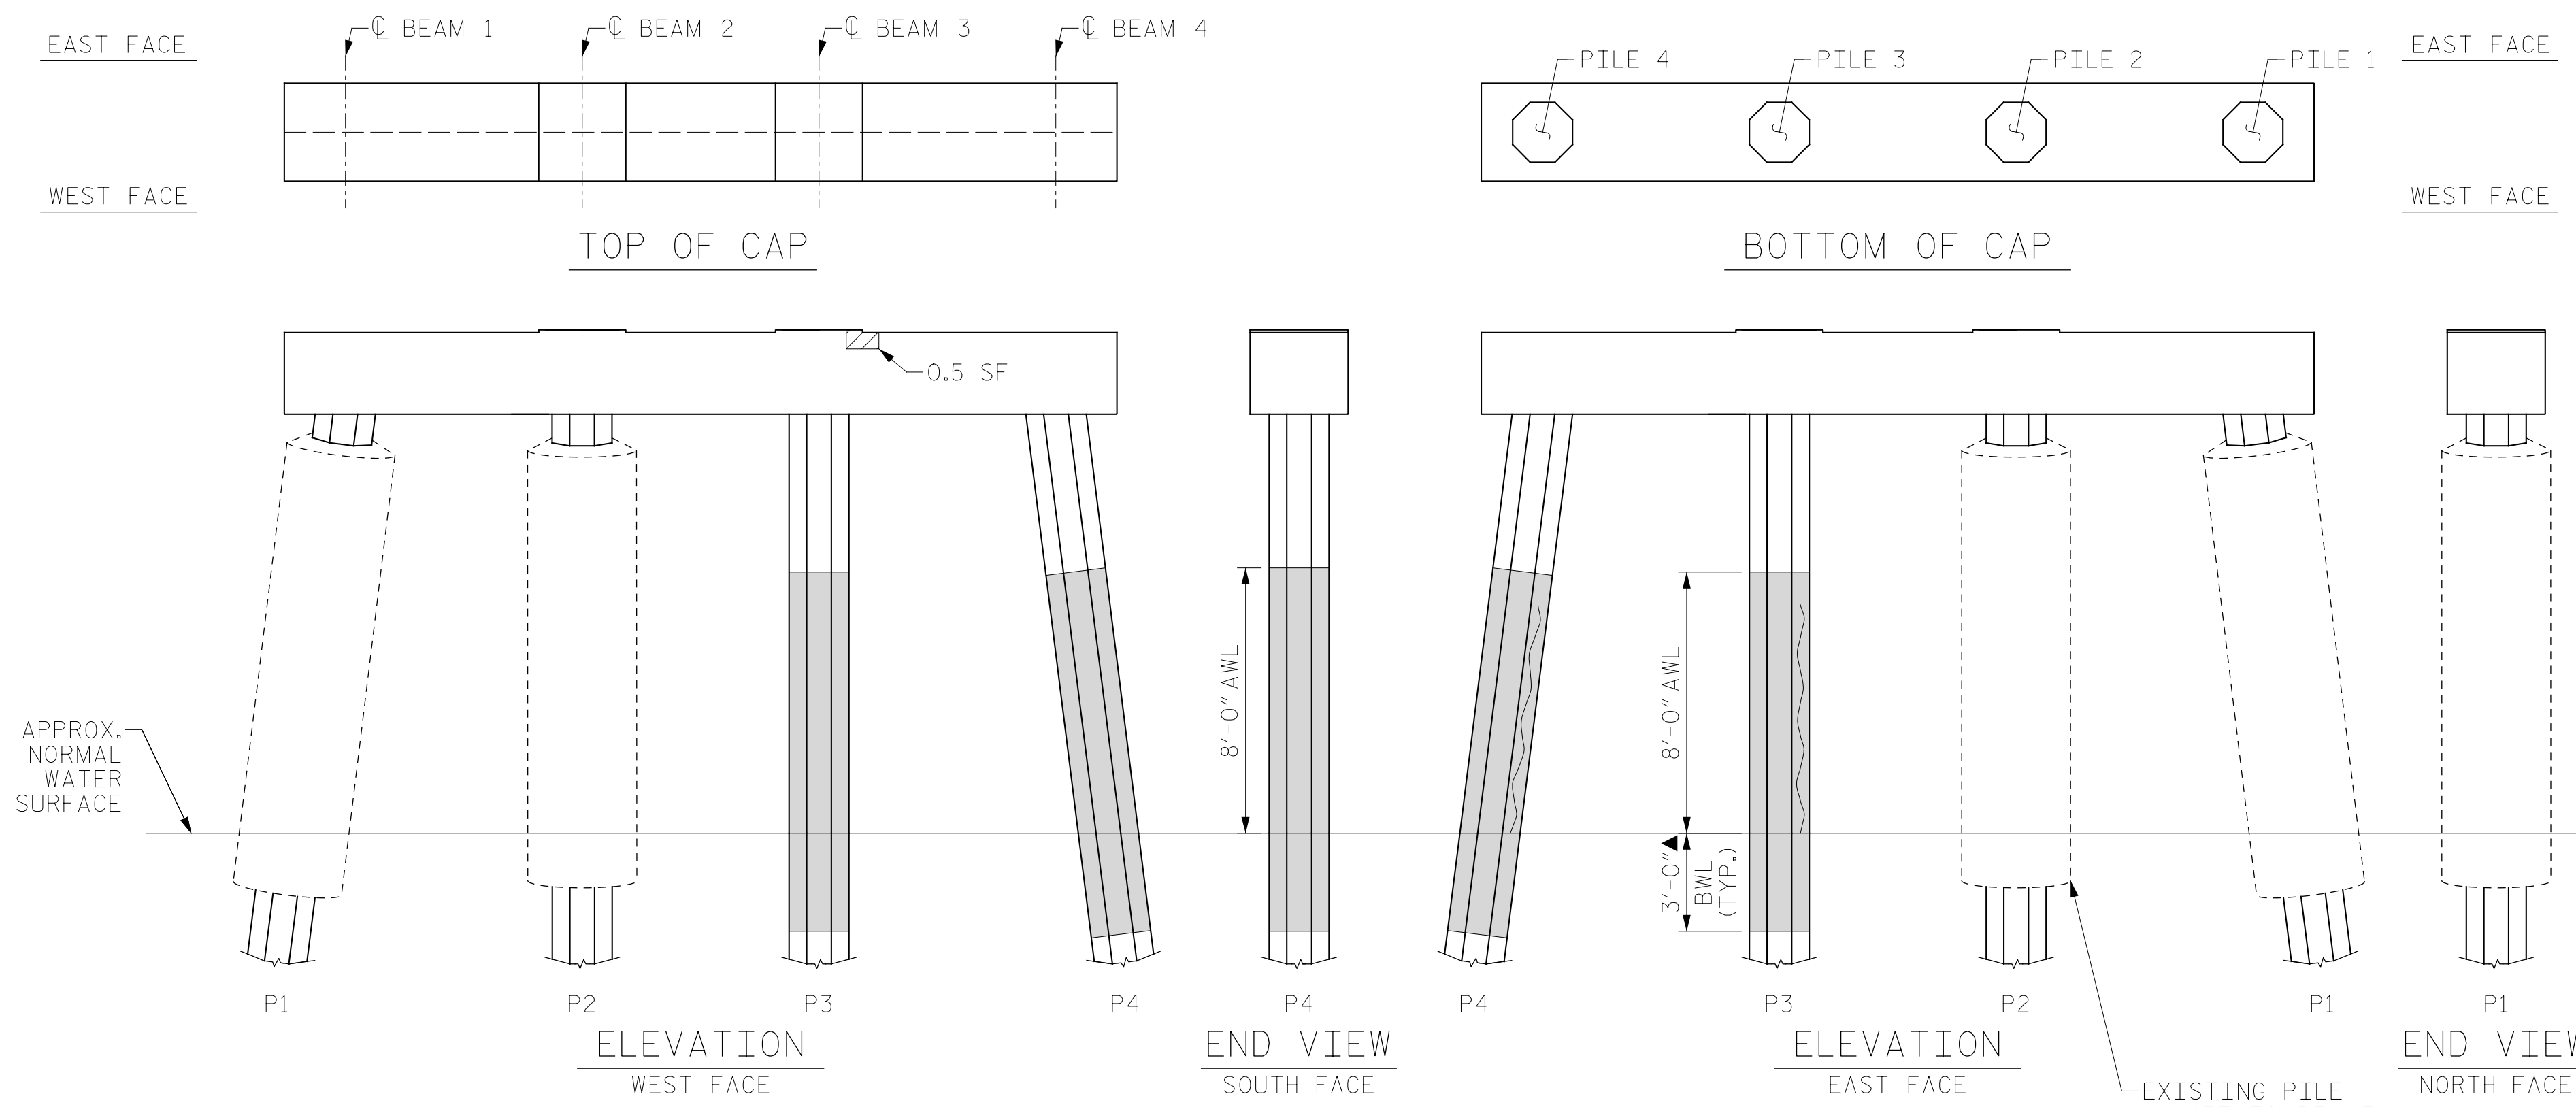
BENT 199

CAP REPAIRS			
SHOTCRETE REPAIRS	0.5 SF	0.3 CF	
EPOXY RESIN INJECTION	- LF		
PILE REPAIRS			
PILE CONCRETE RESTORATION	- SF	- CF	
FRP PROTECTIVE SYSTEM AWL	97.6 SF		
FRP PROTECTIVE SYSTEM BWL	36.6 SF

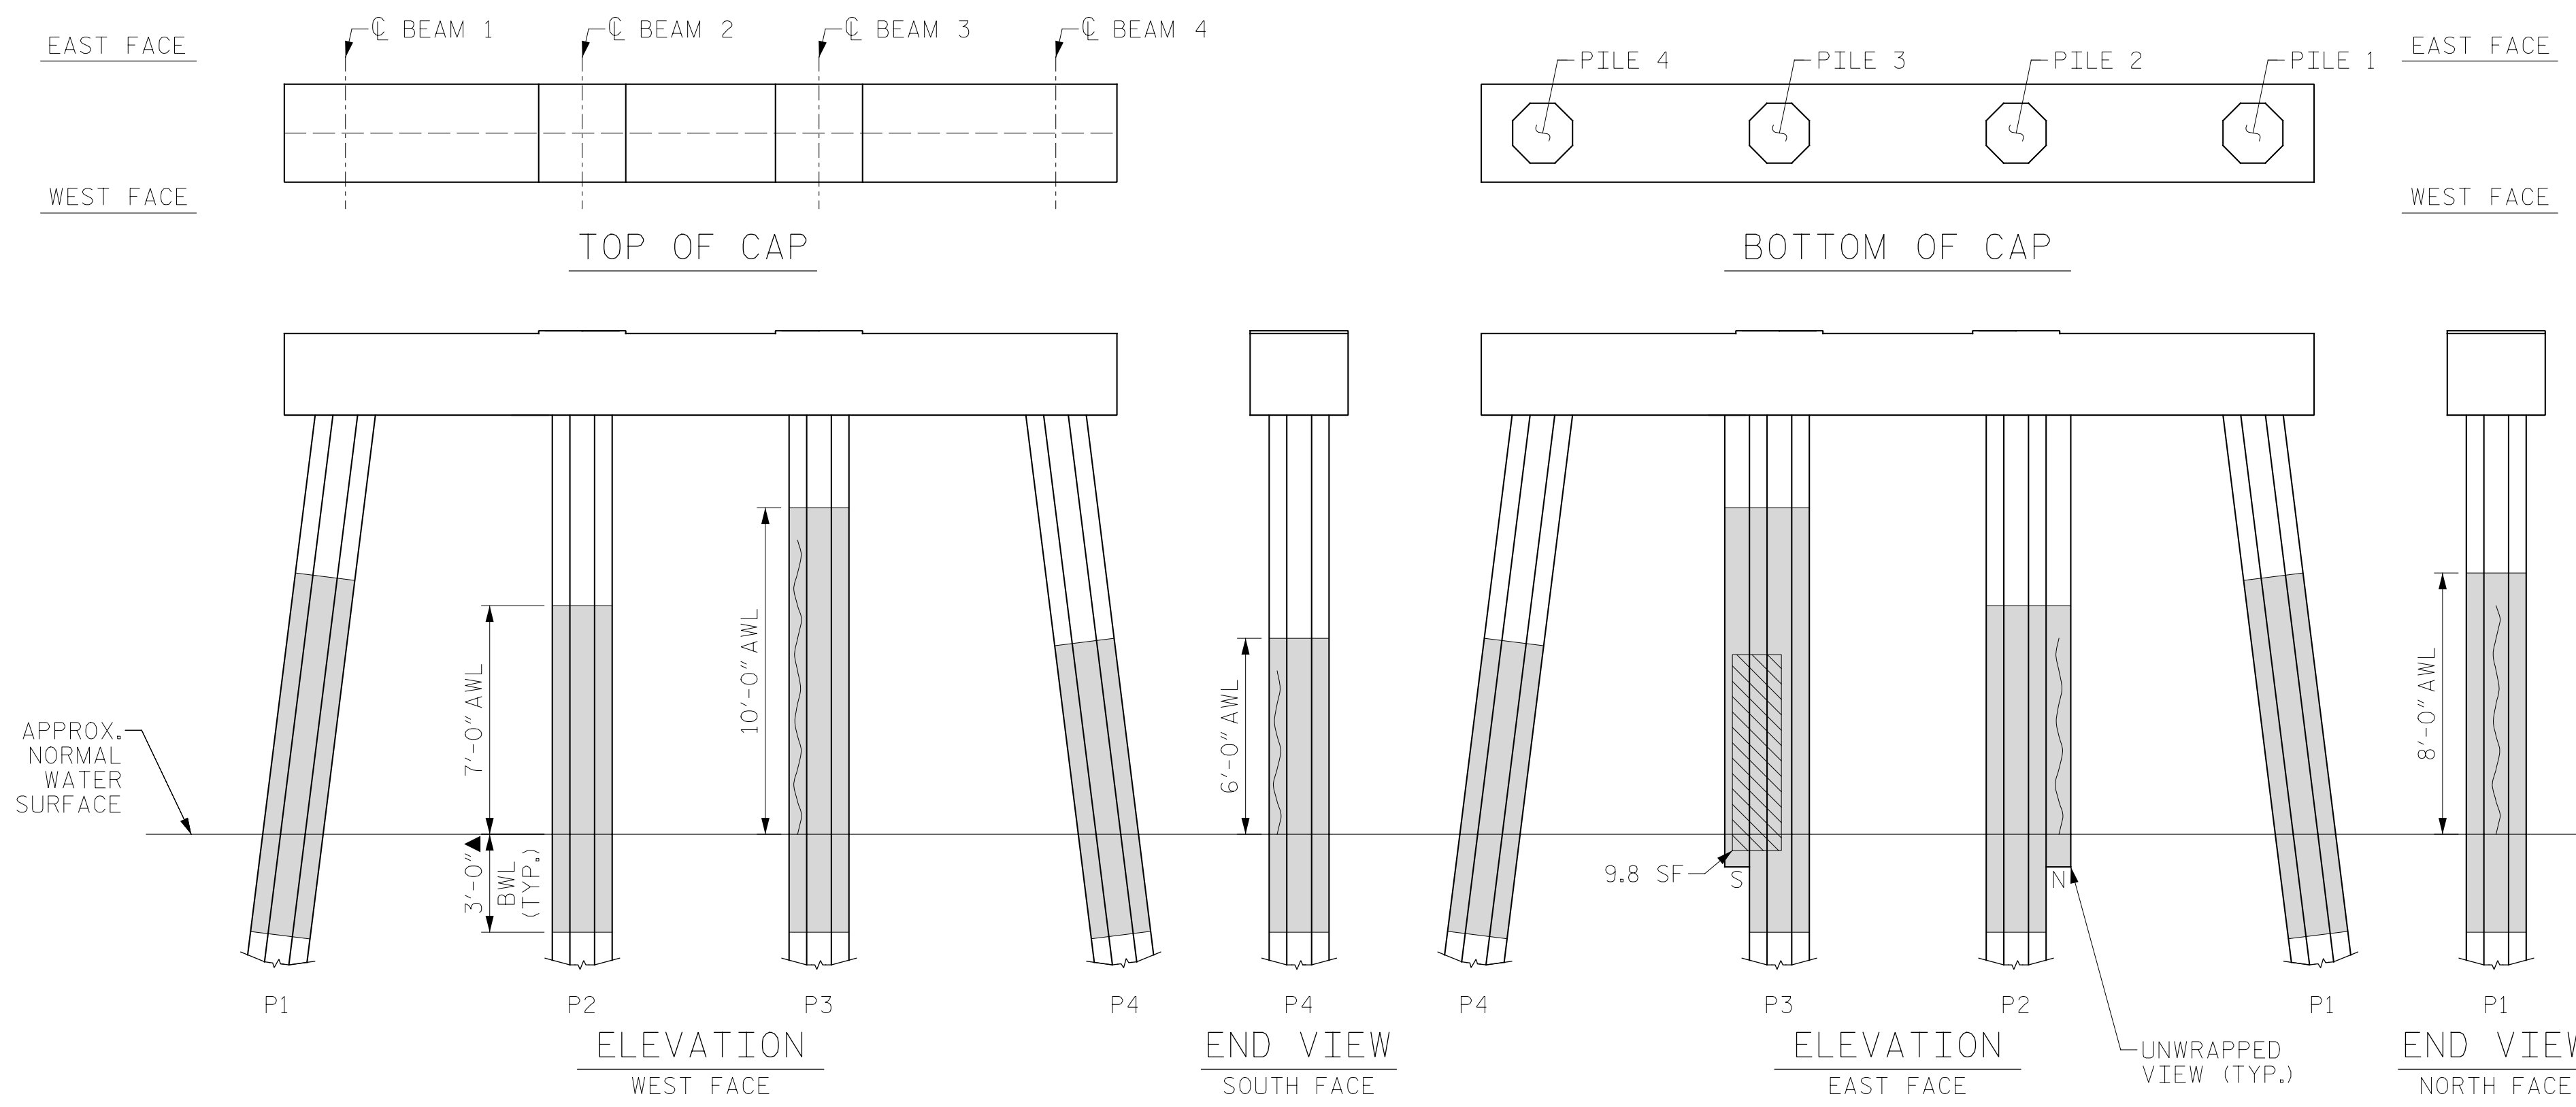
BENT 200

CAP REPAIRS			
SHOTCRETE REPAIRS	- SF	- CF	
EPOXY RESIN INJECTION	- LF		
PILE REPAIRS			
PILE CONCRETE RESTORATION	9.8 SF	4.4 CF	
FRP PROTECTIVE SYSTEM AWL	189.1 SF		
FRP PROTECTIVE SYSTEM BWL	73.2 SF
